Central Police Station Conservation
and Revitalisation Project:
71st Monthly EM&A Report
(1 September to 30 September 2017)

Issue Date: October 2017

Central Police Station Conservation
and Revitalisation Project:
71st Monthly EM&A Report
(From 1 September to 30 September
2017)

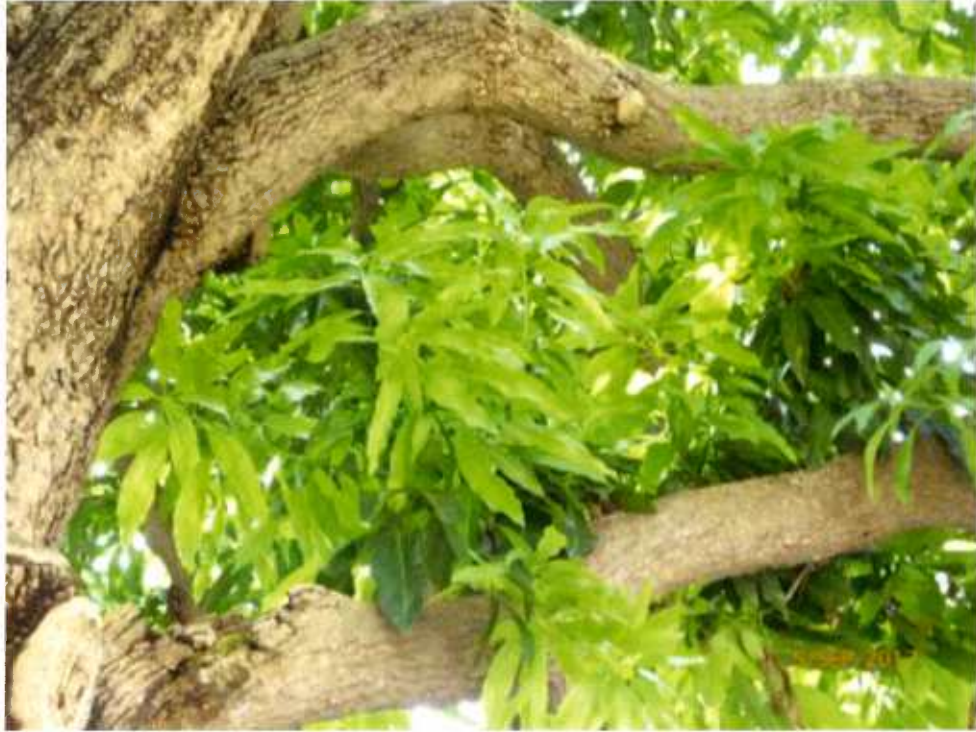
| Tree No. | Botanical Name | Overall Health Condition | Arborist's Observations / Recommendations |
|---|---|---|--|
| Tree -5 | <i>Mangifera indica</i> | Fair | <ul style="list-style-type: none"> • Signs of pests (Mealy Bugs) were observed on the tree. • Application of pesticides and pruning of decayed logs should be carried out as soon as possible. |

Fig. 9 Signs of Pest (Mealy Bugs 粉狀介殼蟲) are found on the tree.

After the monthly tree inspection by the arborist on 5 September 2017, pesticide application and pruning of decayed logs on Tree 5 has been conducted on 26 September 2017.

1. Pest control operation and pruning of decayed logs should be conducted as soon as possible.

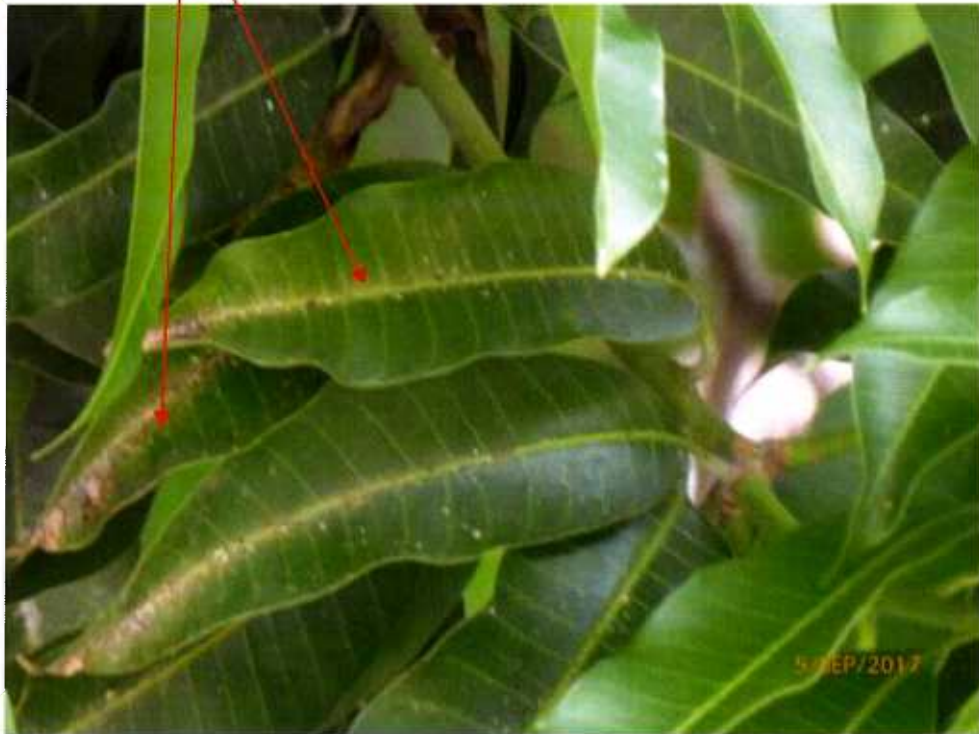
Fig. 10 Some affected leaves have felled on ground.

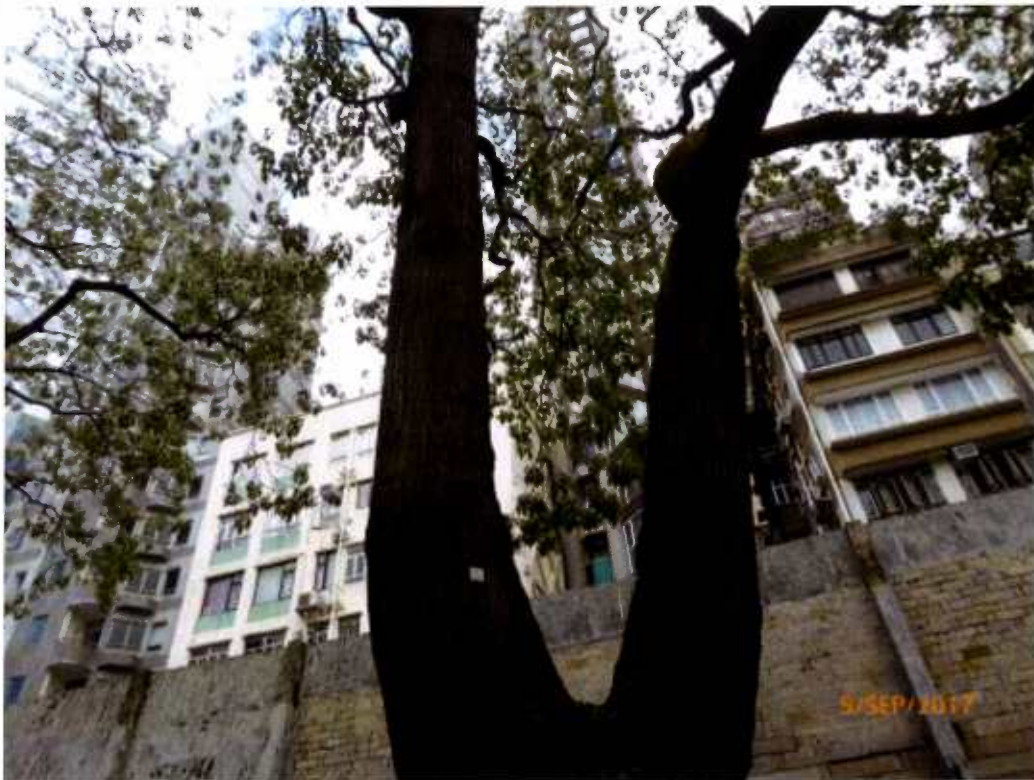
Fig. 6 Leaves on the crown are rather sparse.

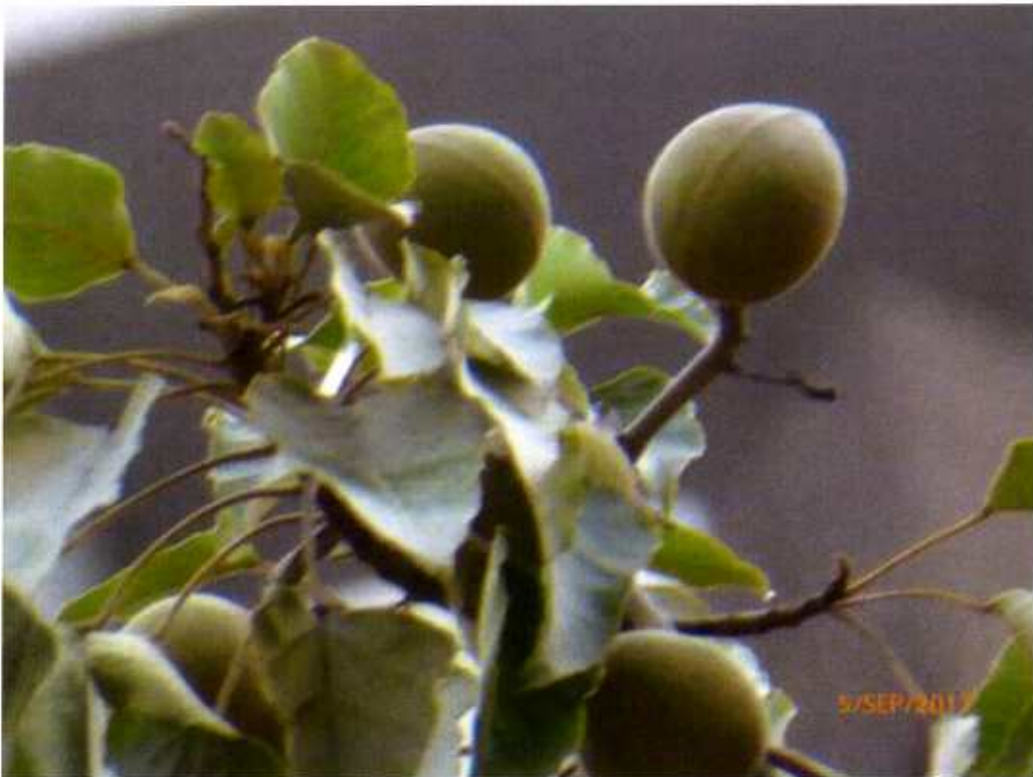
Fig. 10 Signs of Pest “白粉蝨 (*Trialeurodes vaporariorum*)” are rarely found on the leaves due to Pest Control Operation on 3rd & 4th Aug. 2017.

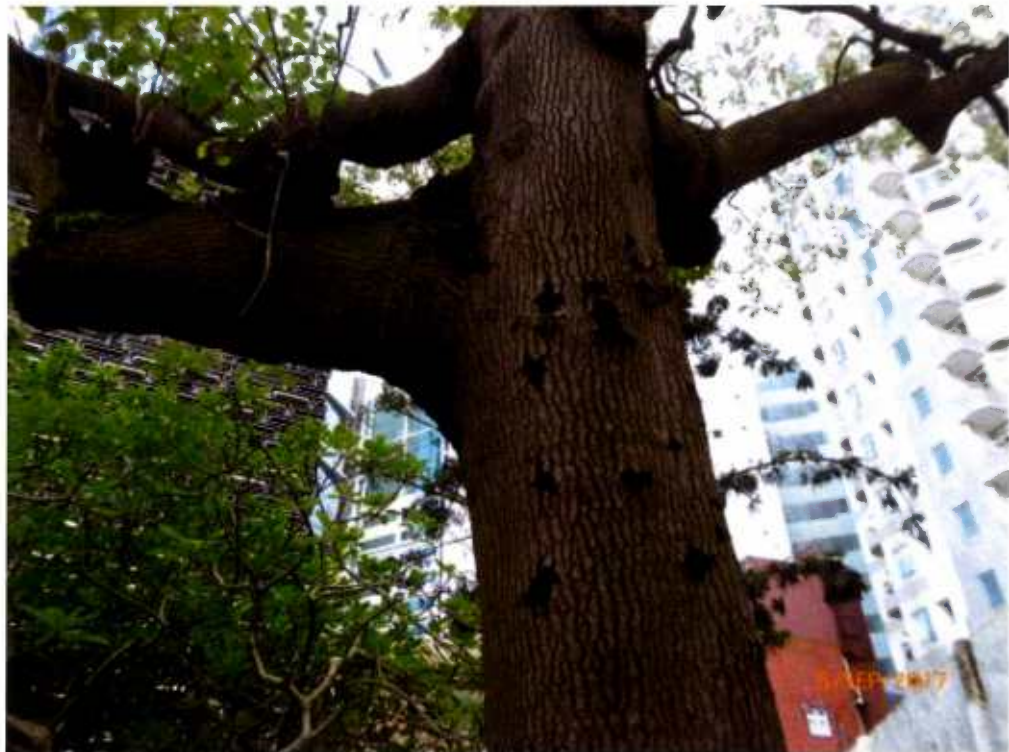
Fig. 6 Leaves on the crown are rather sparse.

1. **Keep close monitoring on the growth of the tree.**

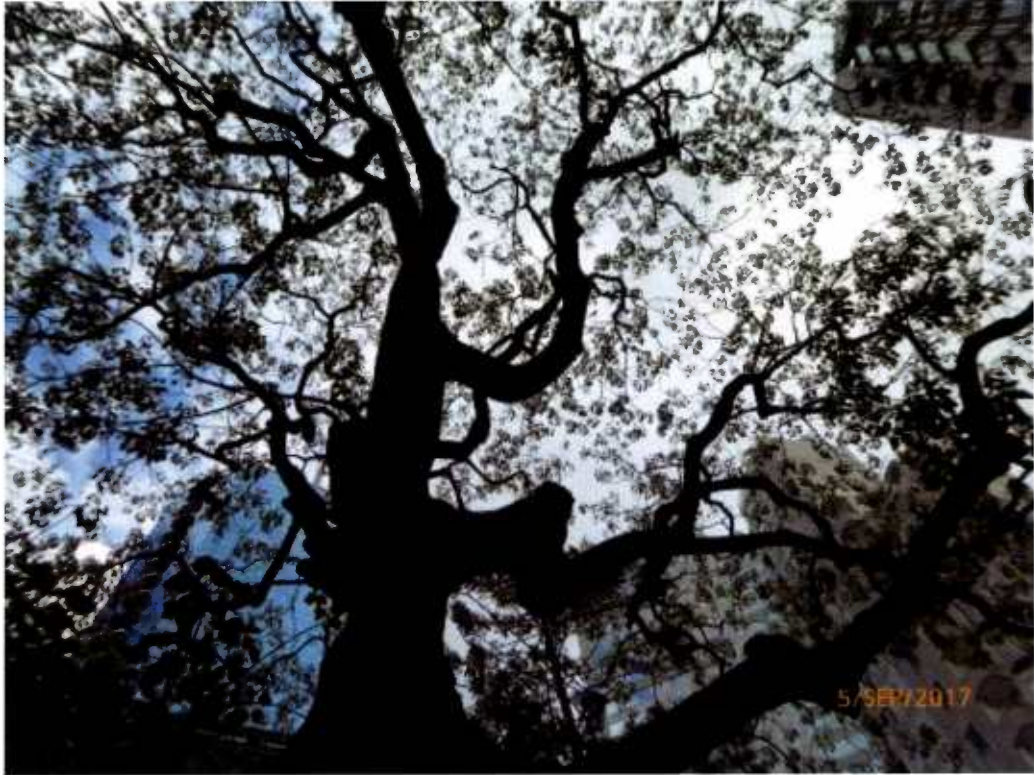
Fig. 7 Signs of Pest “白粉蝨 (*Trialeurodes vaporariorum*)” have apparently reduced due to Pest Control Operation on 3rd & 4th Aug. 2017.

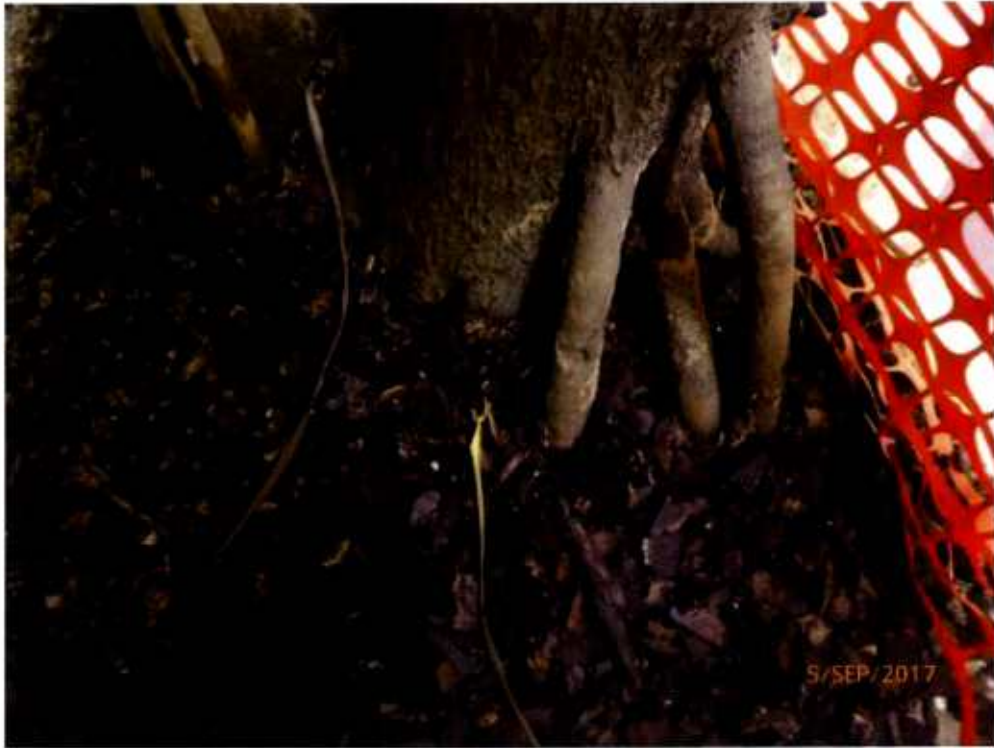
Fig. 3 Lots of construction debris were found at the planter during the previous inspection on 4th August 2017.

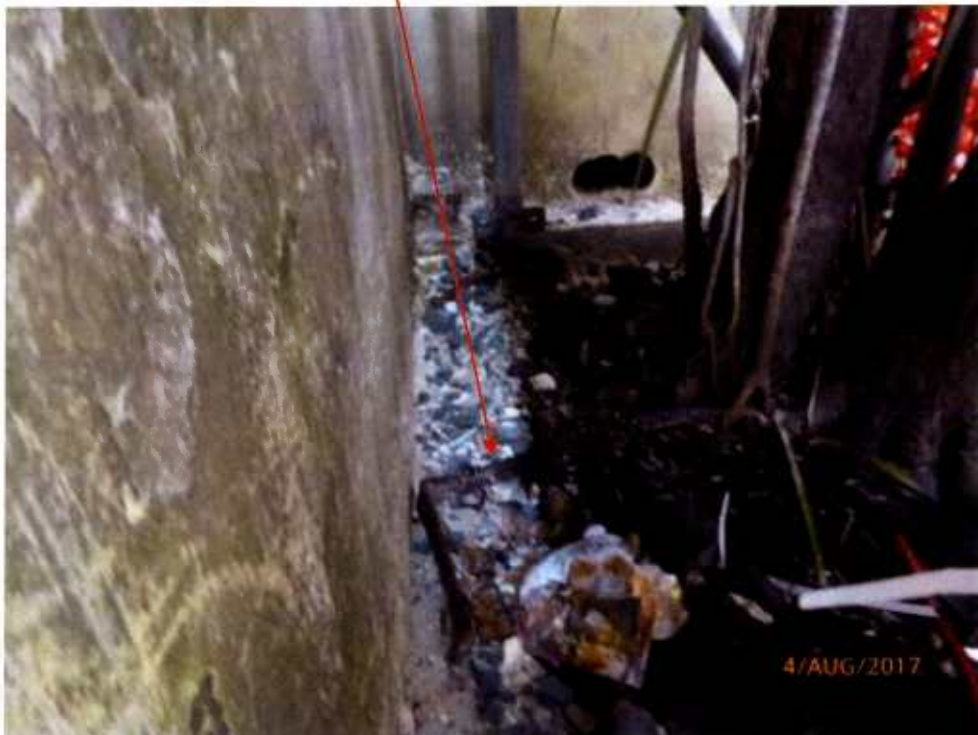
| Tree No. | Botanical Name | Overall Health Condition | Arborist's Observations / Recommendations |
|---|---|---|--|
| Tree-11 | <i>Dracaena marginata</i> | Fair | <ul style="list-style-type: none"> • Construction debris observed in the last inspection has been removed from the planter. • Withered leaves were observed on the tree. • The Contractor should closely monitor the growth of the tree. |

Fig. 4 Construction debris had been removed away prior to inspection on 5th Sept. 2017.

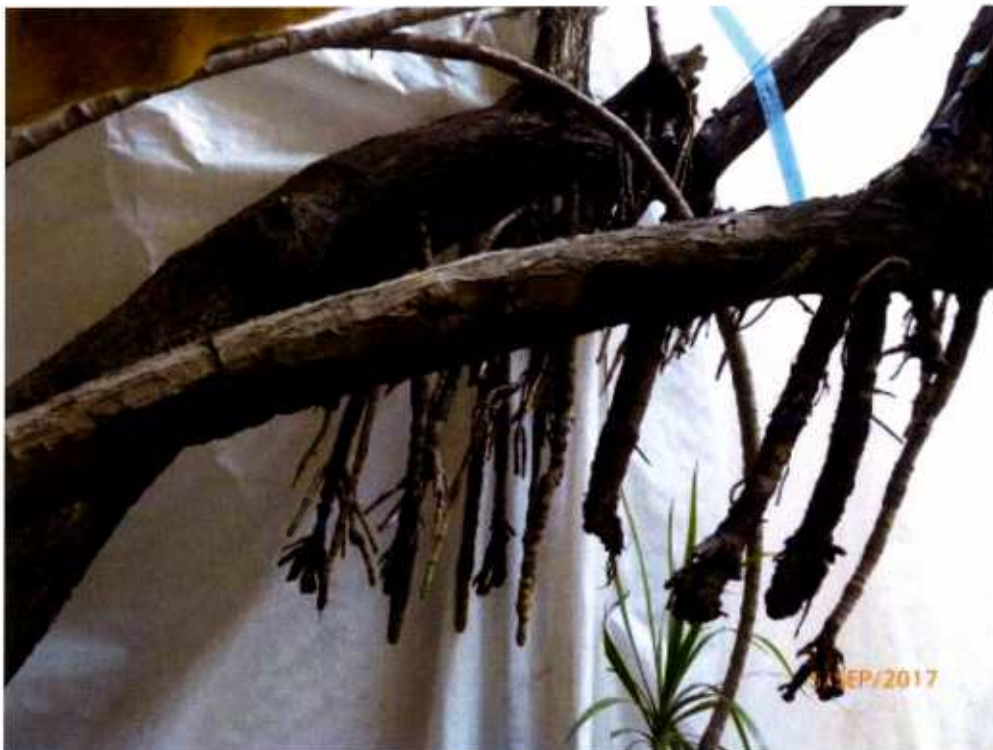
Fig. 8 Withered leaves still remain on the tree.
