Proposed Recovery Work for Block 4 at

The Central Police Station Compound

PURPOSE OF PAPER

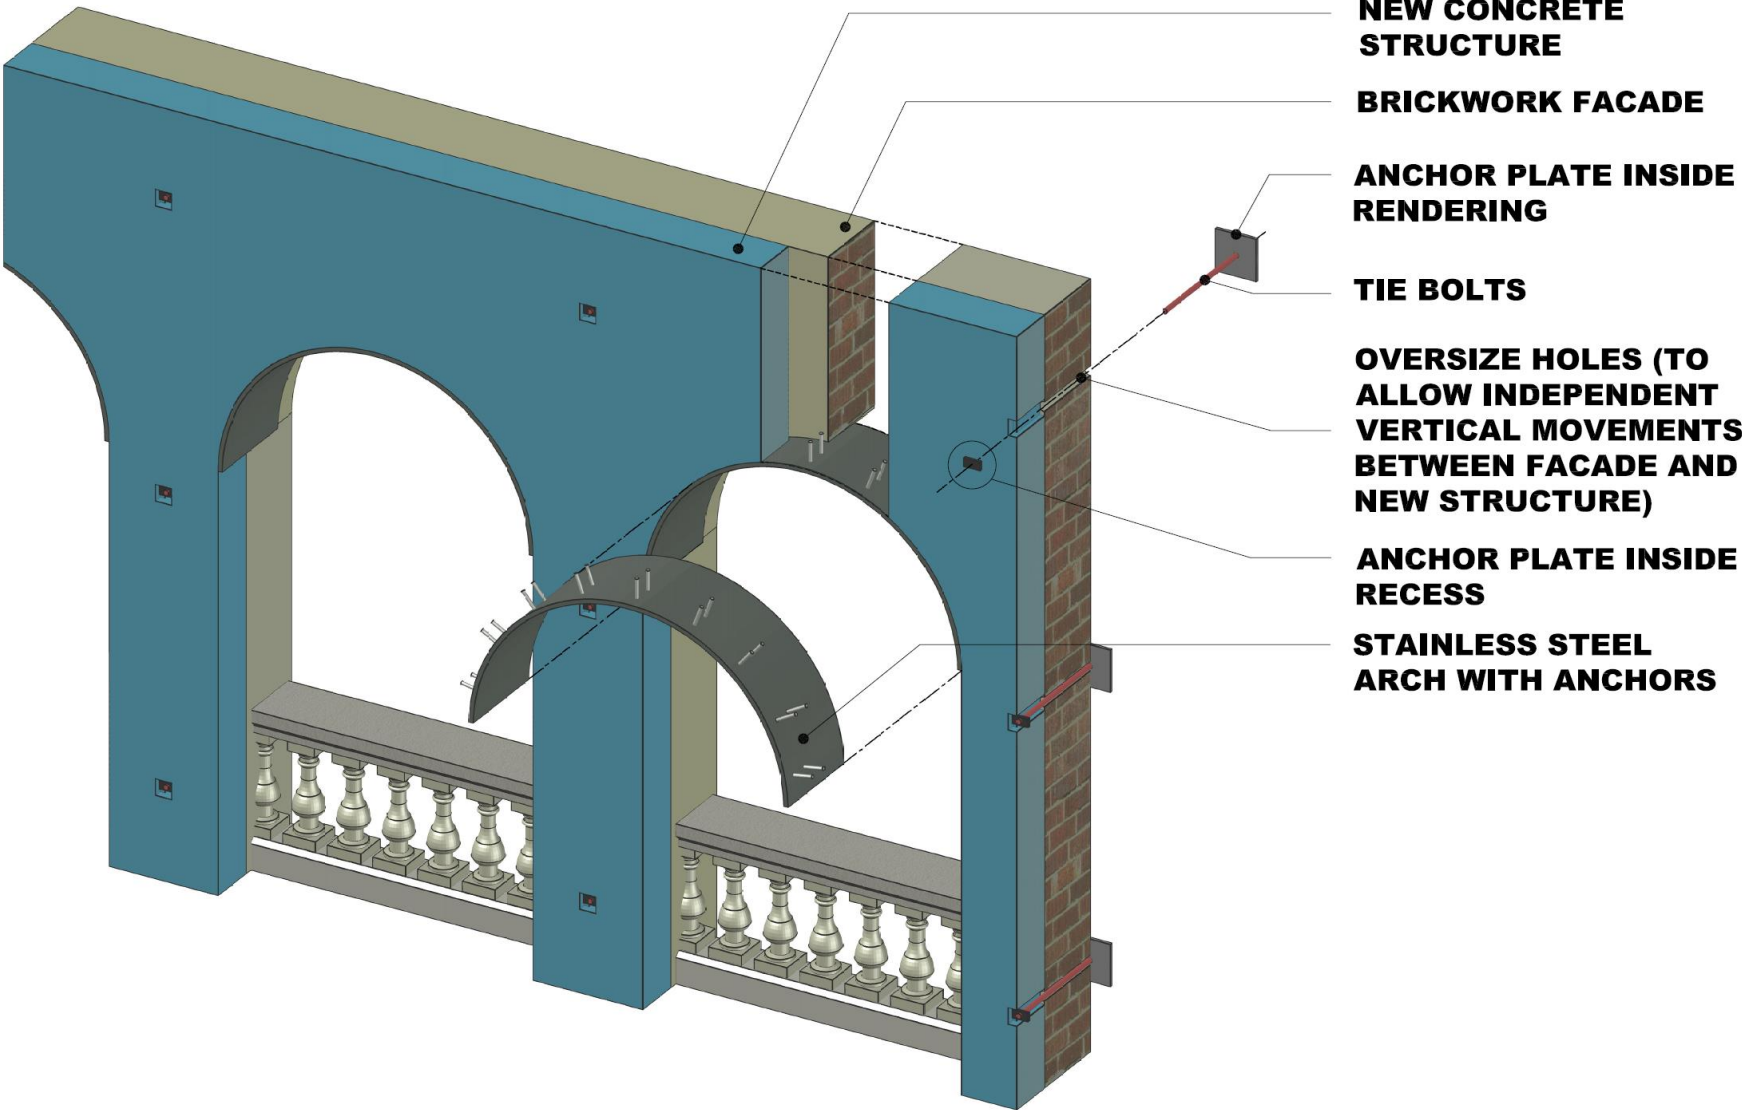
TIE BOLTS AND STEEL ARCH TO SUPPORT BRICKWORK FACADE

Structural frame: In order to safely recover Block 4, priority must be given to retaining the exterior walls of the extant part as they are the façade of the building. The prerequisite to strengthening the exterior walls is to create a structural frame inside the building, thus taking the load away from the external walls (Refer to Appendix II for plan and sections). The existing brick walls cannot be relied upon for strengthening because they, too, are very weak and supported with props. Reinforced concrete frame was selected as the optimal solution as it is easier to adapt to the uneven profile of the building and offers the best protection with the lowest risk. The new concrete frame will comprise new concrete floors, columns and walls. The concrete walls will also act as stiff shear walls to reduce wind loads transferred to the weak brickwork.² The concrete frame will be tied to the external brick walls with stainless steel bolts. Vertical sliding joints will be added between the concrete frame and the brickwork to take away vertical loads from the brickwork. In addition, brick arches will be supported by stainless steel arches underneath, which can prevent the bricks from falling and thereby enable it to function (Refer to Appendix III).

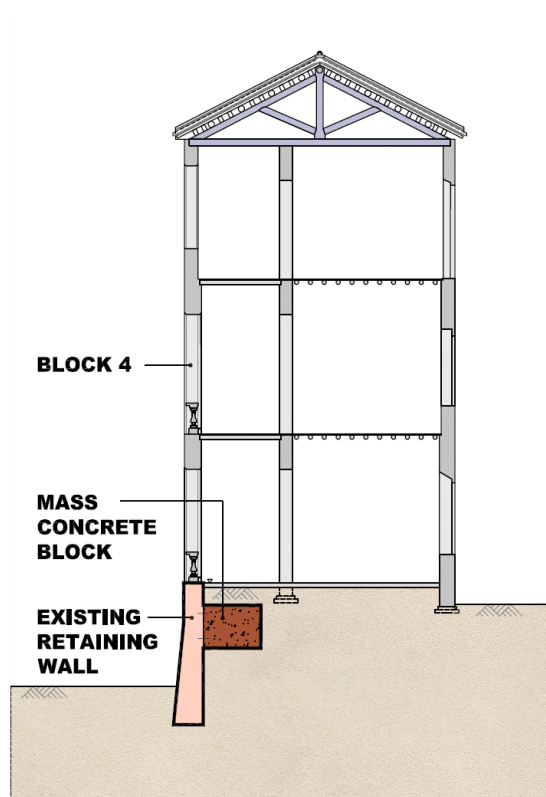
APPENDIX IV

RETAINING WALL STABILIZATION

Retaining wall: Block 4 as a whole will bear new weight after adding the new strengthening materials mentioned above. It is therefore important to ensure that the weight will not create undue load to the granite retaining wall adjacent to Arbuthnot Road, on which Block 4 is sitting. In this respect, a number of possible approaches were explored, including the use of soil nails and building a supplementary retaining wall. It was concluded that the least disruptive solution was to install a cast mass concrete behind the existing retaining walls. This will help stabilise the retaining wall, another important heritage feature of the CPS Compound, without any visual impact on it.

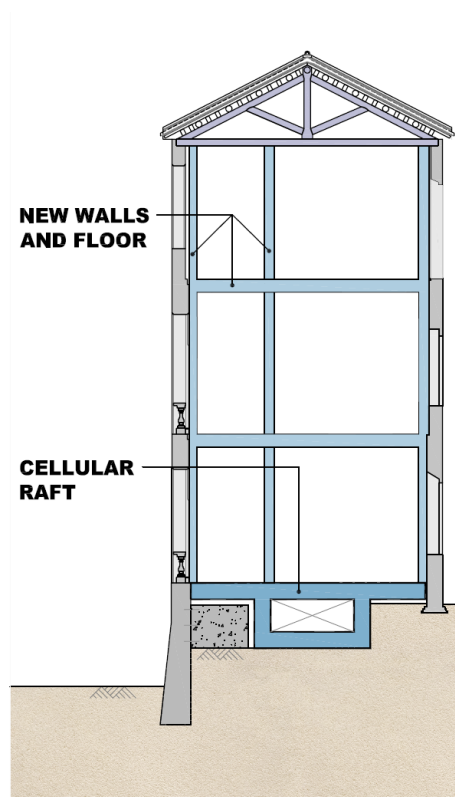
NEW CELLULAR RAFT FOUNDATION

Foundation: On building a new foundation for the extant part of Block 4, a number of methods were considered. These included pile foundation and construction of a shallow raft, a deep raft, or a cellular raft. It was concluded that a cellular raft system was the only viable option as it could even out the load across the footprint of the building and sit well with the

cast mass concrete behind the retaining wall. Furthermore, the system can provide a uniform load platform for the whole building because the new annex will also be built on a cellular raft foundation. This method will also require removing the existing interior walls and floors during work and reinstating them after the construction of the foundation system (Refer to Appendix IV).
