Central Police Station Conservation  
and Revitalisation Project:  
*Second Monthly EM&A Report*  
*(1 December to 31 December 2011)*

Issue Date: January 2012

**Environmental Resources Management**

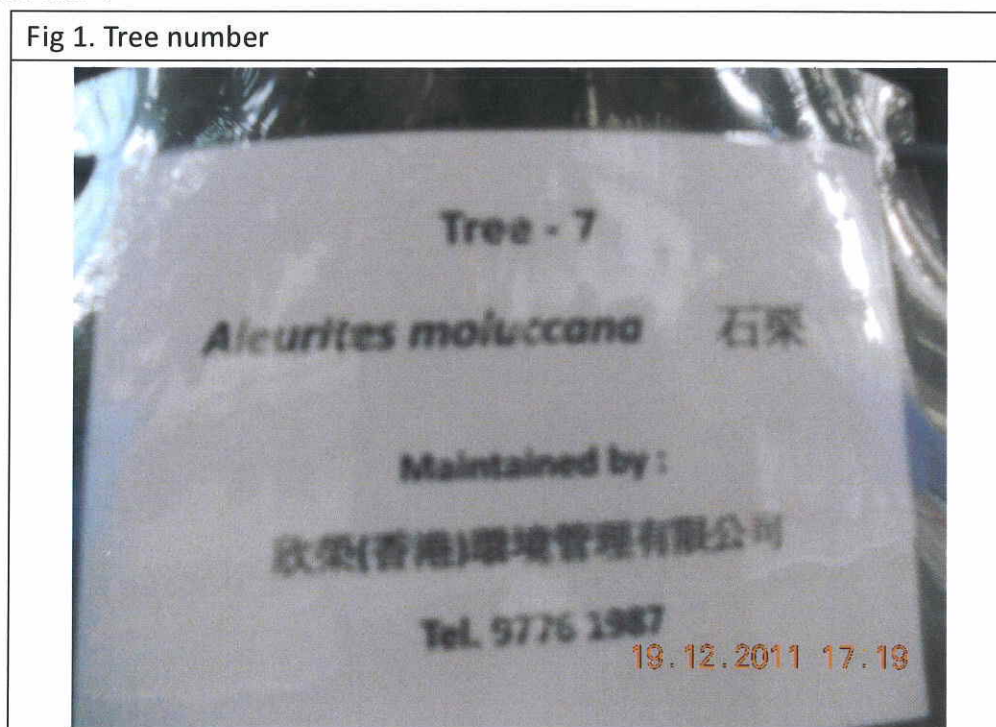
1. Overall health condition of the tree is fair at the time of inspection.
2. A few rubbish has been found at the planter.
3. A net-wired fence in 2.5m H with a padlocked door has been erected to create a protection zone for the tree.
4. Appropriate notices/warning signs being displayed at the site.

Fig 2. A few rubbish has been found at the planter.

1. To remove the rubbish from the planter.

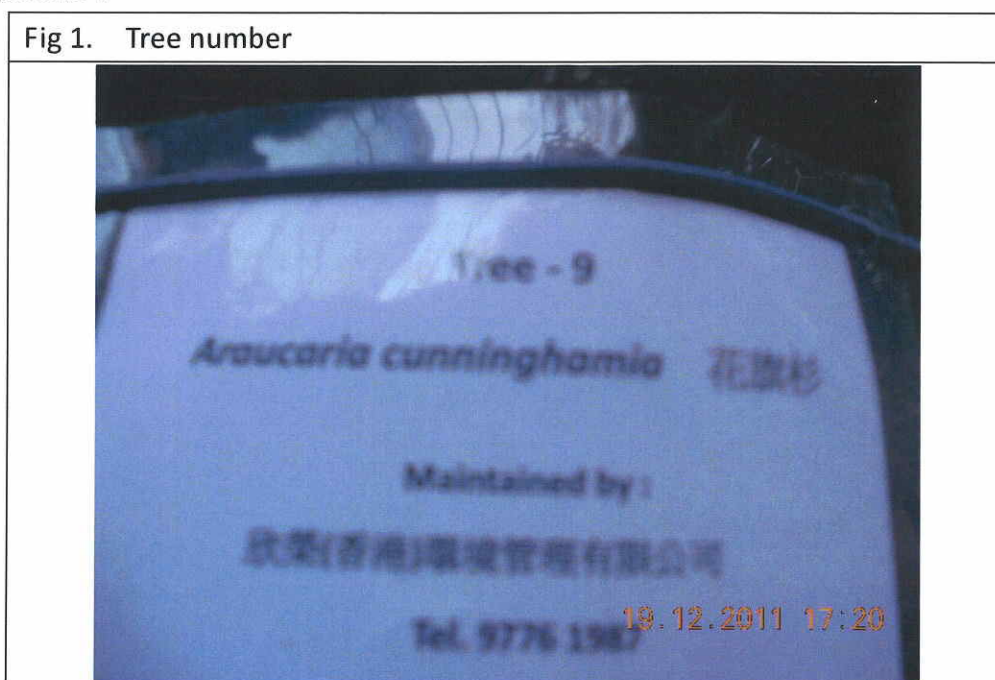
1. Overall health condition of the tree is fair.
2. The planter is clean and tidy at the time of inspection.
3. A barbed wire (about 30cm L) has been found on the mid trunk.
4. A net-wired fence in 2.5m H with a padlocked door has been erected to create a protection zone for the tree.
5. The door has been properly locked and restricts admittance to the protection zone.
6. Appropriate notice displays in front of the protection zone.

Fig 2. The planter is clean and tidy. A barbed wire (about 30cm L) has been found on the mid trunk.

1. To cut off the outer part of the barked wire (about 30 cm in length) from the tree.

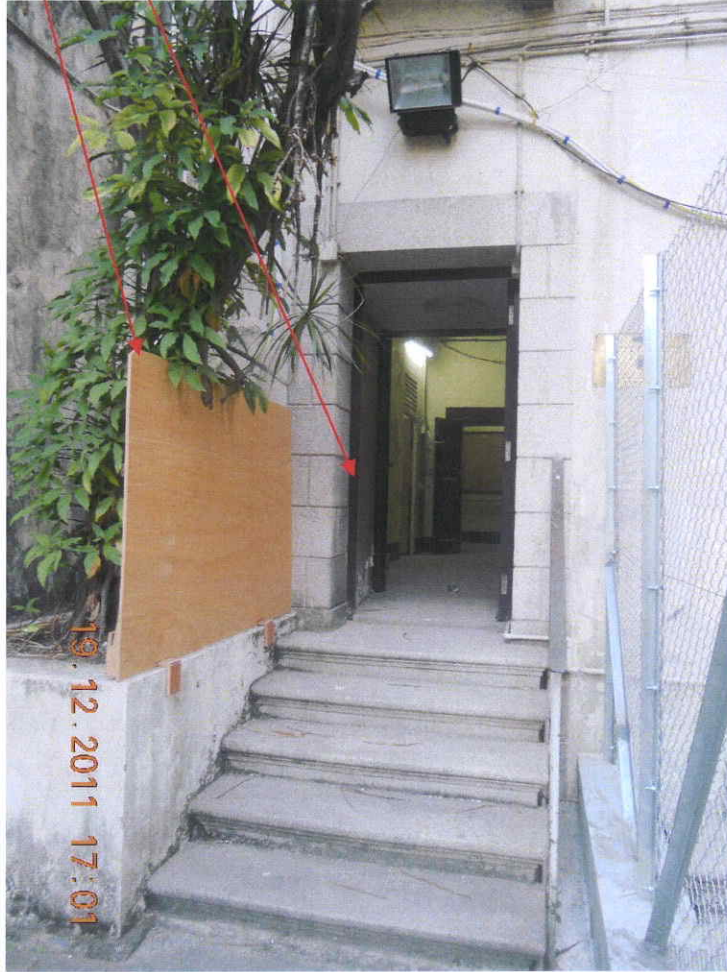
1. Overall health condition of the tree is fair at the time of inspection.
2. The planter is clean and tidy. Some vines are found on the planter. These vines would not affect the growth of the tree. Removal is not required.
3. A net-wired fence in 2.5mH with a padlocked door has been erected to create a protection zone for the tree.
4. Appropriate notice displays in front of the planter.
5. The door of the protection zone has been properly locked, but the main door of the building remains open.

Fig. 6 The door of the building should be always locked so as to restrict admittance to the protection zone. Removal of the temperate fence is recommended.

1. The door of the building should be always locked so as to restrict the admittance to the protection zone.
2. Removal of the temperate fence is recommended.
