Central Police Station Conservation
and Revitalisation Project:
76th Monthly EM&A Report
(1 February to 28 February 2018)

Issue Date: March 2018

Environmental Resources Management

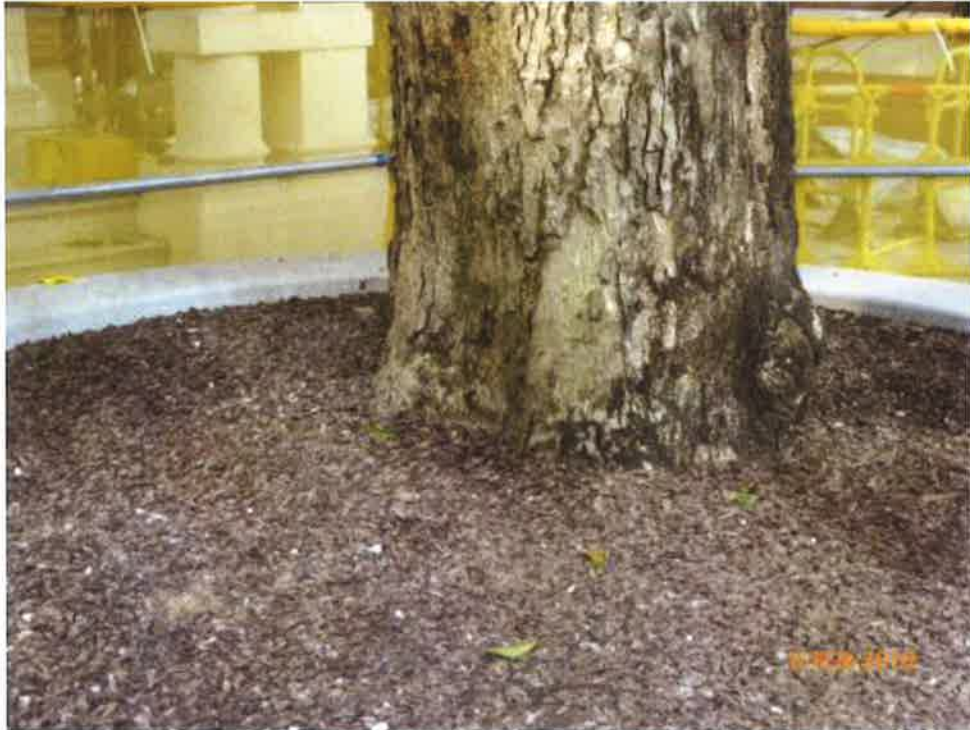
Fig 2. The root collar is normal. The planter is covered with small pieces of pine bark.

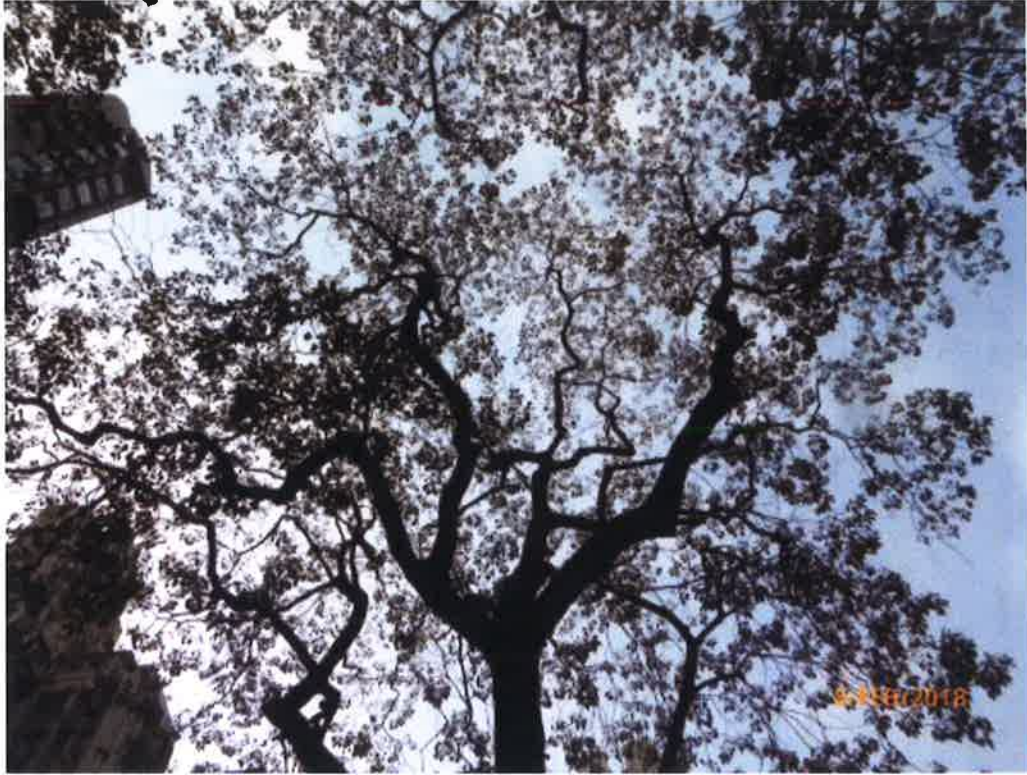
Fig. 6 Leaves on the crown are rather sparse.

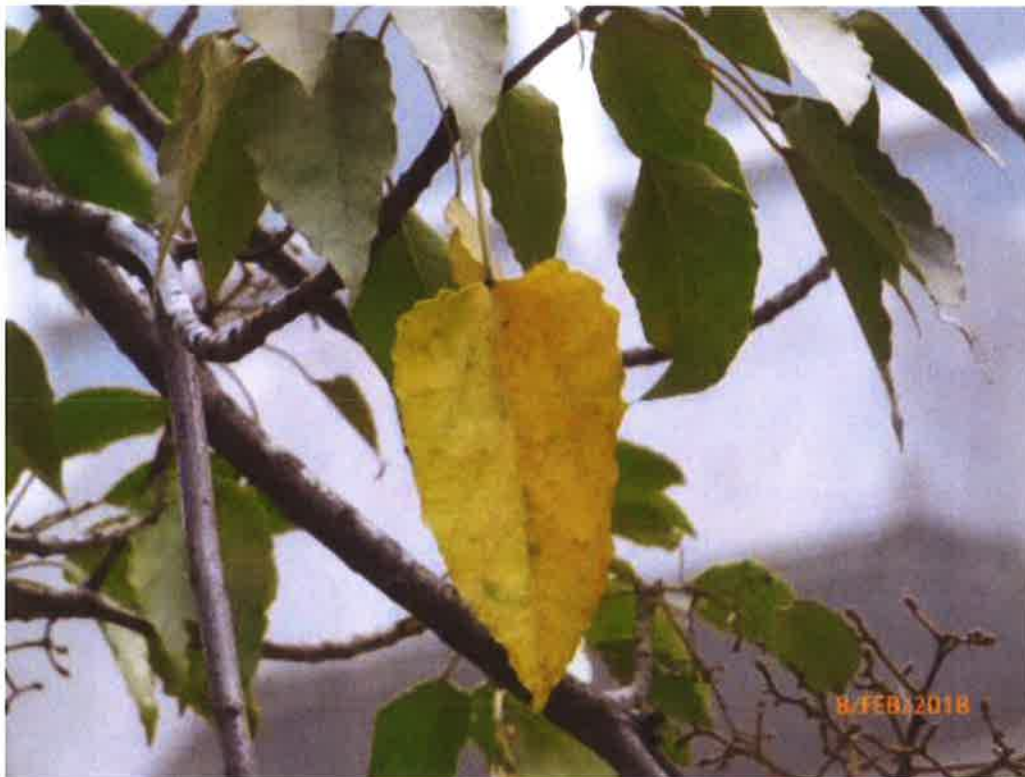
Fig. 9 As dry season has come, some leaves on the tree become faded.

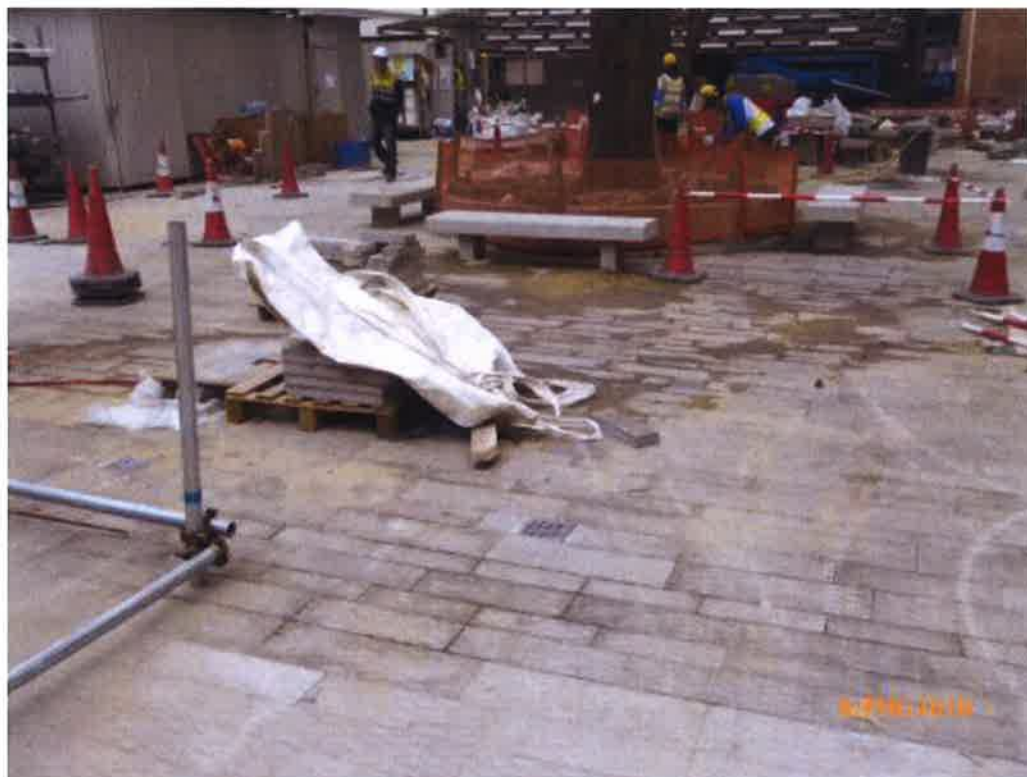
Fig. 11 Renovation works are in progress near the tree.

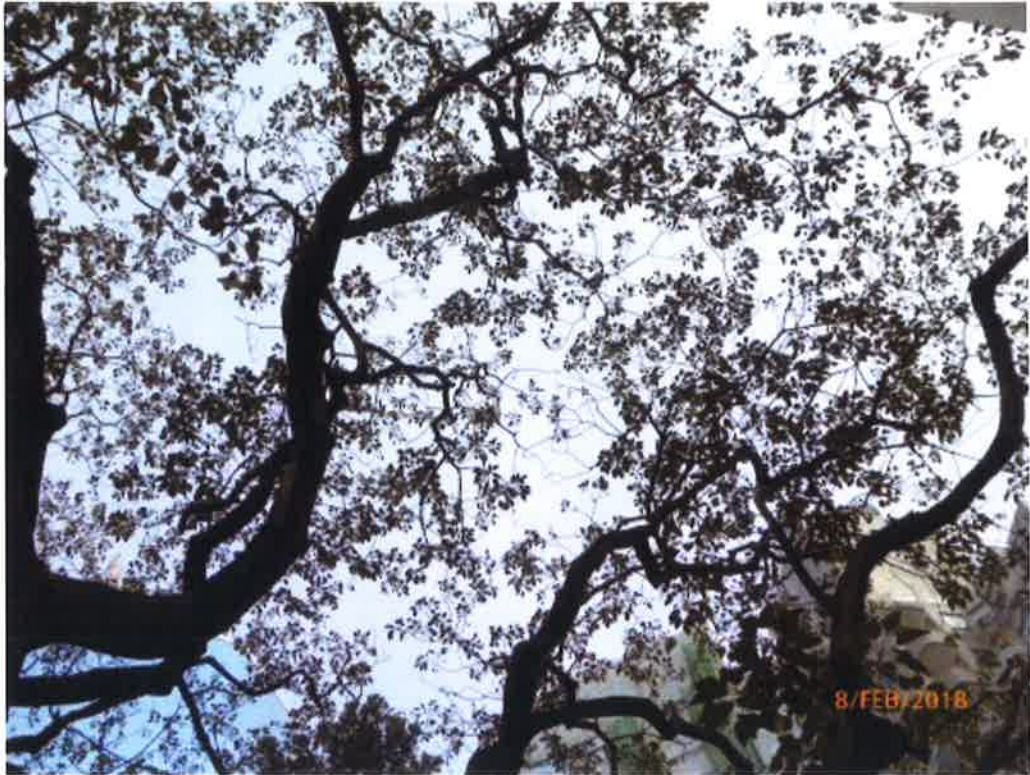
Fig. 6 Leaves on the crown are still sparse.

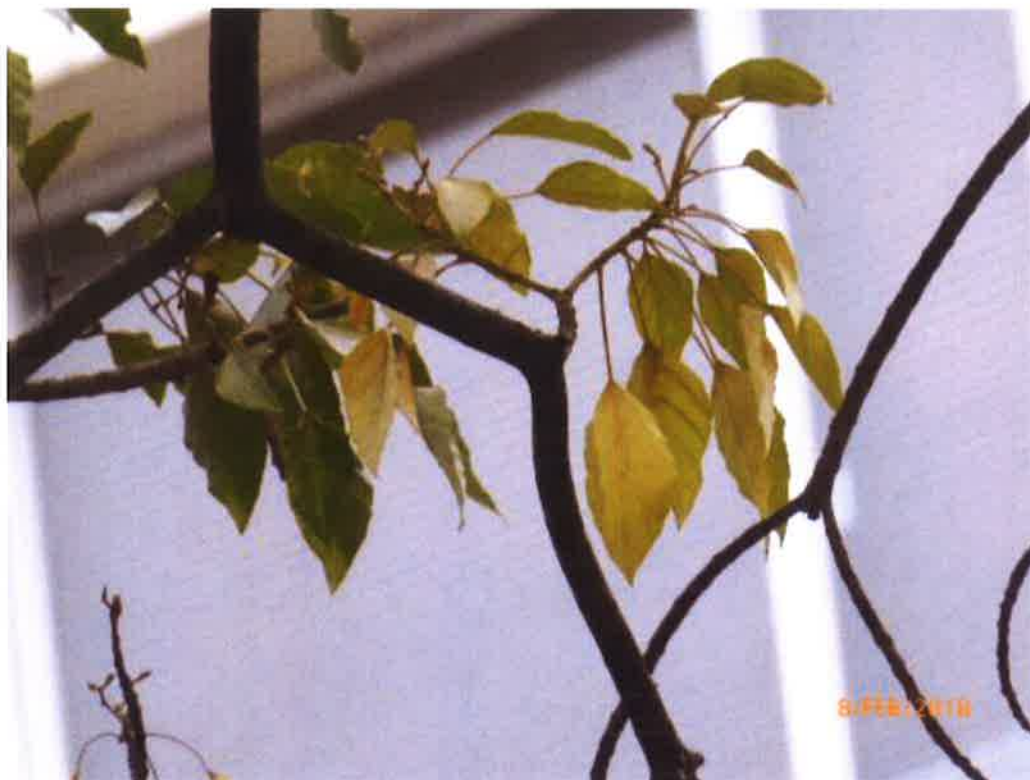
Fig. 9 As dry season has come, some leaves on the tree become faded.

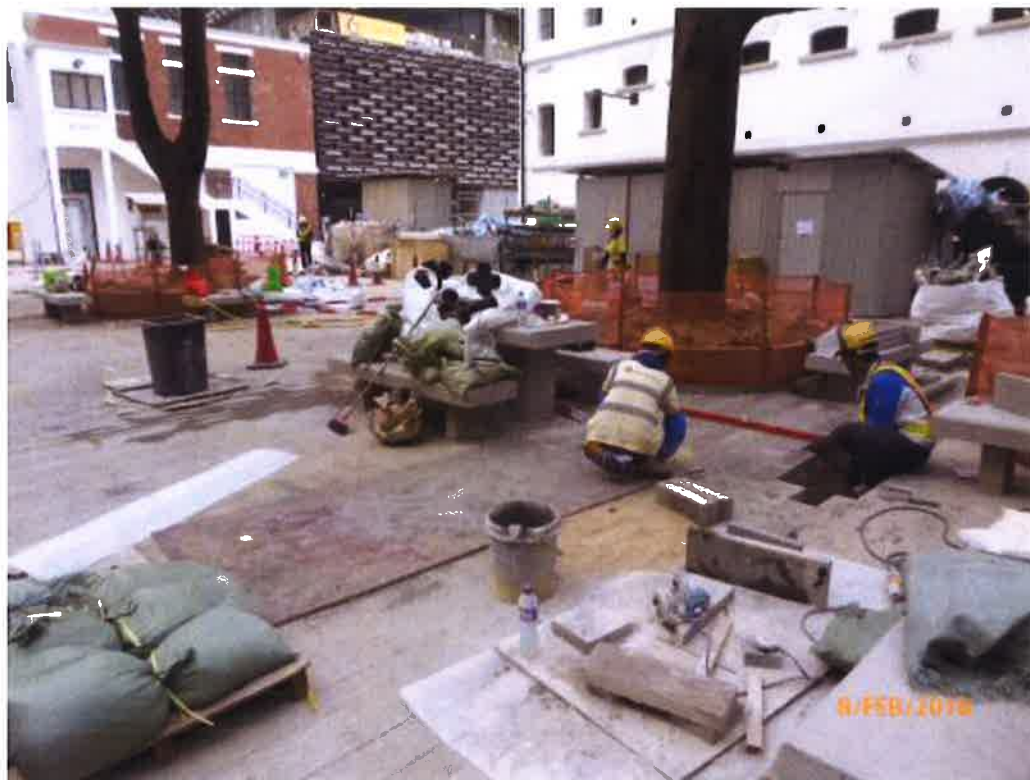
Fig. 11 Renovation works are in progress near the tree.

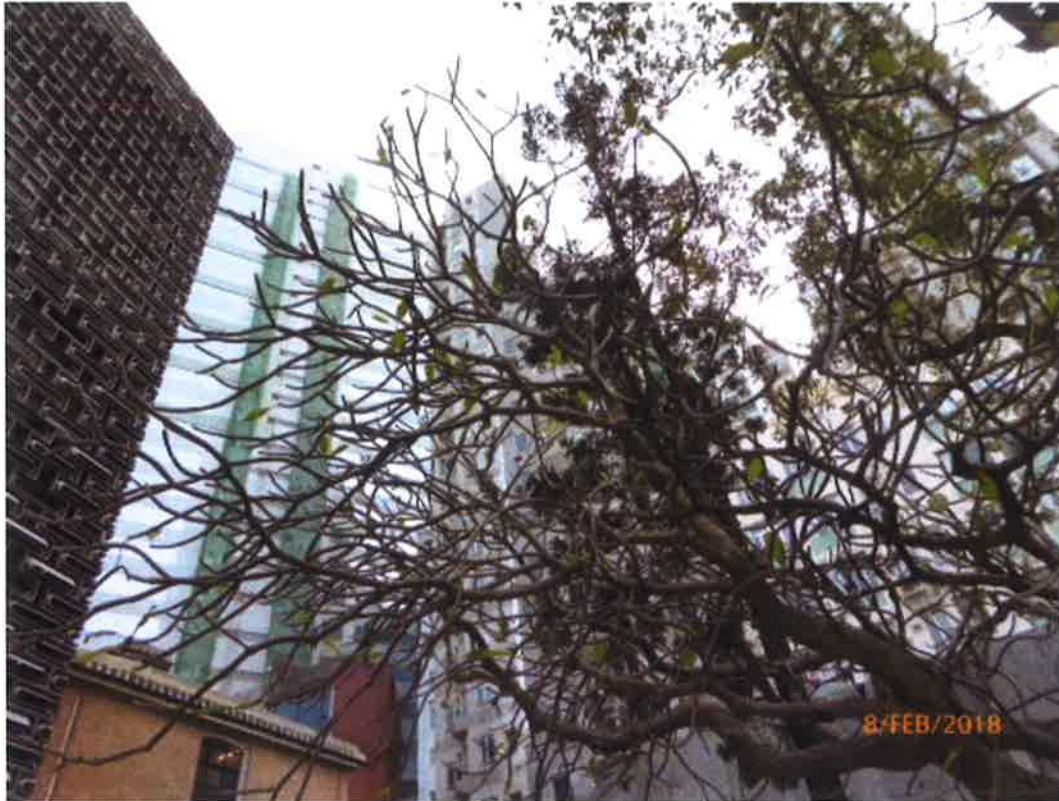
Fig. 6 As dry season has come, leaves are sparse on the tree.

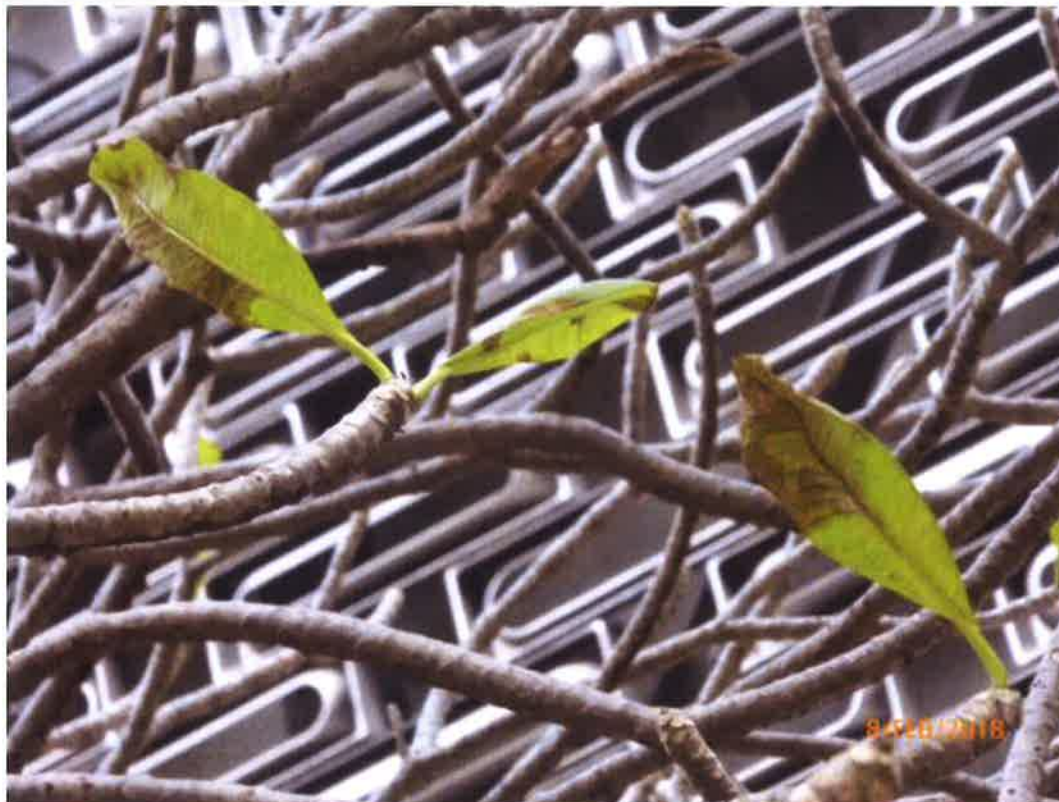
Fig. 7 Some leaves have become faded.

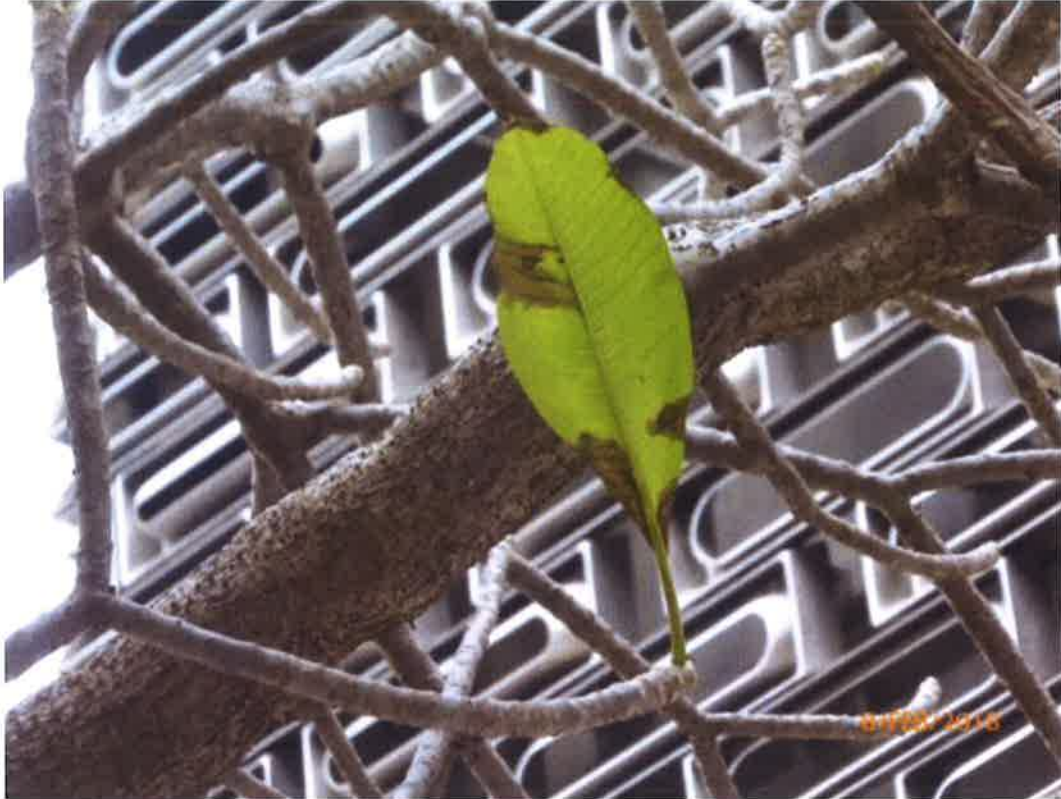
Fig. 8 Only a few leaves still remain on the lower branches.

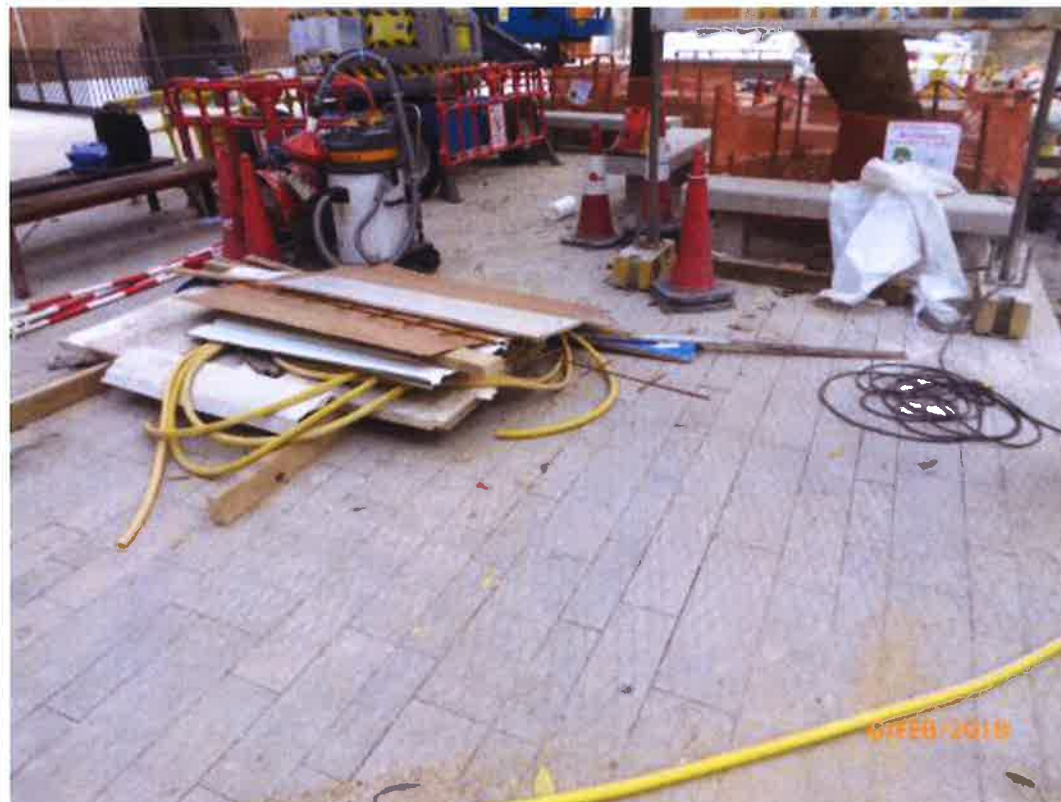
Fig. 11 Many construction materials are placed near the tree.

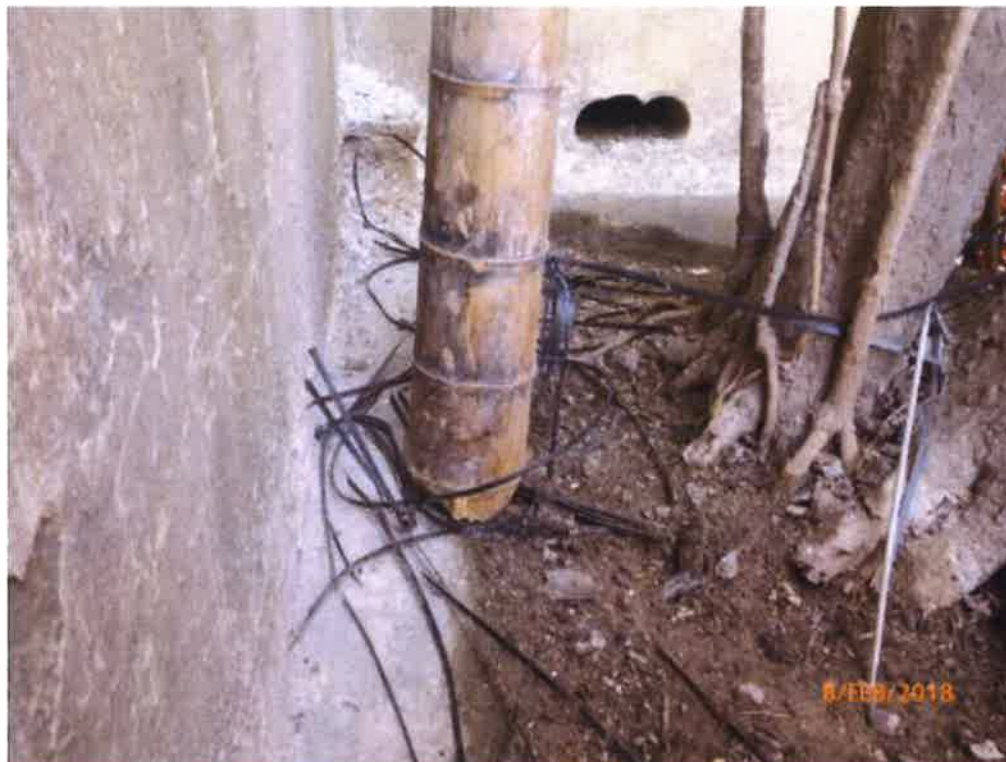
Fig. 3 A few construction debris remained at the planter.

Tree No.	Botanical Name	Overall Health Condition	Arborist's Observations / Recommendations
			<p>monitor the growth of the tree especially when the nearby renovation works are in progress.</p> <ul style="list-style-type: none"> Some construction debris was observed at the planter. The Contractor was reminded to remove the construction debris from the planter.

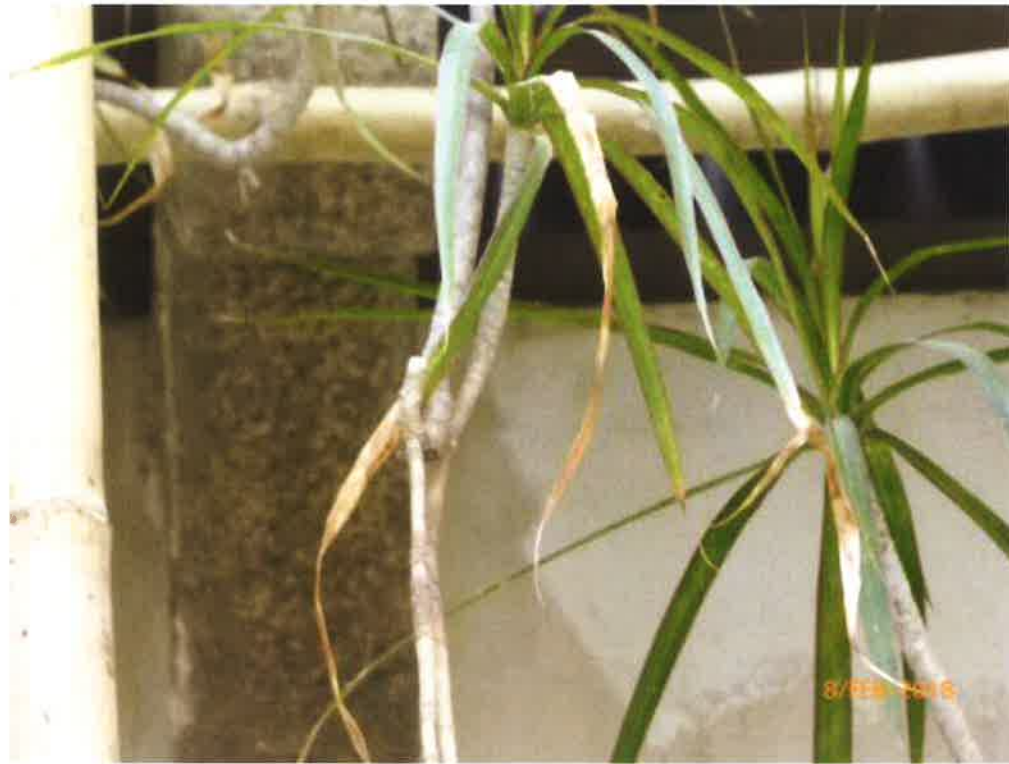
Fig. 8 Withered leaves also appear on the lower branches of Tree-11.
