The Jockey Club CPS Limited

Central Police Station Conservation
and Revitalisation Project:
First Monthly EM&A Report
(From 24 October 2011 to 30
November 2011)

Environmental Resources Management

Reference 0095646

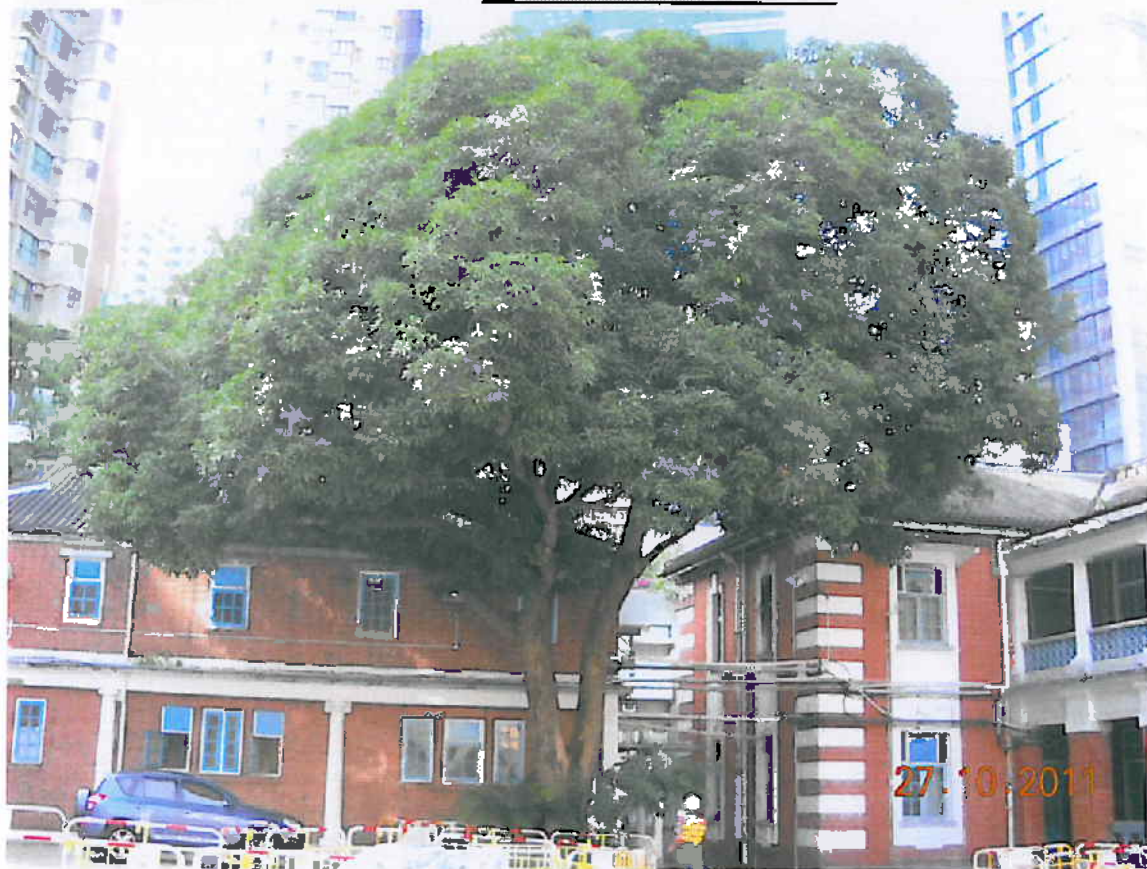
Photo 3. Condition of tree crown

The tree is healthy and strong. Foliage size, density and color are normal.

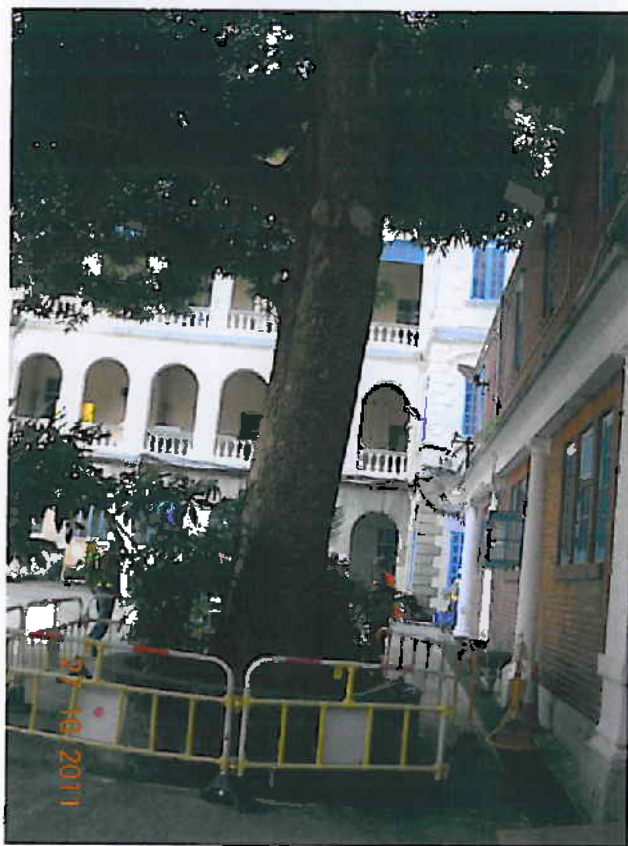
Photo 5. Co-dominant stem with included bark and a slight cavity on the middle part of the trunk.

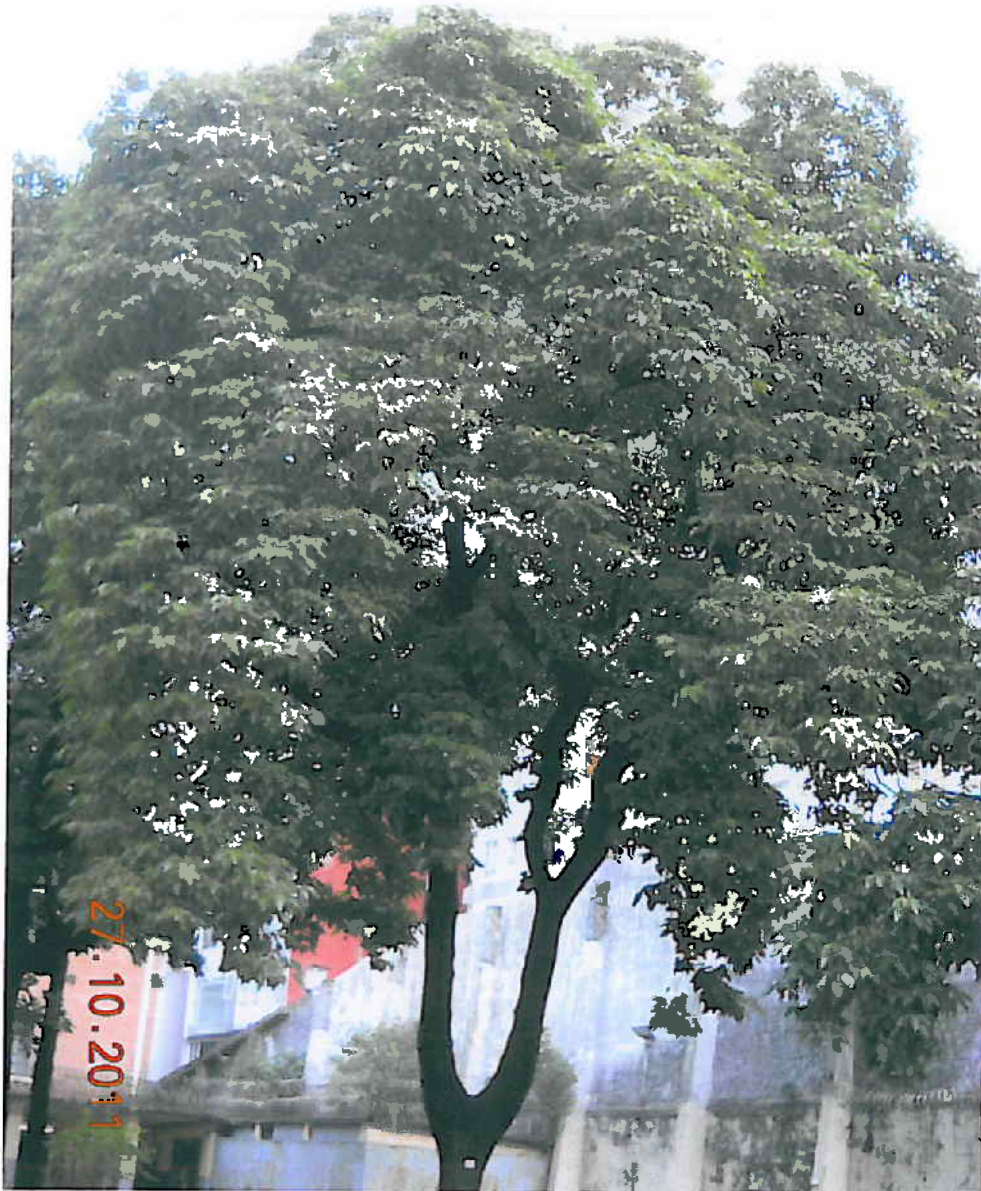
Photo 4. Condition of the trunk
No decay, cavity and wound were found on the trunk

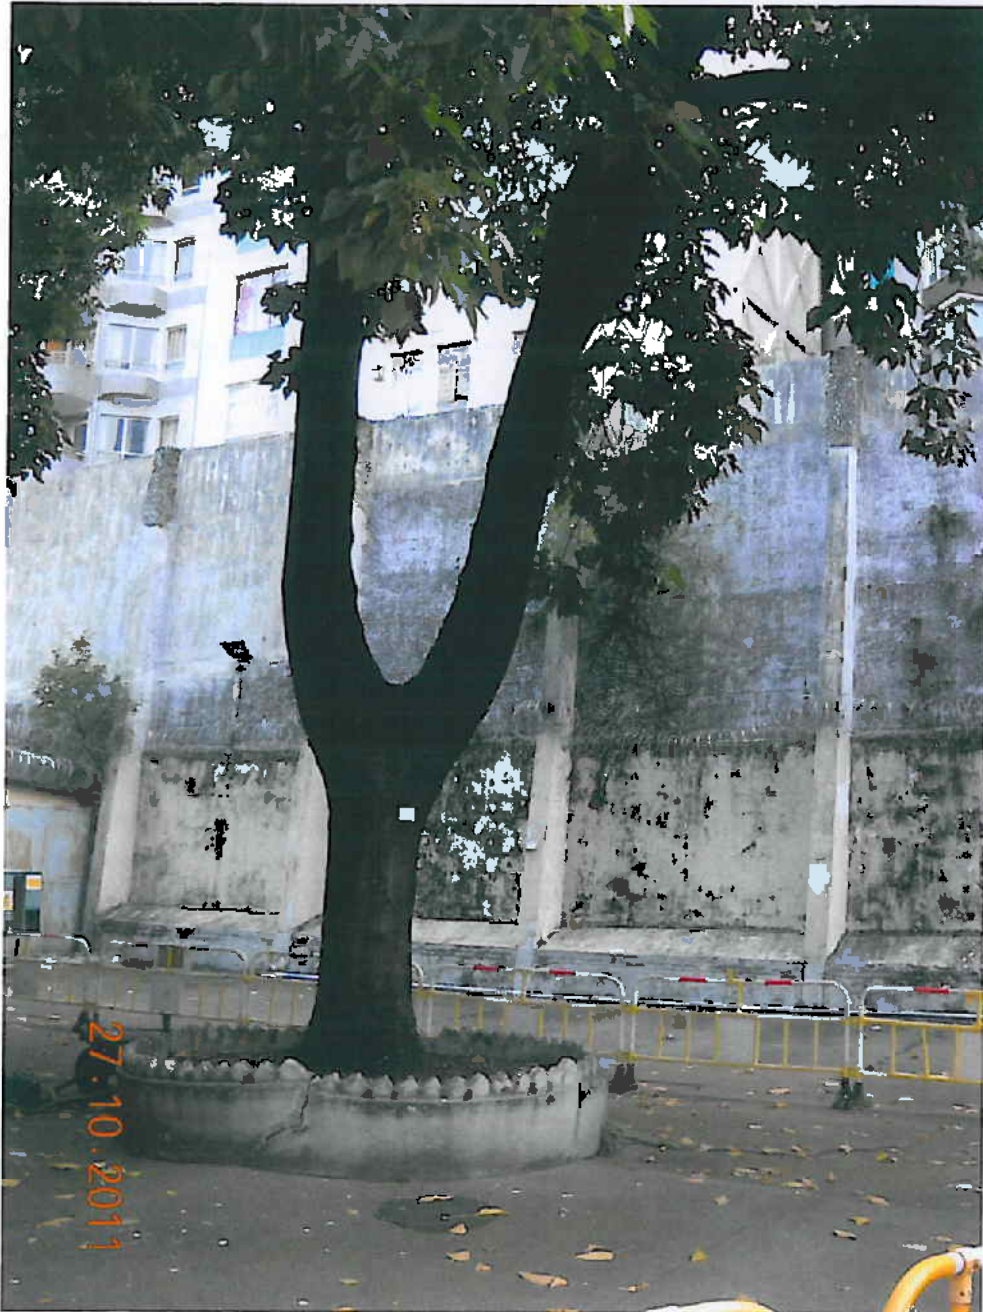
Photo 5.

Condition of root flare

Tree was surround by a raised planter, rooting area was restricted

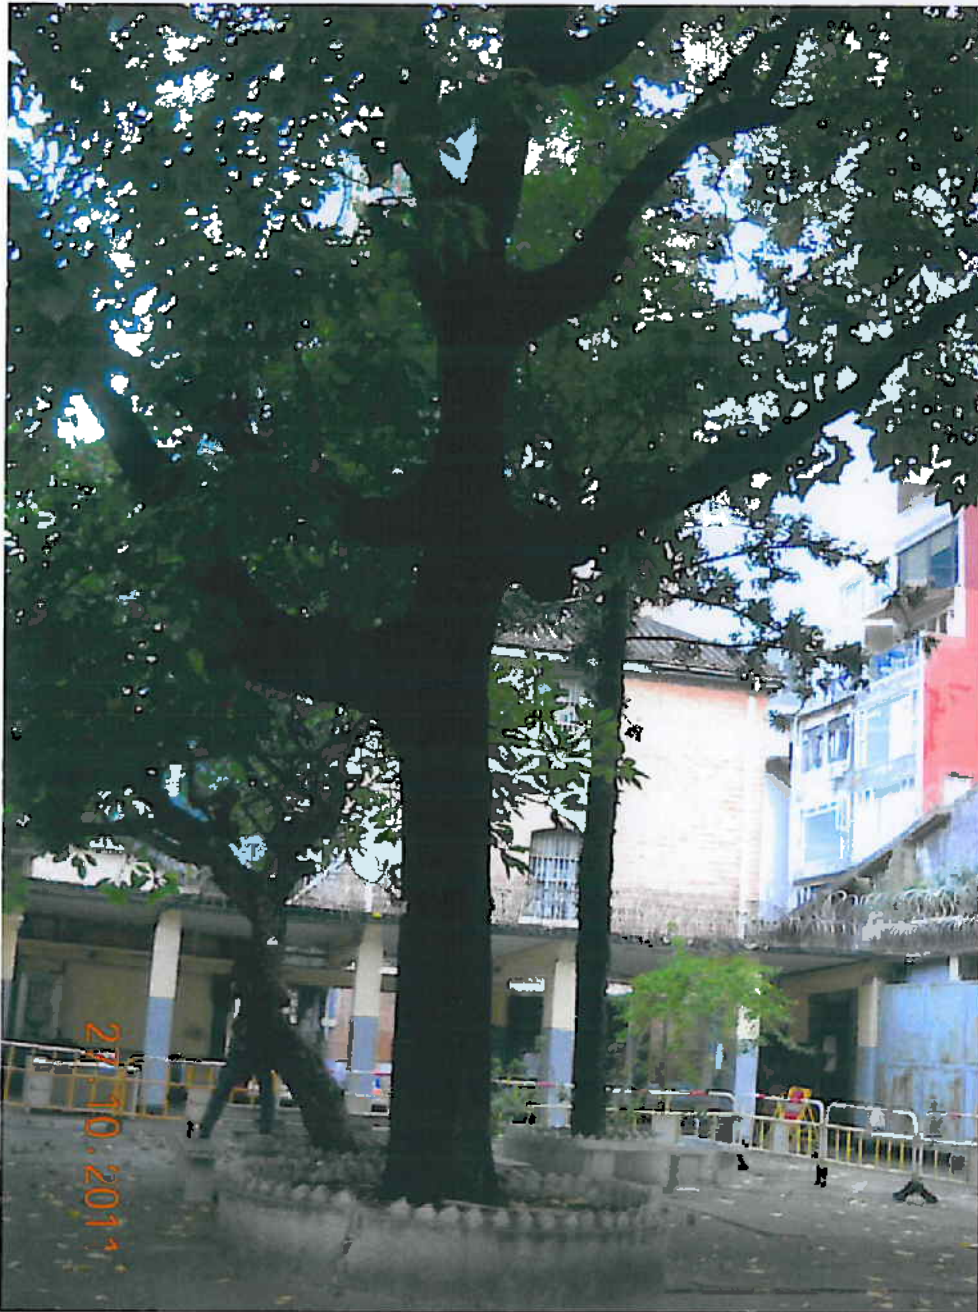
Photo 4. Condition of root flare
Tree is growing in the raised planter. Root flare not visible.
Rooting area are restricted by the planter.

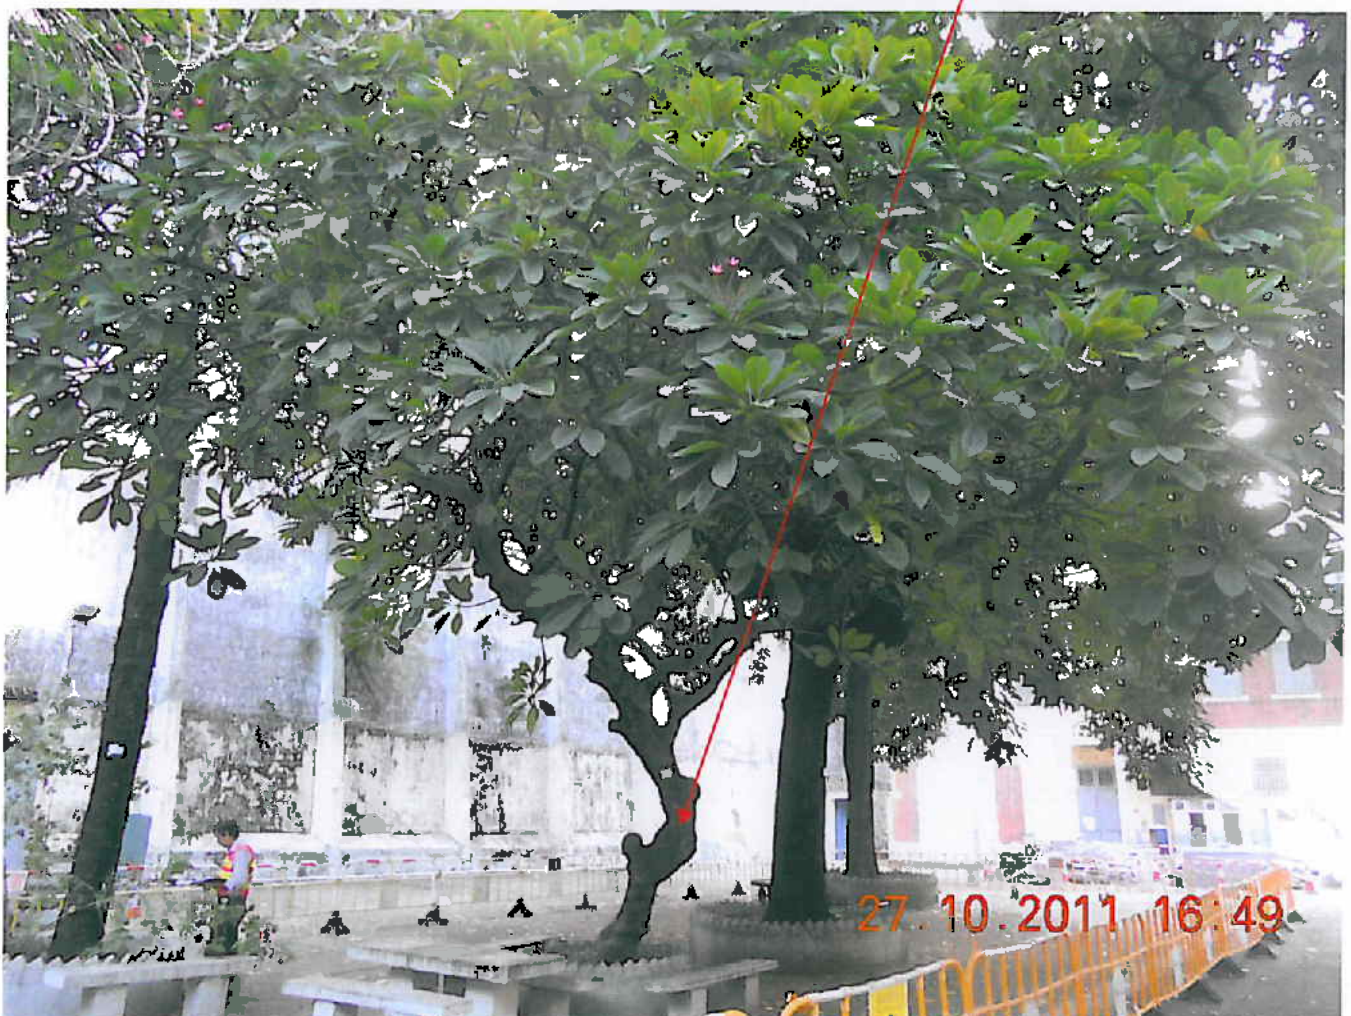
Photo 3. Condition of tree crown
Foliage size density and color are normal.

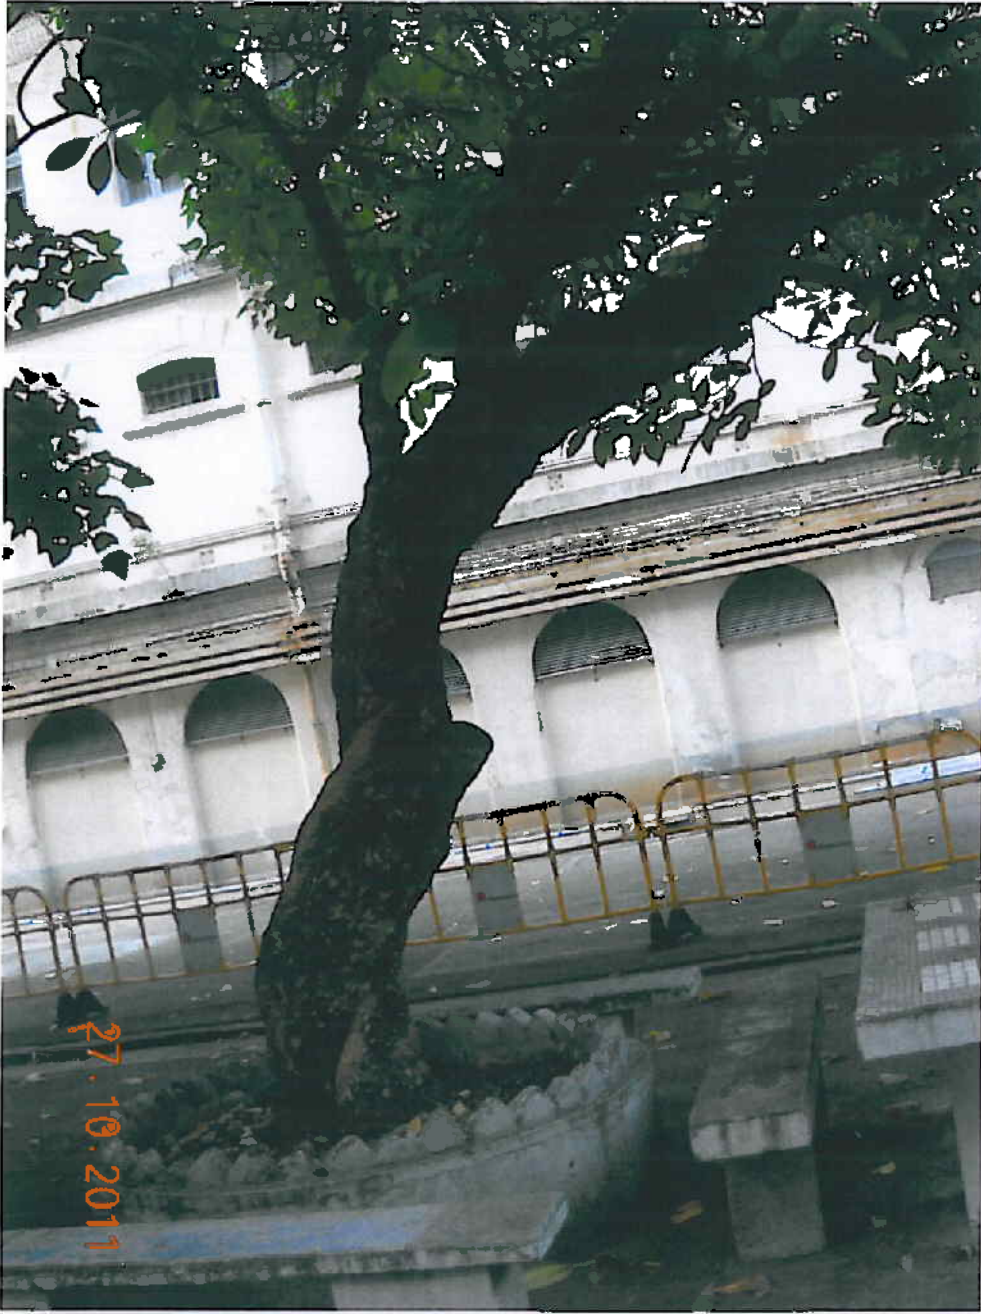
Photo 5. Condition of root flare.
Tree is growing in a raised planter, rooting area was restricted

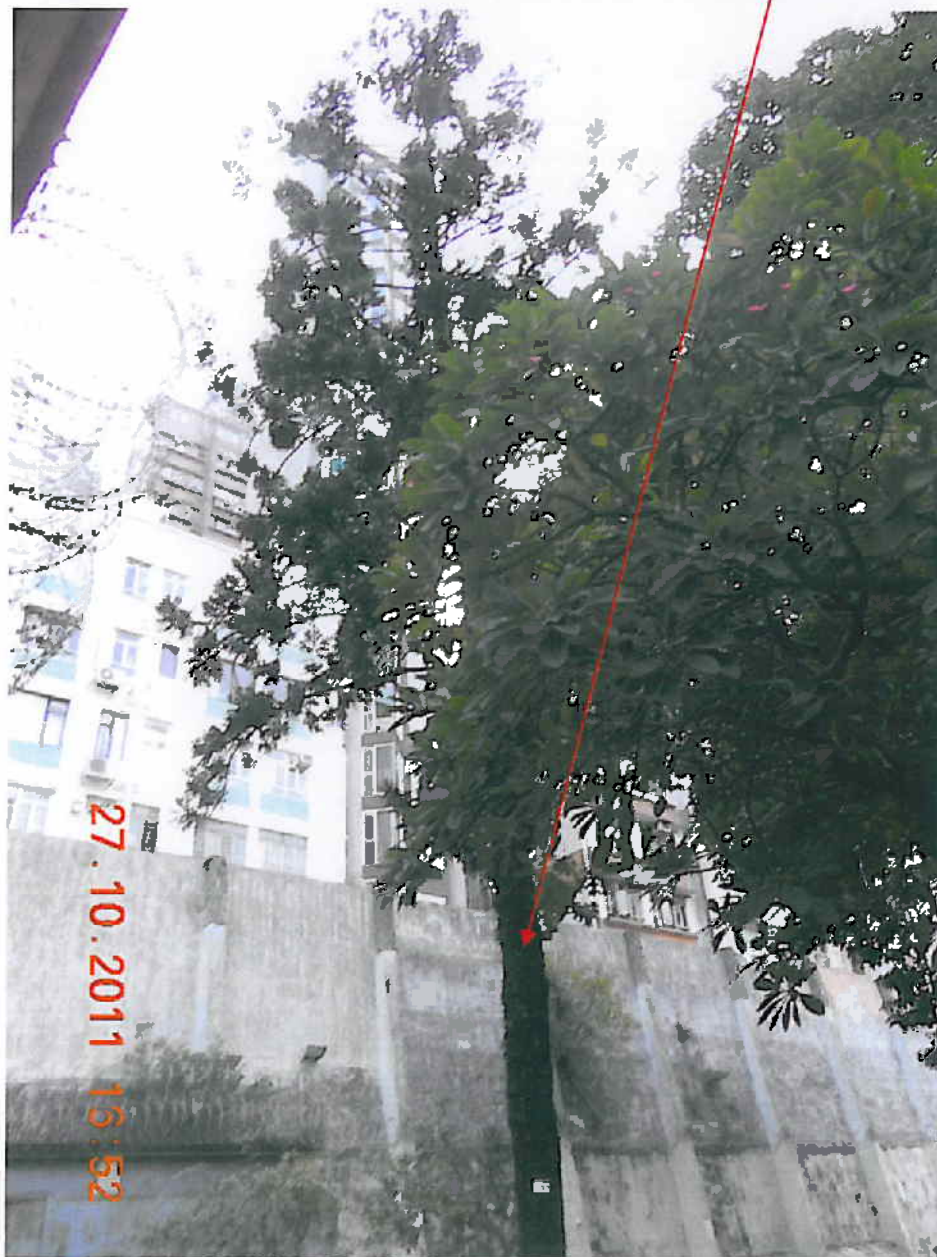
Photo 3. Condition of the tree crown
Foliage size, density and color are normal.
