Central Police Station Conservation
and Revitalisation Project:
65th Monthly EM&A Report
(1 March to 31 March 2017)

Issue Date: April 2017

Environmental Resources Management

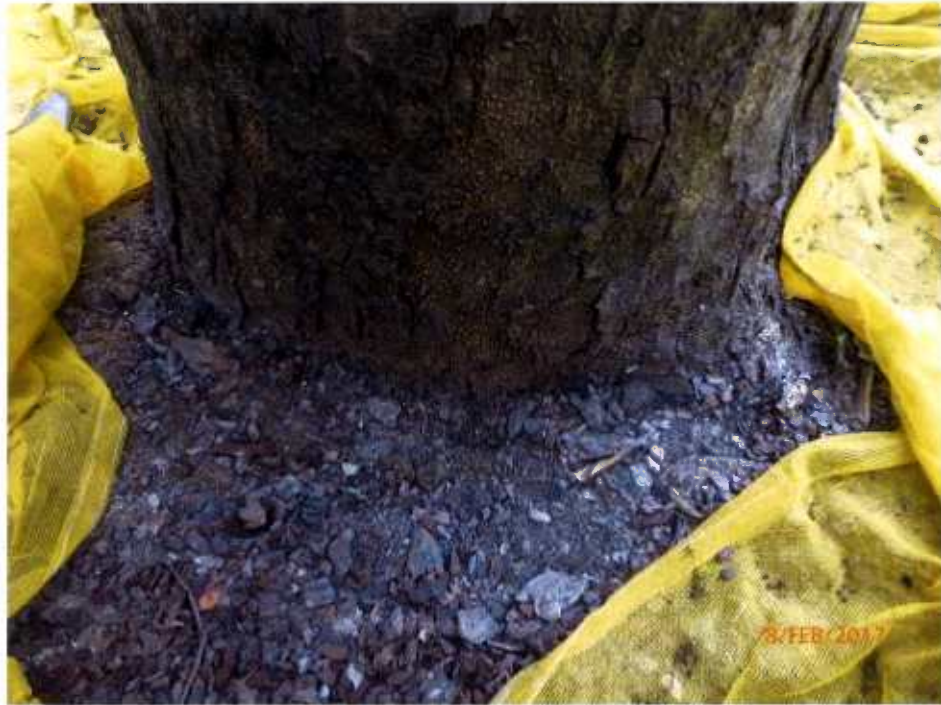
Fig. 3 Health condition of the lower trunk is fair.

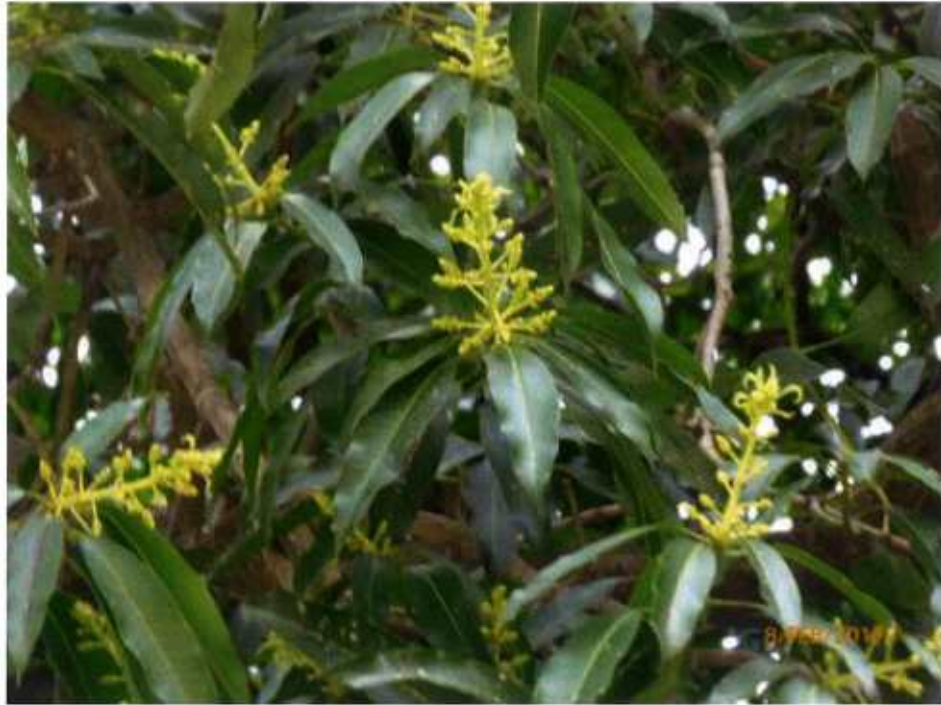
Fig. 9 Signs of Pest (Mealy Bugs 粉狀介殼蟲) are rarely found on the tree due to Pest Control Operation on 26th April 2016.

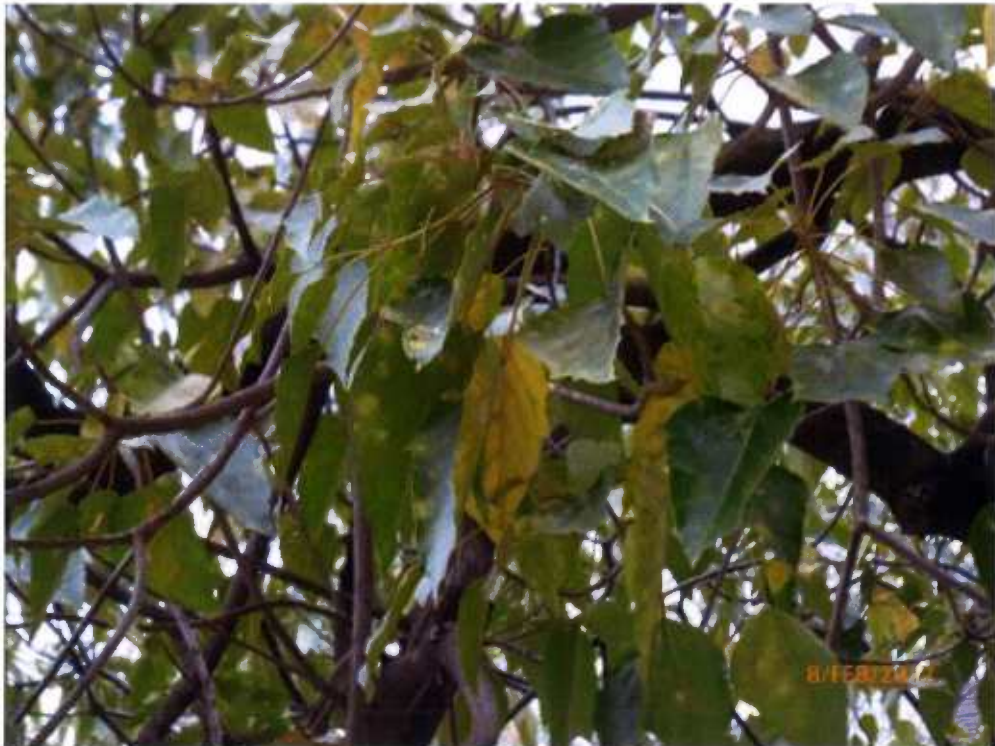
Fig. 9 Signs of Pest (Mealy Bugs 粉狀介殼蟲) are rarely found on the tree due to Pest Control Operation on 25th April 2016.

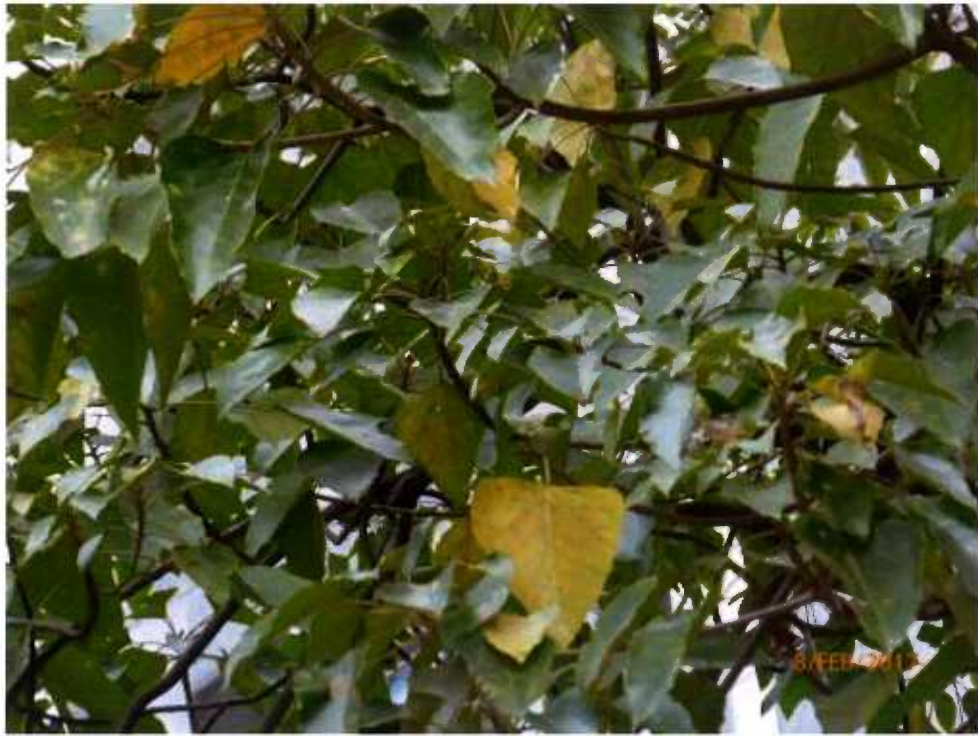
Fig. 9 Signs of Pest (Mealy Bugs 粉狀介殼蟲) are rarely found on Tree-7 due to Pest Control Operation on 25th April 2016.

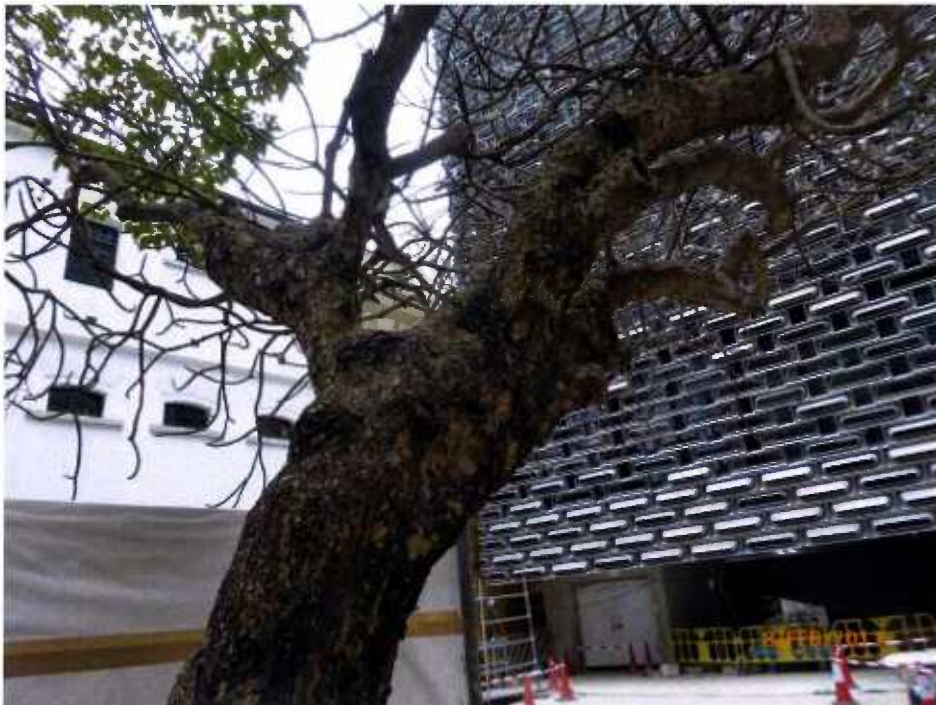
Fig. 6 Leaves on Tree-8 become sparse due to dry seasons.

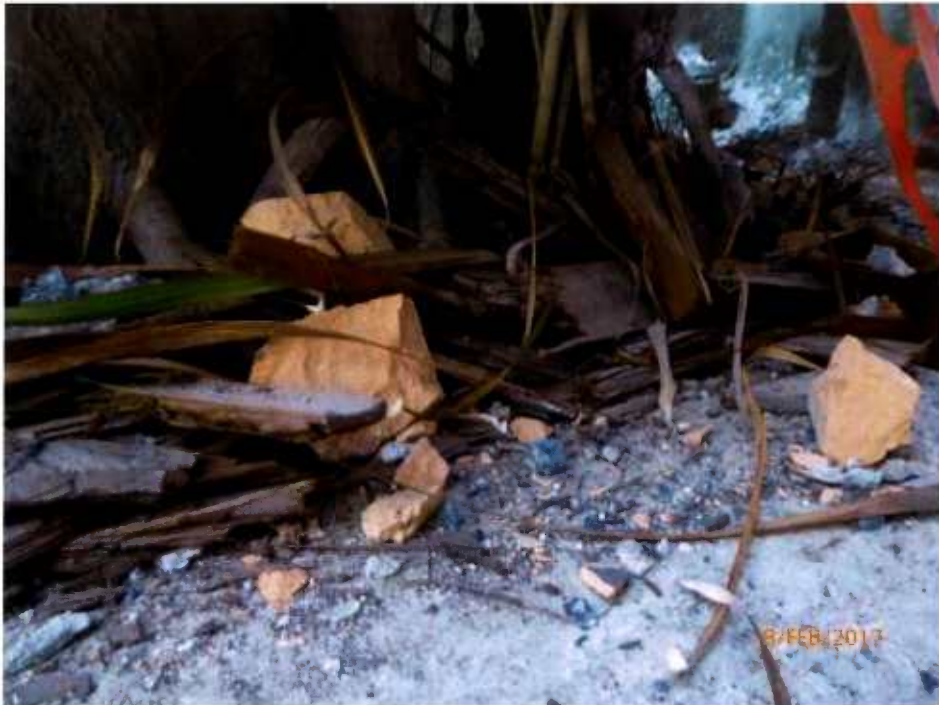
Fig. 3 A few construction debris remain at the planter.

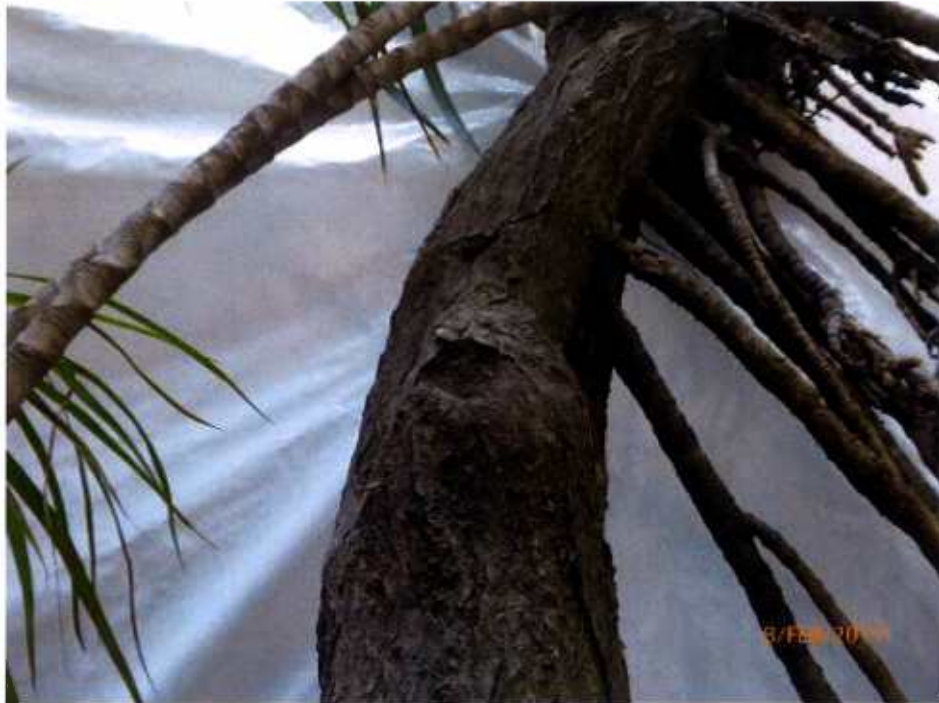
Fig. 7 Withered leaves still appear on the upper branches of the tree.

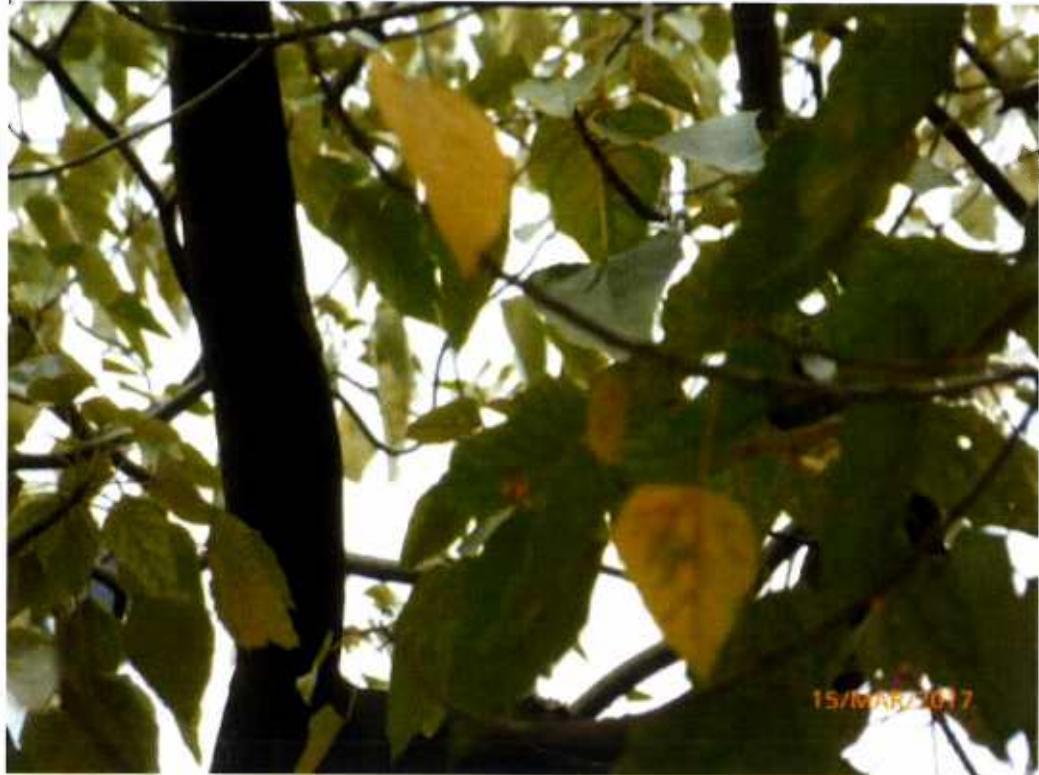
Fig. 9 Signs of Pest (Mealy Bugs 粉狀介殼蟲) are rarely found on the tree due to Pest Control Operation on 25th April 2016.

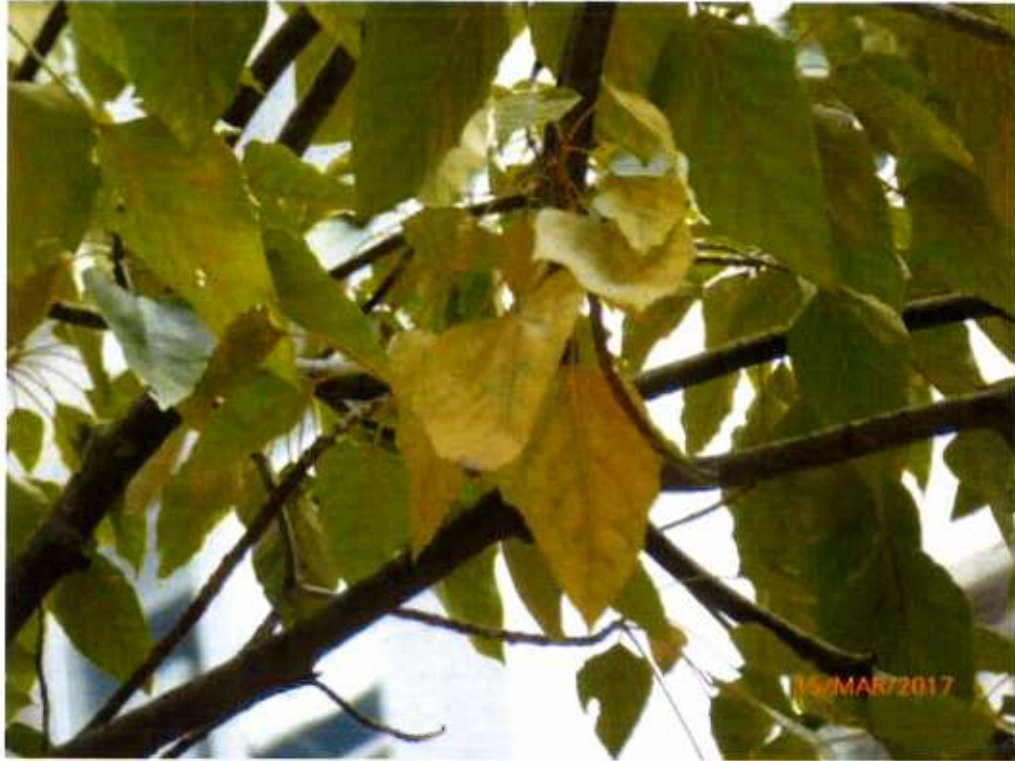
Fig. 9 Signs of Pest (Mealy Bugs 粉狀介殼蟲) are rarely found on Tree-7 due to Pest Control Operation on 25th April 2016.

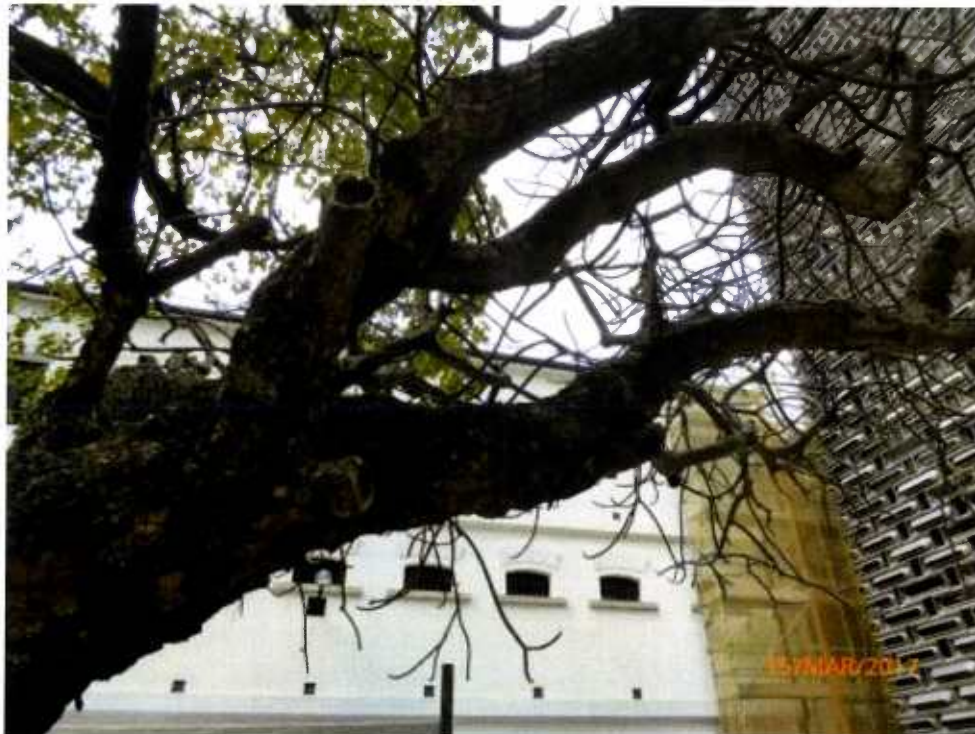
Fig. 6 Leaves on Tree-8 become sparse due to dry seasons.
