The Jockey Club CPS Limited

Central Police Station Conservation
and Revitalisation Project:
15th Quarterly EM&A Report
(1 May 2015 to 31 July 2015)

Issue Date: November 2015

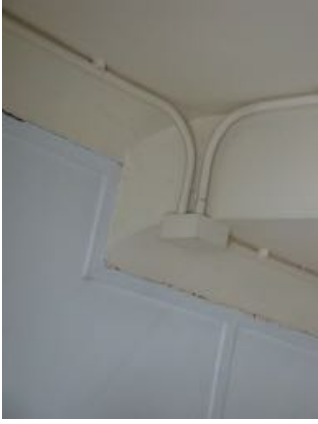
Element no.	Description	Photo ref	Significance	Proposal	Mitigation	Impact
01.001	Flat plywood ceiling lining with plain rectangular cover battens	 	Adverse	Replace with T&G boarding to match existing	Not applicable	High
01.002	Plaster coving at abutments of walls and ceilings

Low	Remove in exceptional cases eg, where adjacent new lift shaft	Cut back neatly to a square edge and ensure remaining section is secure.	Low

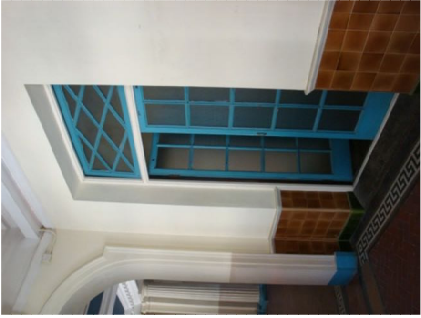
Moderate	Remove in exceptional cases eg. where adjacent new lift shafts	Cut back neatly to a square edge and ensure remaining section is secure.	Moderate
01.006	Panelled doors

Moderate	Replace where necessary to achieve fire resistance to comply with Code	Re-use where possible. Record design on survey drawings where element cannot be re-used.	Moderate

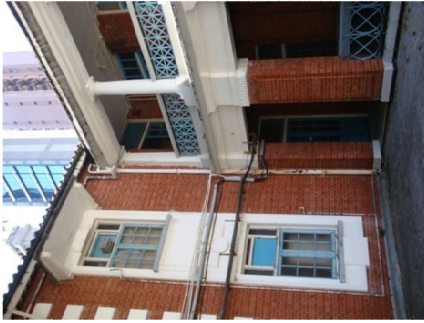
Element no.	Description	Photo ref	Significance	Proposal	Mitigation	Impact
01.012	Rainwater goods

Adverse	Replace with cast iron in pattern to match original and in correct locations	Not applicable	High

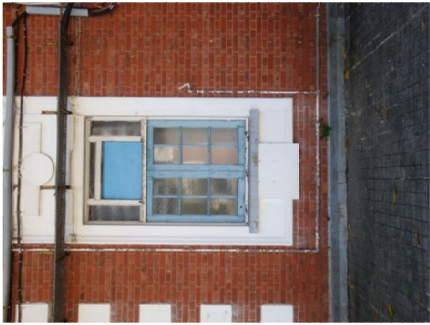
Element no.	Description	Photo ref	Significance	Proposal	Mitigation	Impact
01.016	Altered doors and windows

Adverse	Repair or renew as necessary existing frames to match original patterns	Not applicable	High
01.017	Mezzanine floor in room 01/LG1/13

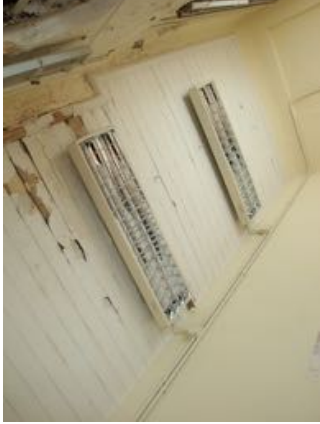
Low	Remove	Record on measured drawings and photographs	Low
01.028	Tongued and grooved flat and sloped timber boarded ceilings

Moderate	Repair where necessary and reinstate where missing	Not applicable	Moderate

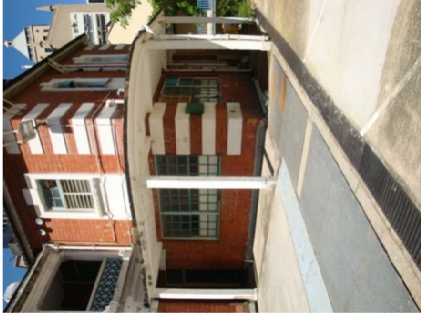
Element no.	Description	Photo ref	Significance	Proposal	Mitigation	Impact
01.031	Reinforced concrete canopy and sash windows

Moderate	Remove canopy and replace sash windows with new windows to match original	Make good brickwork where canopy removed, Reinstate rendered architraves around new window to match similar window facing on West wing	Moderate

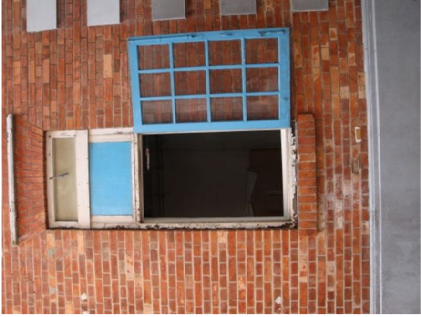
Element no.	Description	Photo ref.	Significance	Proposal	Mitigation	Impact
02.008	Altered doors and windows

Adverse	Repair or renew as necessary existing frames to match original patterns	Not applicable	High

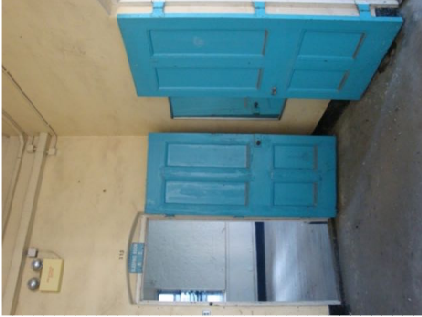
Element no.	Description	Photo ref.	Significance	Proposal	Mitigation	Impact
3.002	Panelled doors

Moderate	Replace where necessary to achieve fire resistance to comply with Code	Re-use where possible. Record design on survey drawings where item cannot be re-used.	Moderate

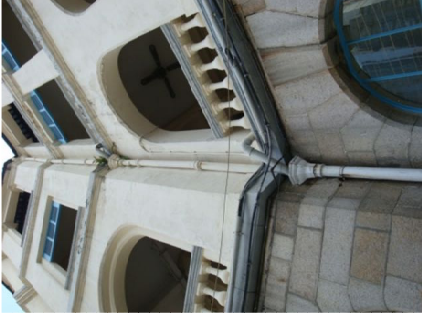
Element no.	Description	Photo ref.	Significance	Proposal	Mitigation	Impact
03.007	Rainwater goods

Adverse	Replace with cast iron in pattern to match original and in correct locations	No applicable	High

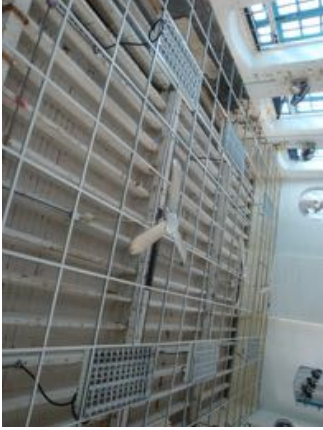
Moderate	Sub-divide two rooms on each floor to provide service core, comprising: lifts, toilets, plant rooms, stores	Form new sub-visions using lightweight partitions to achieve reversibility. Form straight joints at abutments with existing retained walls. Notch new partitions around existing brick corbels at high level as a reminder of current condition.	Moderate
03.021	Exposed soffits of timber floors

Moderate	Underline existing floors to achieve specified fire resistance stated in Code	Avoid unnecessary damage to existing structure. New lining will reduce extent of intervention into existing structure. Keep level of new linings well clear of window heads.	Moderate

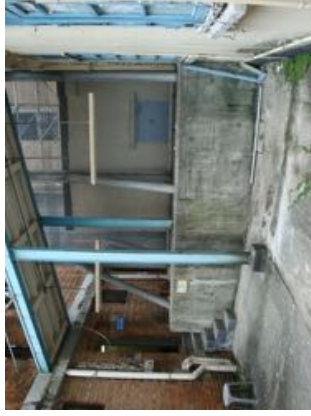
High	Open up selected openings to form new fire escape doors	Retain any salvageable material for possible re-use elsewhere. Retain existing window jambs intact. Cut away masonry to form door openings along same line as window jamb; do not re-bind cut brickwork. Record existing condition on measured survey drawings.	Low
03.023	Single storey outbuildings on south side

Adverse	Demolish	Check for evidence of early route from Magistracy to Prison.	Low

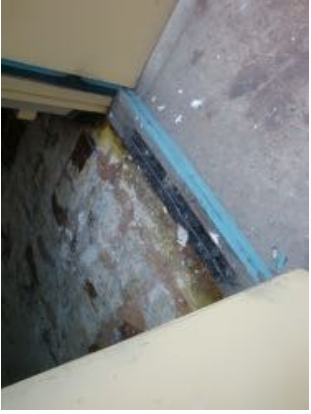
Adverse	Replace with hardwood floor boards	Not applicable	High
07.011	Timber thresholds at external doors and internal doors between main corridor and individual rooms

Low	Remove to enable level access	Splice extensions to door jambs, extend width of bottom rail of doors to match existing	Low

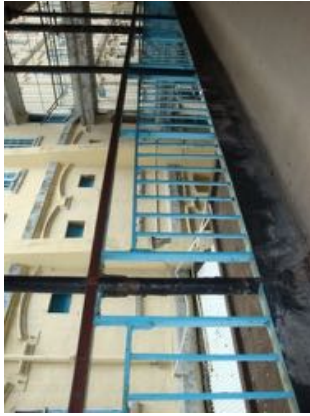
Moderate	Retain	Repair as necessary. Alter balustrade to achieve reasonable level of operational safety. Restrict access to repairs and maintenance and means of escape.	Low
08.013	Balcony balustrades

Low	Repair as necessary and retain. Remove selected sections to enable installation of new bridge connections to Barrack Block.	Avoid removal of associated iron columns. Form interventions at selected positions so as to maintain the rhythm of the balustrades and ensure proper support at ends.	Low

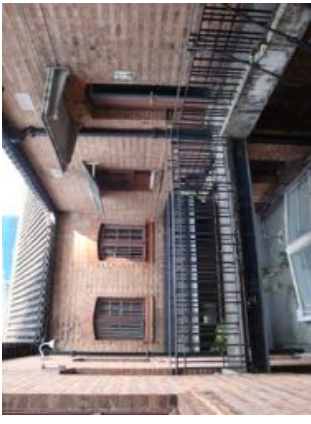
Moderate	Replace with larger sizes/closer spacing to improve performance	Use cast iron to match original pattern Make good all redundant fixing holes	High
09.013	Metal walkways across lightwell

Adverse	Remove walkways and make good brickwork at abutments	Not applicable	High

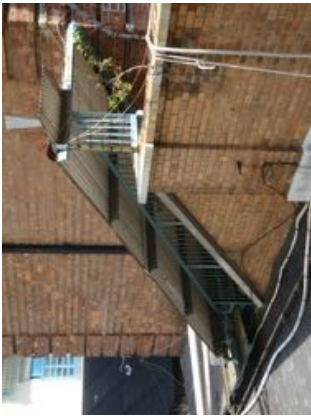
Adverse	Repair or renew as necessary existing frames to match original patterns	Not applicable	High
09.015	Sloping canopy over external stair on west side

Adverse	Remove canopy and supporting structure	Not applicable	Moderate

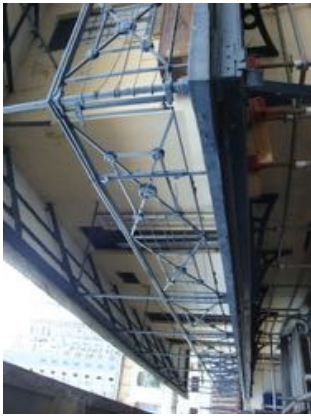
High	Repair as necessary and retain	Lift carefully and refix upon completion of fire-proofing and services installation	Low
10.005	Exterior decorations

Adverse	Strip off and redecorate	Sample and analyse existing paint media; select new media to suit substrate and significance	High

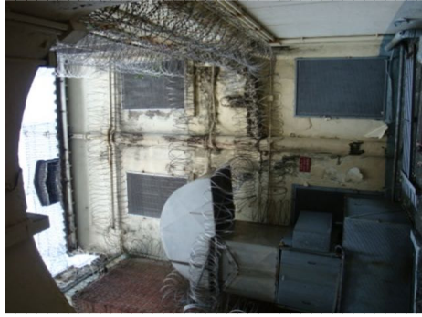
Adverse	Repair or renew as necessary existing frames to match original patterns	Not applicable	High
10.009	External airconditioning units and other external services

Adverse	Remove and make good brickwork	Not applicable	High

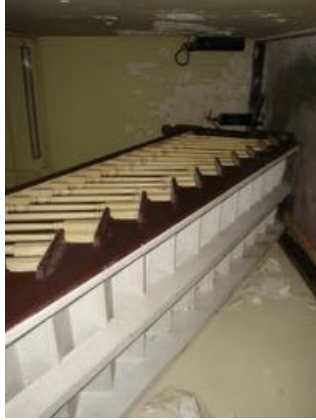
Moderate	Repair as necessary and retain	Avoid intrusive alteration. Retain open appearance/	Low
10.019	Timber stair

Moderate	Underline with fire-resisting lining	Repair as necessary and retain.	Low

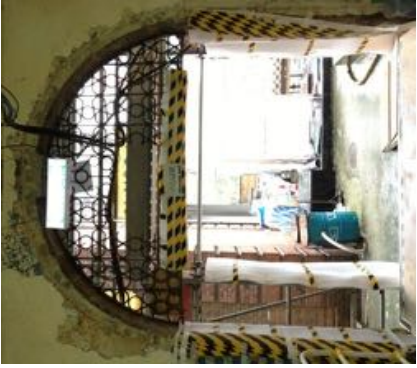
Moderate	Repair as necessary and retain	Not applicable	Neutral
10.030	Decorative metal screen (See also item 10.026)

Low	Repair and retain	Not applicable	Positive

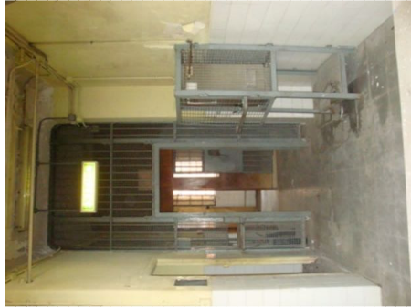
Moderate	Repair and retain	Not applicable	Neutral
13.010	Internal security screens

Moderate	Retain where possible	Where necessary record on measured survey drawings prior to removal	Low

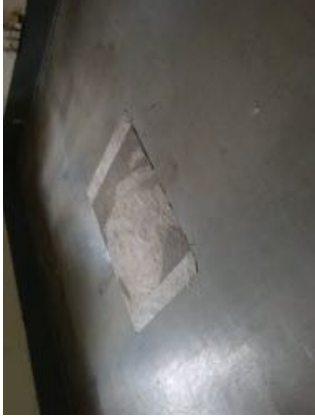
Low	Repair as necessary and retain	Not applicable	Neutral
13.015	Vinyl tile floor

Adverse	Replace	Not applicable	Low

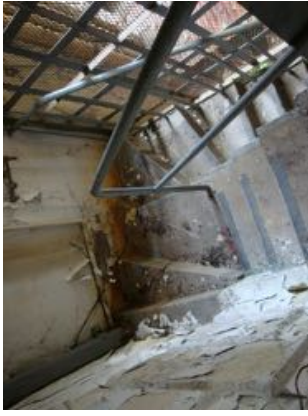
Moderate	Open up window opening to full extent.	Record existing condition on measured survey drawings. Add further detail during demolition works.	Low
14.008	External granite stair from Lower Ground to Ground Floor level

Moderate	Remove stair to make way for new stair in similar position	Review design proposals to see whether existing stair can be retained.	Low
