Central Police Station Conservation
and Revitalisation Project:
Fourteenth Monthly EM&A Report
(1 December to 31 December 2012)

Issue Date: January 2013

Central Police Station Conservation
and Revitalisation Project:
Fourteenth Monthly EM&A Report
(From 1 December to 31 December
2012)

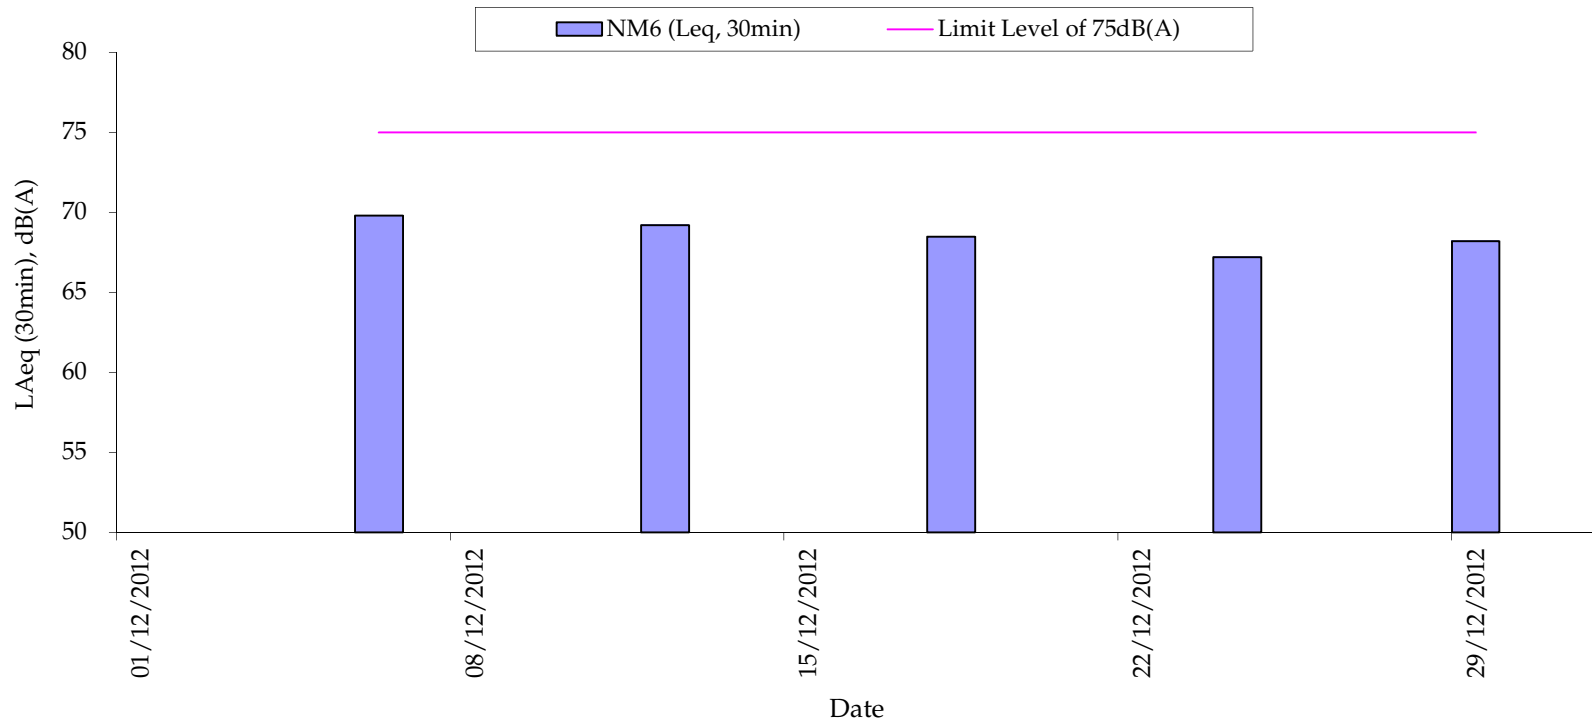
Normal Weekdays Noise Monitoring Results at NM6 - Chancery Mansion (Leq, 30min)

Remark:
- 75dB(A) was adopted as the Limit Level during normal weekdays in the reporting period

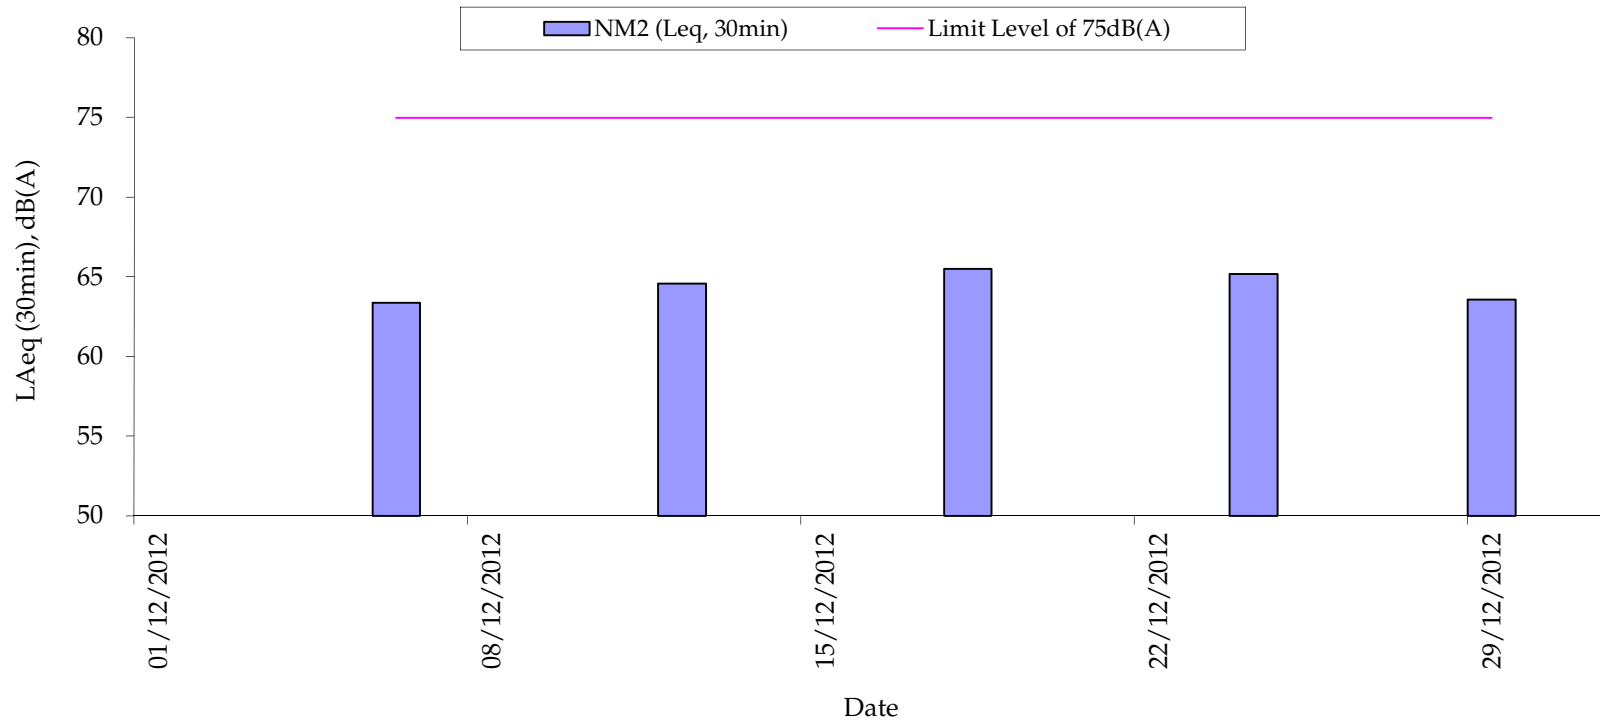
Normal Weekdays Noise Monitoring Results at NM2 - Ho Fook Building (Leq, 30min)

- 75dB(A) was adopted as the Limit Level during normal weekdays in the reporting period

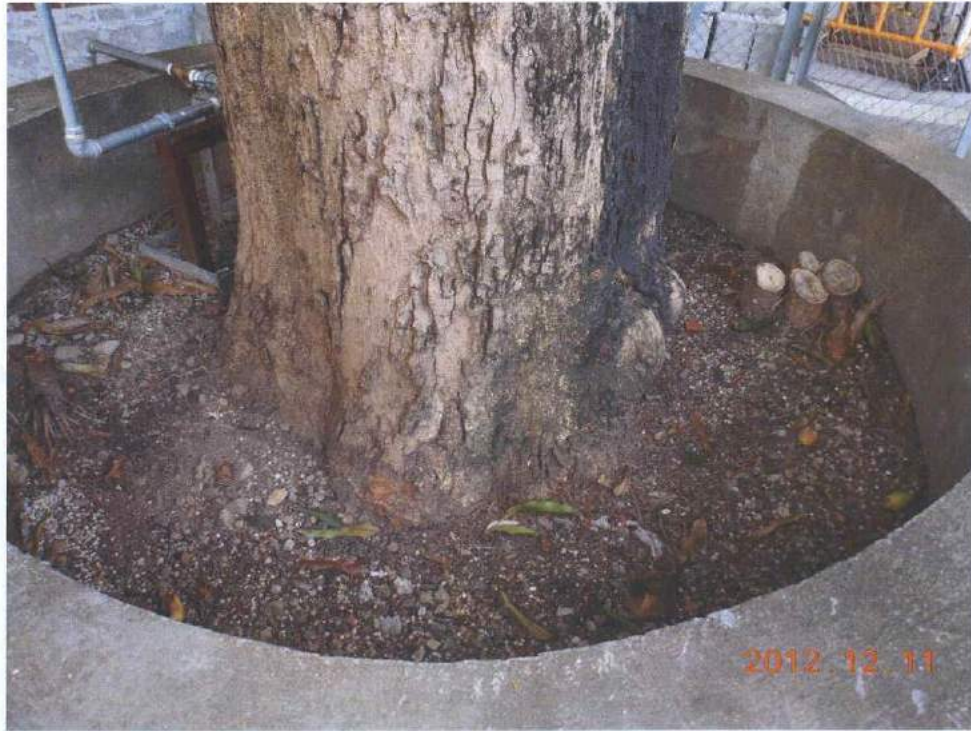
Fig. 3 A root-wall is newly built inside the cordon zone. Cleanliness of the site is acceptable.

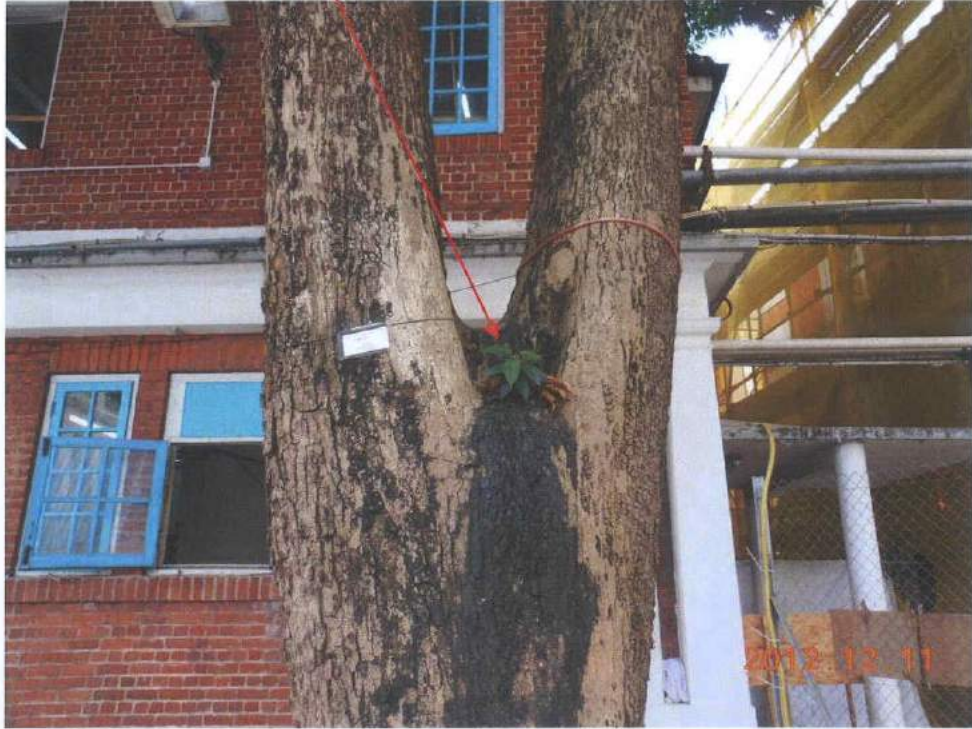
Fig. 7 Some defective branches also appear on the tree.

1. Remove the defective branches and parasitic plant a.s.a.p.

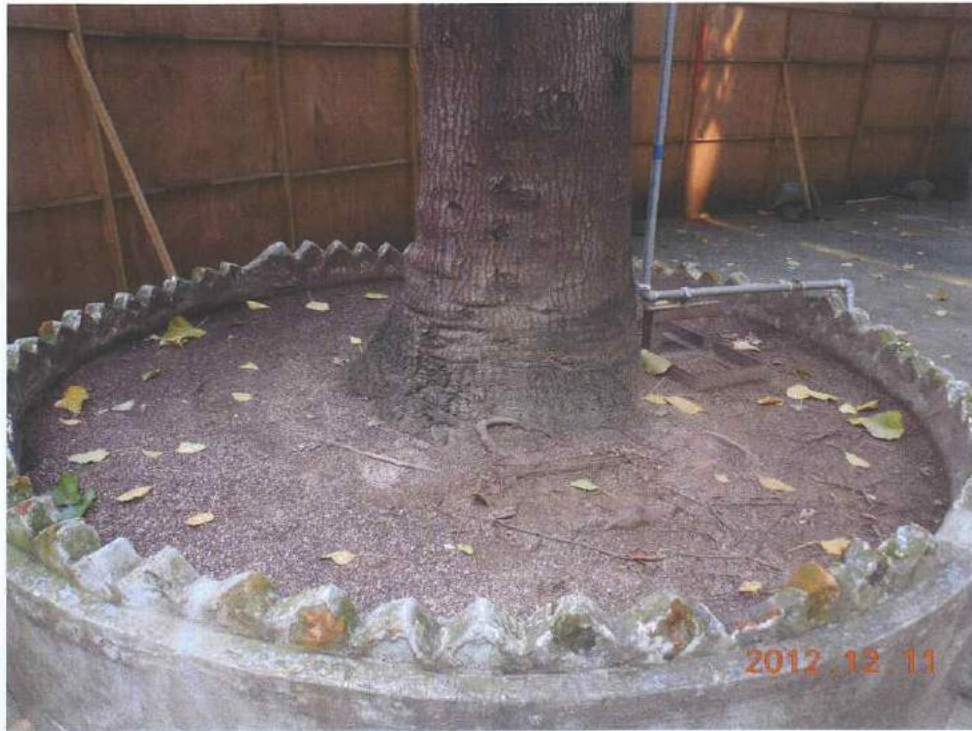
Fig. 3 Bulky items are still placed near Tree-6. Cleanliness of the site is acceptable.

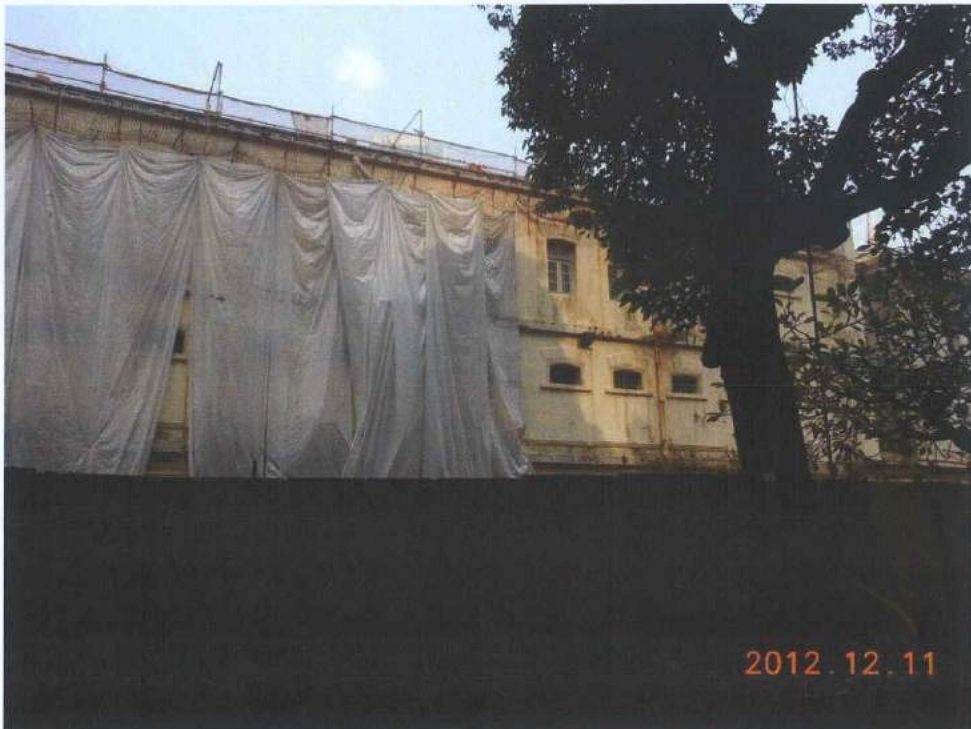
Fig. 6 Some drooping branches/leaves still appear on the tree.
Removal of such branches/leaves are recommended..

1. To inspect the cracks at regularly interval.
2. To remove the drooping branches/leaves from the tree.

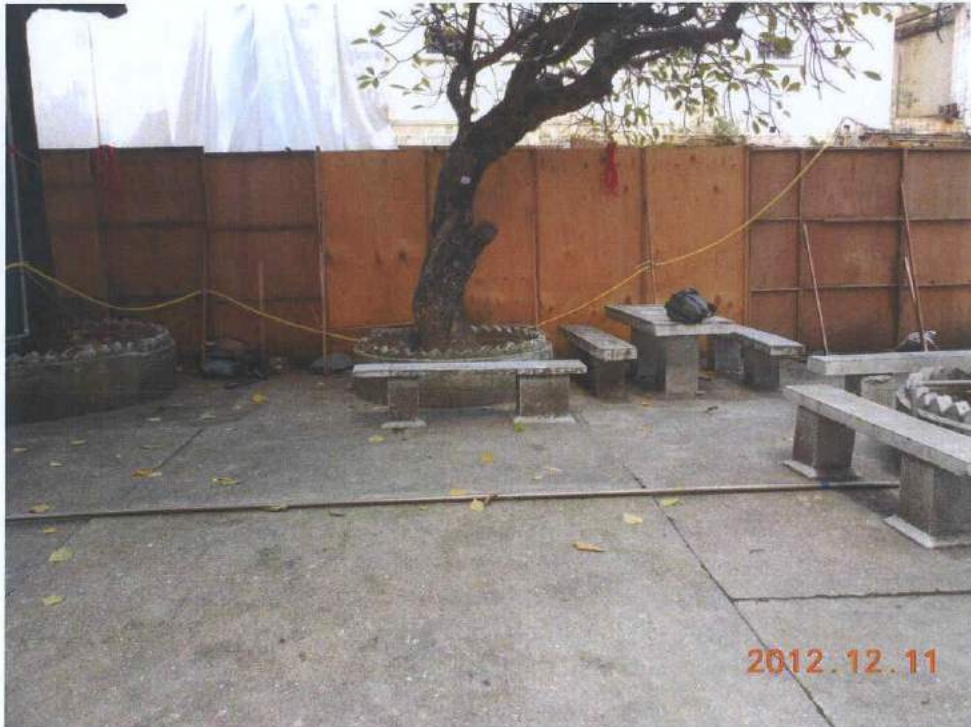
Fig. 4 Foliage of Tree-8 becomes sparse at the time of inspection.
