The Jockey Club CPS Limited

Central Police Station Conservation
and Revitalisation Project:
Third Quarterly EM&A Report
(1 May 2012 to 31 July 2012)

Environmental Resources Management

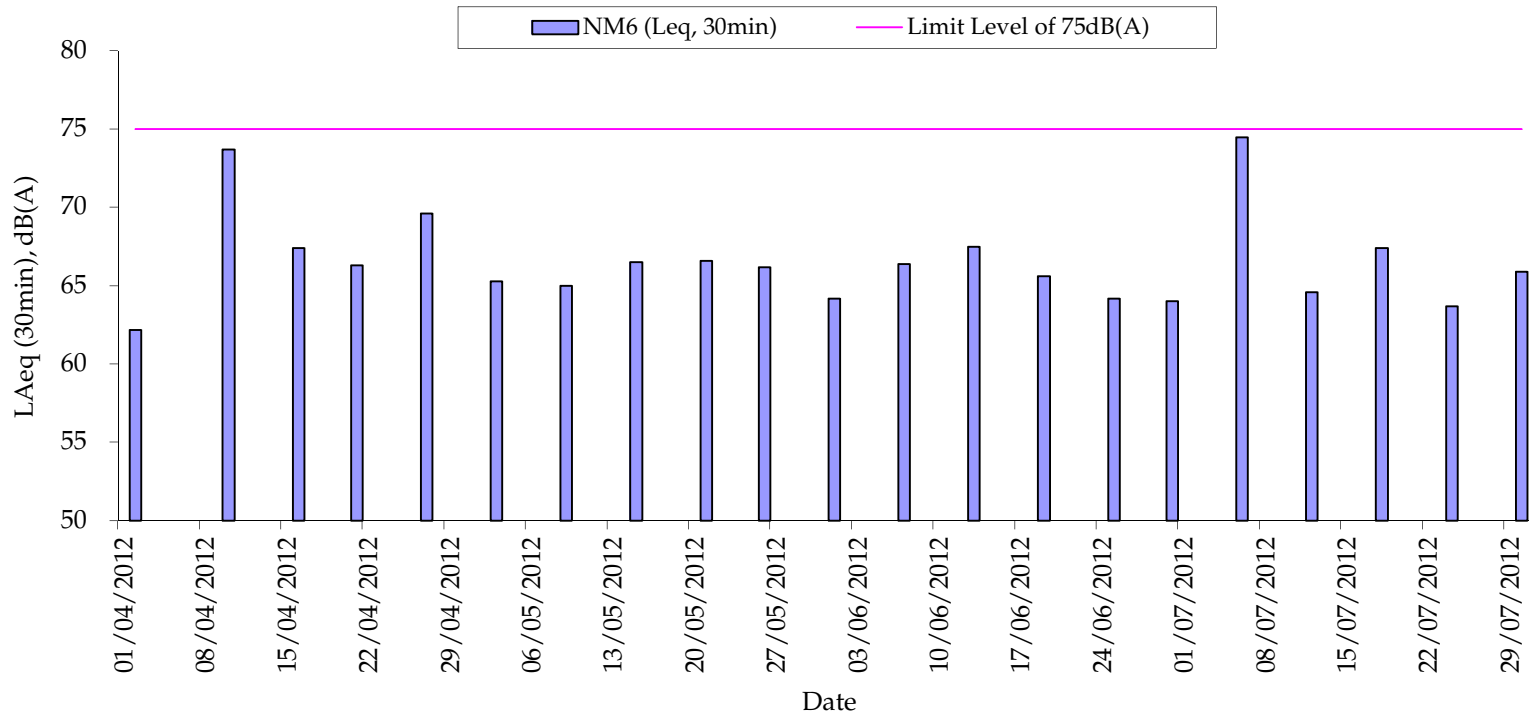
Normal Weekdays Noise Monitoring Results at NM6 - Chancery Mansion (Leq, 30min)

- 75dB(A) was adopted as the Limit Level during normal weekdays in the reporting period

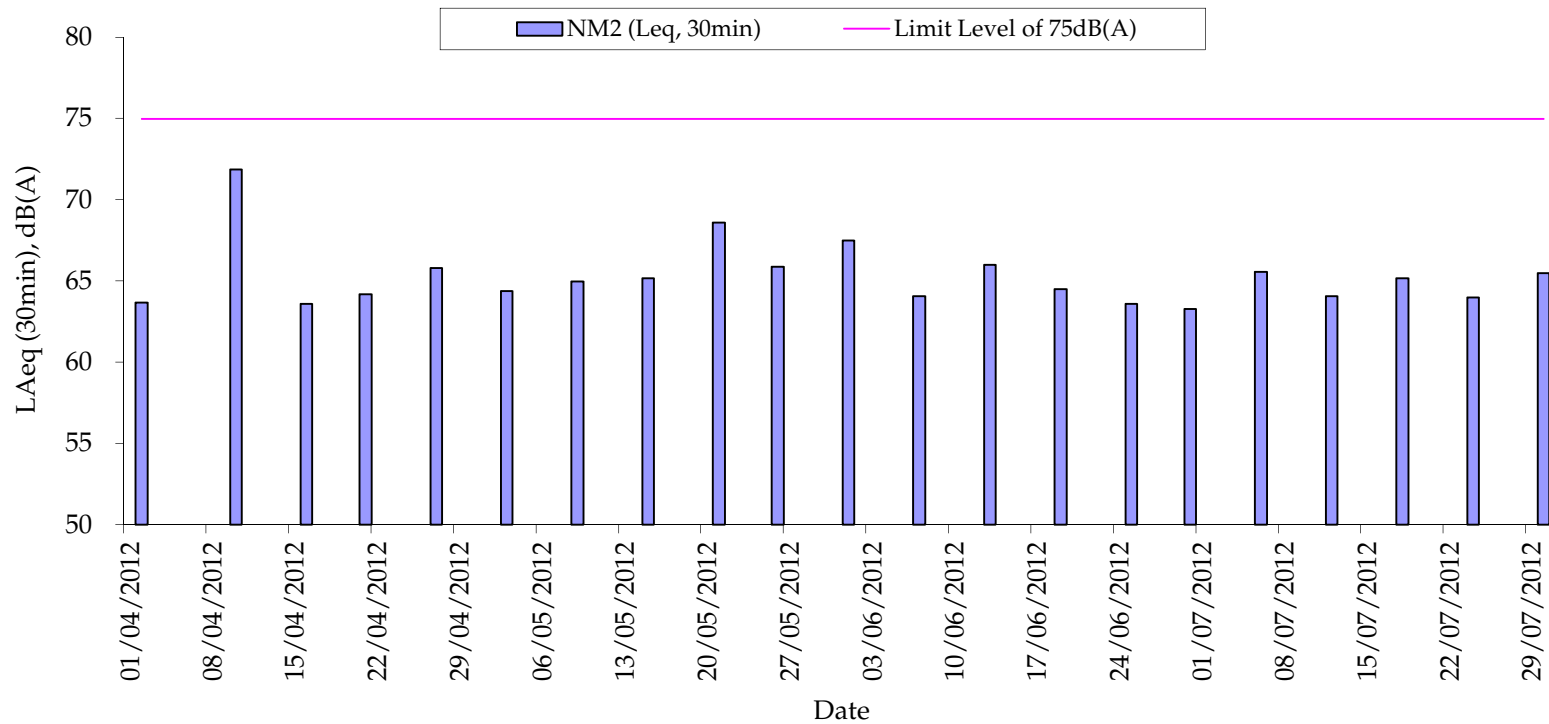
Normal Weekdays Noise Monitoring Results at NM2 - Ho Fook Building (Leq, 30min)

- 75dB(A) was adopted as the Limit Level during normal weekdays in the reporting period

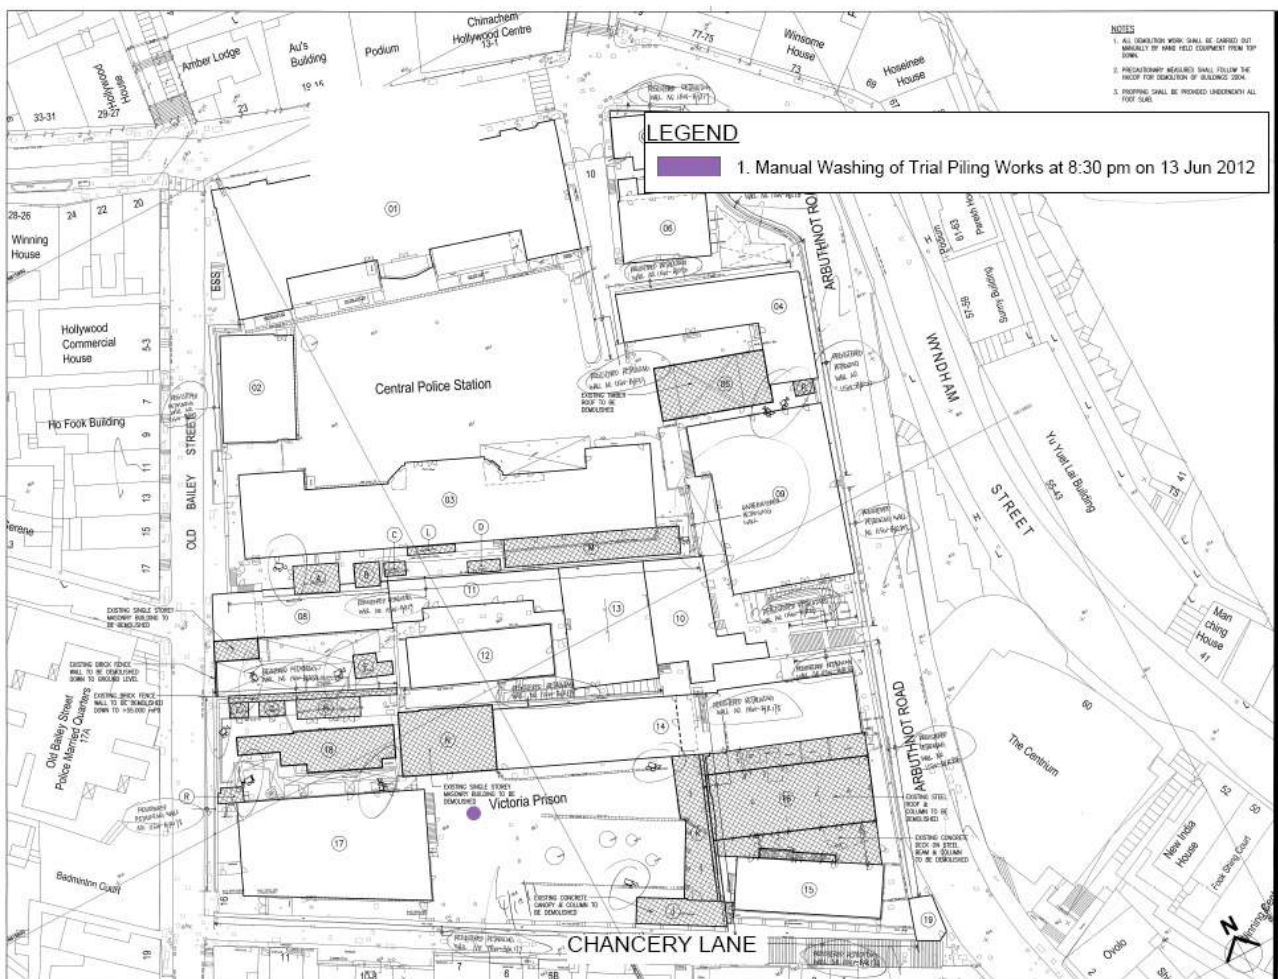
Figure 1 Site layout plan marking for Enquiry & Complaint log (CPS/E&C/06)

1. According to the works summary provided by the Contractor, no major construction activities were carried out but only manual washing of pile tube was conducted near block 17 at around 8:30pm on 13 June 2012. The location of the work area is presented in the Figure 1.

2. In view of the location of the information of the complaint and the location of the works taken, manual washing of pipe tube could be the possible source of noise nuisance. Follow-up action is recommended.

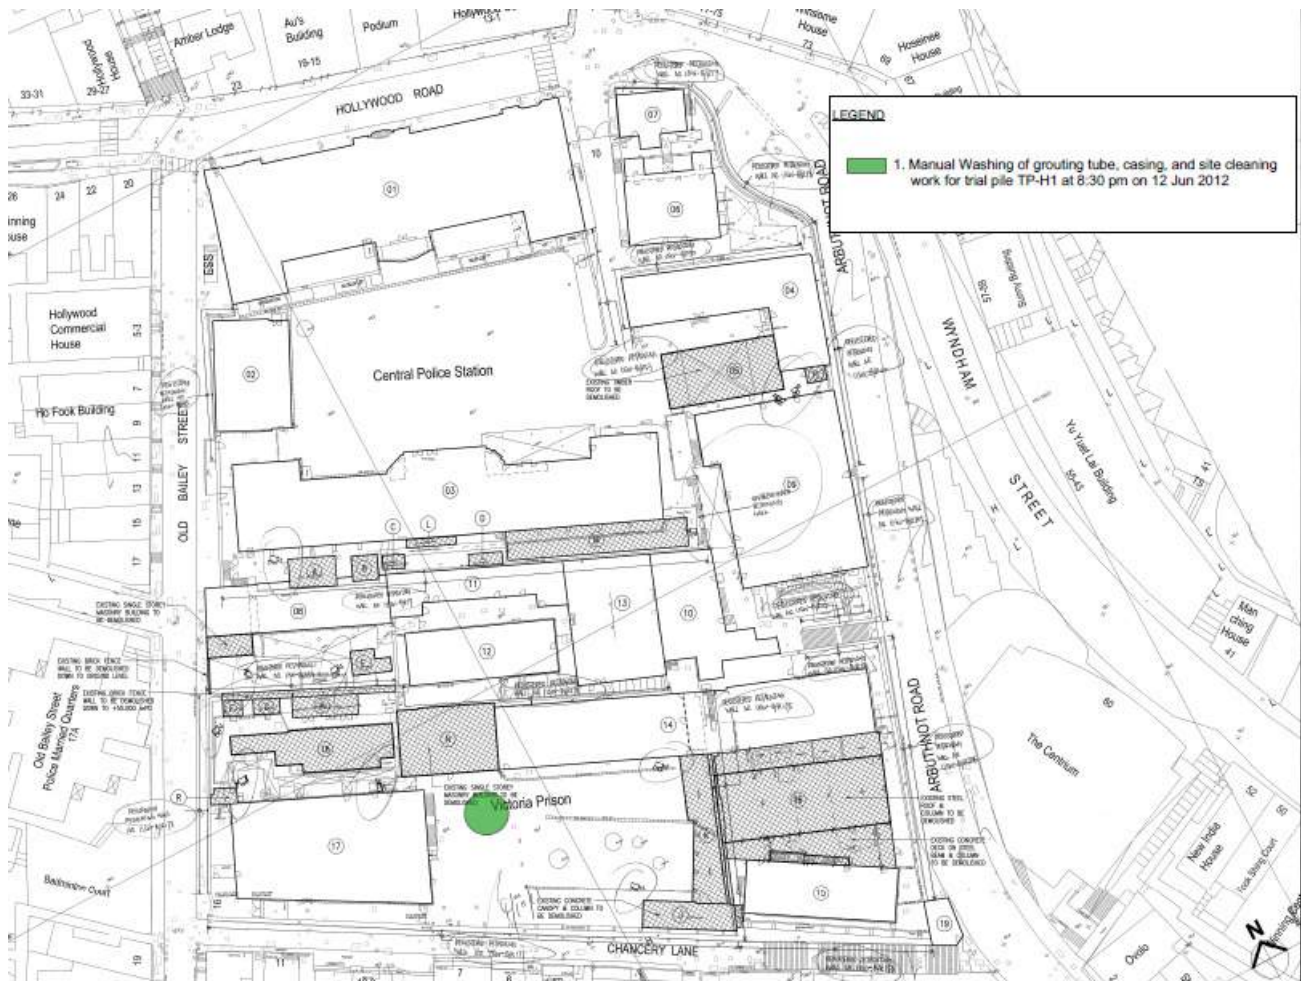
1. According to the information provided by the Contractor, no major construction activities were carried out, but only manual washing of grouting tube and casing and site cleaning work were conducted near Block 17 at around 8:30pm on 12 June 2012. The location of the work area is presented in the Figure 1.

2. Manual washing of grouting tube and casing and site cleaning work could be the possible source of noise nuisance. Follow-up action is recommended.

Mitigation Measures and Follow-Up Actions Recommended to Contractor

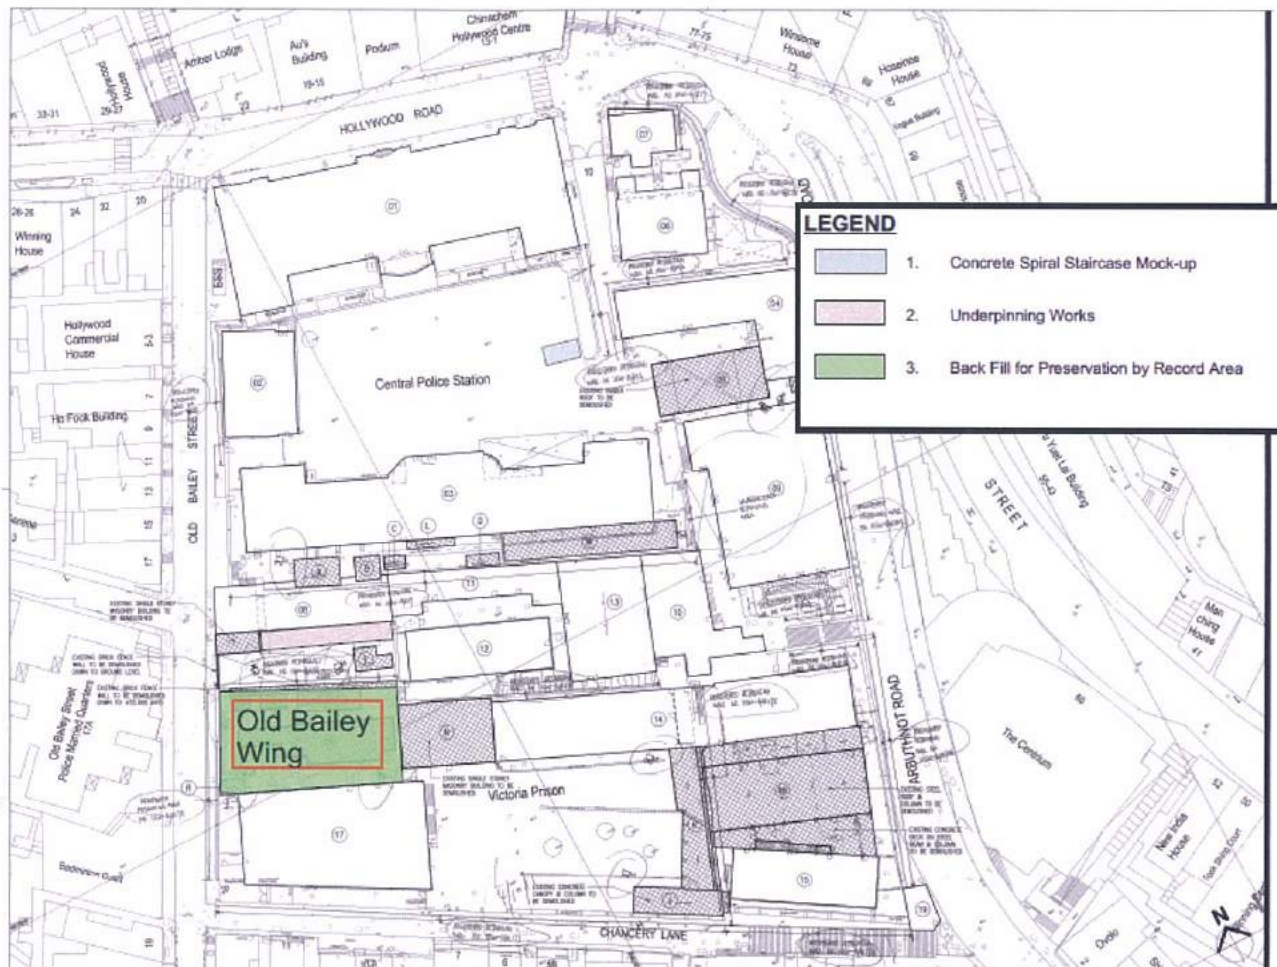
Figure 1. Locations of works being carried out on 20 July 2012

1. According to the information provided by the Contractor, the following activities were carried out on 20 July 2012:
 - Installation of handrails and other embellishing work for the concrete spiral staircase mockup in the vicinity of the site office;
 - Underpinning works of Block 8 (i.e. outdoor rebar fixing work); and
 - Manual back filling using hand tools at the Preservation by Record Area adjoining Block 17 with the aid of a light lorry.
2. The locations of the work areas are presented in Figure 1.

3. The above works carried out on 20 July 2012 are not considered to give rise a significant noise due to the work nature and the equipment used for each work. Handheld electric grinder and electric welding machine were only used for five to ten minutes during the embellishing work for the concrete spiral staircase mockup. Ventilation fan was used during underpinning works, while hand tools such as shovels or trowels were used for manual back filling. No major construction activities were carried out during the date of complaint. However, to avoid potential noise nuisance in the future, follow-up action is recommended.

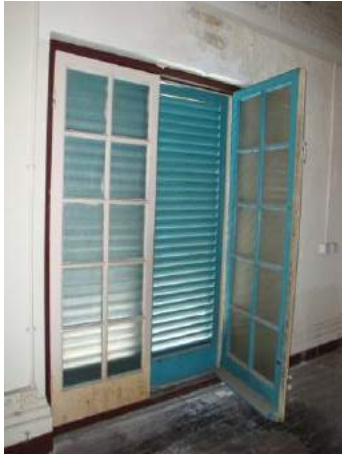
Element no.	Description	Photo ref	Significance
01.007	External shutters

High
01.008	External terraces at 1/F

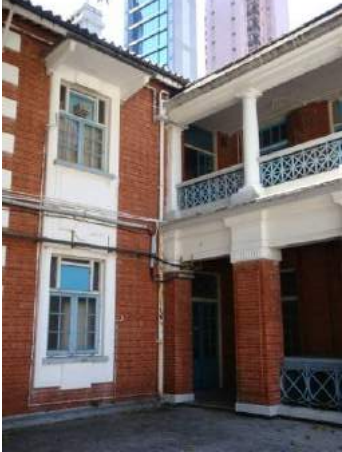
Low
01.012	Rainwater goods

Adverse

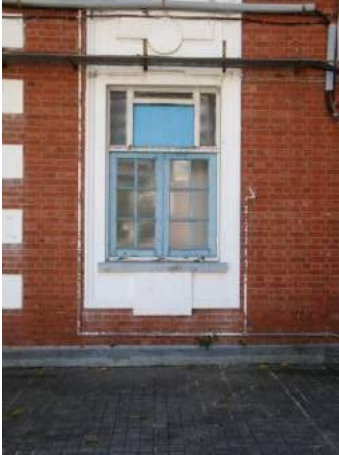
Element no.	Description	Photo ref	Significance
01.016	Altered doors and windows

Adverse
01.017	Mezzanine floor in room 01/LG1/13

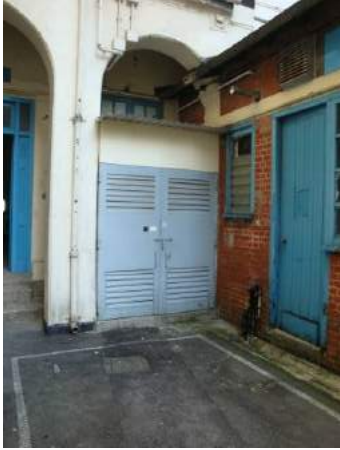
Element no.	Description	Photo ref.	Significance
04.019	Switchgear in old porch 04/G/13

Adverse
04.020	Flat plywood ceiling lining with plain rectangular cover battens

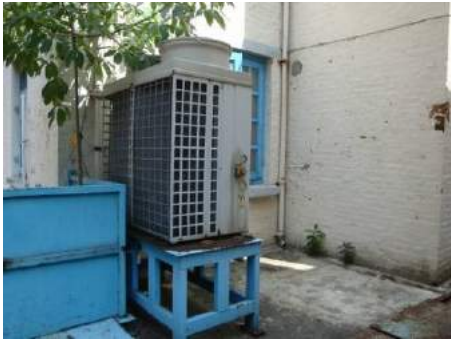
Adverse
06.006	External airconditioning units and other external services

Adverse
06.007	Painted signs

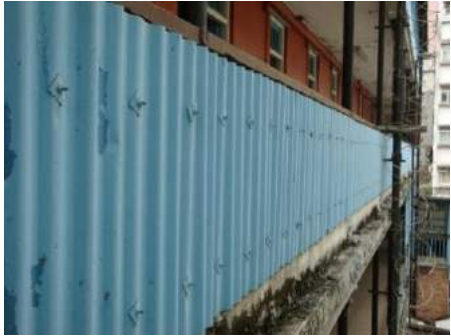
Low
08.015	Corrugated steel sheet on balcony balustrades

Adverse

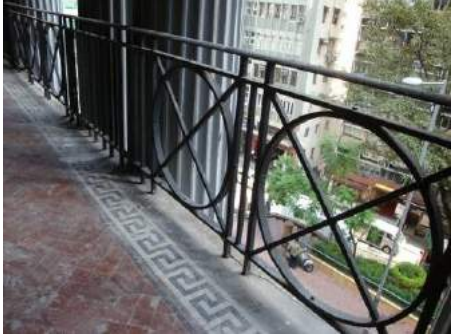
A photograph showing two black wrought-iron gates with circular decorative patterns, set against a brick wall at the top of an external staircase.	Moderate
09.027	Iron balustrade adjacent terrace at First Floor east side

A photograph of a black wrought-iron balustrade with circular decorative elements, overlooking a terrace area with a brick floor and a Greek key pattern. In the background, a city street and buildings are visible.	High

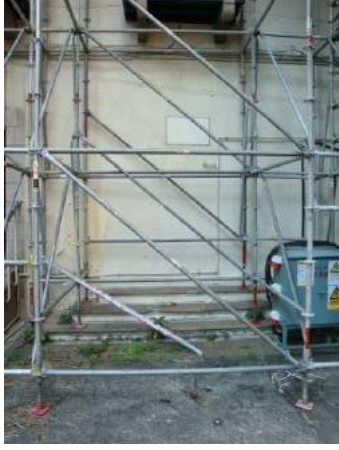
Moderate
10.026	Blocked archway on East elevation

Adverse
10.027	Chimney on east elevation

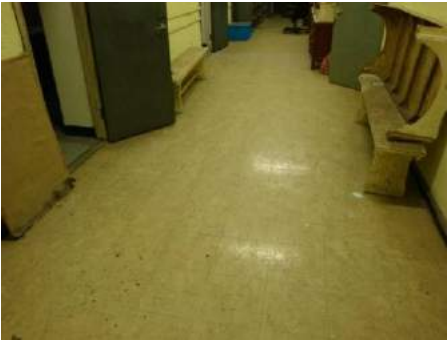
Low
14.015	Vinyl tile floor on suspended timber floor

Adverse
