Central Police Station Conservation
and Revitalisation Project:
Tenth Quarterly EM&A Report
(1 February 2014 to 30 April 2014)

Issue Date: June 2014

Environmental Resources Management

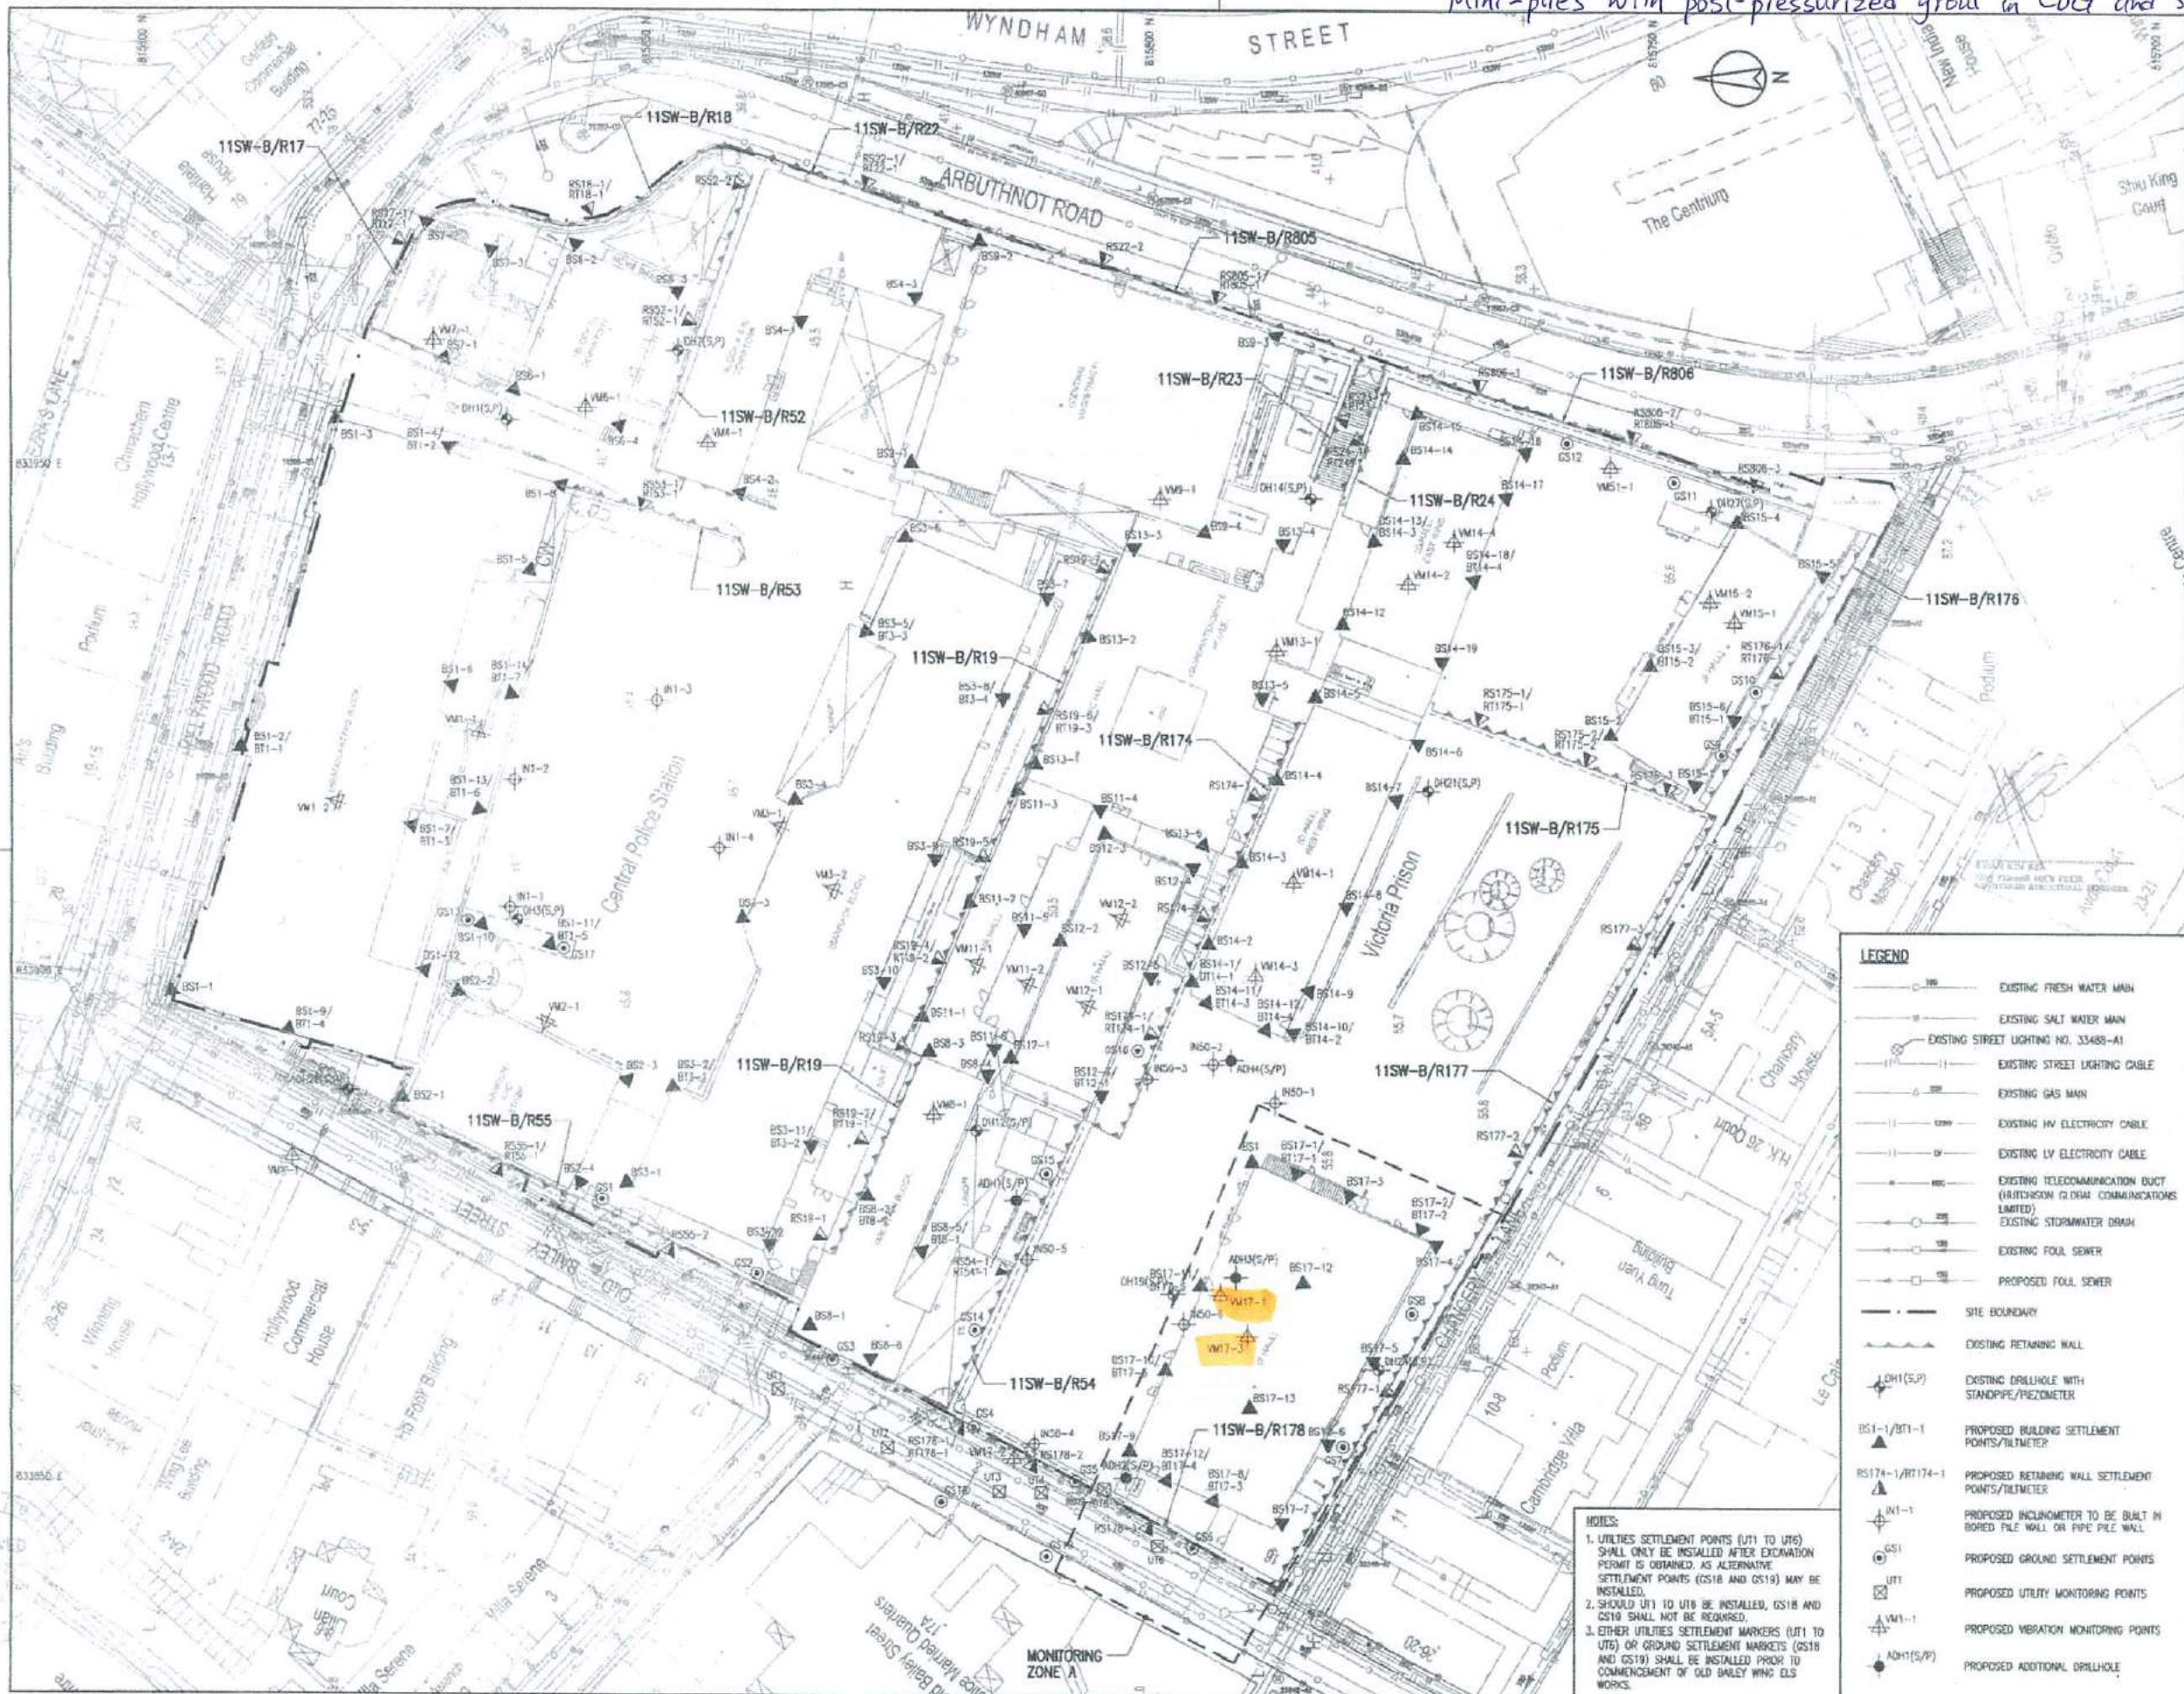
Mini-piles with post-pressurized grout in CDG and steel shear H-piles at Block 1

NOTES:
 1. UTILITIES SETTLEMENT POINTS (UT1 TO UT6) SHALL ONLY BE INSTALLED AFTER EXCAVATION PERMIT IS OBTAINED AS ALTERNATIVE SETTLEMENT POINTS (GS18 AND GS19) MAY BE INSTALLED.
 2. SHOULD UT1 TO UT6 BE INSTALLED, GS18 AND GS19 SHALL NOT BE REQUIRED.
 3. EITHER UTILITIES SETTLEMENT MARKERS (UT1 TO UT6) OR GROUND SETTLEMENT MARKERS (GS18 AND GS19) SHALL BE INSTALLED PRIOR TO COMMENCEMENT OF OLD BAILEY WORKS.

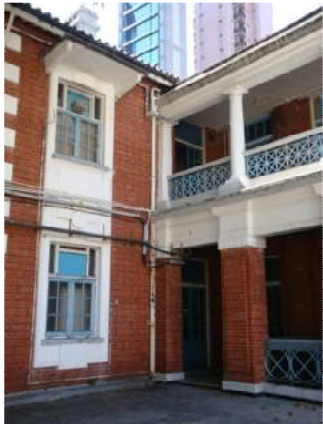
Element no.	Description	Photo ref	Significance	Proposal	Mitigation	Impact
01.012	Rainwater goods

Adverse	Replace with cast iron in pattern to match original and in correct locations	Not applicable	High

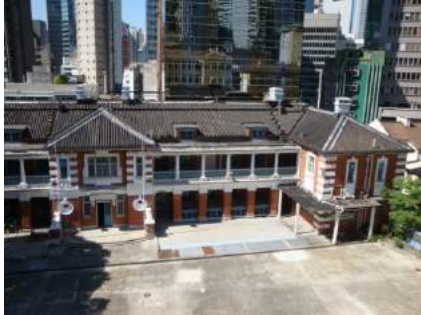
Element no.	Description	Photo ref	Significance	Proposal	Mitigation	Impact
01.025	Pitched roofs

High	New penetrations through roofs for ventilation ducts and other services	<p>Arrange new penetrations so that they conform with the geometry of the existing roof.</p> <p>Model the size and shape of the new ducts so that the impact on the roofscape is minimised.</p> <p>Finish the new ducts in a non-reflective material in a neutral mid-tone.</p>	High

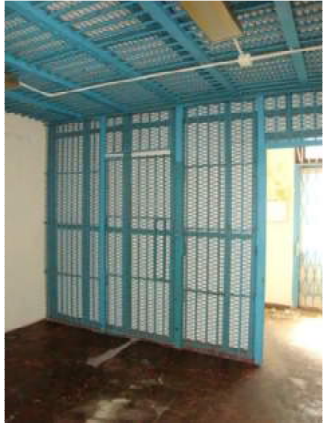
Element no.	Description	Photo ref	Significance	Proposal	Mitigation	Impact
01.027	Steel railing enclosure at FF level

Low	Remove	Record on measured drawings and photographs	Low
01.028	Tongued and grooved flat and sloped timber boarded ceilings

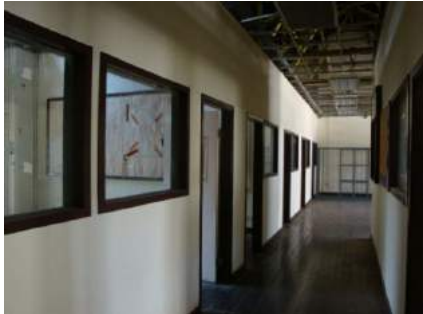
Element no.	Description	Photo ref	Significance	Proposal	Mitigation	Impact
01.029	Modern partitions

Adverse	Remove	Not applicable	High
01.030	Tiled dado

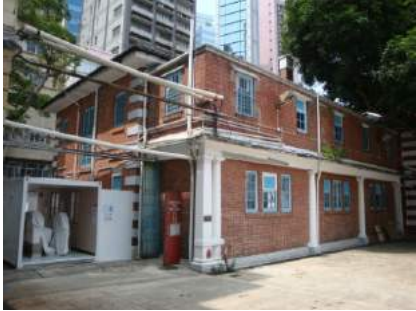
Element no.	Description	Photo ref.	Significance	Proposal	Mitigation	Impact
02.007	Rainwater goods

Adverse	Replace with cast iron in pattern to match original and in correct locations	No applicable	High

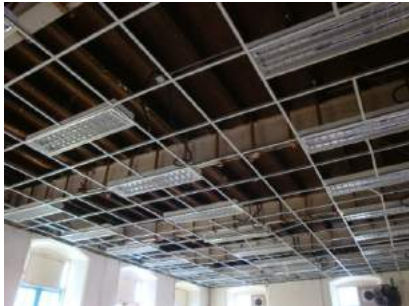
Element no.	Description	Photo ref.	Significance	Proposal	Mitigation	Impact
03.001	Lay-in grid suspended ceiling

Adverse	Remove	Not applicable	High

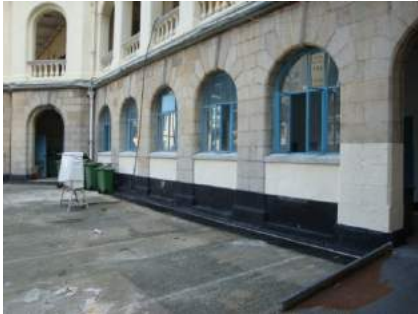
Element no.	Description	Photo ref.	Significance	Proposal	Mitigation	Impact
03.008	Exterior decorations

Adverse	Strip off and redecorate	Sample and analyse existing paint media; select new media to suit substrate and significance	High
03.009	Block existing door openings

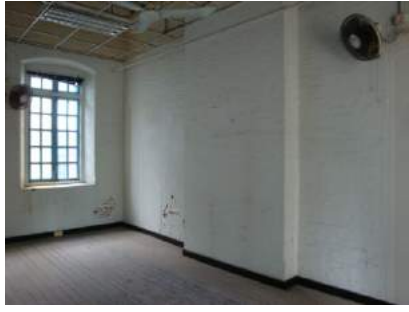
Low	Repair and retain in current location	Not applicable	Neutral
03.026	Window in south wall; original dormitory space

Moderate	Remove window and take down brickwork spandrel; subdivide space to form new fire-protected escape route.	Record existing condition on measured survey drawings. New partition wall to be reversible.	Low

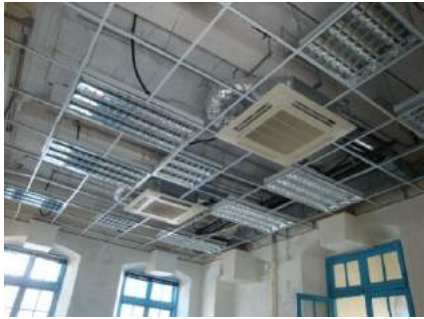
Element no.	Description	Photo ref.	Significance	Proposal	Mitigation	Impact
04.001	Lay-in grid suspended ceiling

Adverse	Remove	Not applicable	High
04.002	Timber thresholds at external doors and internal doors between main corridor and individual rooms

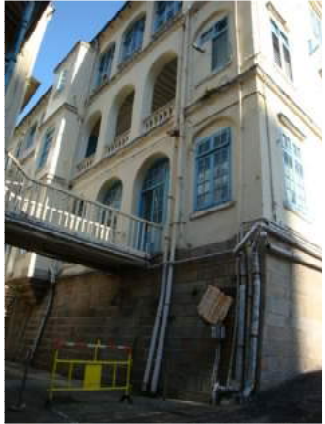
Element no.	Description	Photo ref.	Significance	Proposal	Mitigation	Impact
04.004	Rainwater goods

Adverse	Replace with cast iron in pattern to match original and in correct locations	No applicable	High

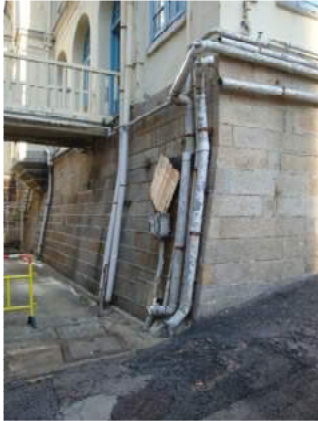
Element no.	Description	Photo ref.	Significance	Proposal	Mitigation	Impact
04.010	External airconditioning units and other external services

Adverse	Remove and make good brickwork	Not applicable	High

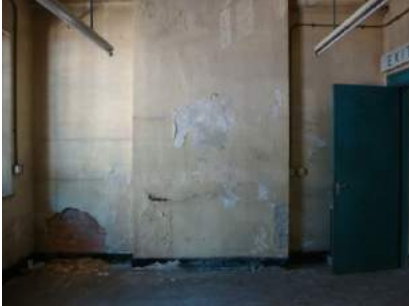
Element no.	Description	Photo ref.	Significance	Proposal	Mitigation	Impact
06.013	Form new door openings

Moderate	Form new opening as part of re-planning of interiors	New doors and frames to be of their time to avoid confusion about provenance	Moderate
06.014	Stair balustrades

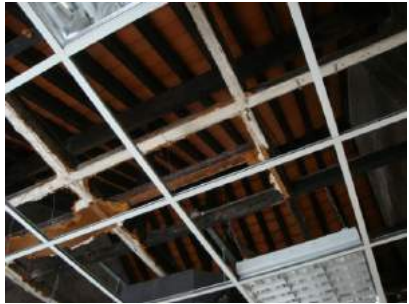
Element no.	Description	Photo ref.	Significance	Proposal	Mitigation	Impact
07.015	Exposed roof tiling

Moderate	Retain as existing	Consider insulating between upper and lower layers of roof tiles to provide thermal insulation and vapour barrier	Low
07.016	Concrete floor

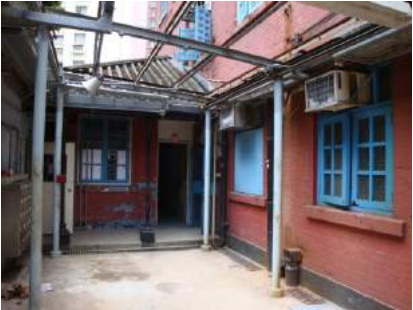
Element no.	Description	Photo ref.	Significance	Proposal	Mitigation	Impact
08.003	Exterior decorations

Adverse	Strip off and redecorate	Sample and analyse existing paint media; select new media to suit substrate and significance	High
08.004	Block existing door openings

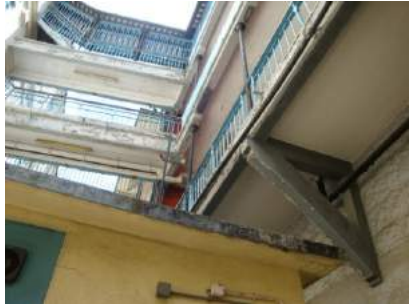
Element no.	Description	Photo ref.	Significance	Proposal	Mitigation	Impact
					clashes.	
08.011	Cantilever balconies on north side

Moderate	Repair and retain insitu	Not applicable

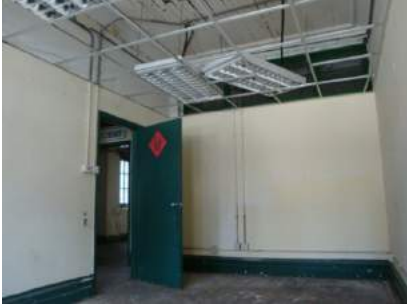
Element no.	Description	Photo ref.	Significance	Proposal	Mitigation	Impact
09.003	Internal walls

Moderate	Remove selected internal walls where strictly necessary as part of re-planning of interiors	Walls or early or original date to be retained in part eg. By leaving a “nib” where the wall is bonded to another wall. At the point where the wall is cut away, form the cut-line on the line of a vertical joint in alternate courses. Bricks in the remaining courses to be left “as cut”, and not re-bonded, as evidence of the current condition.	Moderate
09.004	Plaster box cornice

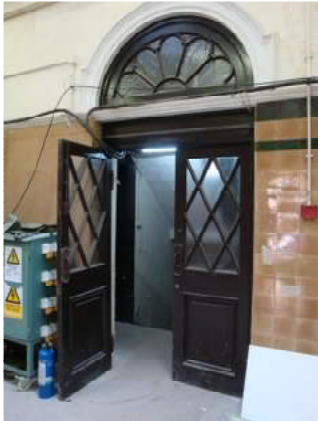
Element no.	Description	Photo ref.	Significance	Proposal	Mitigation	Impact
09.005	Panelled doors

Moderate	Replace where necessary to achieve fire resistance to comply with Code	Re-use where possible. Record design on survey drawings where element cannot be re-used.	Moderate

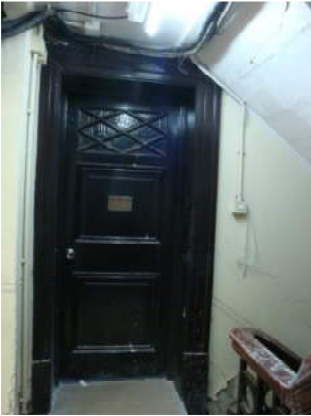
Element no.	Description	Photo ref.	Significance	Proposal	Mitigation	Impact
09.006	Block existing door openings

Moderate	Block opening as part of re-planning of interior	Retain existing door frame and architraves. Use framing and non-combustible sheet linings to block opening.	Moderate
09.007	Form new door openings		Moderate	Form new opening as part of re-planning of interiors	New doors and frames to be of their time to avoid confusion about provenance	Moderate

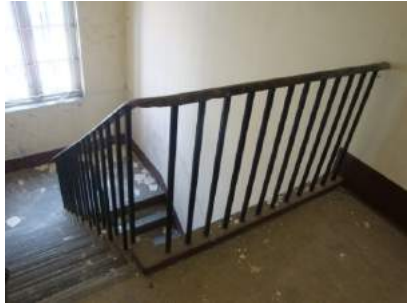
Element no.	Description	Photo ref.	Significance	Proposal	Mitigation	Impact
09.008	Stair balustrades

High	Balustrades to be supplemented with additional handrails and supports to mitigate non-compliance with code	New fittings to be of their time and made reversible. Physical intervention to existing stairs and balustrades to be kept to the minimum.	Moderate
09.009	Fixed signs

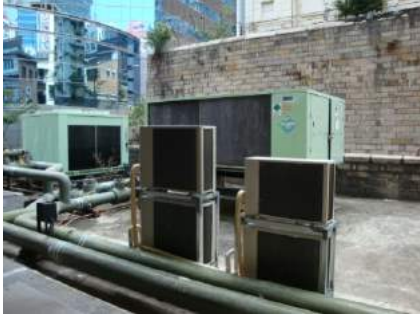
Element no.	Description	Photo ref.	Significance	Proposal	Mitigation	Impact
09.010	External airconditioning units and other external services

Adverse	Remove and make good brickwork	Not applicable	High
09.011	Pitched roofs

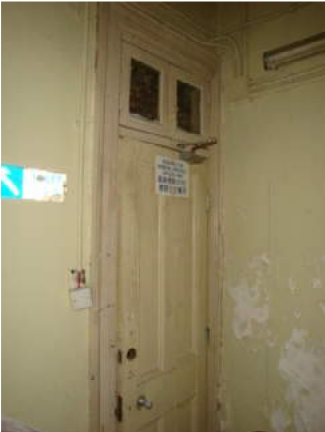
Element no.	Description	Photo ref.	Significance	Proposal	Mitigation	Impact
10.003	Panelled doors and linings

Moderate	Replace where necessary to achieve fire resistance to comply with Code	Re-use where possible. Record design on survey drawings where element cannot be re-used.	Moderate

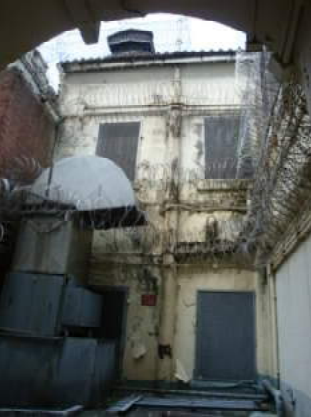
Adverse	Repair or renew as necessary existing frames to match original patterns	Not applicable	High
10.009	External airconditioning units and other external services

Adverse	Remove and make good brickwork	Not applicable	High

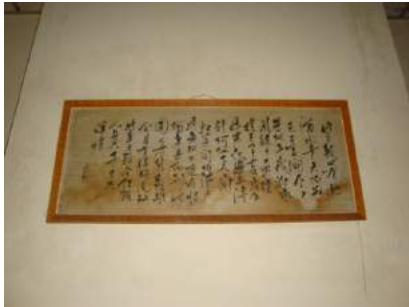
Element no.	Description	Photo ref.	Significance	Proposal	Mitigation	Impact
10.011	Fixed signs

Low-High	Remove and refix/display in visitors' centre/discard	Record each sign and assess significance individually and treat accordingly	N/A
10.012	Pitched roofs

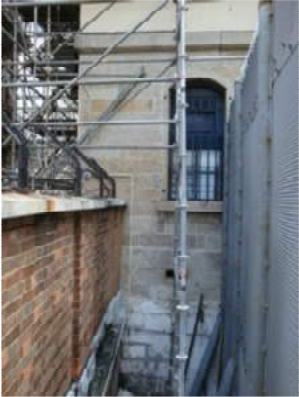
Element no.	Description	Photo ref.	Significance	Proposal	Mitigation	Impact
10.020	Clay/terrazzo tile floor on Ground Floor and steps	 	Adverse	Adjust levels to enable level access and replace floor finish	Not applicable	Low
10.024	Granite wall on North elevation

High	Construct new external steps adjacent wall	Keep new stair clear of wall; avoid any physical connection between steps and wall.	Low

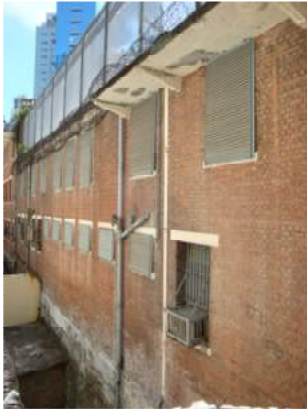
Element no.	Description	Photo ref.	Significance	Proposal	Mitigation	Impact
11.002	External airconditioning units and other external services

Adverse	Remove and make good brickwork	Not applicable	High
11.003	Painted signs

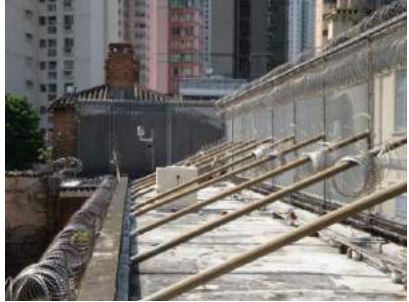
Element no.	Description	Photo ref.	Significance	Proposal	Mitigation	Impact
11.006	Flat roof

Low	Form new rooftop extension at West end to accommodate fire escape stair	Form straight joint at abutment with building 08 Ablutions Block	Low
11.007	Security screen at roof level

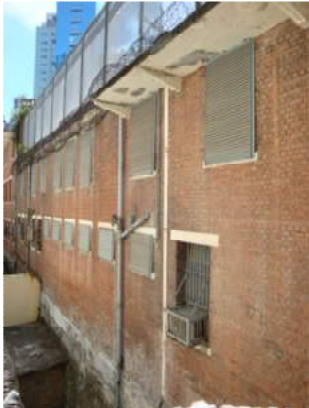
Element no.	Description	Photo ref.	Significance	Proposal	Mitigation	Impact
11.008	Rainwater goods

Adverse	Replace with cast iron in pattern to match original and in correct locations	Not applicable	High

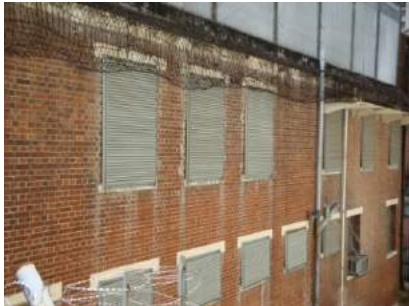
Element no.	Description	Photo ref.	Significance	Proposal	Mitigation	Impact
11.013	Metal louvres on window openings

Adverse	Remove	Not applicable	Low

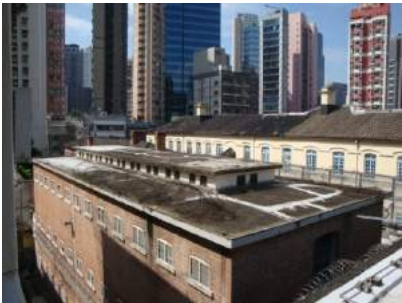
Element no.	Description	Photo ref.	Significance	Proposal	Mitigation	Impact
12.001	Flat roof

Moderate	Repair and retain	Avoid roof penetrations as far as possible	Low
12.002	Cells at GF level

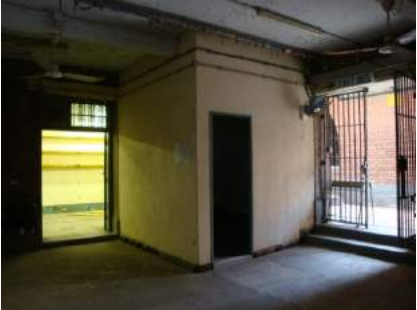
Element no.	Description	Photo ref.	Significance	Proposal	Mitigation	Impact
13.007	Internal partition walls

Low	Remove as part of re-planning of interiors	Record on measured survey drawings	Low
13.008	Fixed signs

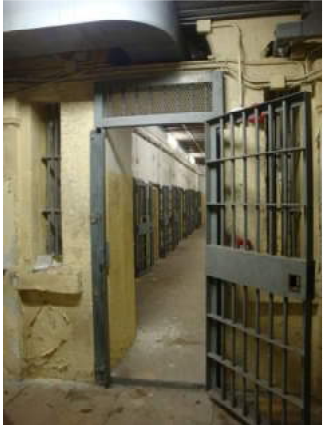
Element no.	Description	Photo ref.	Significance	Proposal	Mitigation	Impact
14.001	West entrance at Lower Ground Floor

Moderate	Retain as public entrance at this level.	<p>Retain security gate and granite threshold.</p> <p>Adjust adjacent ground level as necessary to achieve barrier-free access.</p> <p>Pin gate back against adjacent wall in the open position if necessary.</p>	Low

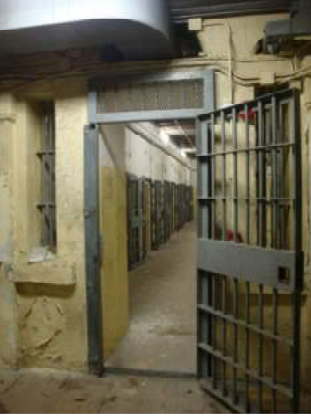
Element no.	Description	Photo ref.	Significance	Proposal	Mitigation	Impact
14.002	Half-round headed doorway and side lights

Moderate	Retain	Remove air duct and make good masonry above arch.	Low

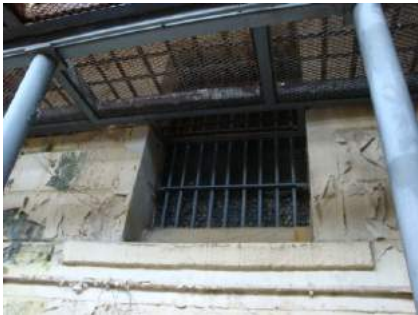
Element no.	Description	Photo ref.	Significance	Proposal	Mitigation	Impact
14.007	Part-blocked windows at Lower Ground Floor - extent of blocking varies.

Moderate	Open up window opening to full extent.	Record existing condition on measured survey drawings. Add further detail during demolition works.	Low
14.008	External granite stair from Lower Ground to Ground Floor level

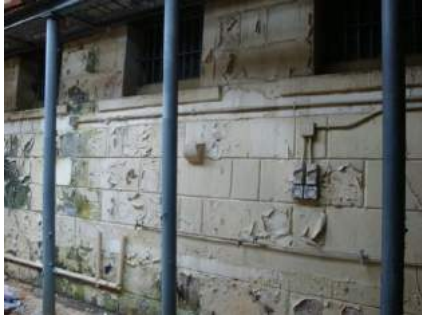
Element no.	Description	Photo ref.	Significance	Proposal	Mitigation	Impact
14.009	Ashlar pattern on external walls

Moderate	Form new openings for entrance/exit to building	<p>Set out new openings to cause minimum disruption to ashlar pattern.</p> <p>Record existing pattern on measured survey drawings.</p>	Low

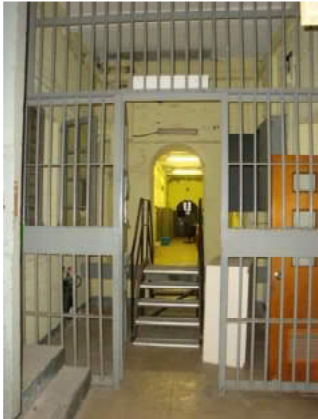
Element no.	Description	Photo ref.	Significance	Proposal	Mitigation	Impact
14.011	Metal security gate and screen

Low	Retain insitu	Pin gate in open position if necessary	Neutral

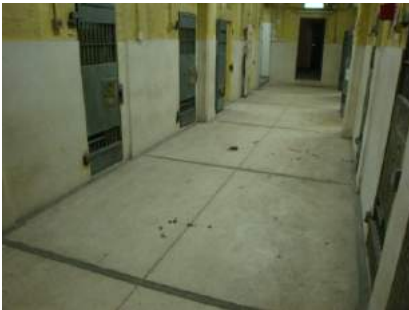
High	Retain insitu	Not applicable	Neutral
14.032	Terrazzo floor in central hall at Ground floor

Moderate	Remove to enable piled underpinning	Record on measured survey drawings	Moderate

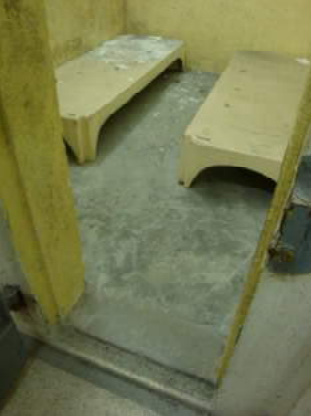
Element no.	Description	Photo ref.	Significance	Proposal	Mitigation	Impact
14.037	Cell floors

Low	Remove to enable piled underpinning	Record on measured survey drawings	Low

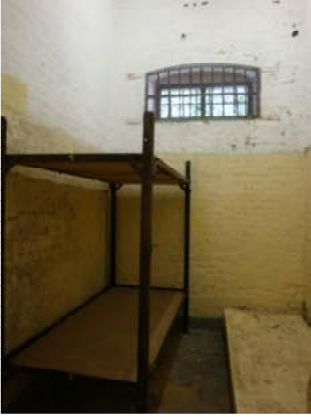
Element no.	Description	Photo ref.	Significance	Proposal	Mitigation	Impact
14.043	Cell walls flanking central hall at First Floor	 	High	Retain insitu	Not applicable	Neutral
14.044	Brickwork spandrels below cell windows at Second Floor

Moderate	Remove to enable new use	Record on measured drawings. Confine changes to one elevation, north or south.	Low

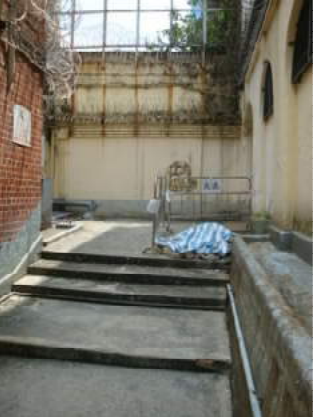
Low	Retain insitu	Not applicable	Neutral
14.052	Fence wall, east end of D Hall Yard

Low	Remove to reinstate access to granite stair to Lower Ground Floor level	Record on measured drawings	Low

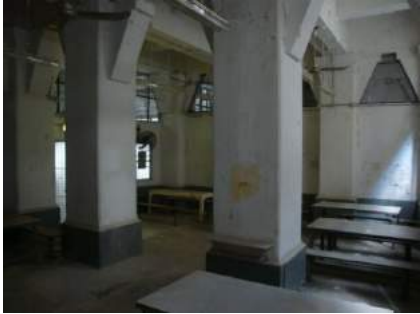
Element no.	Description	Photo ref.	Significance	Proposal	Mitigation	Impact
15.001	Dividing walls at Lower Ground Floor	 	Moderate	Remove to enable multi-purpose use	Record on measured survey drawings	Low
15.002	Dividing walls at Lower Ground Floor

Moderate	Remove to enable multi-purpose use	Record on measured survey drawings	Low

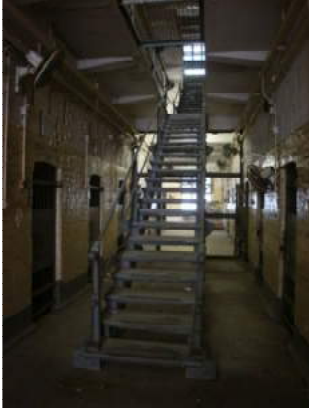
Element no.	Description	Photo ref.	Significance	Proposal	Mitigation	Impact
15.008	Central staircase

High	Retain	Provide secondary staircase within cell blocks to achieve code compliance	Low

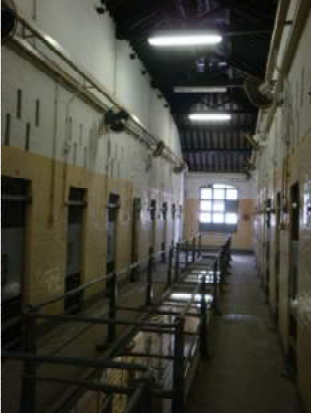
Element no.	Description	Photo ref.	Significance	Proposal	Mitigation	Impact
15.012	Second Floor central hall

High	Retain	Not applicable	Neutral

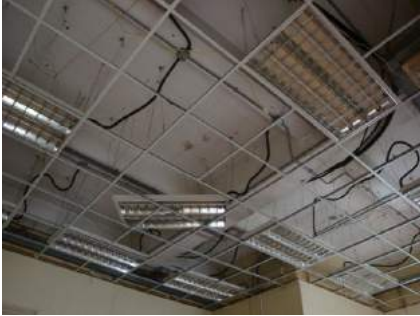
Element no.	Description	Photo ref.	Significance	Proposal	Mitigation	Impact
17.001	Lay-in grid suspended ceiling

Adverse	Remove	Not applicable	High

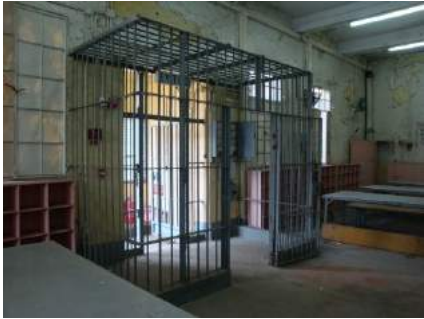
Element no.	Description	Photo ref.	Significance	Proposal	Mitigation	Impact
17.006	Security screen at First Floor entrance

Low	Remove	Record on measured drawings	Low
17.007	Metal windows	 	Moderate	Remove at First Floor to accommodate gallery space and block structural openings with blockwork	Record on measured drawings.	Moderate

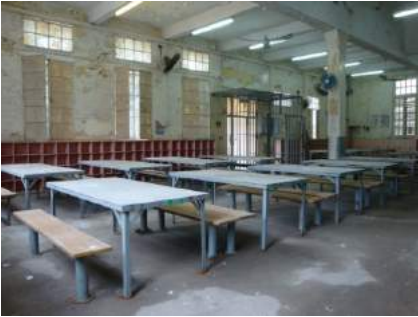
Element no.	Description	Photo ref.	Significance	Proposal	Mitigation	Impact
17.008	Fixed furniture

Moderate	Remove to accommodate gallery space	None	Low
17.009	Security screens

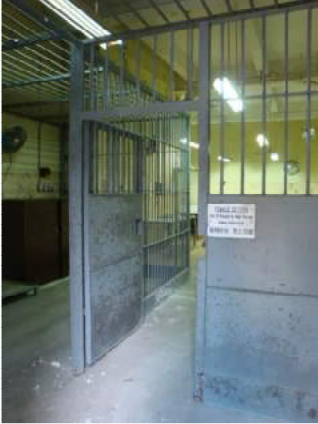
Element no.	Description	Photo ref.	Significance	Proposal	Mitigation	Impact
17.017	Security screen at Ground Floor main entrance

Low	Remove to accommodate gallery space	Record on measured drawings	Low

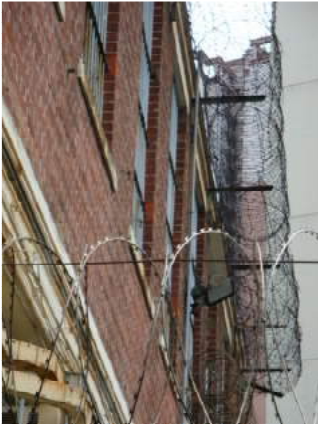
Element no.	Description	Photo ref.	Significance	Proposal	Mitigation	Impact
17.021	Barbed wire

Moderate	Remove	Record on measured drawings. Make good fixing points where attached to brickwork.	Low

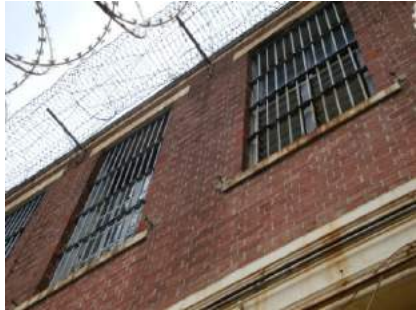
Element no.	Description	Photo ref.	Significance	Proposal	Mitigation	Impact
17.022	Metal security bars at windows

Moderate	Remove as part of blocking up window openings to accommodate gallery space at First Floor	Record on measured drawings	Low
17.023	External toilets at Ground Floor adjacent East elevation

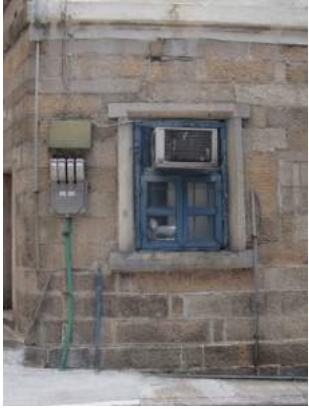
Element no.	Description	Photo ref.	Significance	Proposal	Mitigation	Impact
19.003	Rainwater goods and other external services

Adverse	Remove and make good wall surface. Replace defective and non-matching rainwater goods with cast iron fittings to match original.	Not applicable	Moderate

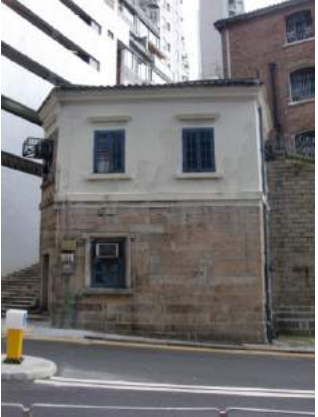
Element no.	Description	Photo ref.	Significance	Proposal	Mitigation	Impact
19.004	External stone wall facing

High	Carry out close inspection of painted areas to determine extent of original granite facing and remove paint media where applicable.	Not applicable	Moderate

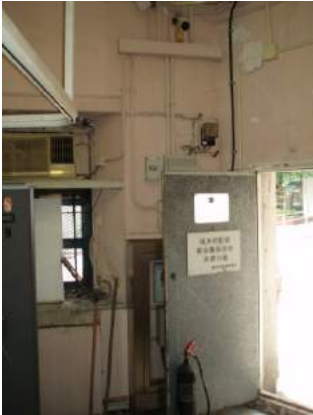
Element no.	Description	Photo ref.	Significance	Proposal	Mitigation	Impact
19.009	Electrical services

Adverse	Remove	Not applicable	Moderate
19.010	Lay-in grid suspended ceiling
