Central Police Station Conservation
and Revitalisation Project:
71st Monthly EM&A Report
(1 September to 30 September 2017)

Issue Date: October 2017

Central Police Station Conservation
and Revitalisation Project:
71st Monthly EM&A Report
(From 1 September to 30 September
2017)

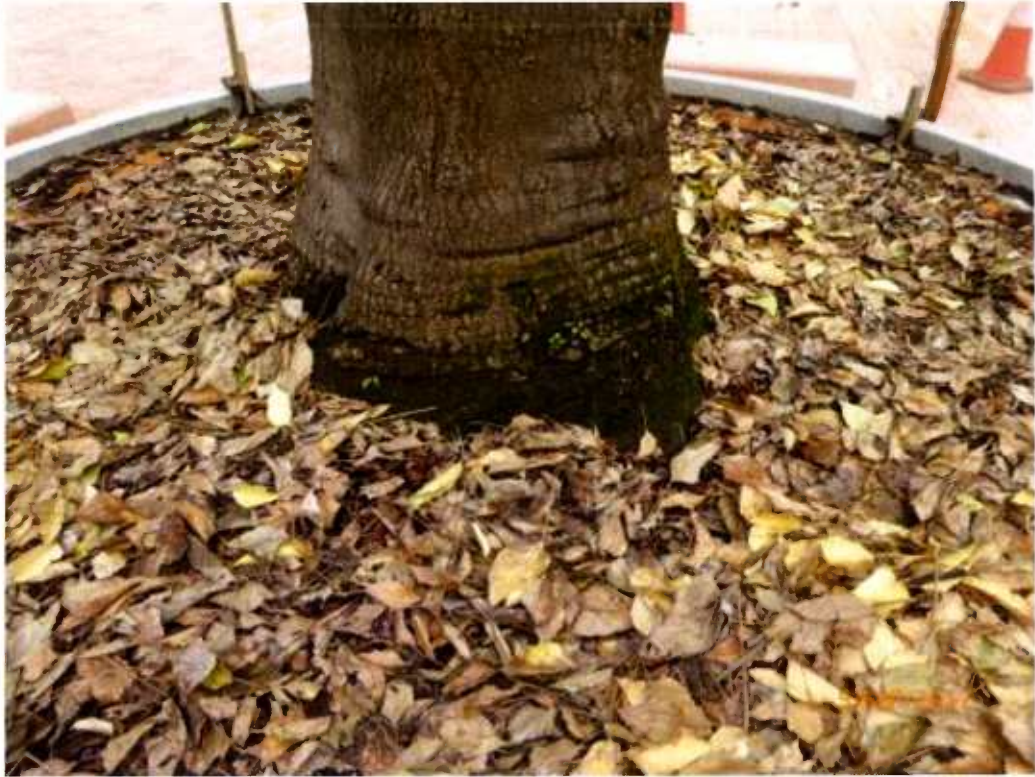
Fig 3. Health condition of the lower trunk is fair.

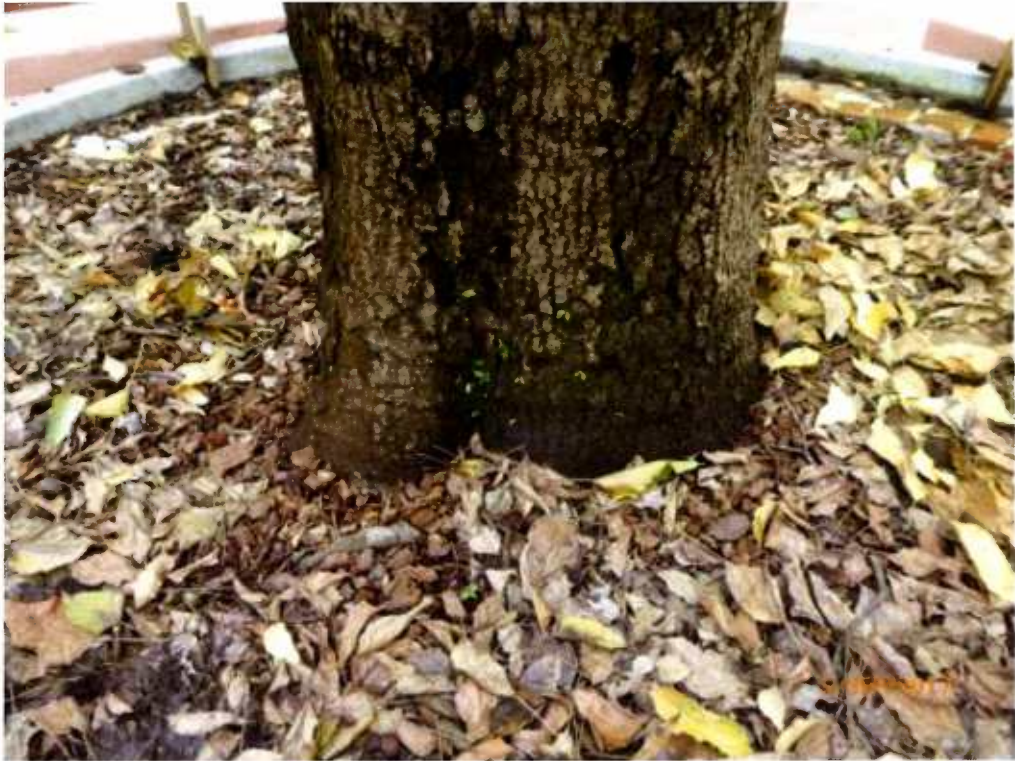
Fig 3. Health condition of the lower trunk is fair.

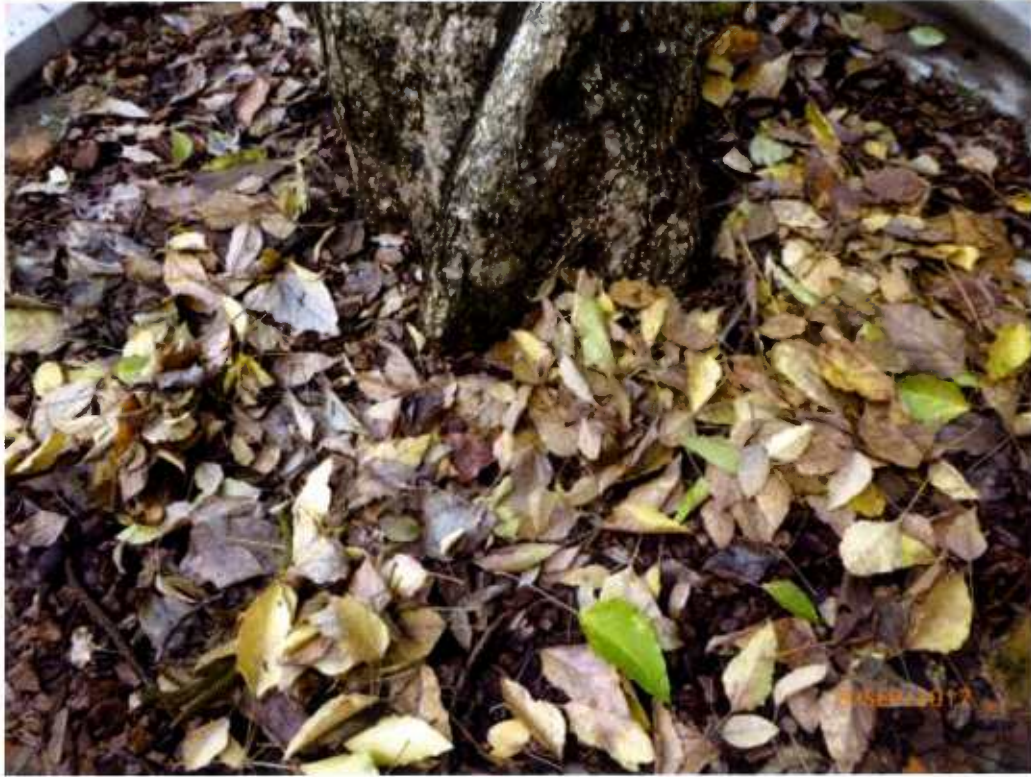
Fig. 3 Health condition of the lower trunk is fair.

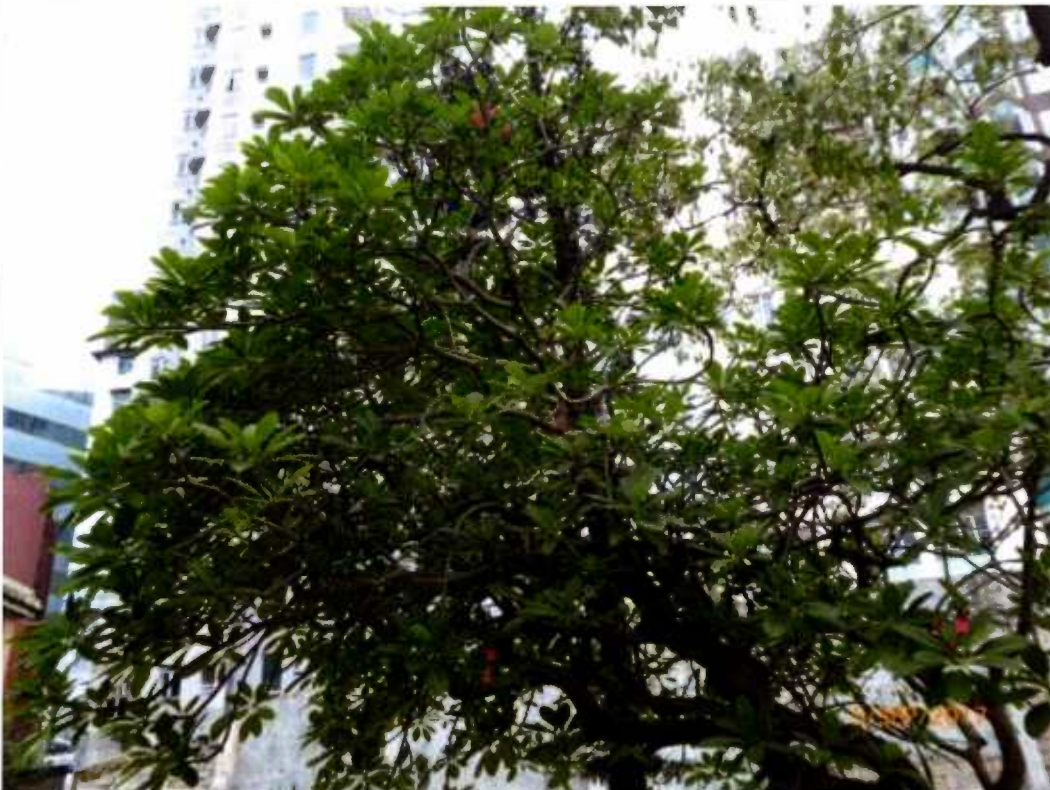
Fig. 9 Side view of Tree-8 at the time of inspection on 5th Sept. 2017.

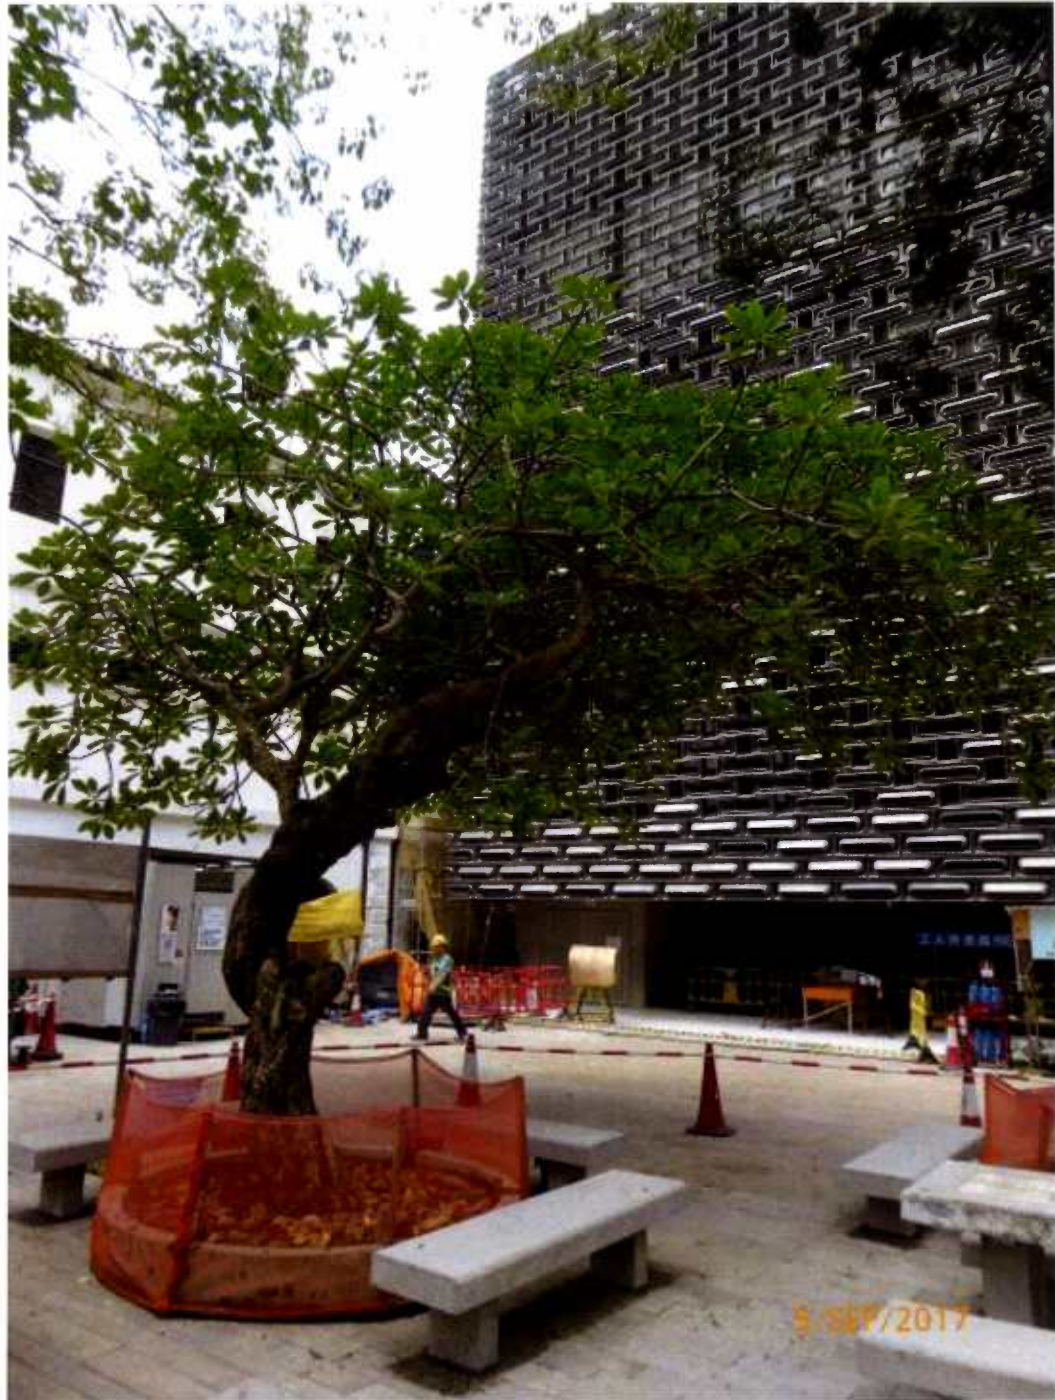
Fig. 12 Overall view of Tree-8 during inspection on 5th Sept. 2017.

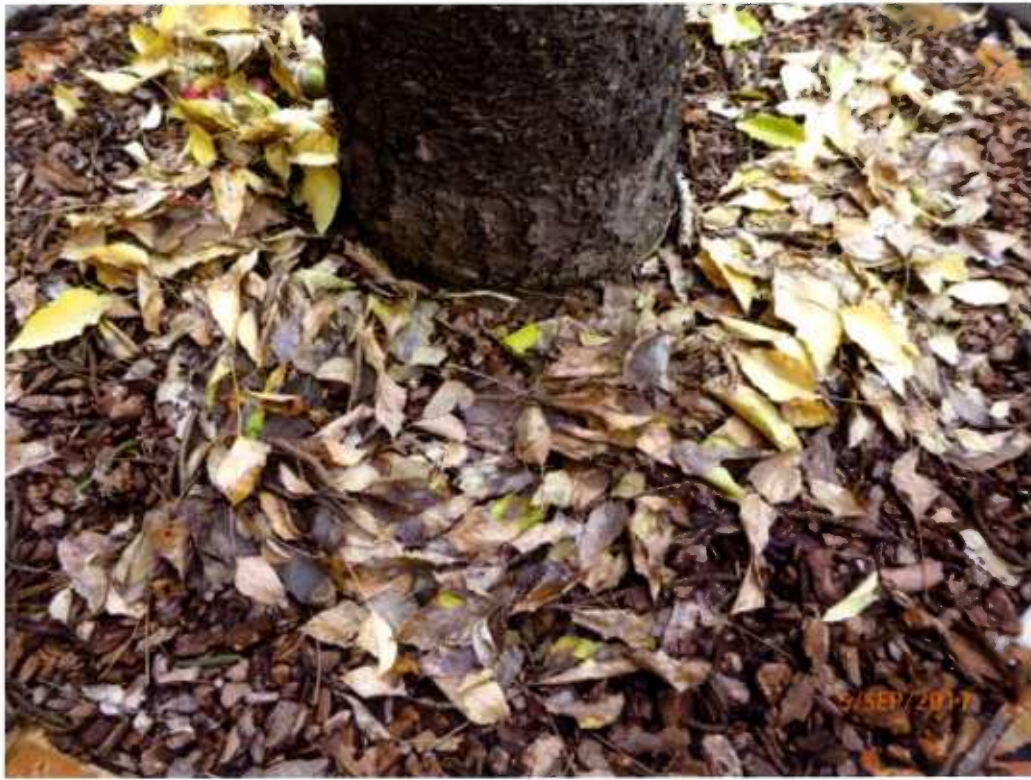
Fig. 3 Health condition of the lower trunk is fair.

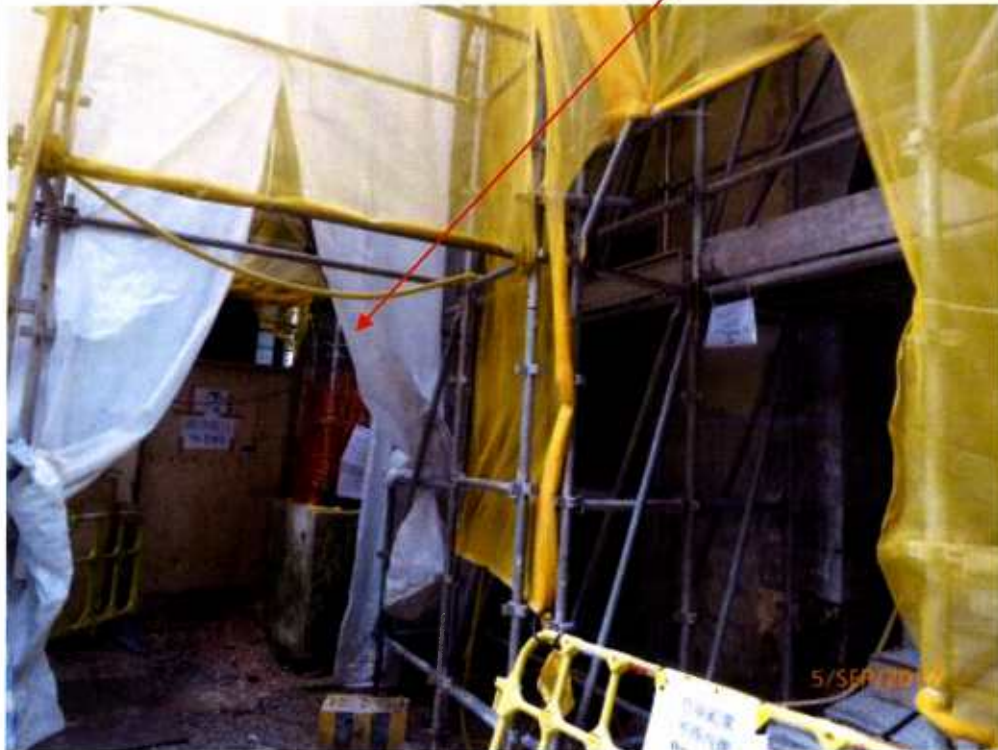
Fig. 12 Overall view of Tree-11 during inspection on 5th Sept. 2017.
