Central Police Station Conservation
and Revitalisation Project:
76th Monthly EM&A Report
(1 February to 28 February 2018)

Issue Date: March 2018

Environmental Resources Management

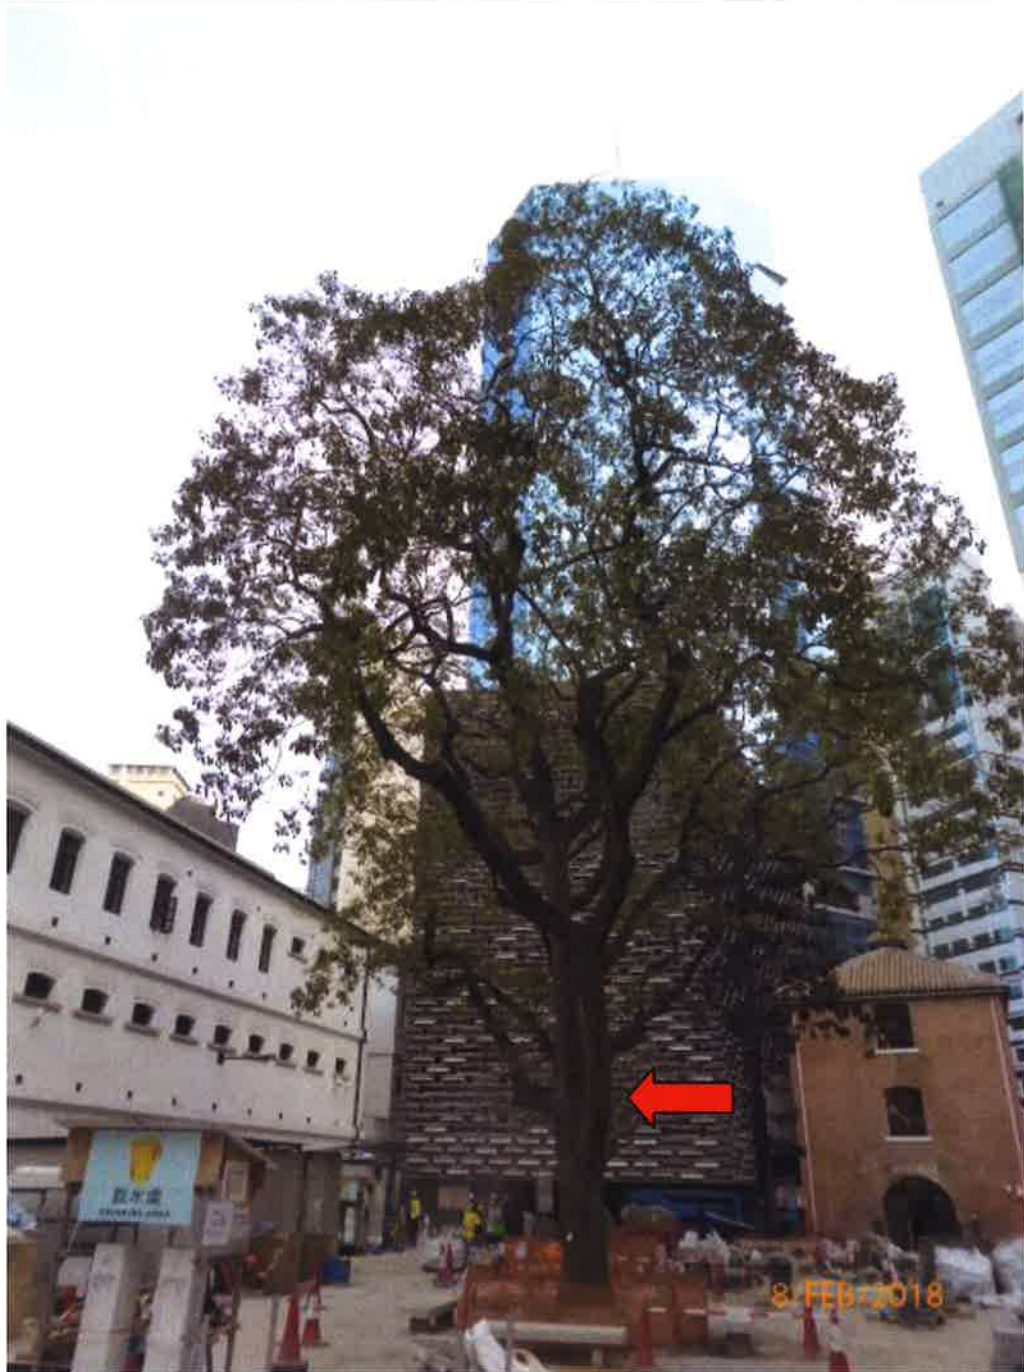
Fig. 12 Overall view of Tree-6 during inspection on 8th February 2018.

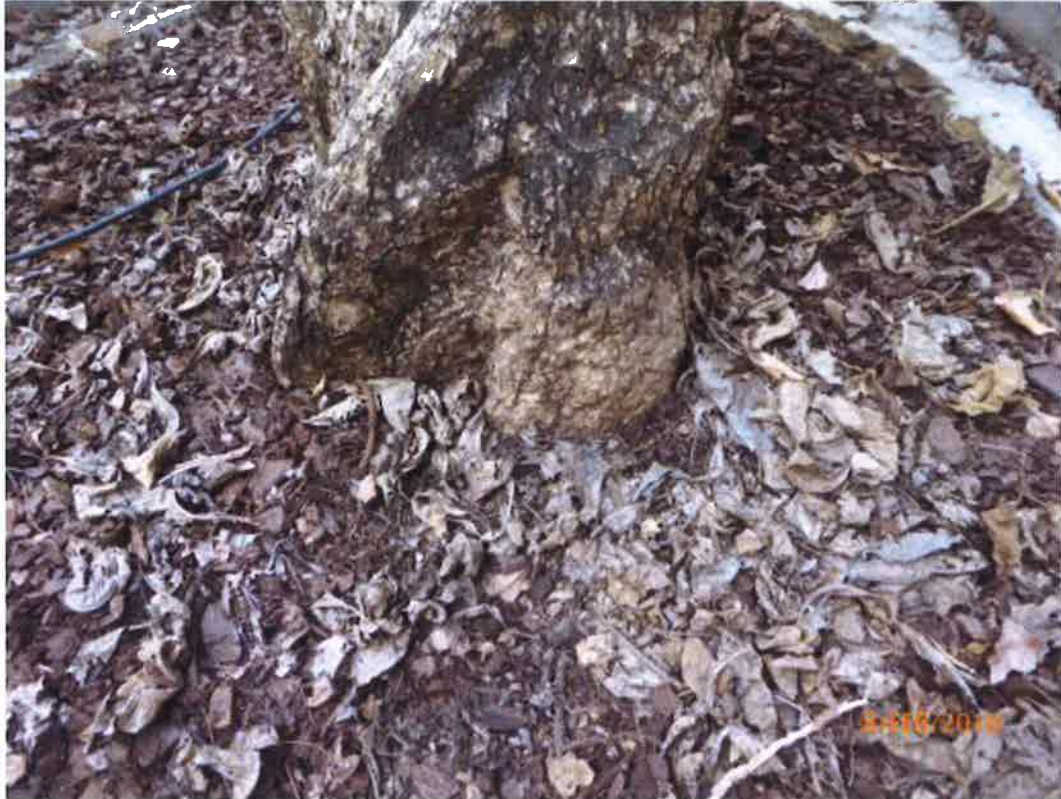
Fig. 3 Health condition of the lower trunk is fair.

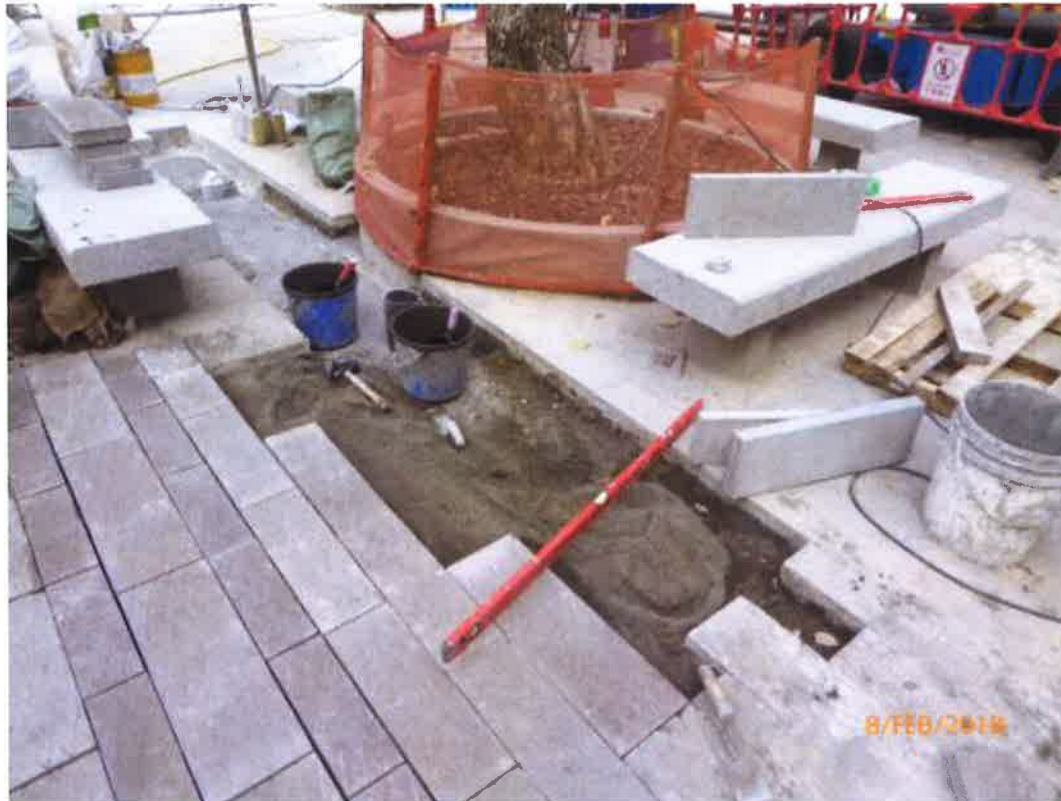
Fig. 11 Many construction materials are placed near the tree.

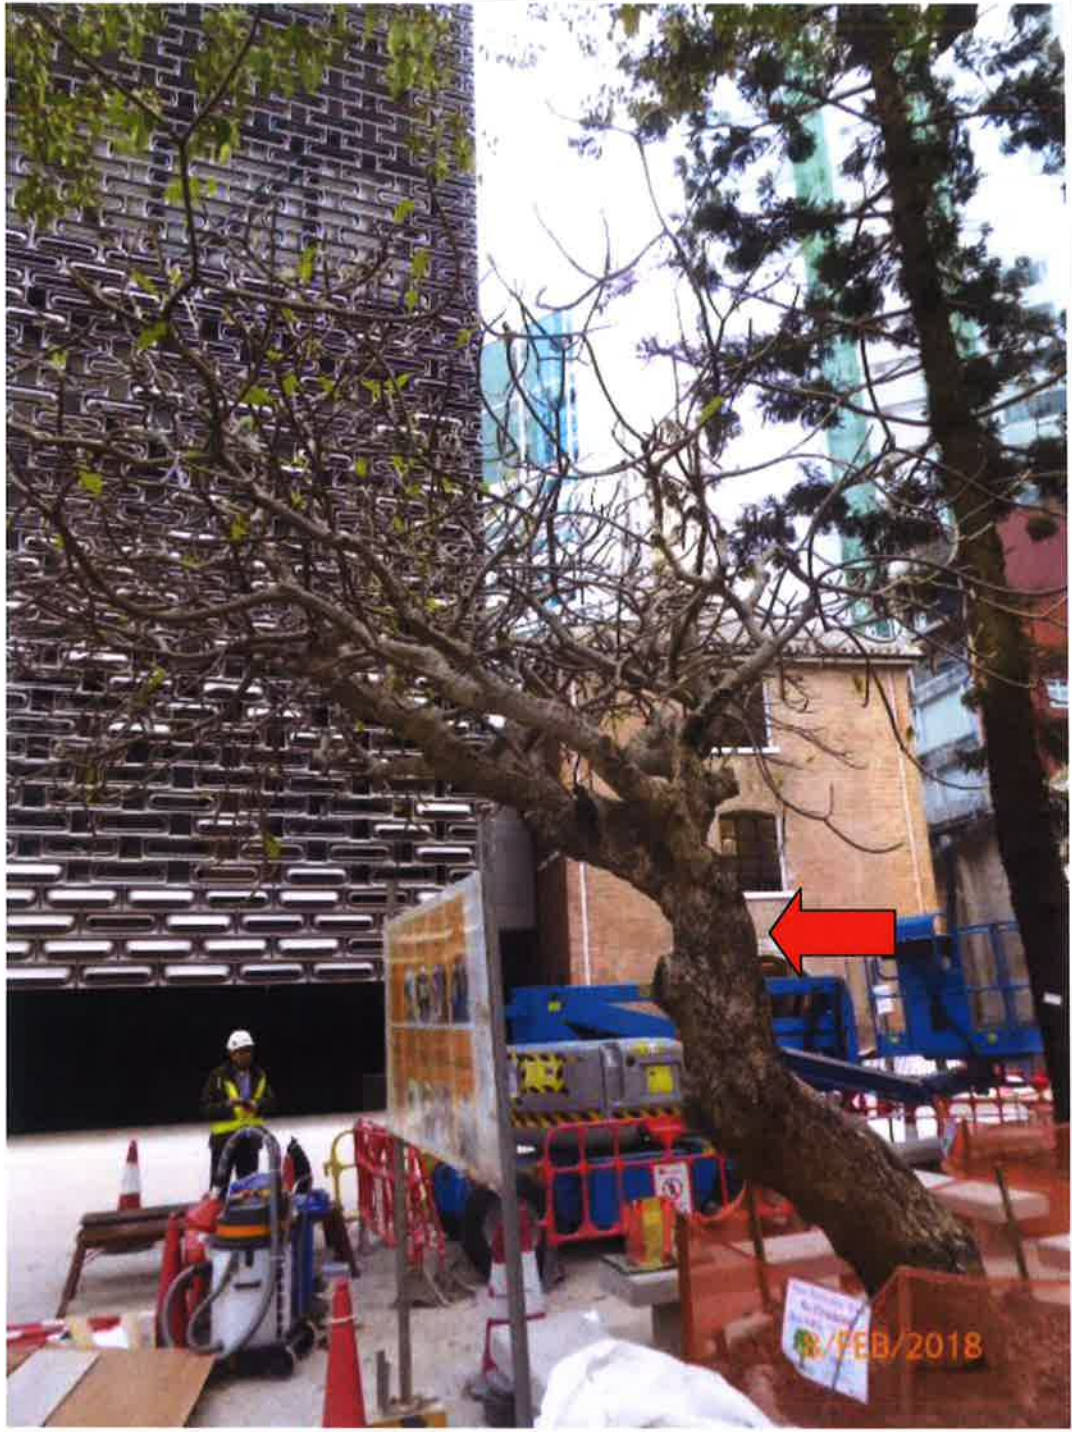
Fig. 12 Overall view of Tree-8 during inspection on 8th February 2018.

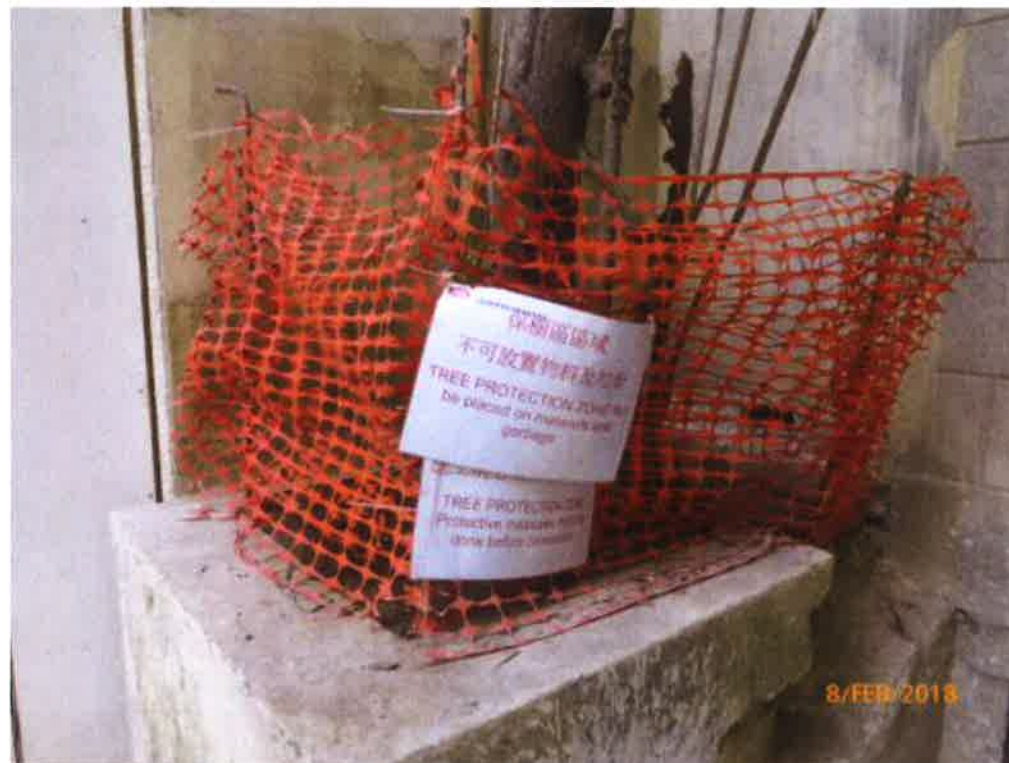
Fig. 10 Renovation works are in progress near the tree.

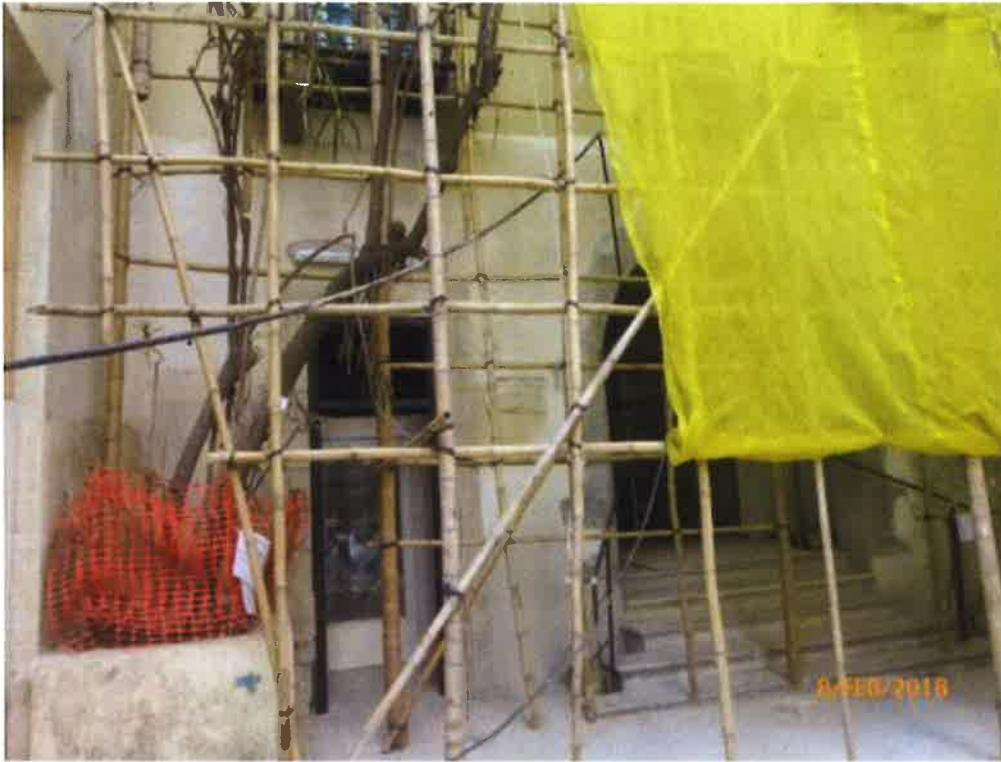
Fig. 11 The site near Tree-11 appears clean and tidy.

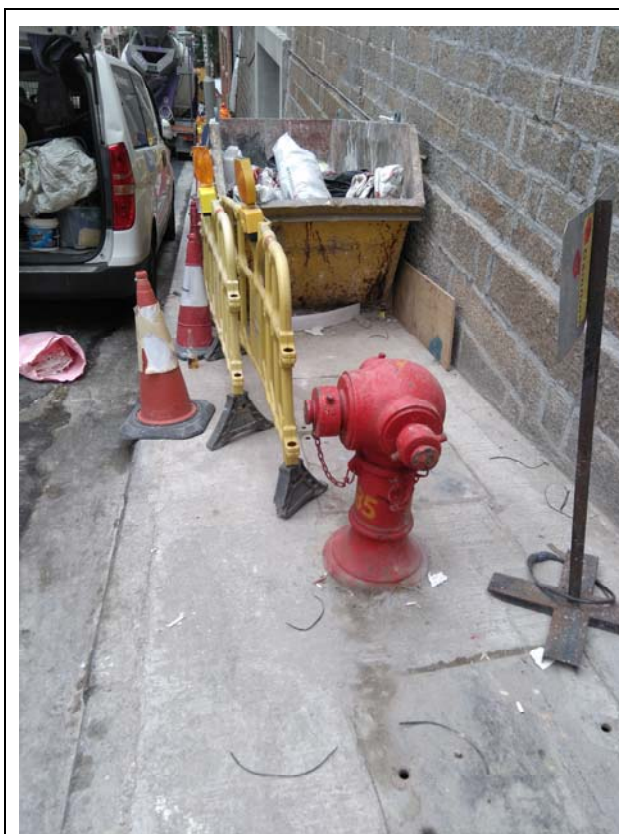
1. As advised by Gammon Construction Limited (the Contractor), one waste skip belonging to the CPS Site is located near the main entrance gate (blue gate) on the sidewalk of Old Bailey Street. The waste skip is located within the barricaded area on the east sidewalk of Old Bailey Street which is part of the approved road works area for CPS. The waste skip would not cause obstruction to road or pedestrians. A photo of the waste skip is shown in *Photo 1* and its location is shown in *Figure 1*. Construction waste generated from the CPS Site would be temporarily deposited in the waste skip, which will be cleared at the end of each working day. There is no illegal dumping of construction waste from the CPS Site. It should be noted that this waste skip has been in the same location for at least the past 1-2 years.

Photo 1: Construction Waste Skip (CPS Site)

All construction works are carried out strictly following the necessary requirements specified in EIA, EM&A Manual, EMP, Method Statements, General and Particular Specifications of this Project. The Contractor has been reminded to maintain tidiness of the construction waste skip and its surroundings. Construction waste should only be stored inside the waste skip and should be cleared on a daily basis to prevent accumulation. With regard to the temporary storage area at the junction of Old Bailey Street and Hollywood Road, the Contractor was also reminded to keep the temporary storage area tidy and clear of litter.
