The Jockey Club CPS Limited

Central Police Station Conservation
and Revitalisation Project:
First Monthly EM&A Report
(From 24 October 2011 to 30
November 2011)

Environmental Resources Management

Reference 0095646

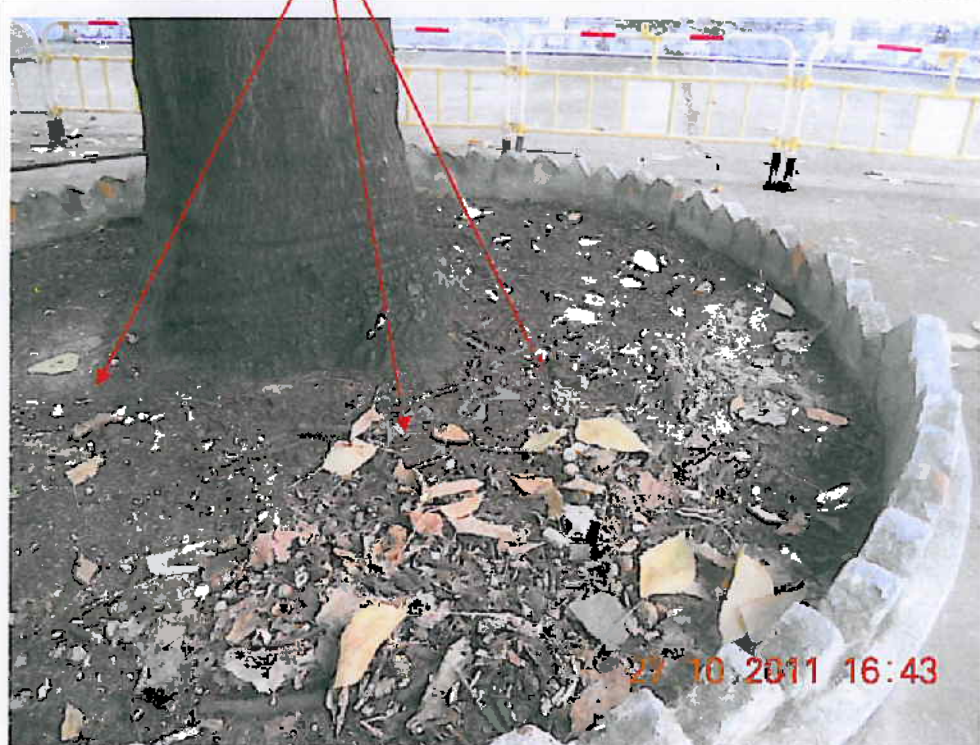
Fig 3 Too much top soil accumulated on the root collar.

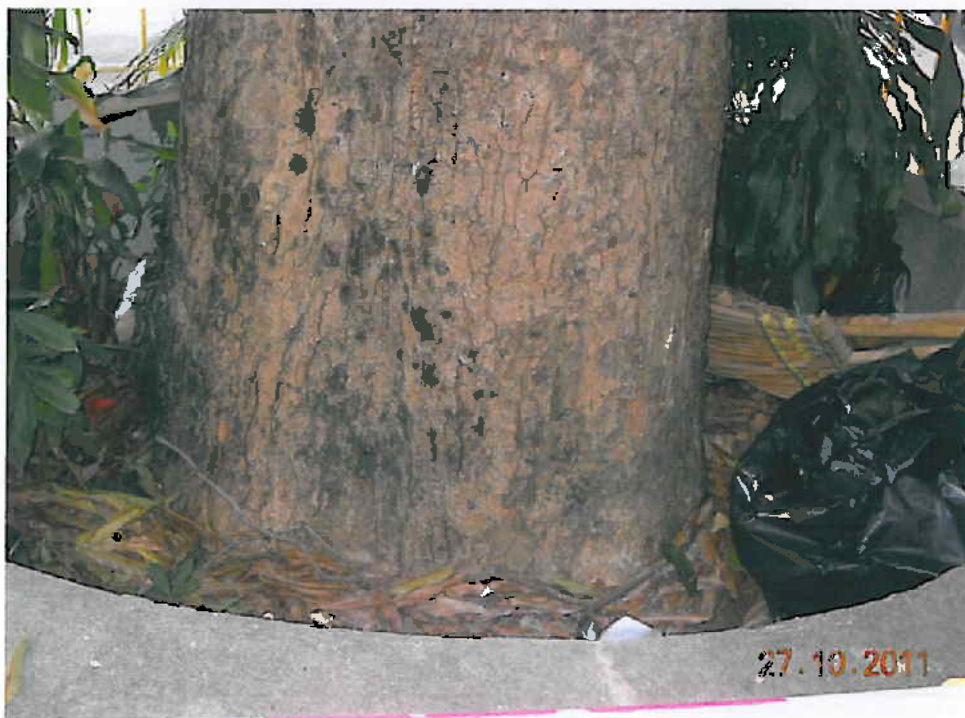
Photo 7. Condition of root flare
Soil level in the planter flare has been raised, root flare is invisible.
Rooting area was restricted by the planter.

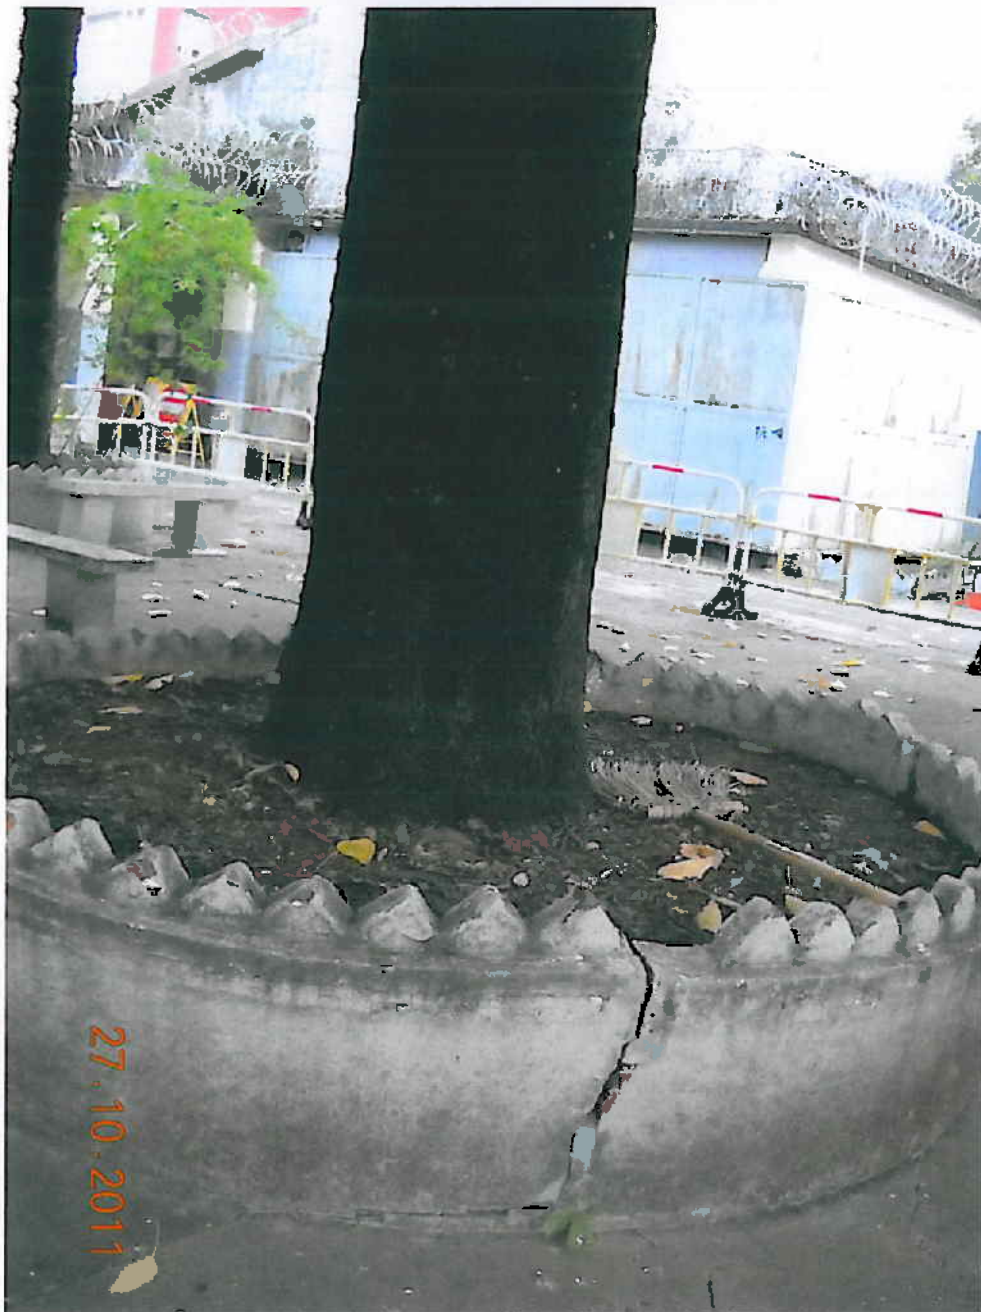
Photo 4. Condition of root flare
Tree is growing in the raised planter. Root flare not visible.
Rooting area are restricted by the planter.

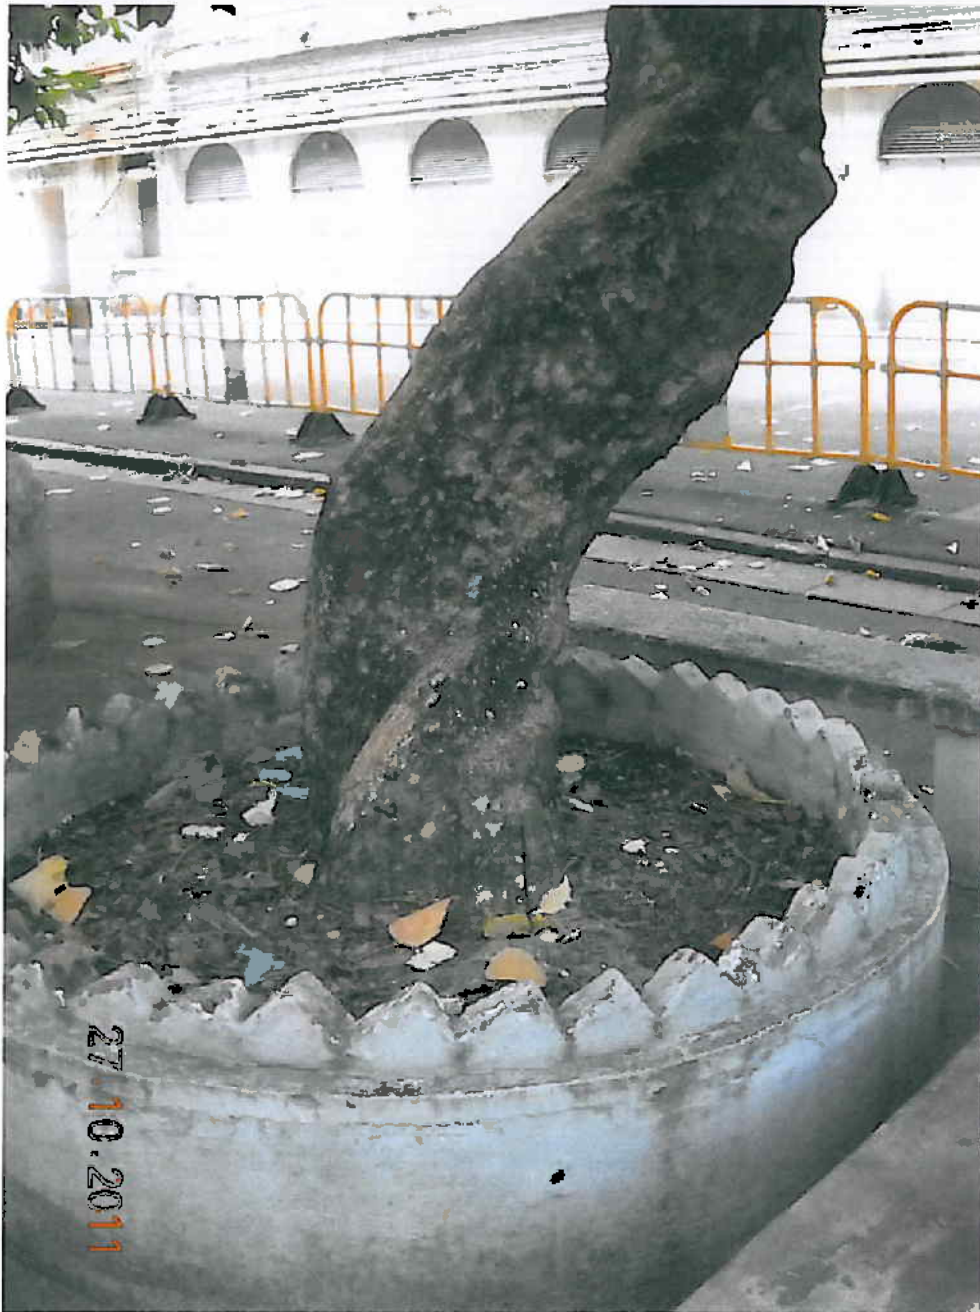
Photo 5. Condition of root flare.
Tree is growing in a raised planter, rooting area was restricted

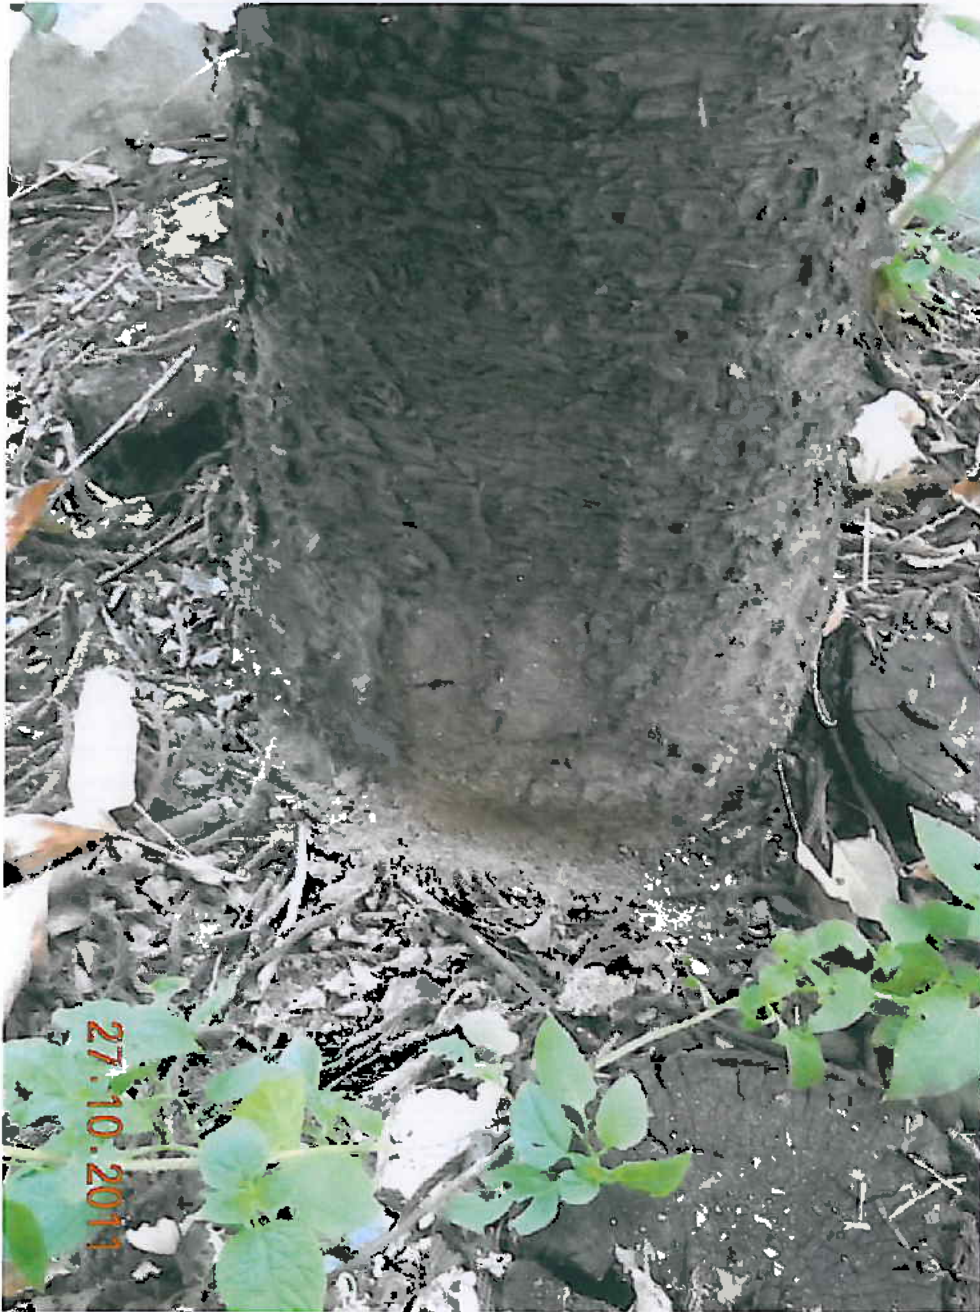
Photo 5. Condition of root flare.
Root flare invisible.
Decayed barks were found at the base.

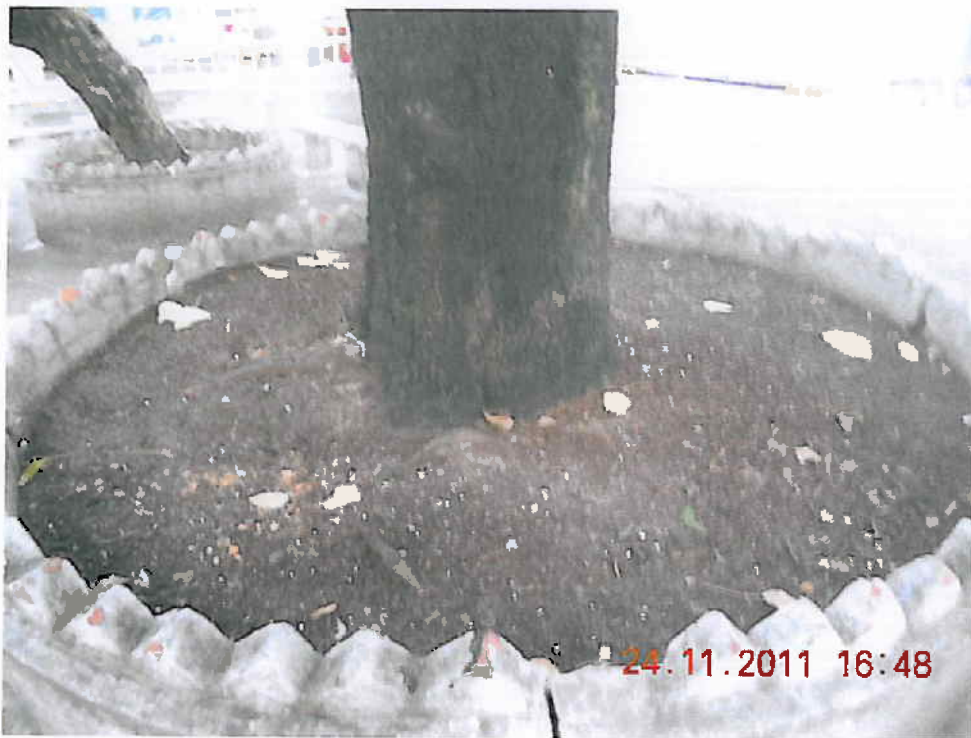
Fig. 3 The planter is clean and tidy at the time of inspection.

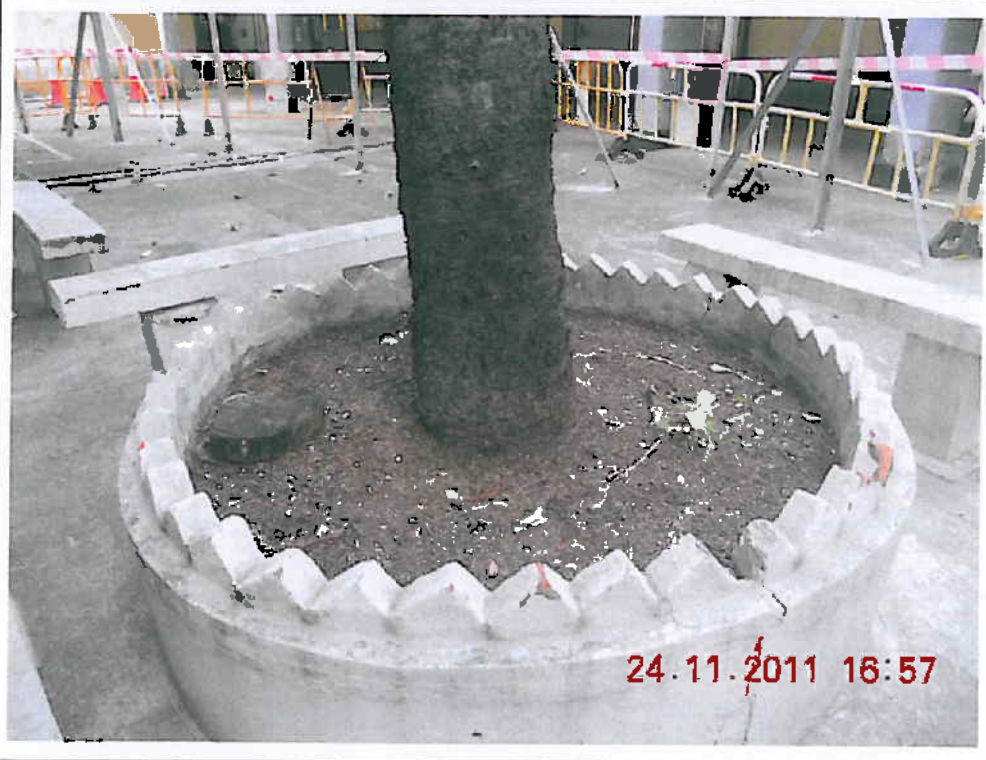
**Fig. 3 Under-growth and rubbish have been cleared prior to inspection,
The planter keeps clean and tidy.**
