Central Police Station Conservation
and Revitalisation Project:
65th Monthly EM&A Report
(1 March to 31 March 2017)

Issue Date: April 2017

Environmental Resources Management

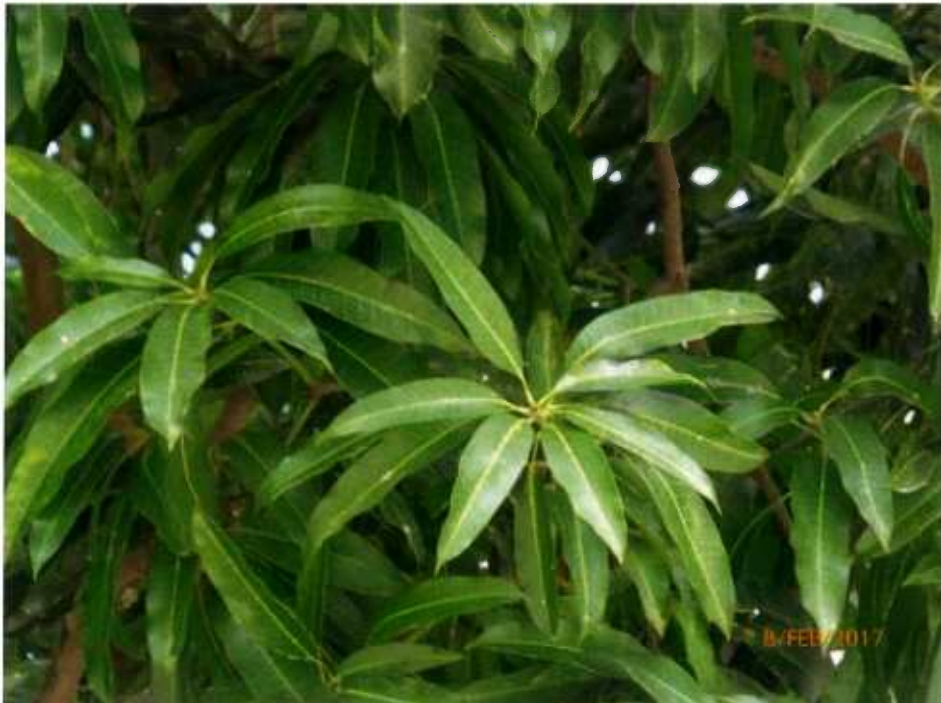
Fig. 9 Signs of Pest (Mealy Bugs 粉狀介殼蟲) are rarely found on the tree due to Pest Control Operation on 26th April 2016.

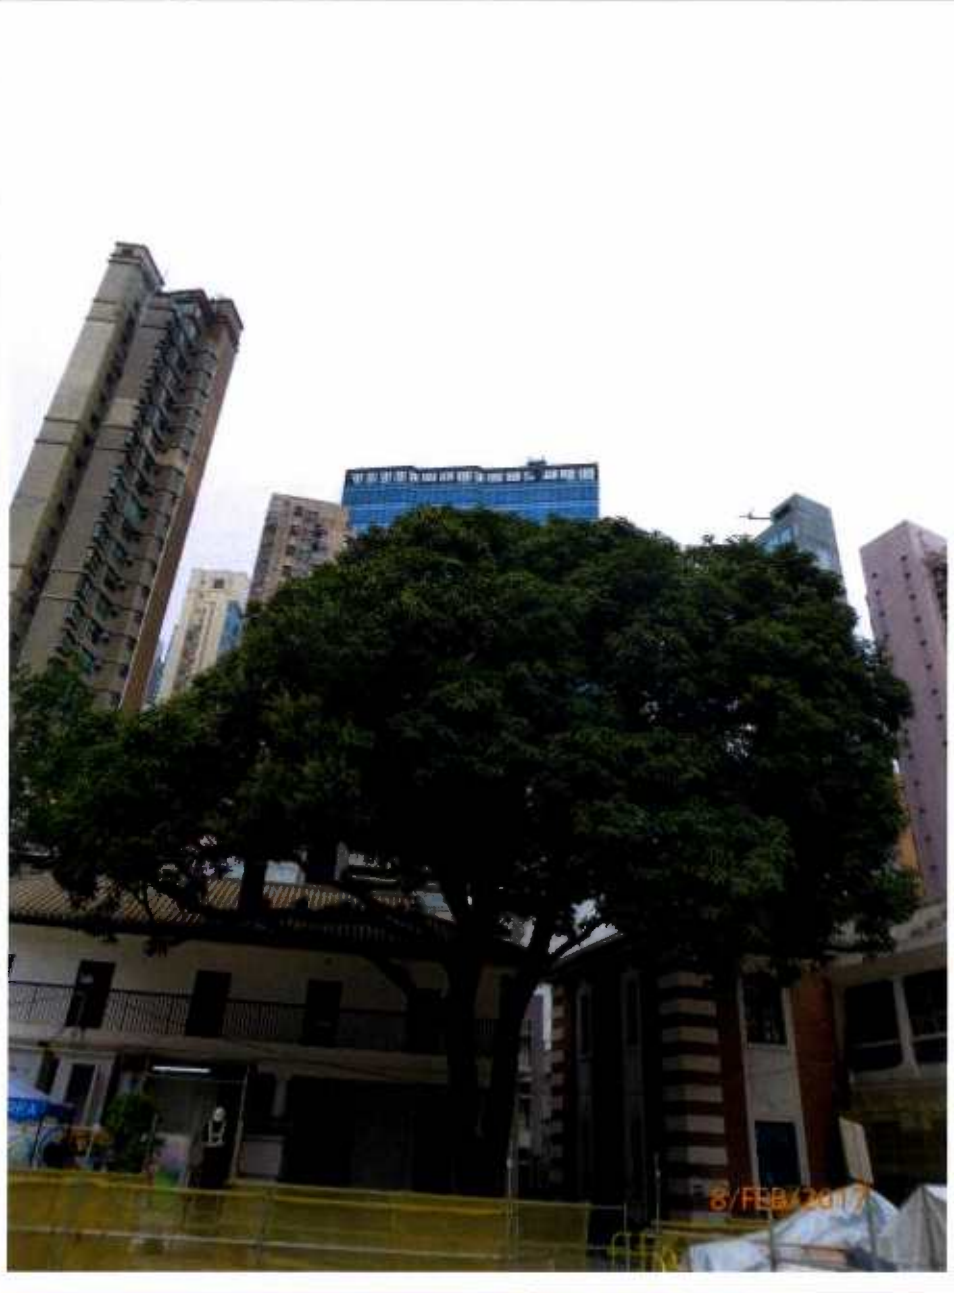
Fig. 12 Overall view of Tree-5 during inspection on 8th February 2017.

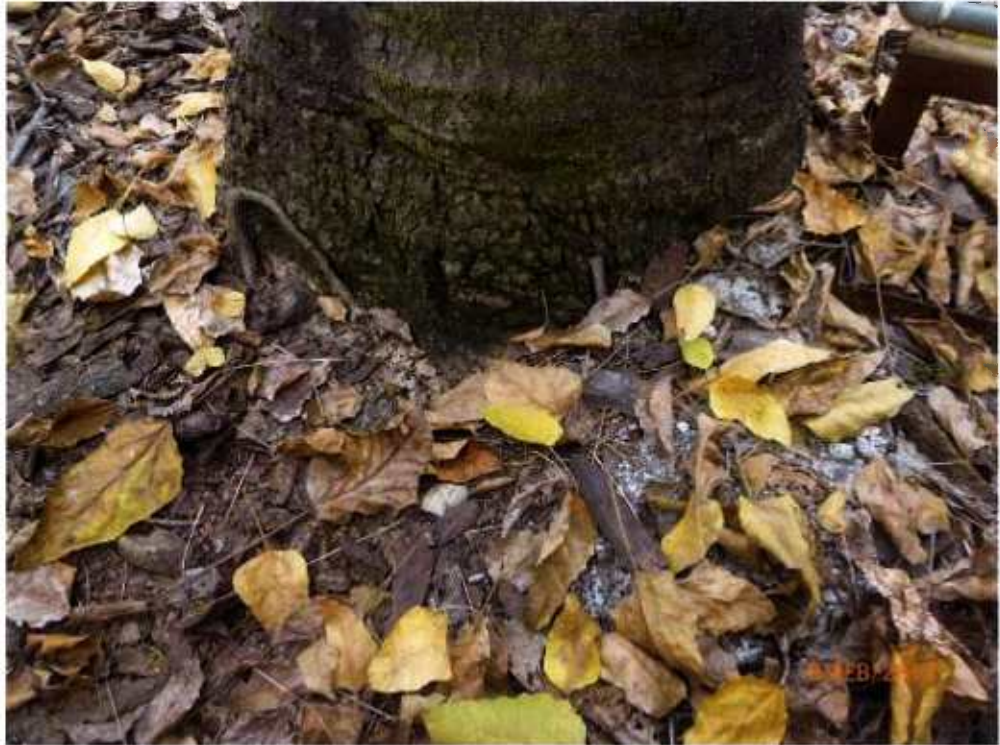
Fig 2. Root collar is normal. The planter is covered with mulch and dry leaves.

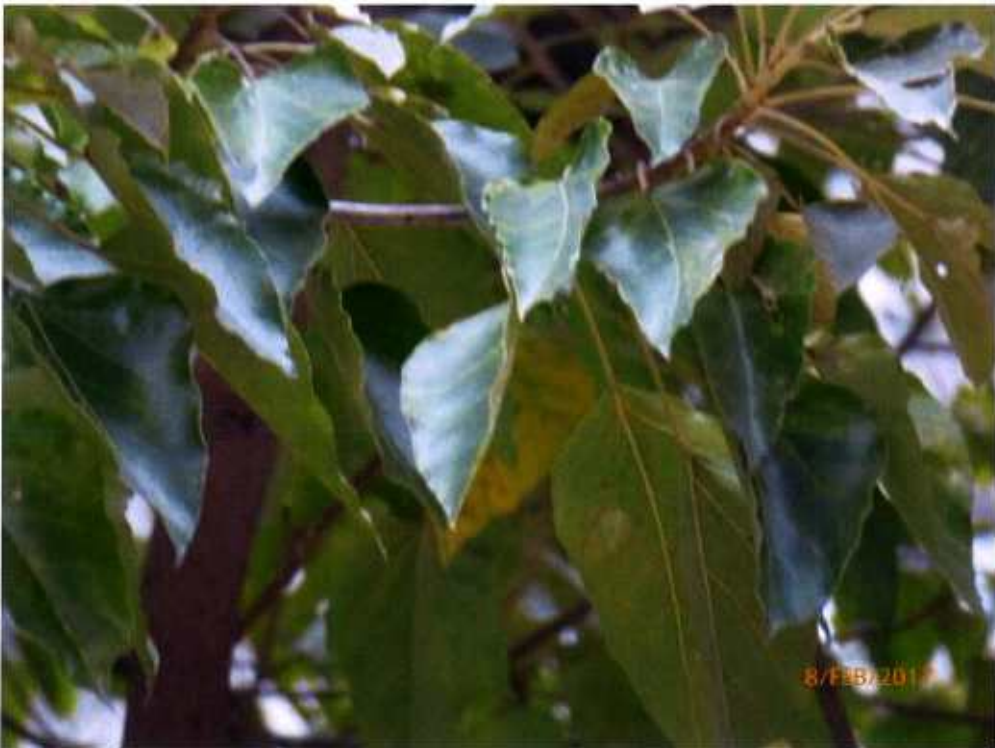
Fig. 9 Signs of Pest (Mealy Bugs 粉狀介殼蟲) are rarely found on the tree due to Pest Control Operation on 25th April 2016.

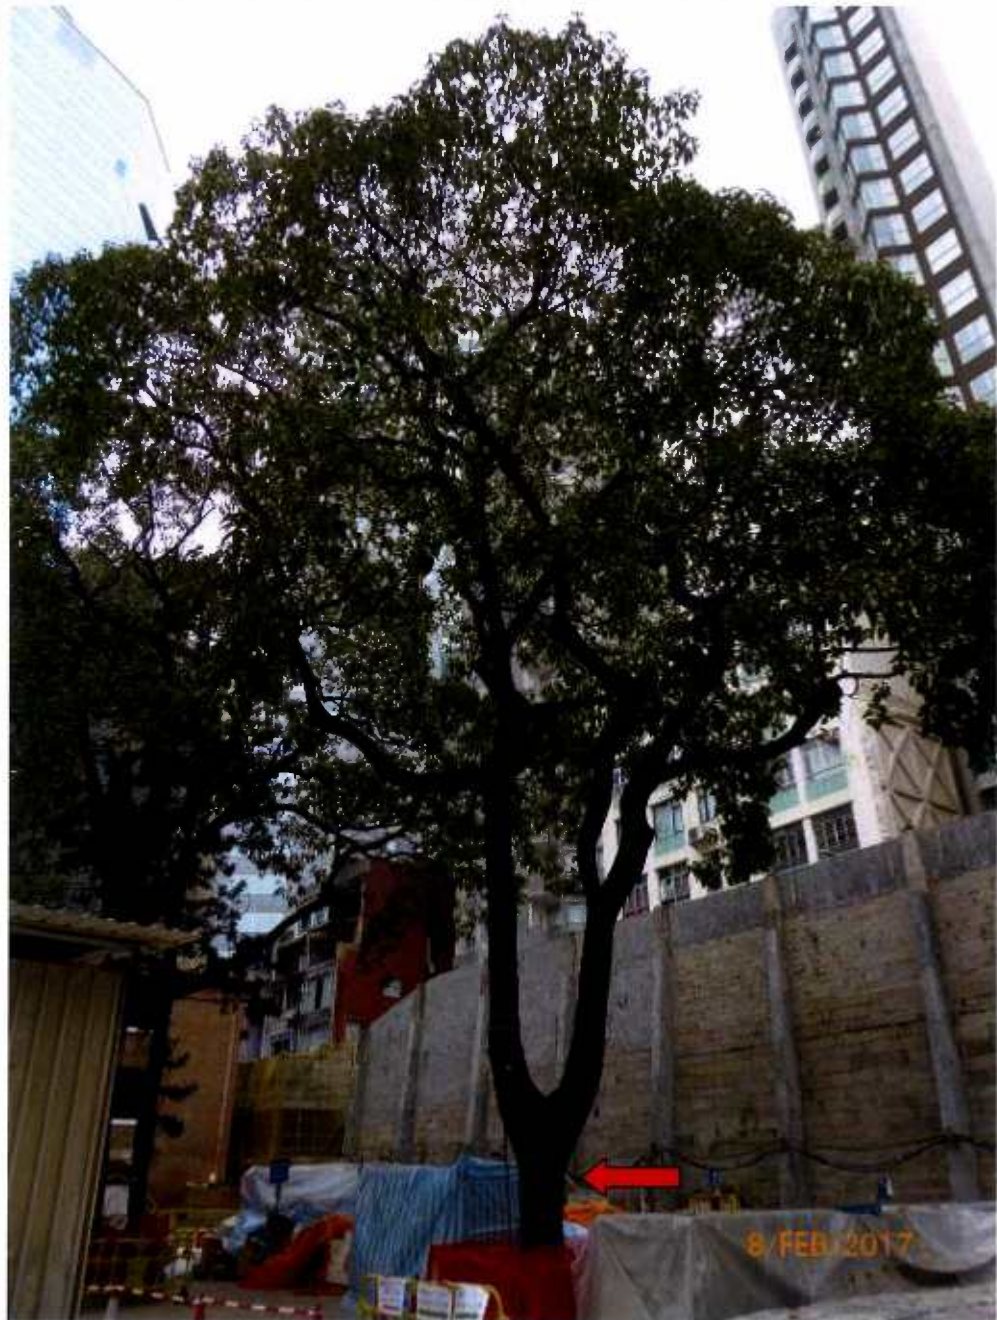
Fig. 12 Overall view of Tree-6 during inspection on 8th February 2017.

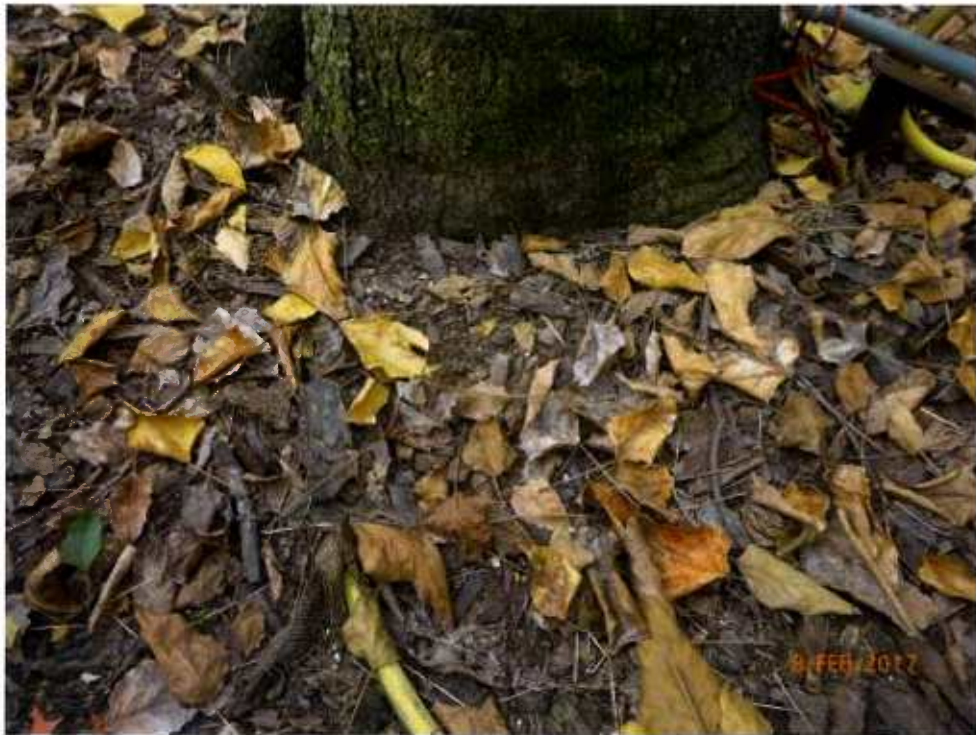
Fig 2. Root collar is normal. The planter is covered with mulch and leaves.

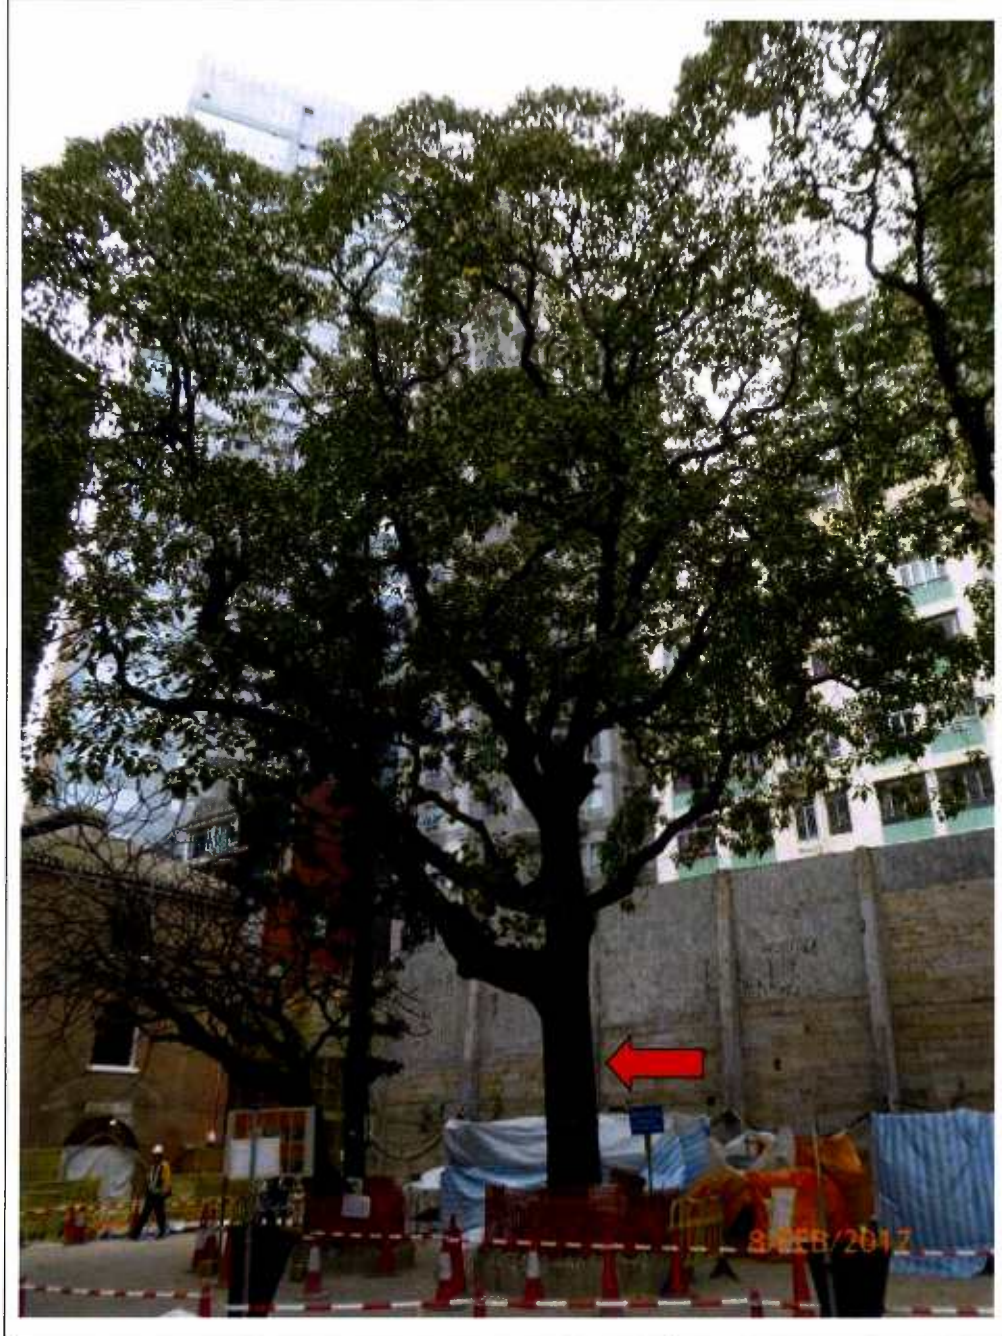
Fig. 12 Overall view of Tree-7 during inspection on 8th February 2017.

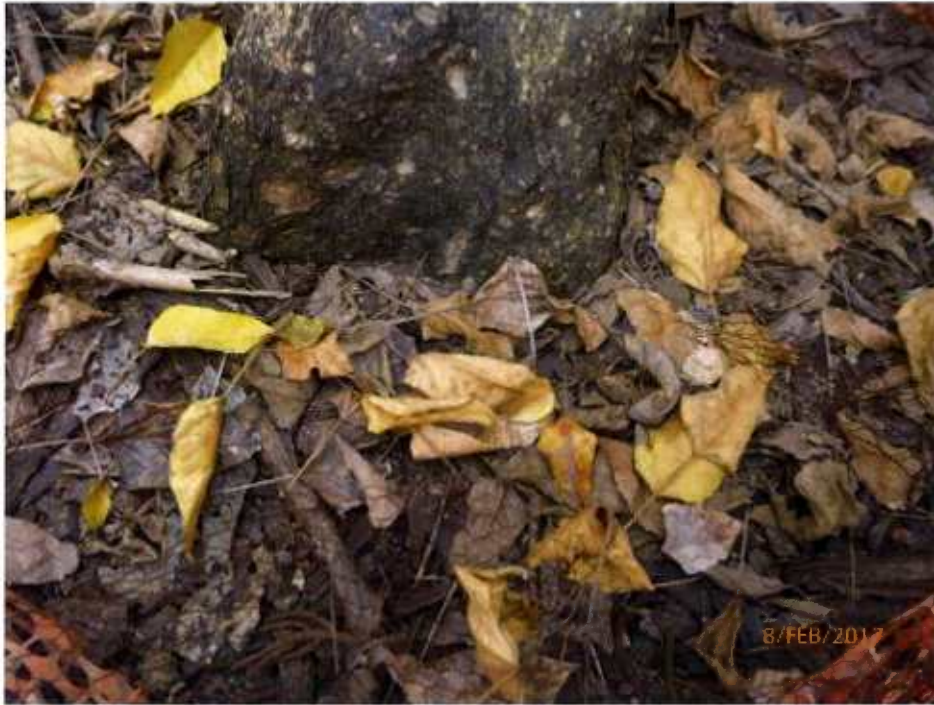
Fig. 3 Health condition of the lower trunk is fair.

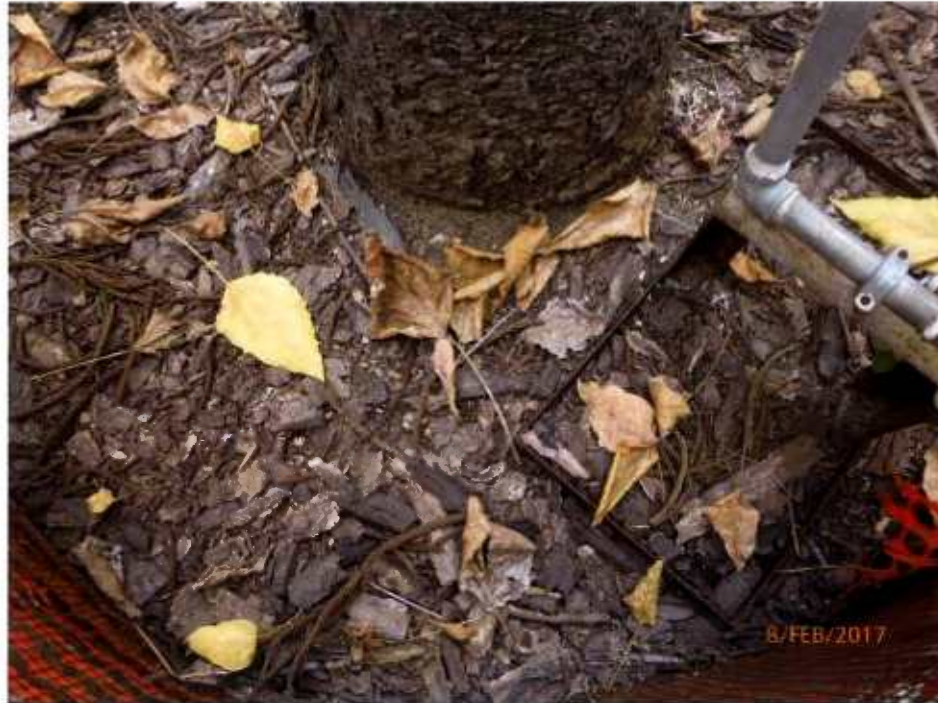
Fig. 3 Health condition of the lower trunk is fair.

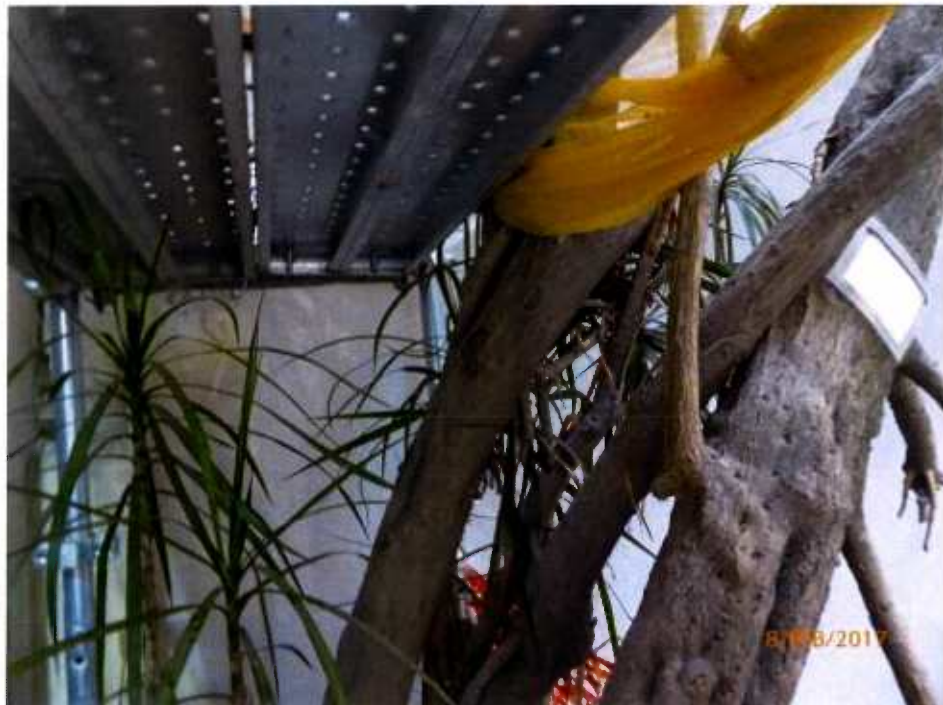
Fig. 10 A temporary shelter has been erected to protect the tree.

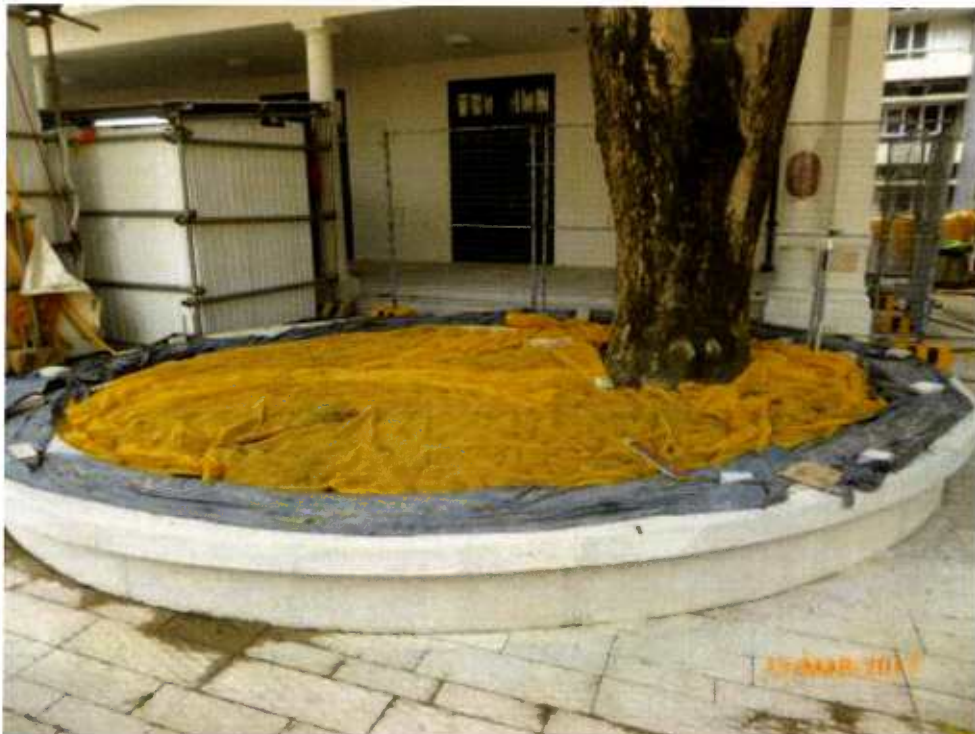
Fig. 10 The site near Tree-5 is clean and tidy.

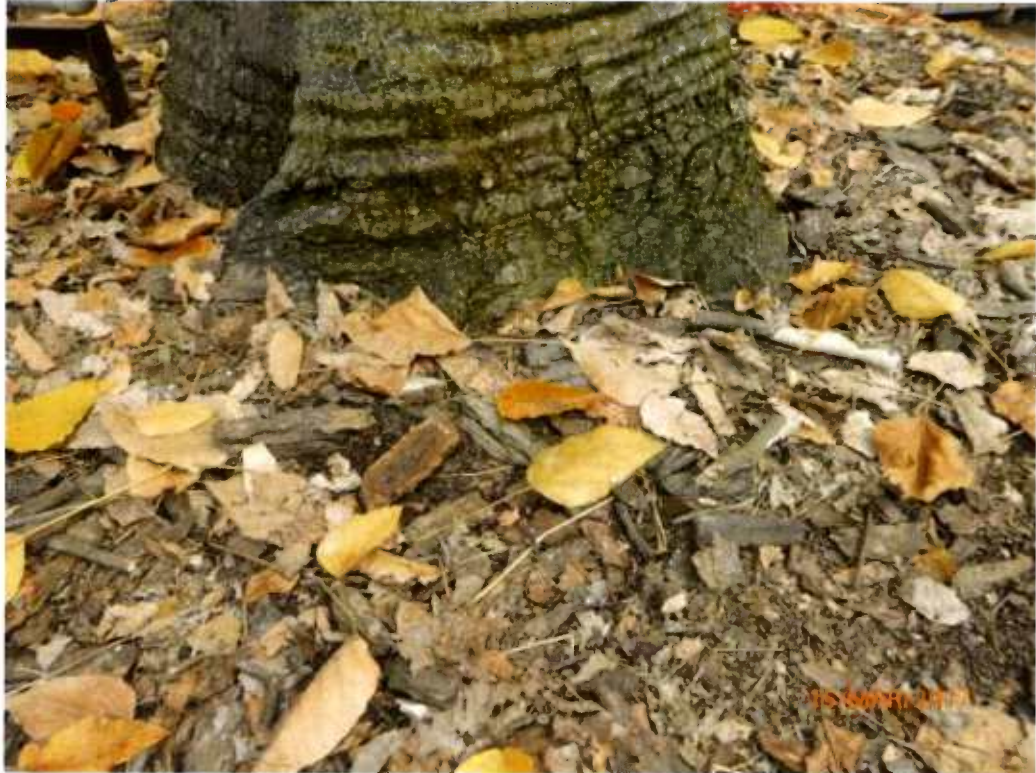
Fig 3. Health condition of the lower trunk is fair.

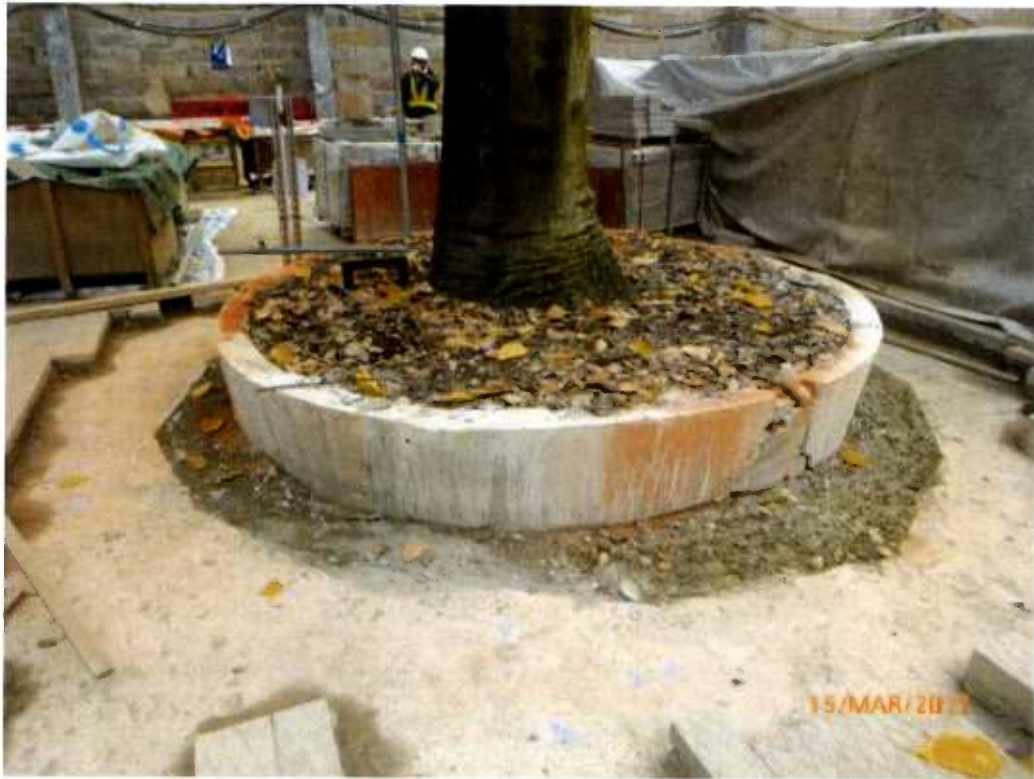
Fig. 11 The site near the planter is clean and tidy.

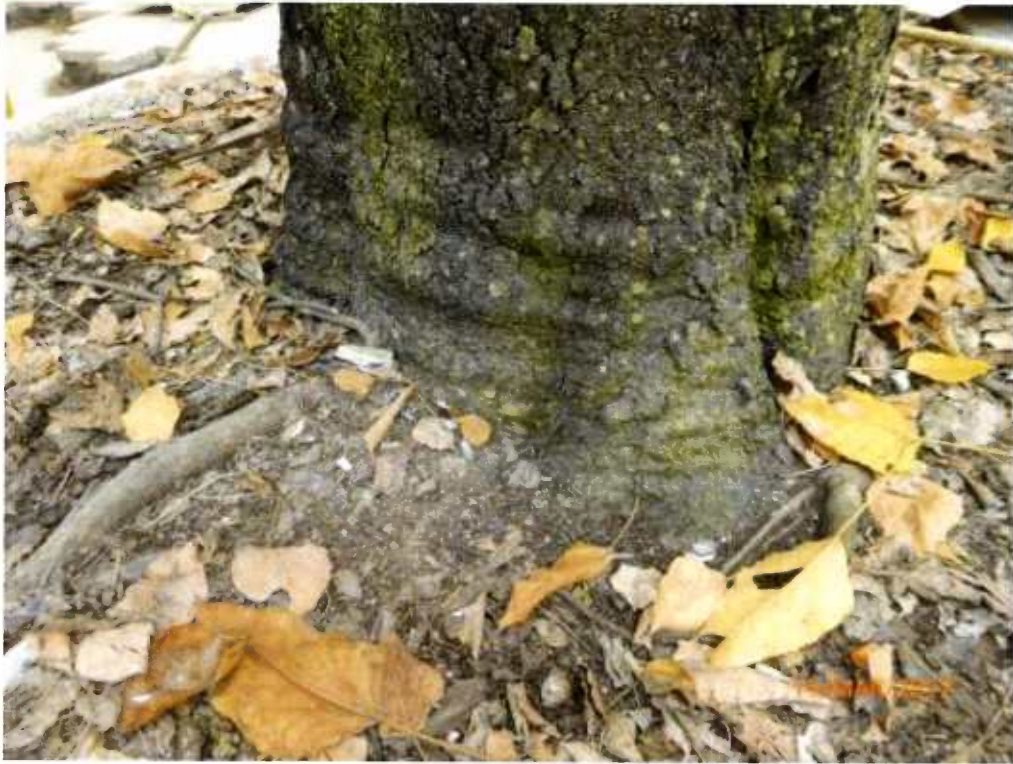
Fig 3. Health condition of the lower trunk is fair.

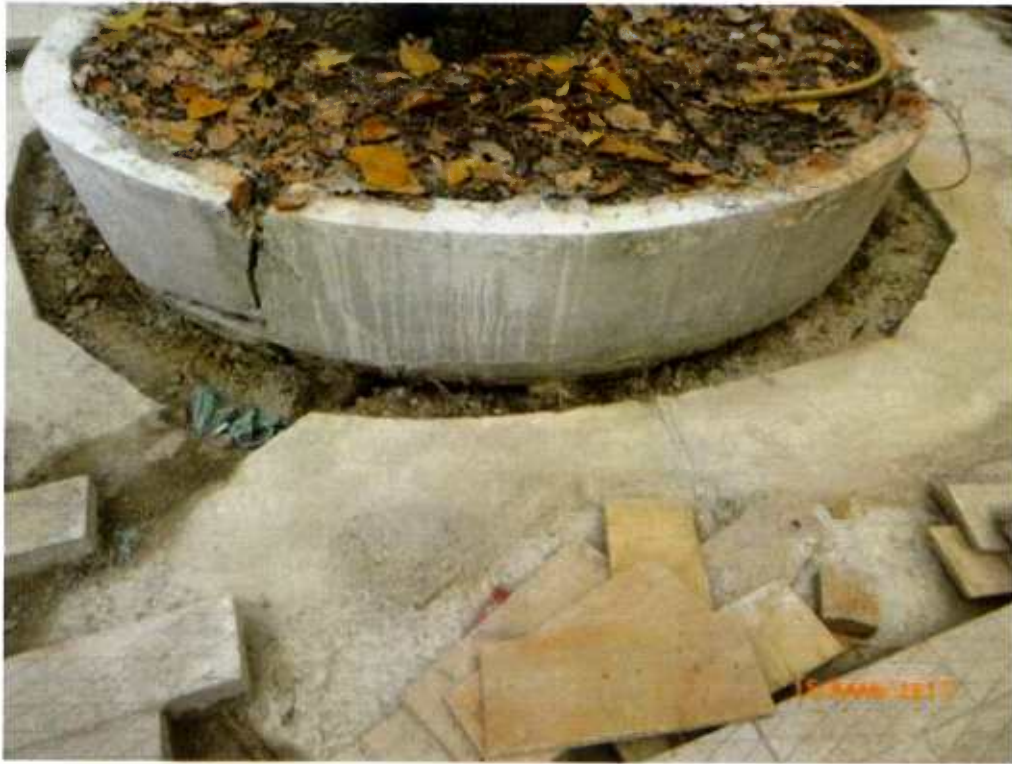
Fig. 11 The site near the tree is clean and tidy.

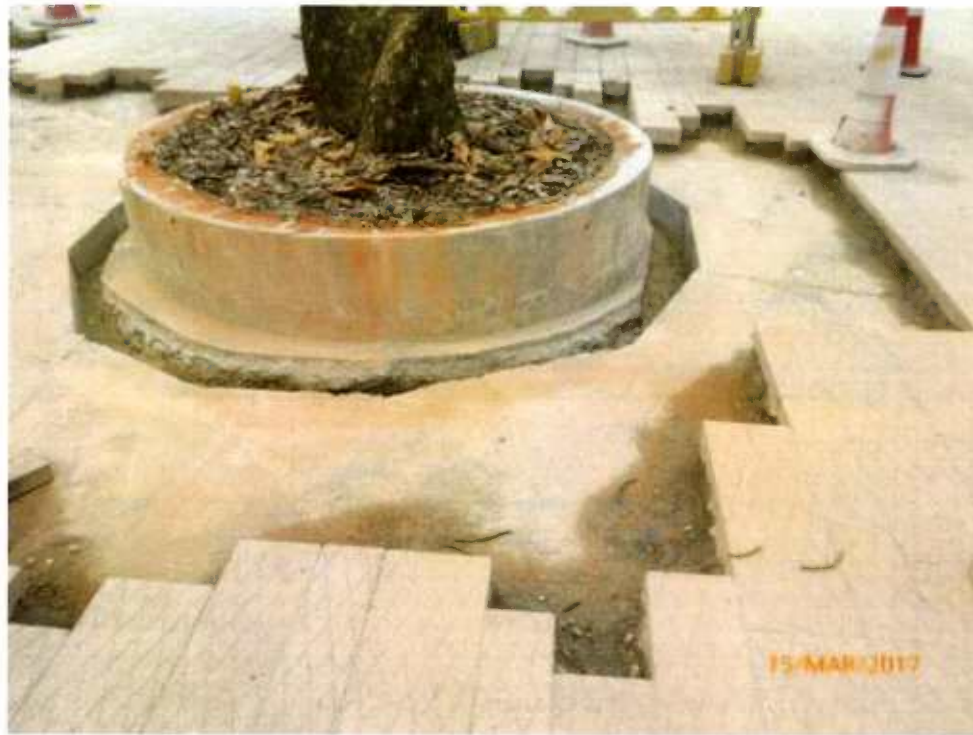
Fig. 9 The site near the tree is clean and tidy.

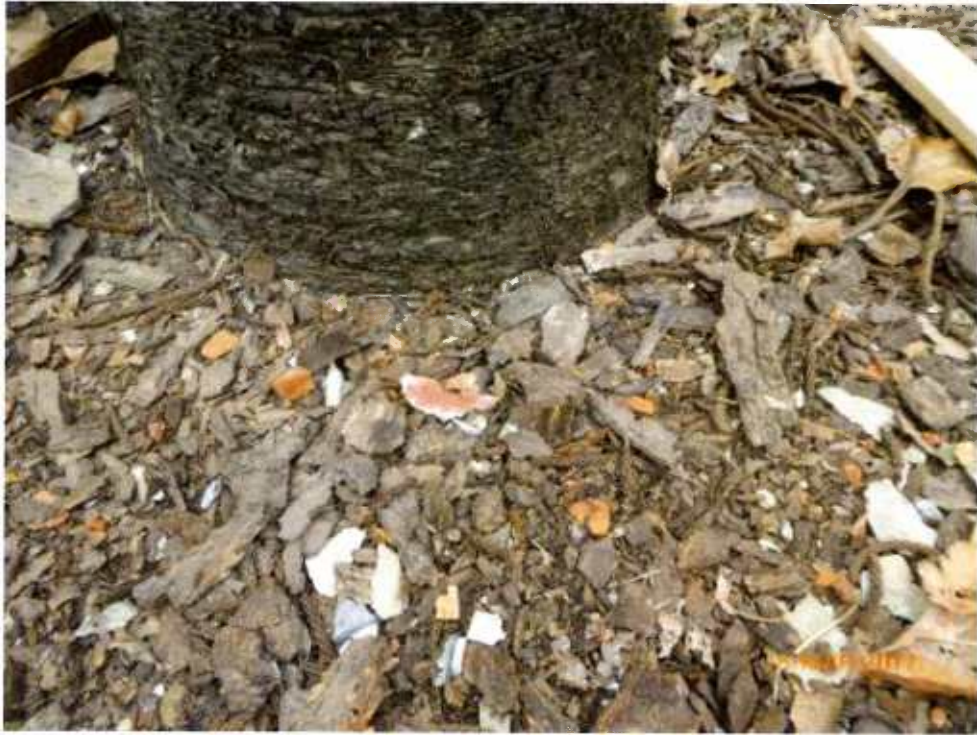
Fig. 3 Health condition of the lower trunk is fair.

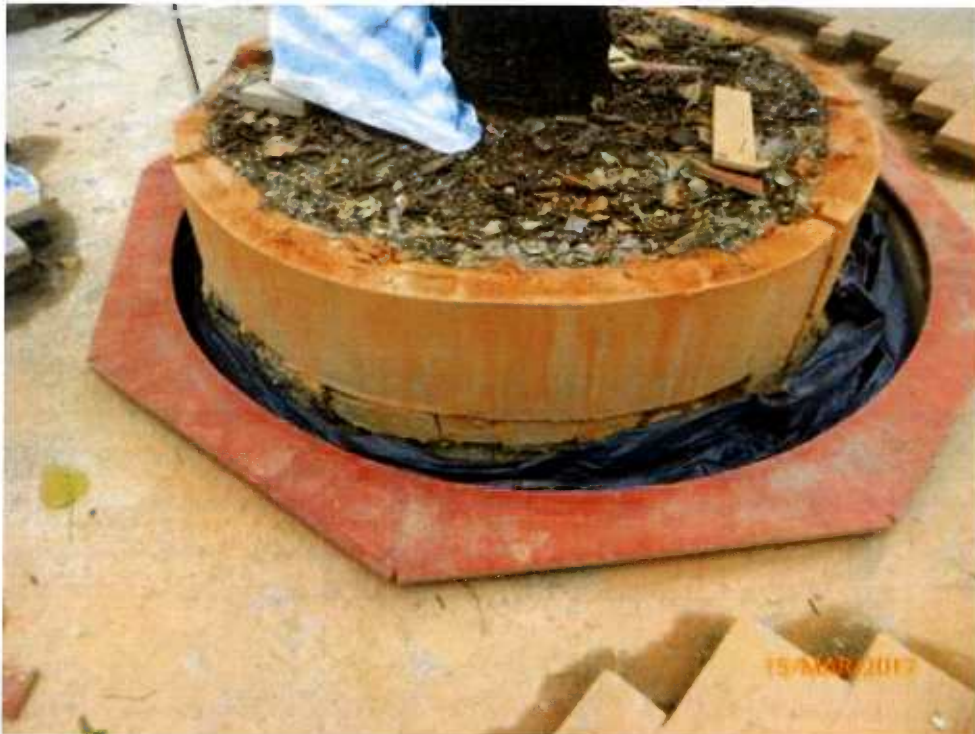
Fig. 10 The site near the planter is clean and tidy.

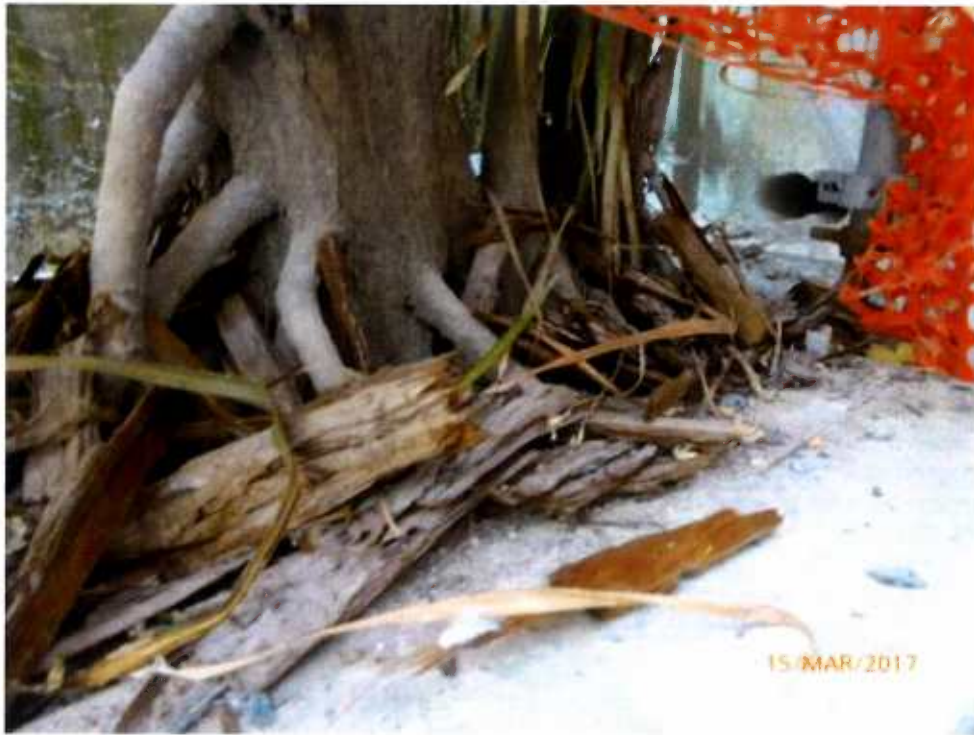
Fig. 4 Construction debris has been removed away from the planter during inspection on 15th March 2017.

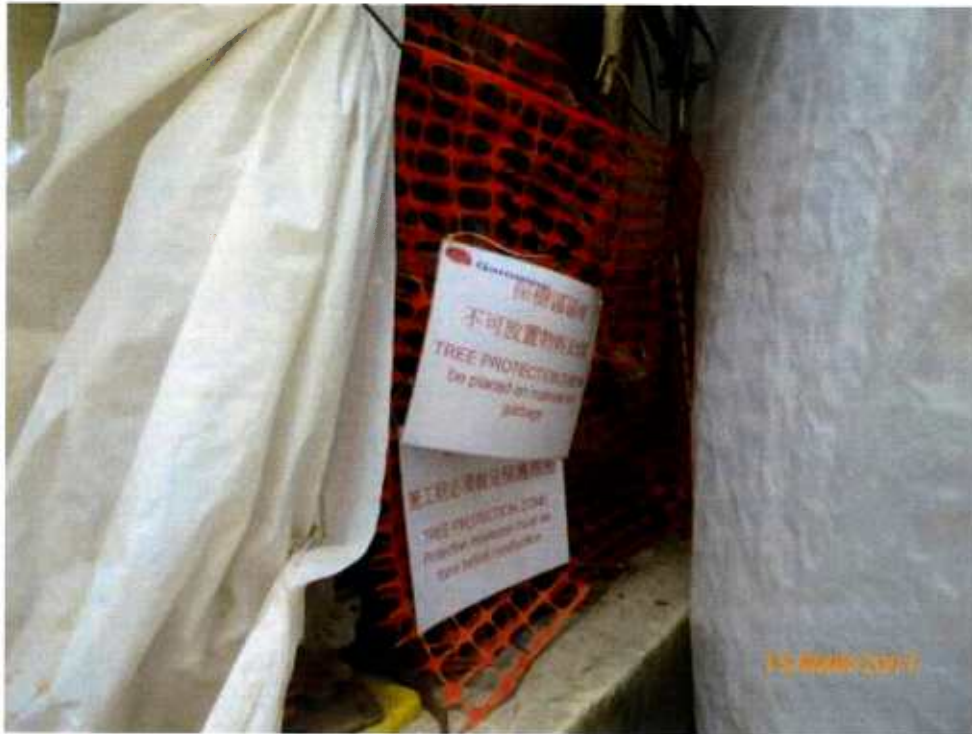
Fig. 10 Tree protection zone is in order at the time of inspection.

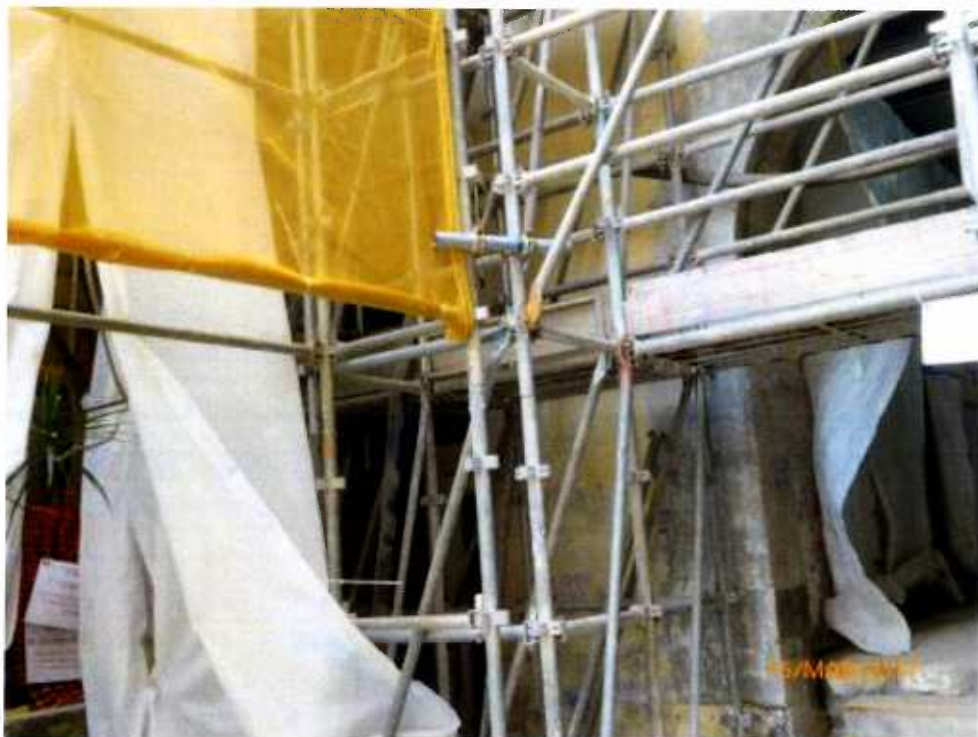
Fig. 11 Renovation works are in progress near Tree-11.
