Central Police Station Conservation
and Revitalisation Project:
71st Monthly EM&A Report
(1 September to 30 September 2017)

Issue Date: October 2017

Central Police Station Conservation
and Revitalisation Project:
71st Monthly EM&A Report
(From 1 September to 30 September
2017)

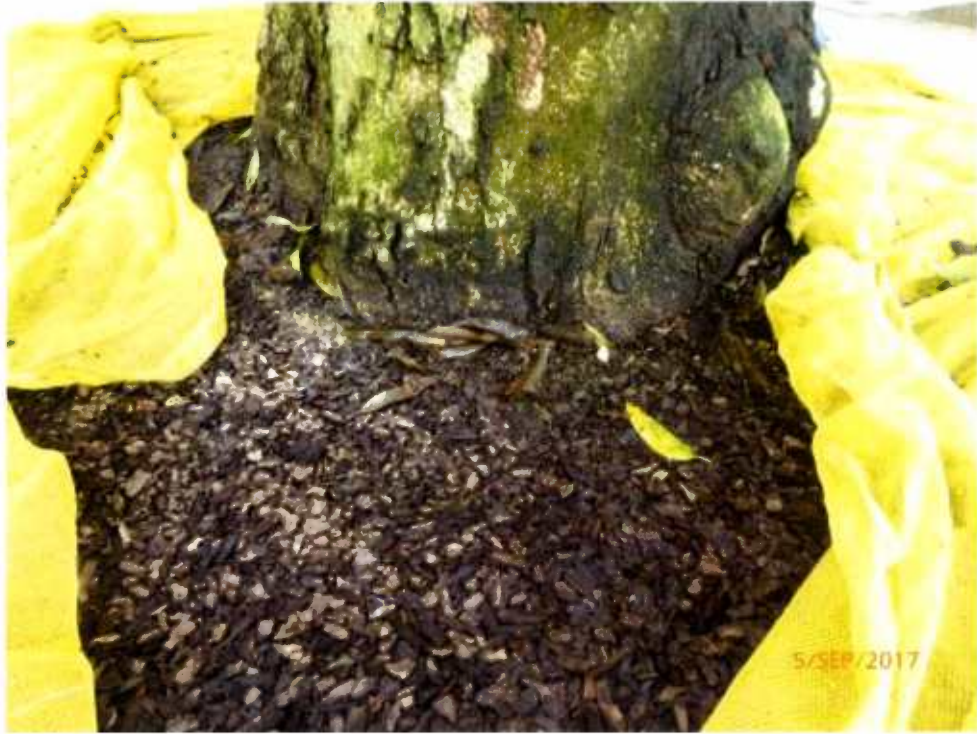
Fig. 3 Health condition of the lower trunk is fair.

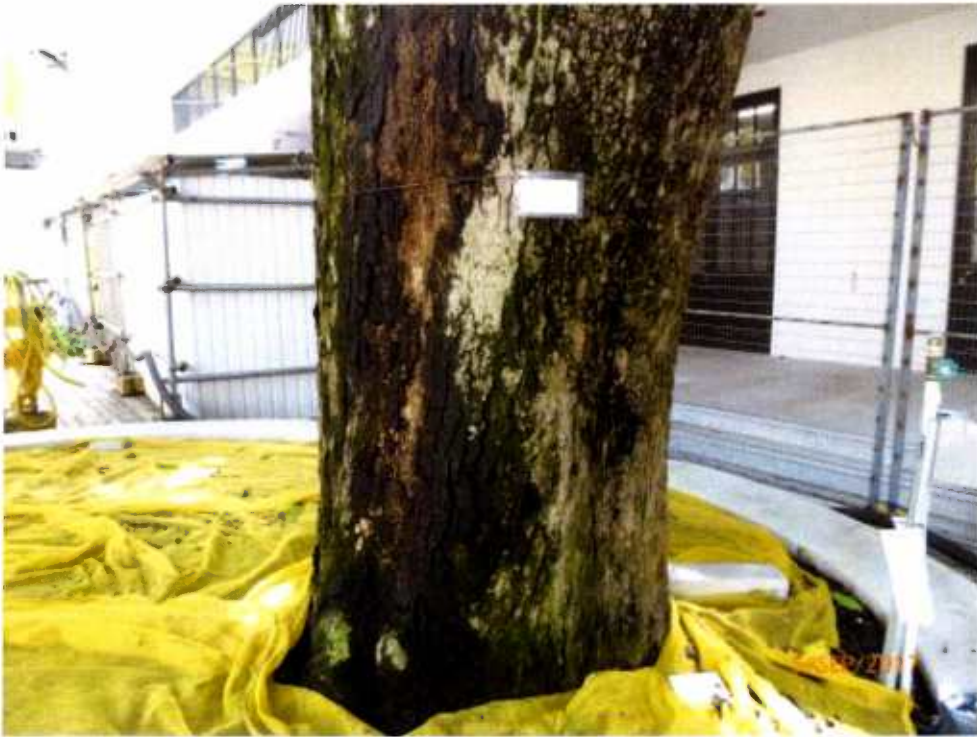
Fig. 4 Health condition of the mid trunk is fair.

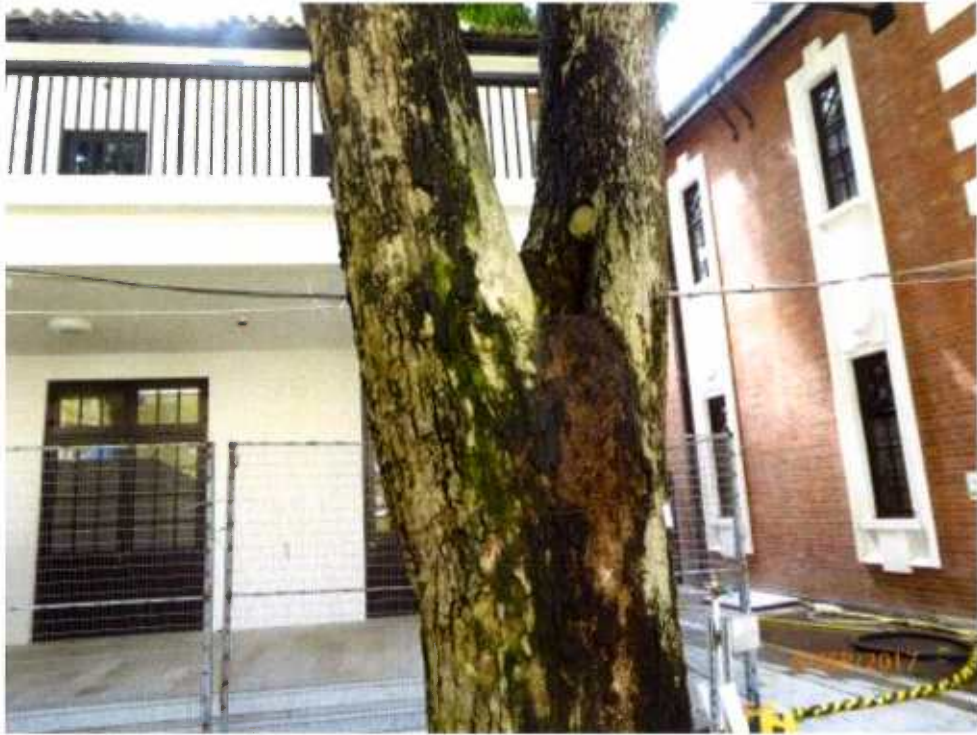
Fig. 5 Health condition of the upper trunk also is fair.

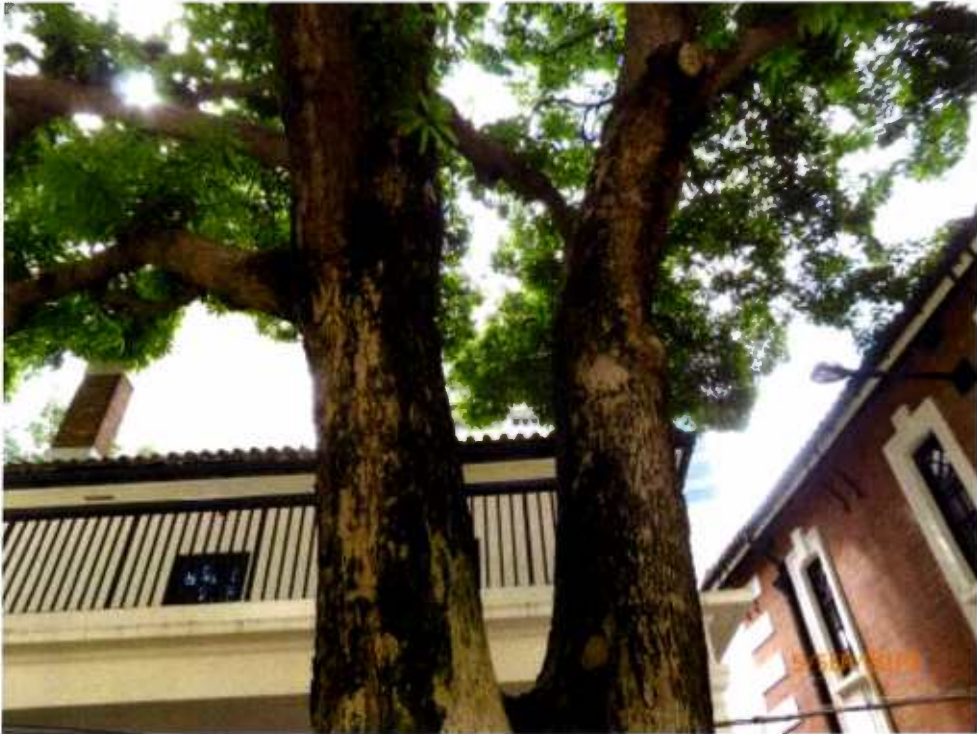
Fig. 6 The crown is full of vigorous and green leaves.

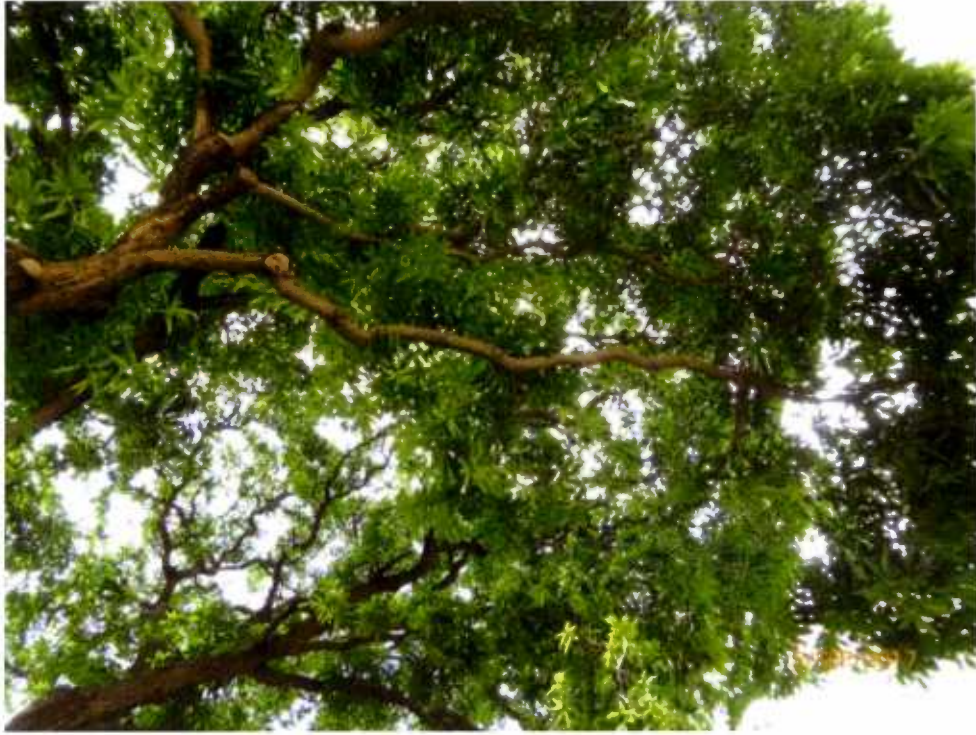
Fig. 7 Vigorous and green leaves also are growing on the lower branches.

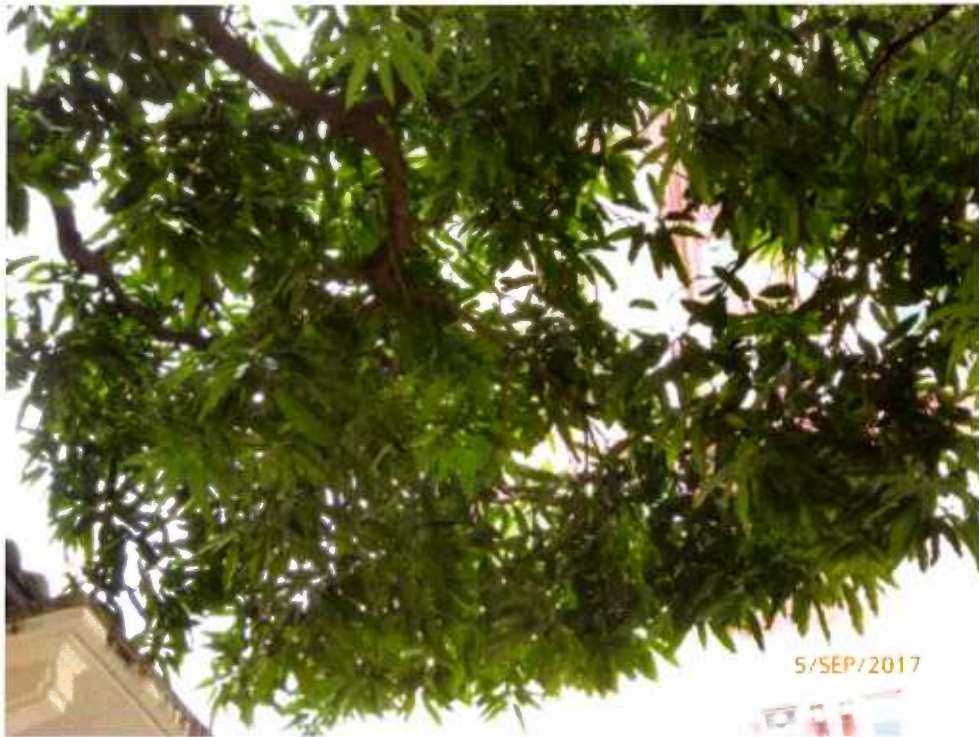
Fig. 8 Young and green leaves appear on the tree.

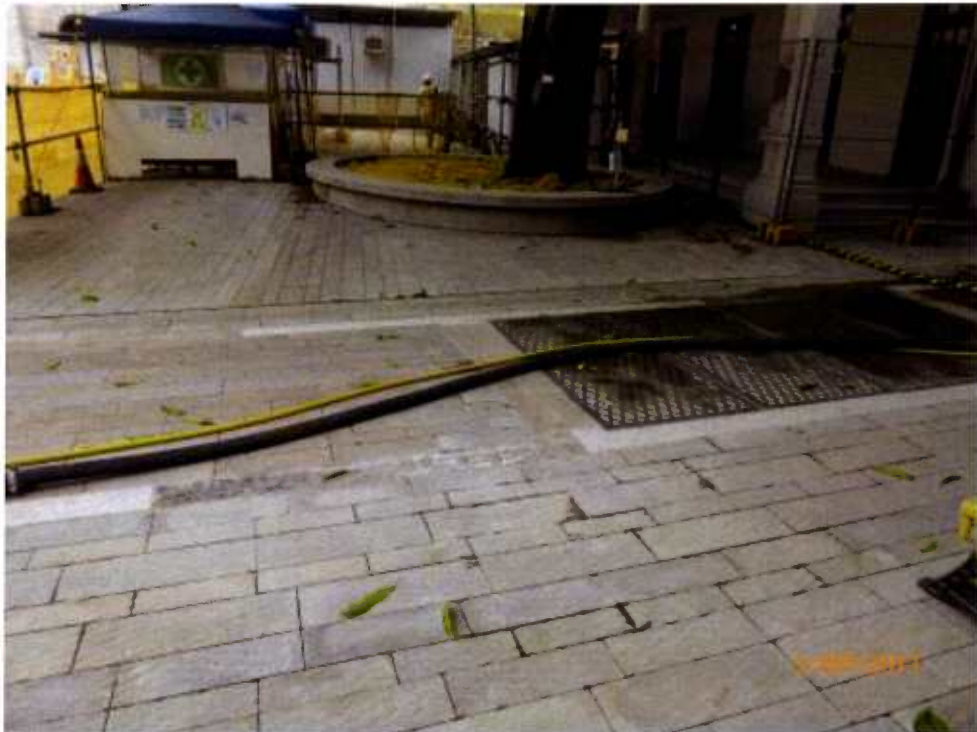
Fig. 12 Overall view of Tree-5 during inspection on 5th Sept. 2017.

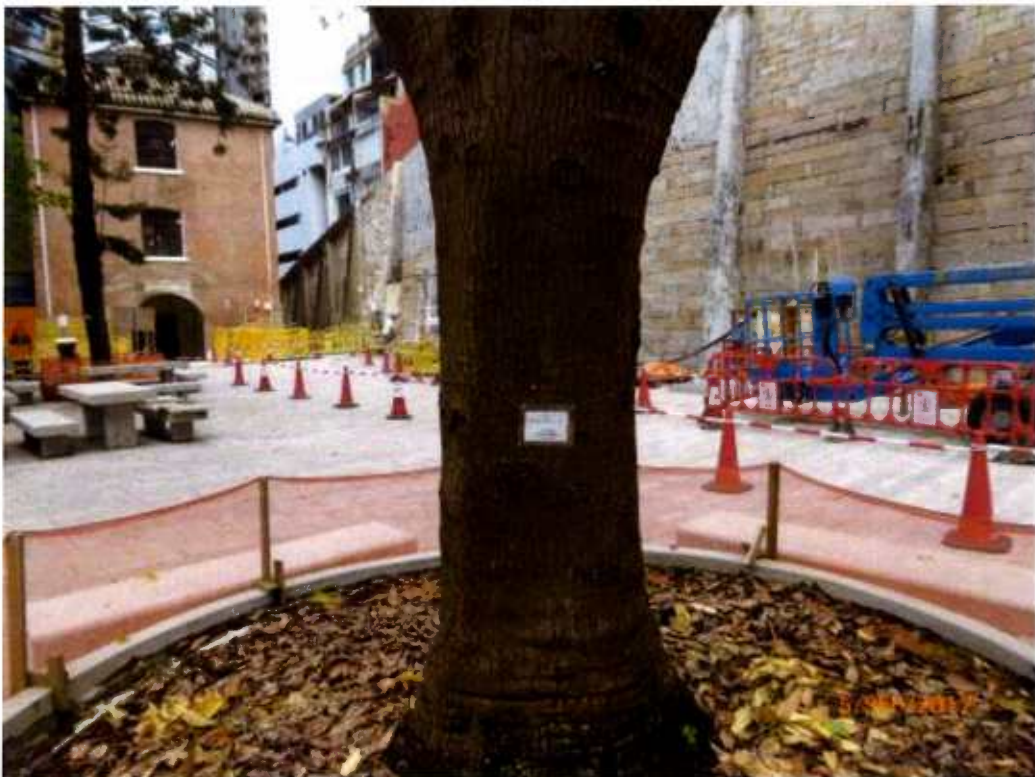
Fig. 4 Health condition of the mid trunk is fair.

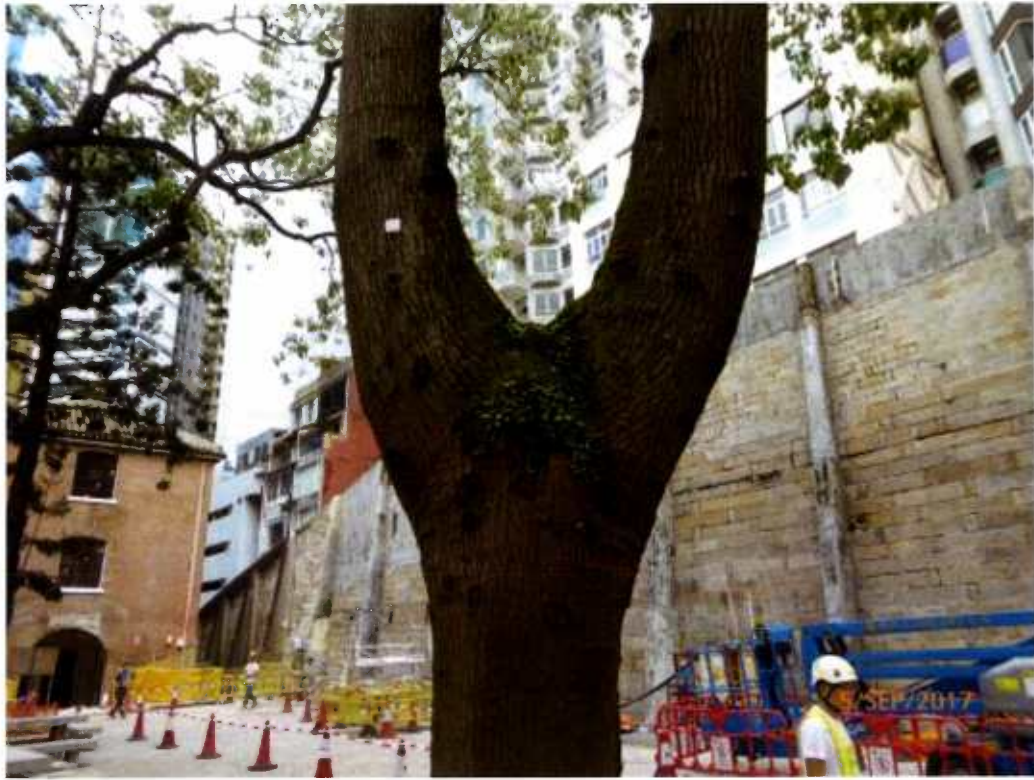
Fig. 5 Health condition of the upper trunk also is fair.

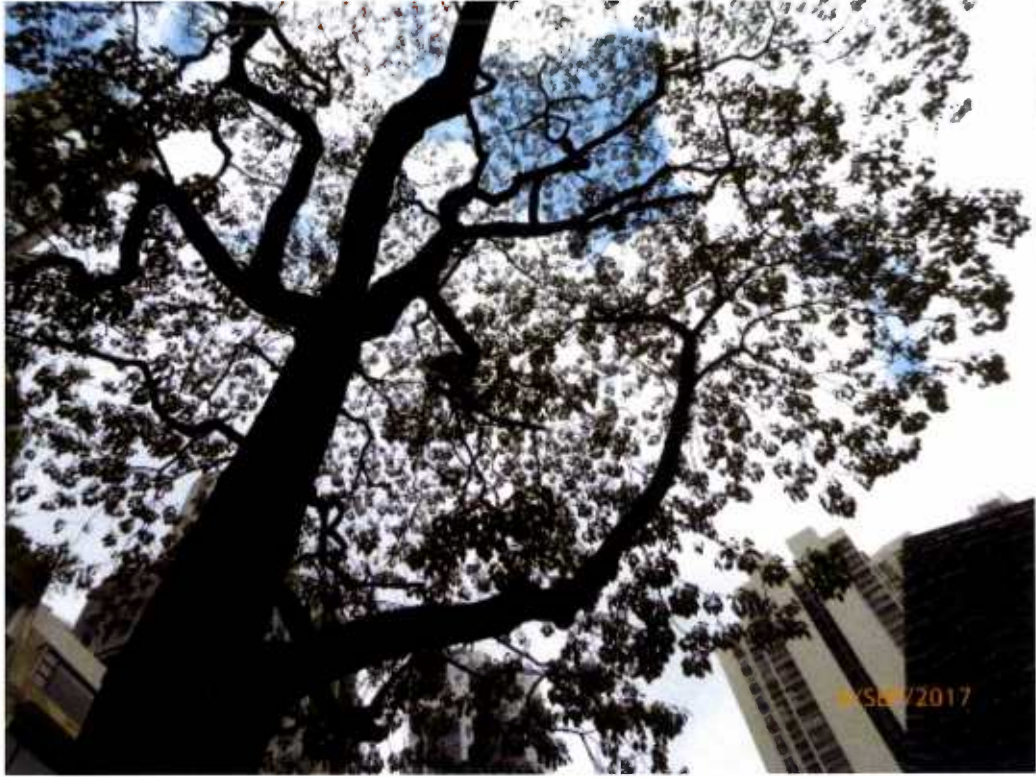
Fig. 7 Leaves on the lower branches are normal.

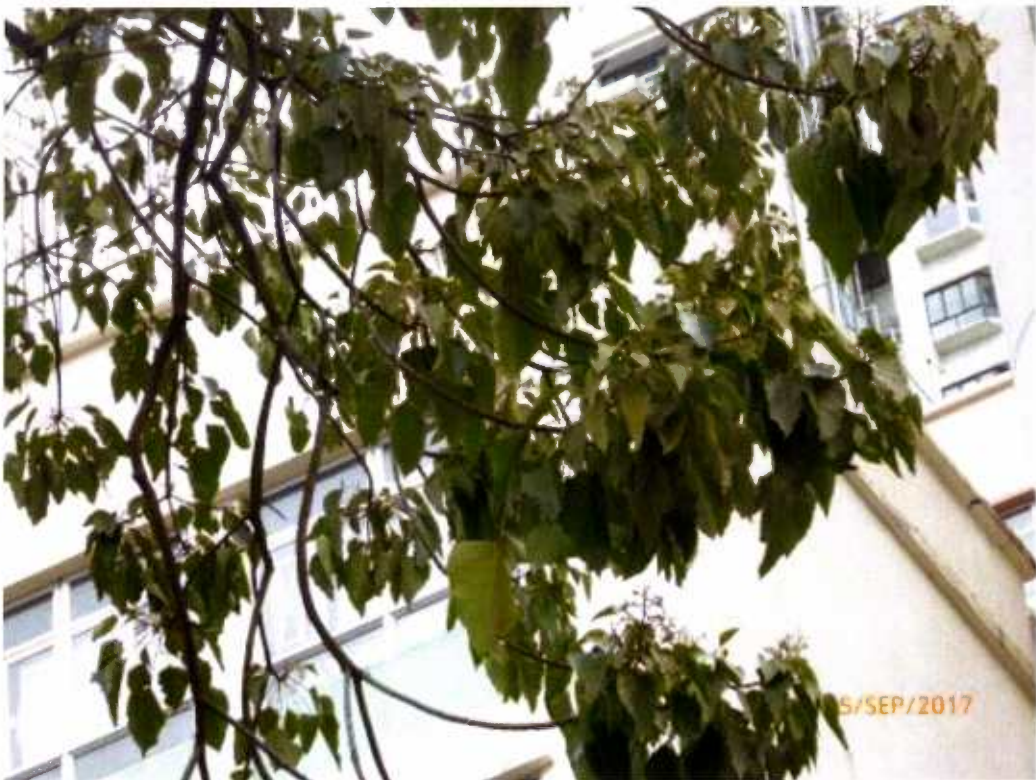
Fig. 8 Flowers still remain on the branches.

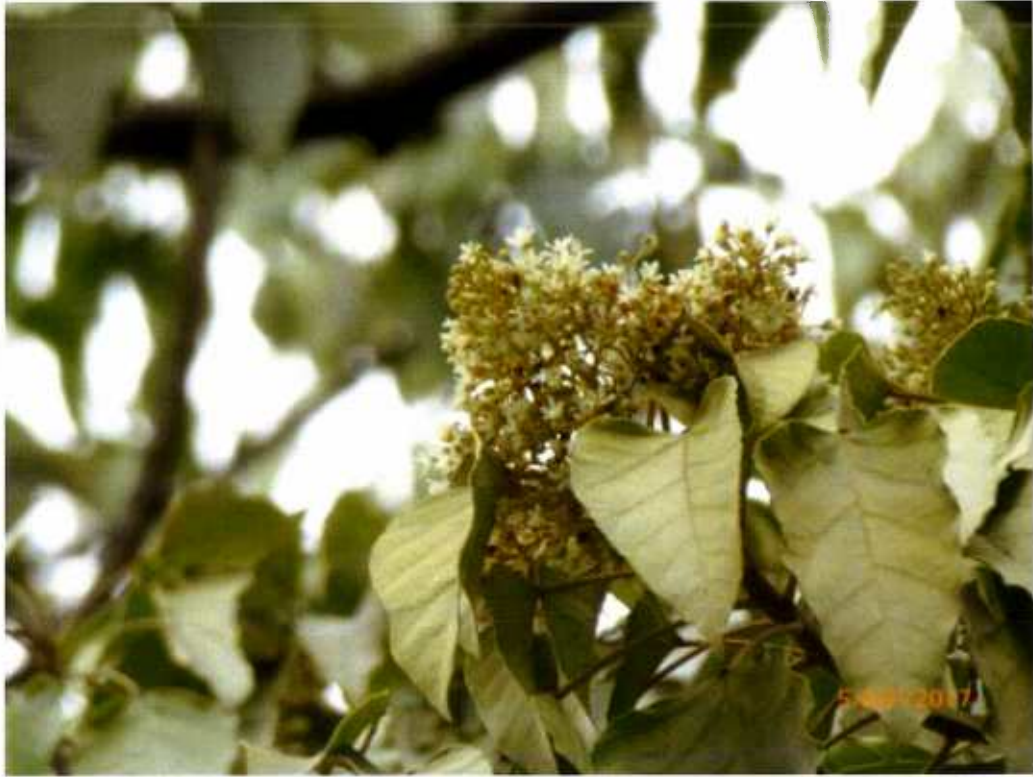
Fig. 9 Fresh nuts appear on the tree.

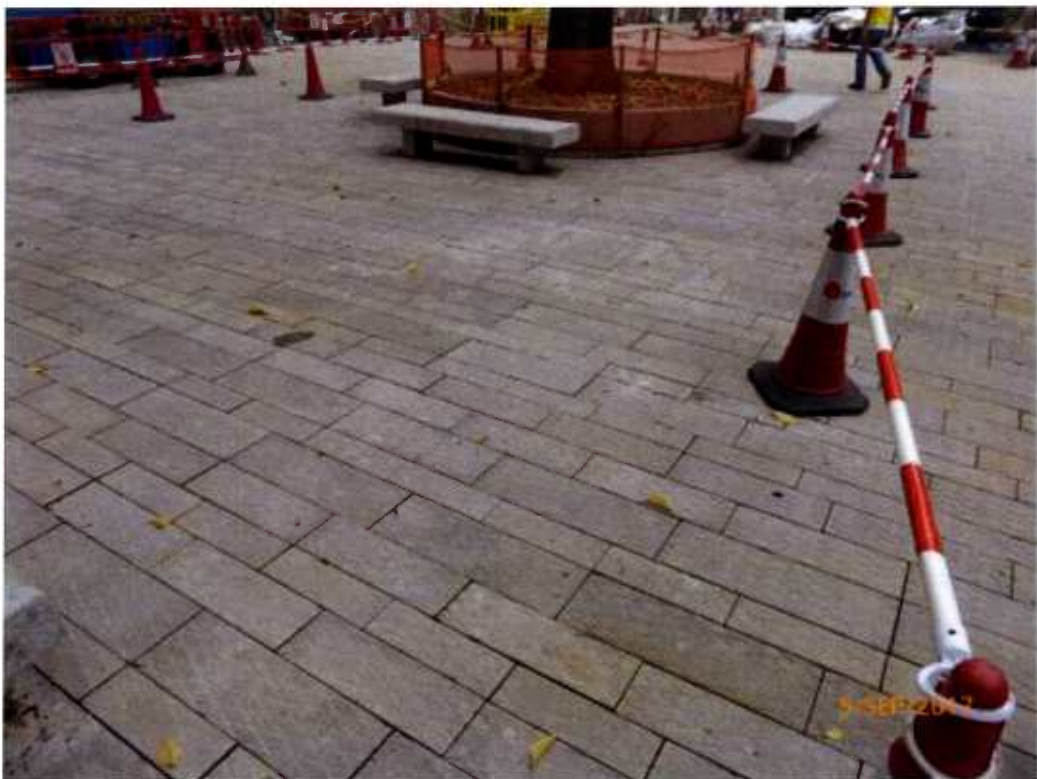
Fig. 12 Overall view of Tree-6 during inspection on 5th Sept. 2017.

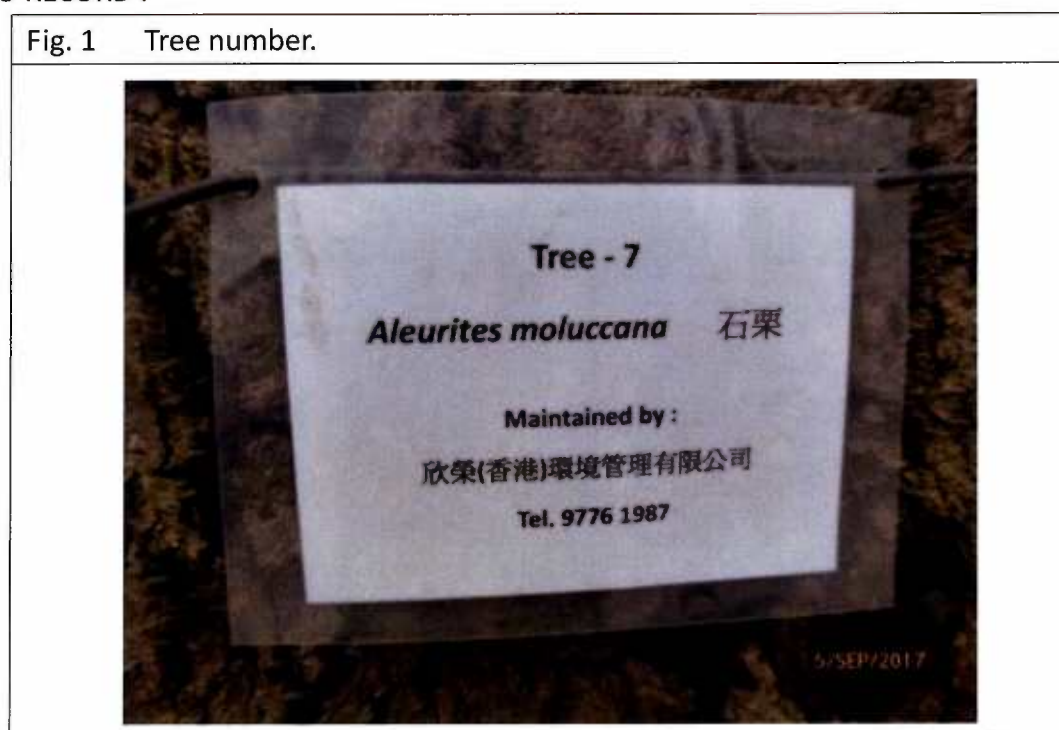
Fig. 2 Root collar is normal. The planter is covered with mulch and dry leaves.

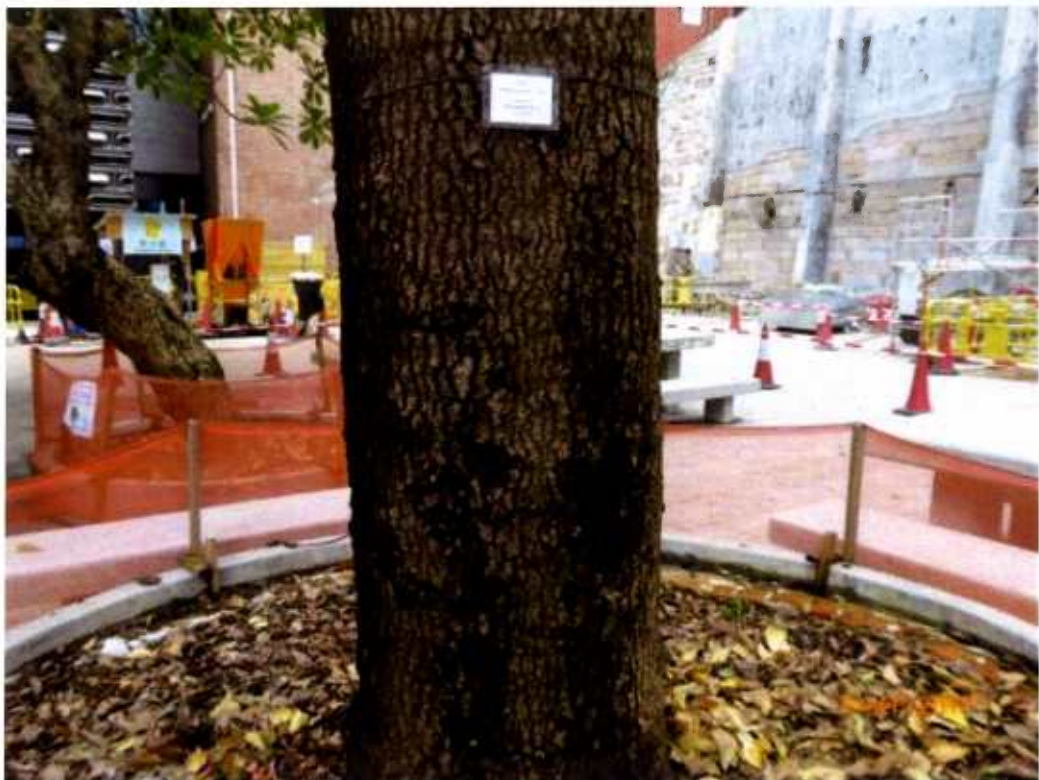
Fig. 4 Health condition of the mid trunk is fair.

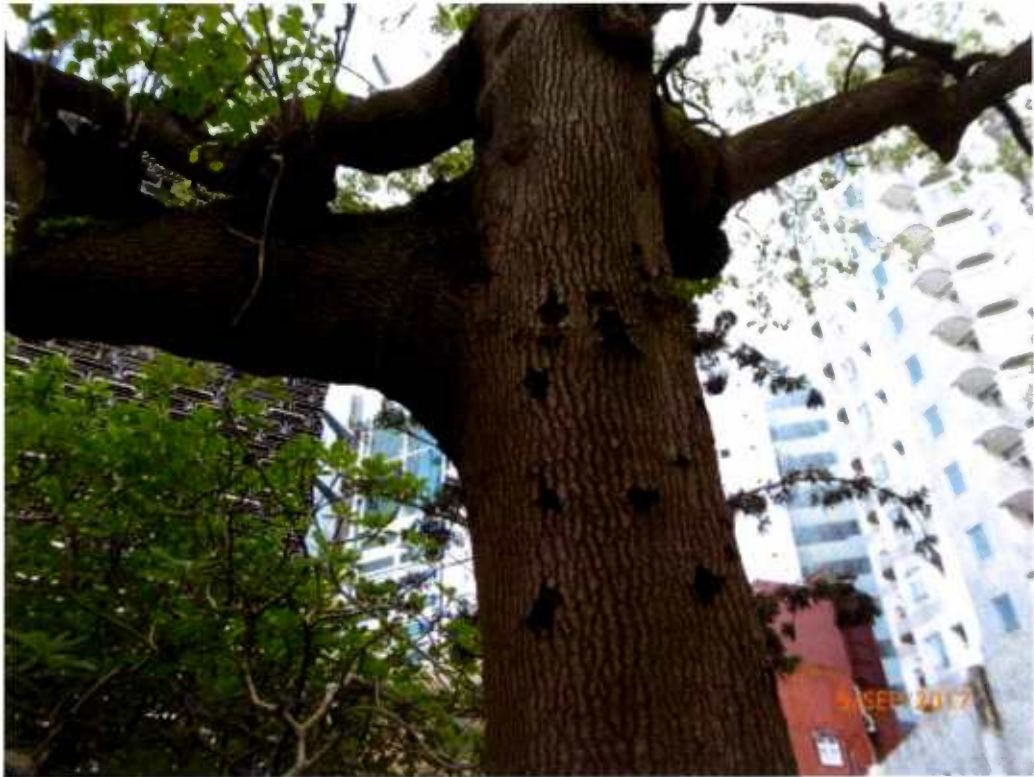
Fig. 5 Health condition of the upper trunk also is fair.

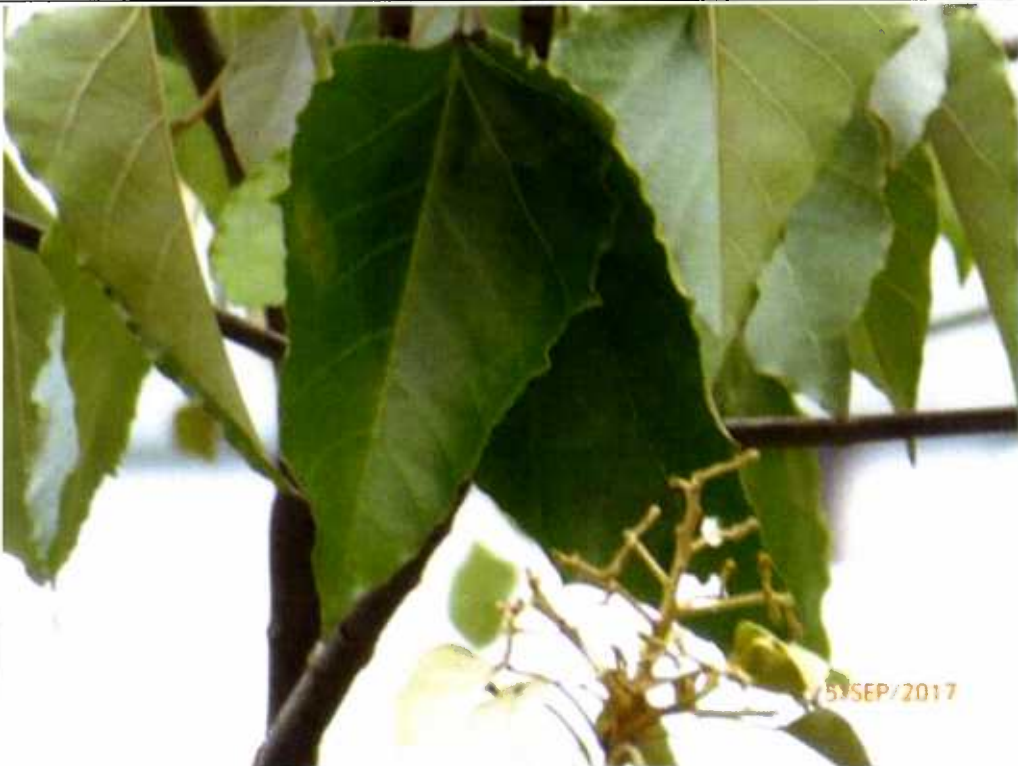
Fig. 8 Young and green leaves are growing on the lower branches.

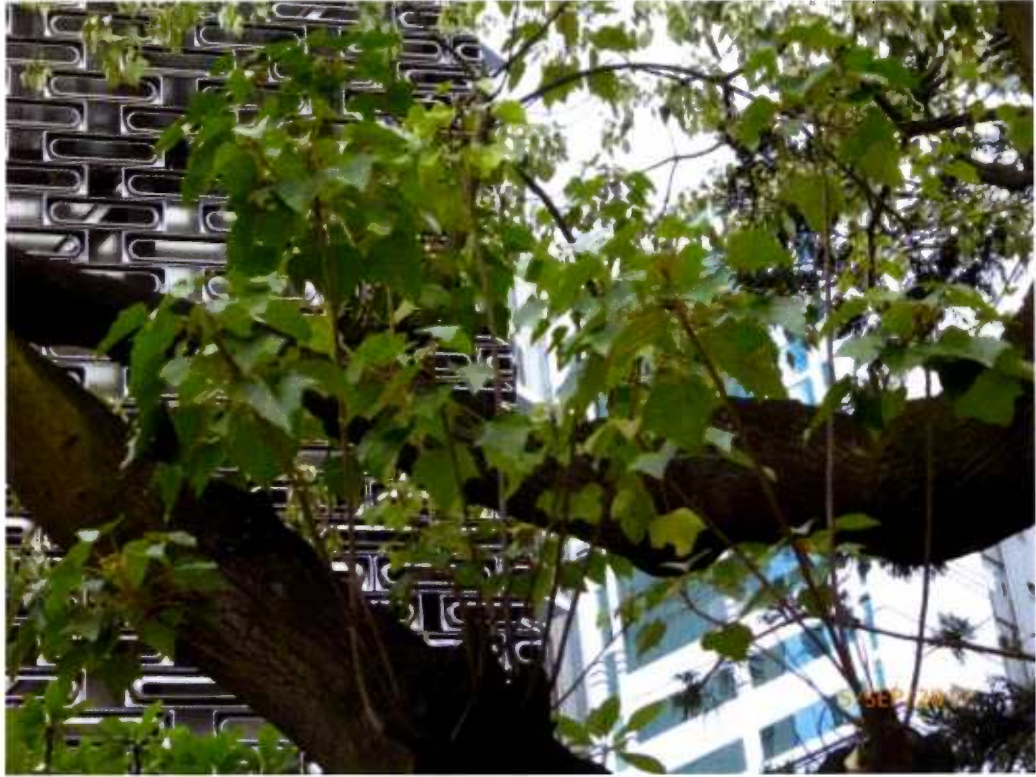
Fig. 9 Some fresh nuts appear on the top part of Tree-7.

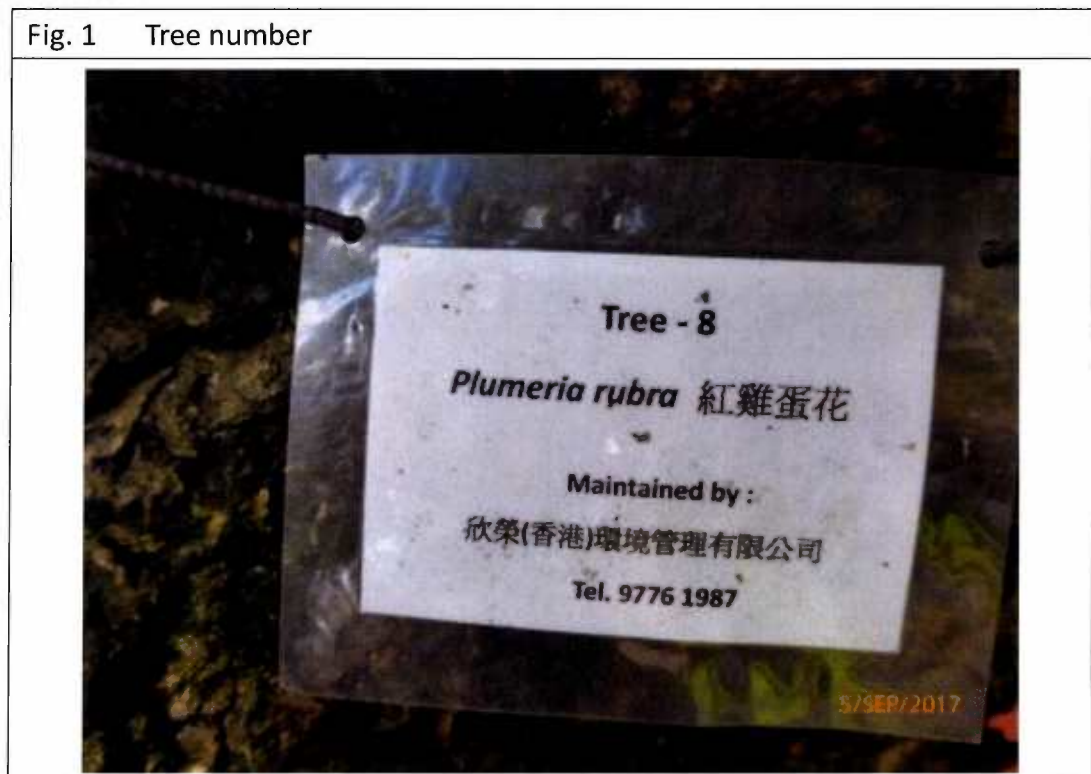
Fig. 2 Root collar is normal. The planter is covered with mulch and dry leaves.

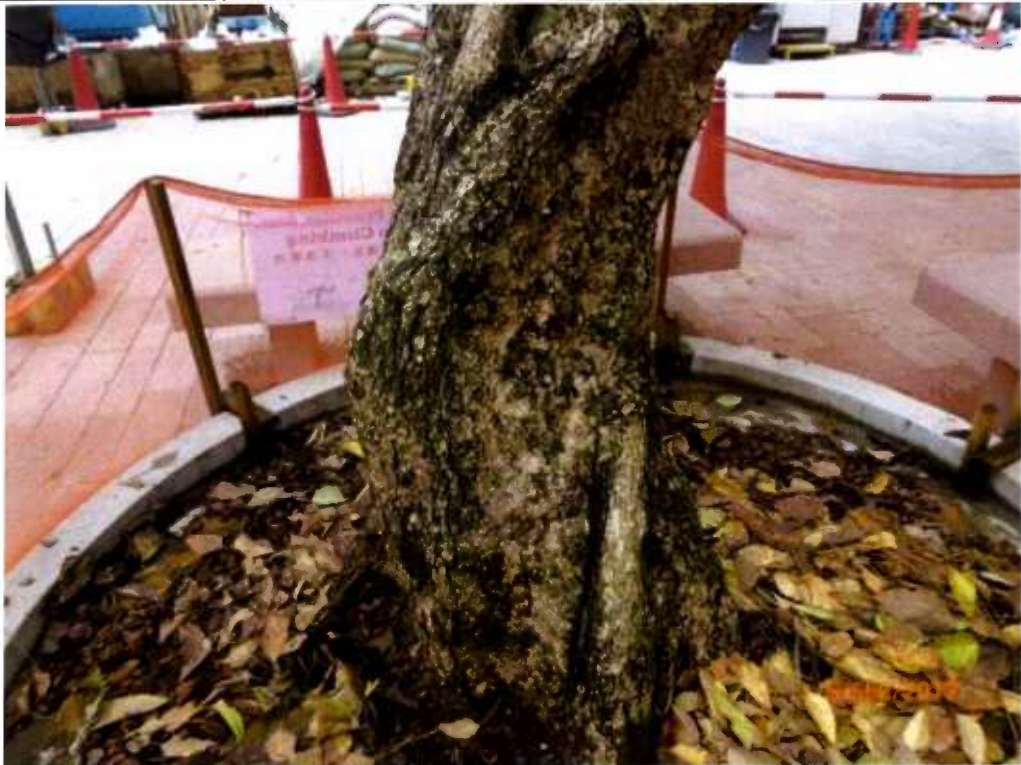
Fig. 4 Health condition of the mid trunk is fair.

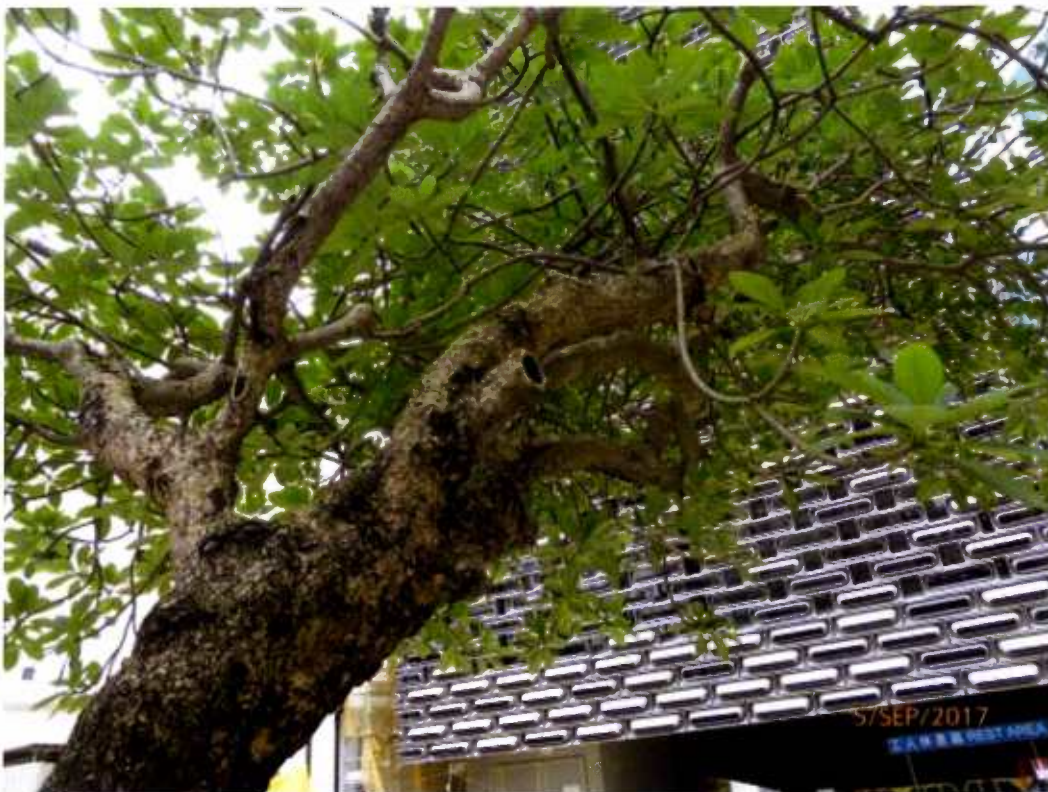
Fig. 5 Health condition of the upper trunk also is fair.

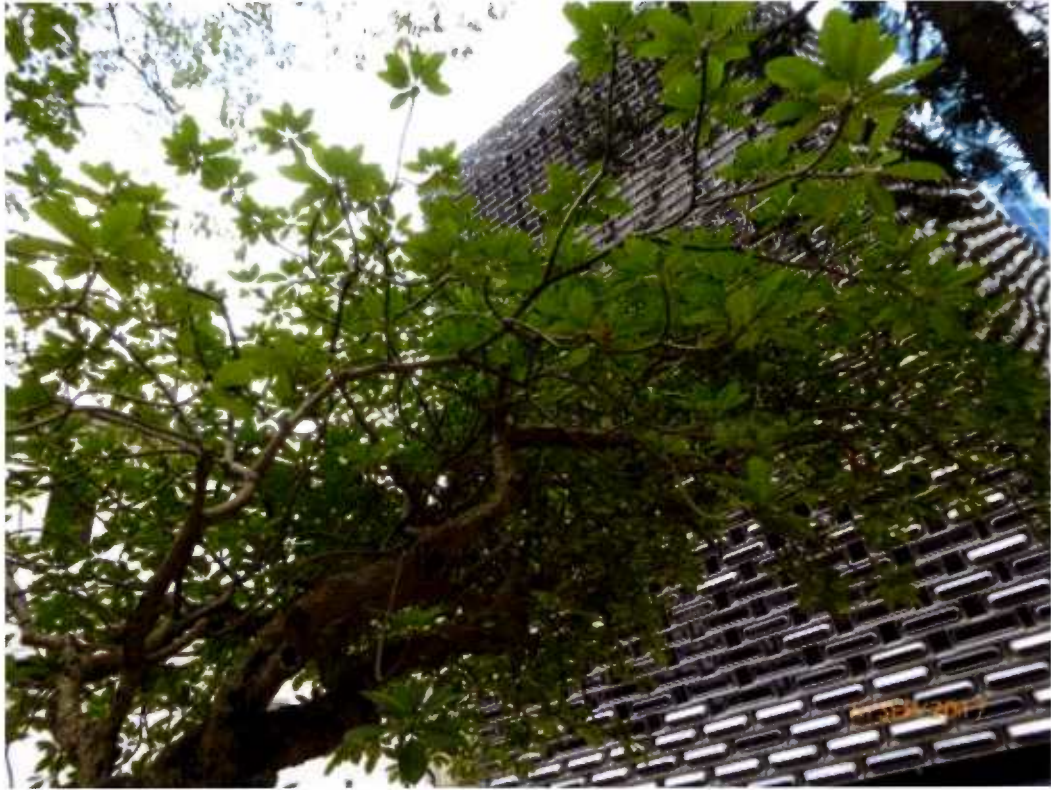
Fig. 6 The crown is full of vigorous and green leaves.

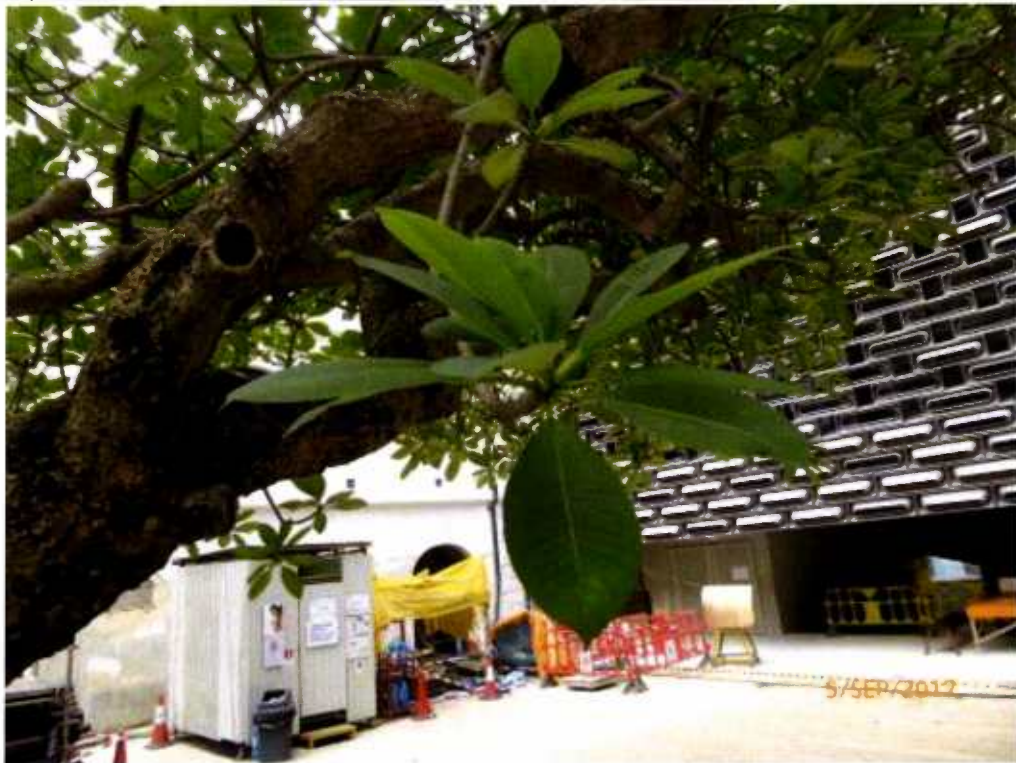
Fig. 7 Vigorous and green leaves also are growing on the lower branches.

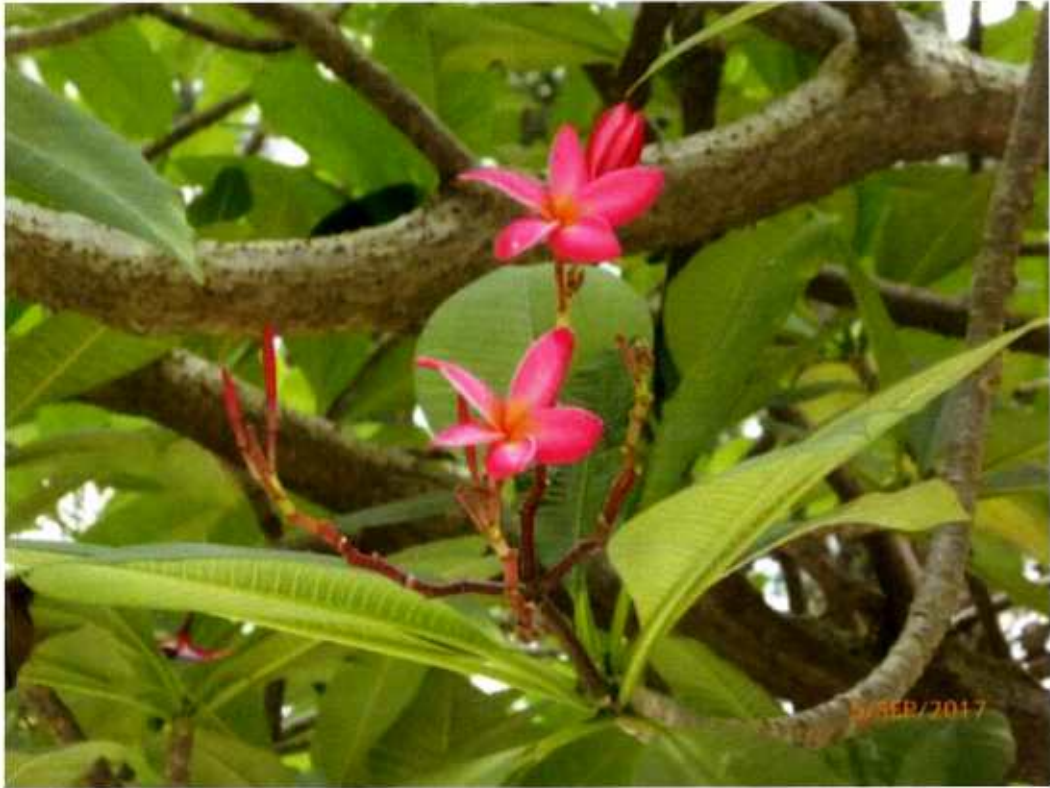
Fig. 8 Flowers still remain on the tree.

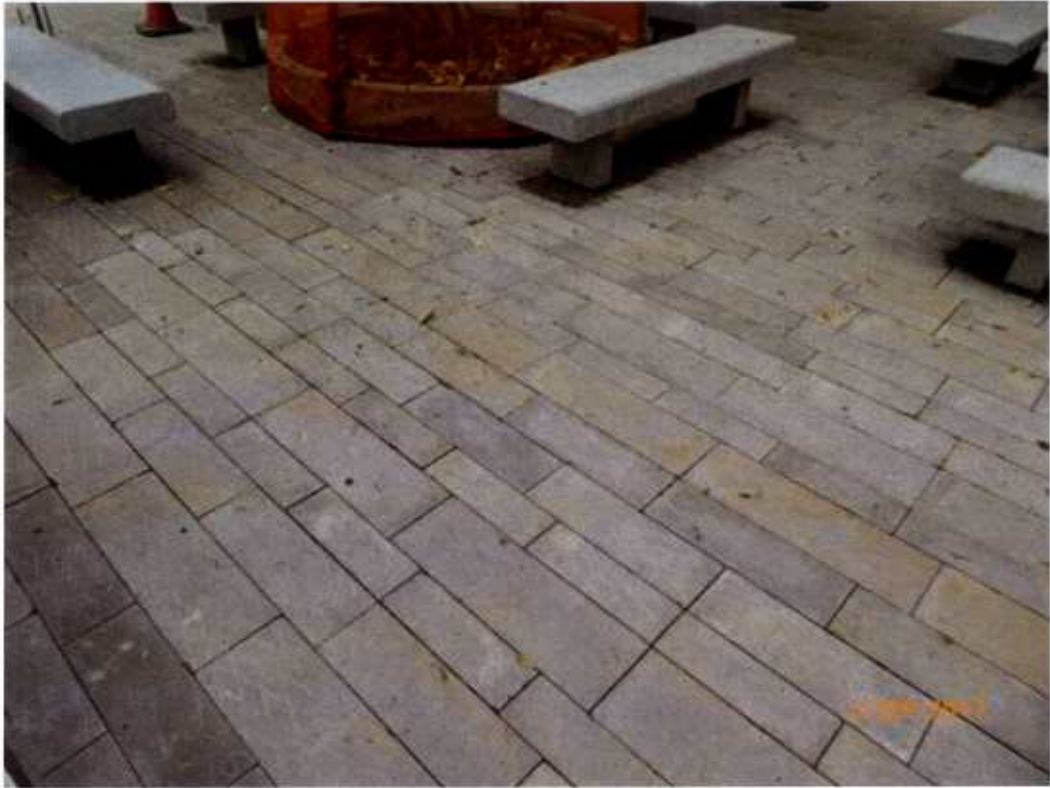
Fig. 10 The site near Tree-8 is clean and tidy.

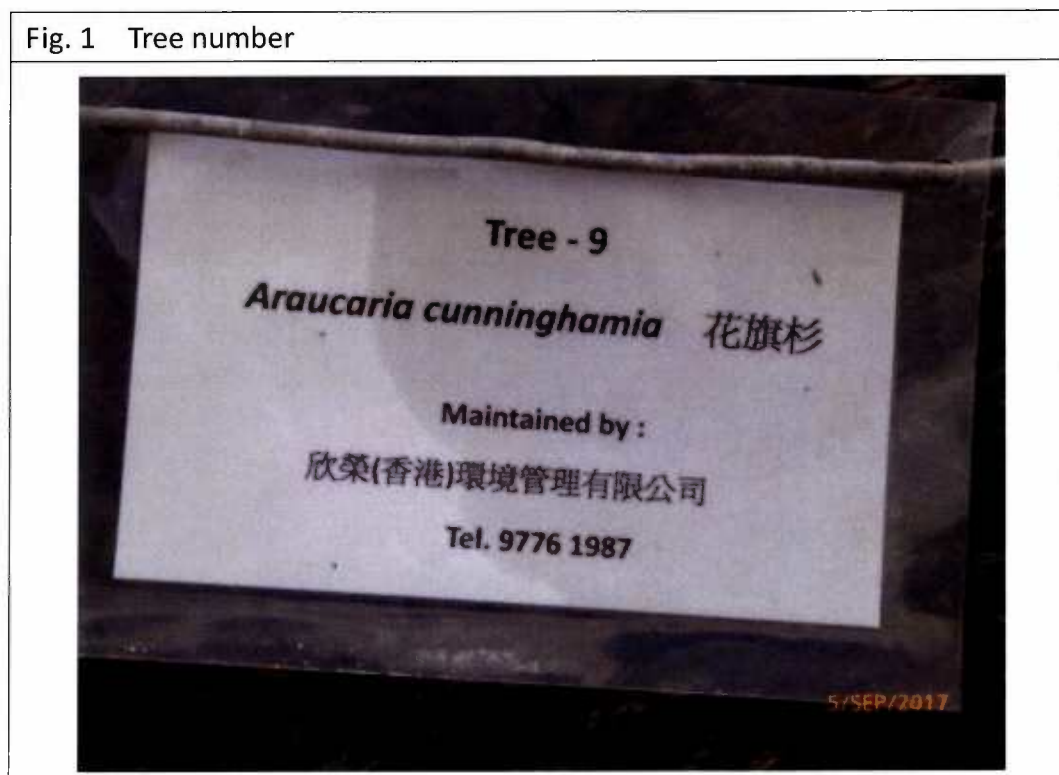
Fig. 2 Root collar is normal. The planter is covered with mulch and dry leaves.

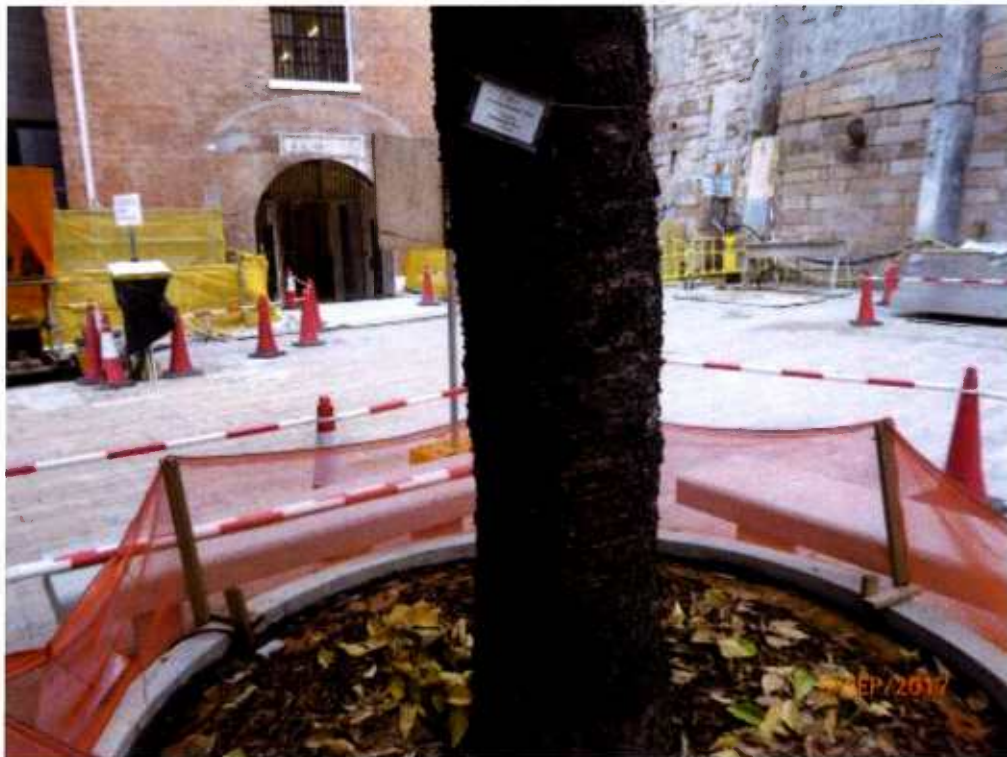
Fig. 4 Health condition of the mid trunk is fair.

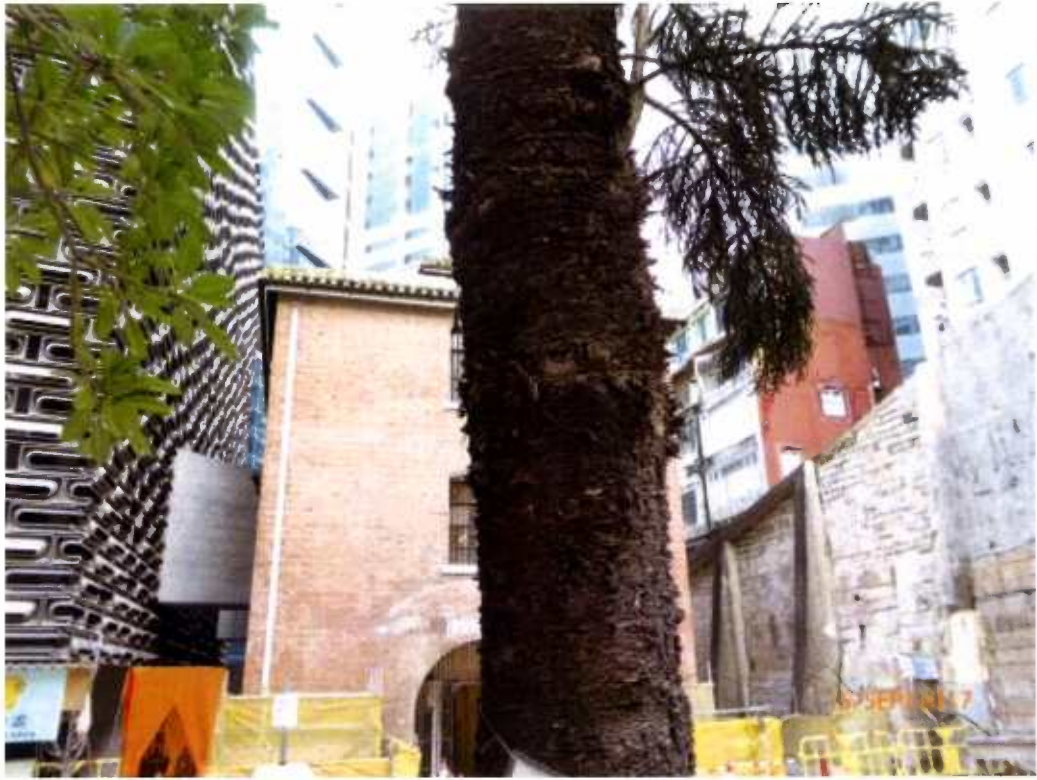
Fig. 5 Health condition of the upper trunk also is fair.

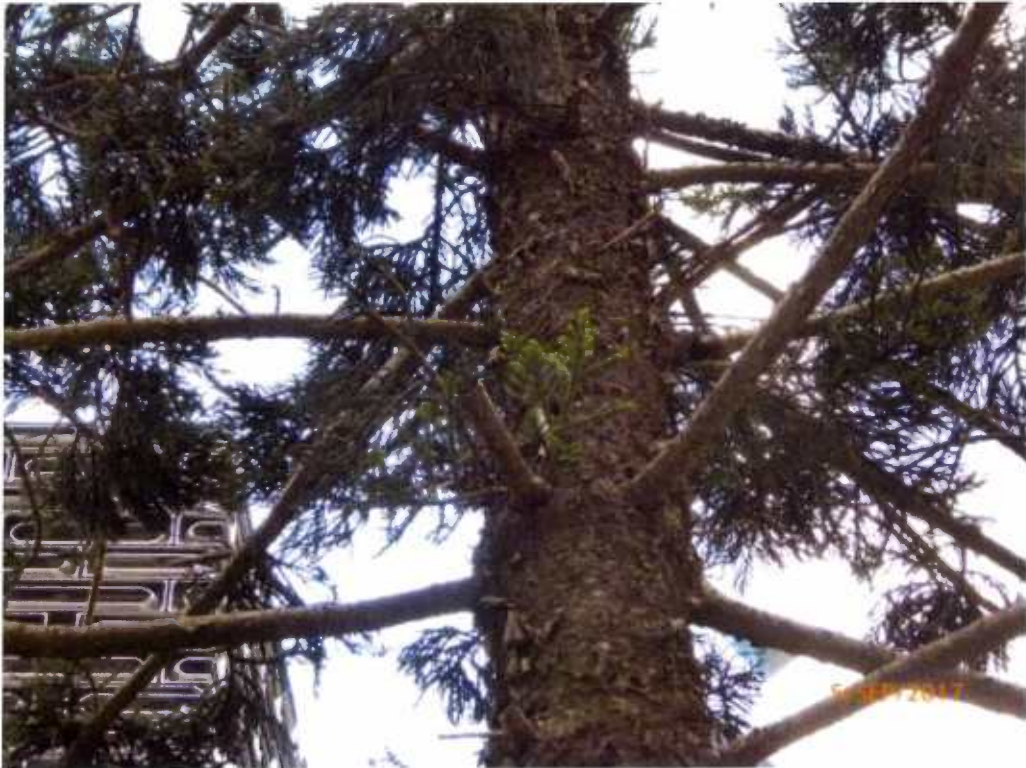
Fig. 6 The crown is full of vigorous and green leaves.
