Central Police Station Conservation
and Revitalisation Project:
71st Monthly EM&A Report
(1 September to 30 September 2017)

Issue Date: October 2017

Central Police Station Conservation
and Revitalisation Project:
71st Monthly EM&A Report
(From 1 September to 30 September
2017)

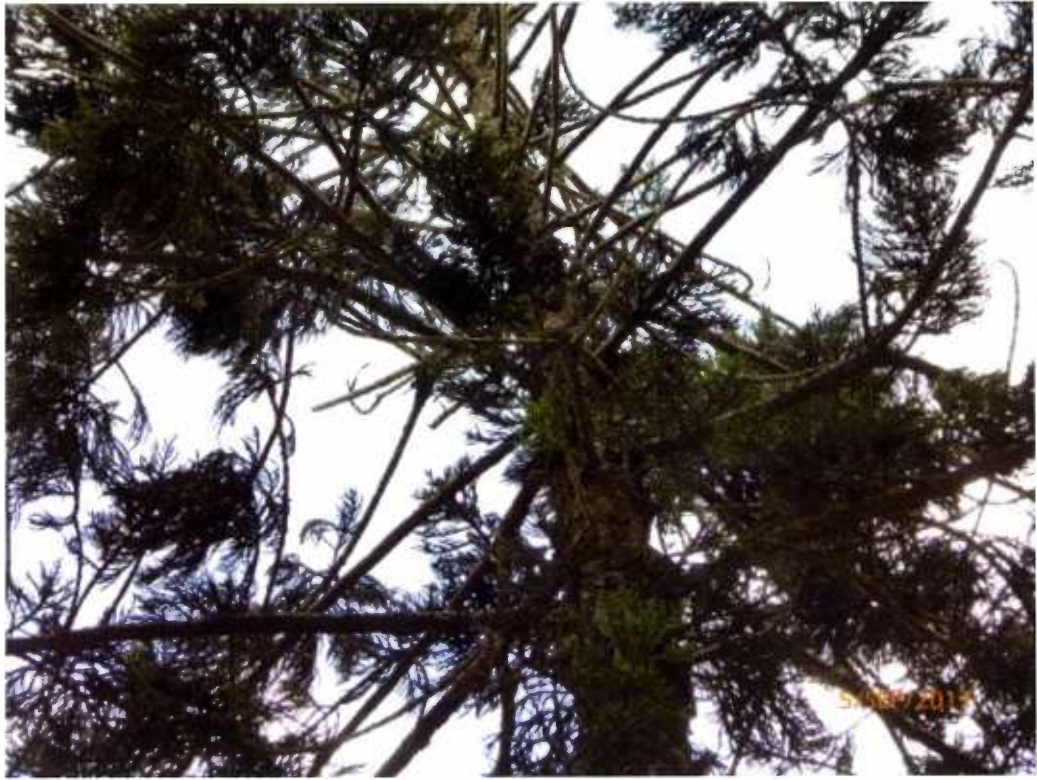
Fig. 7 Vigorous and green leaves also are growing on the lower branches.

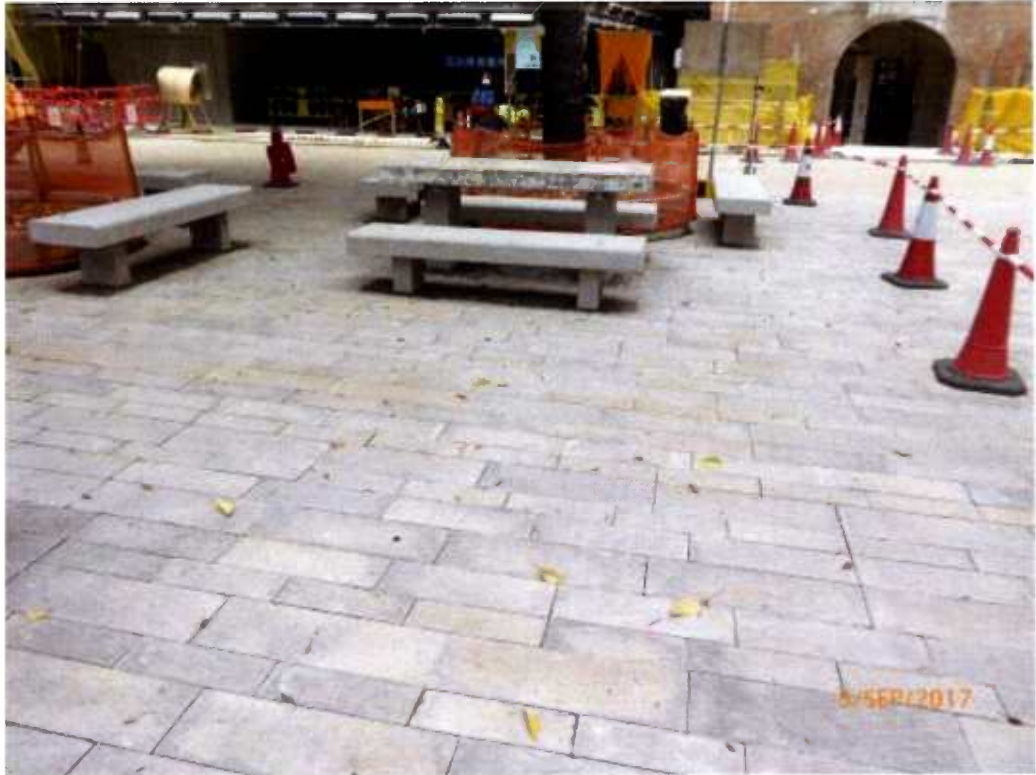
Fig. 11 The access near Tree-9 also is clean and tidy.

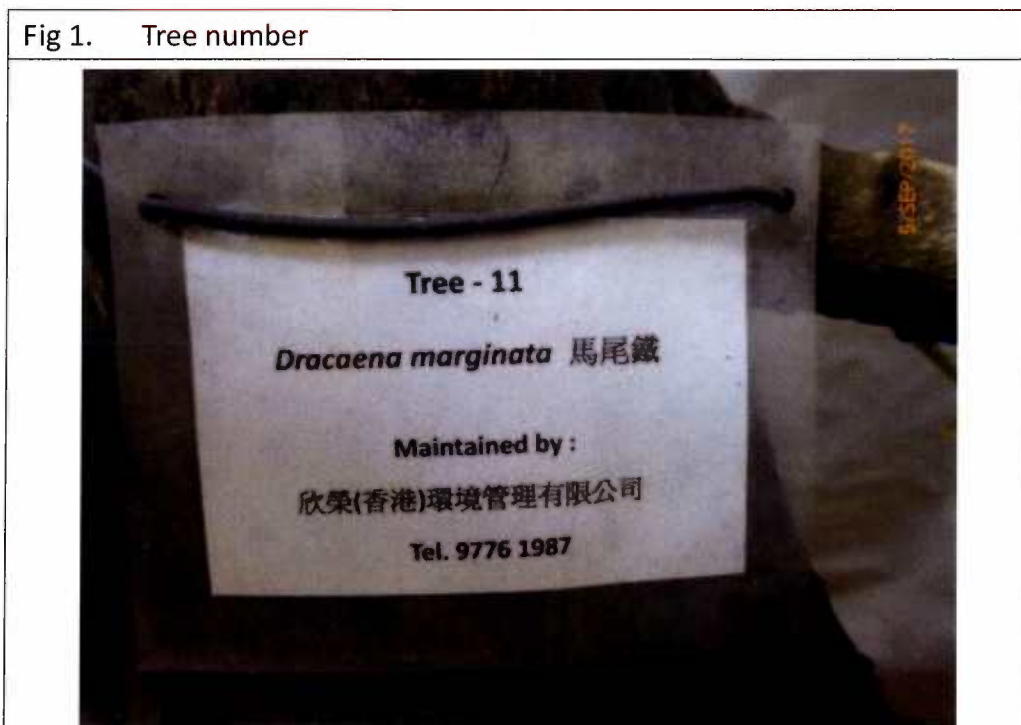
Fig. 2 Root collar is normal. The planter is covered with mulch.

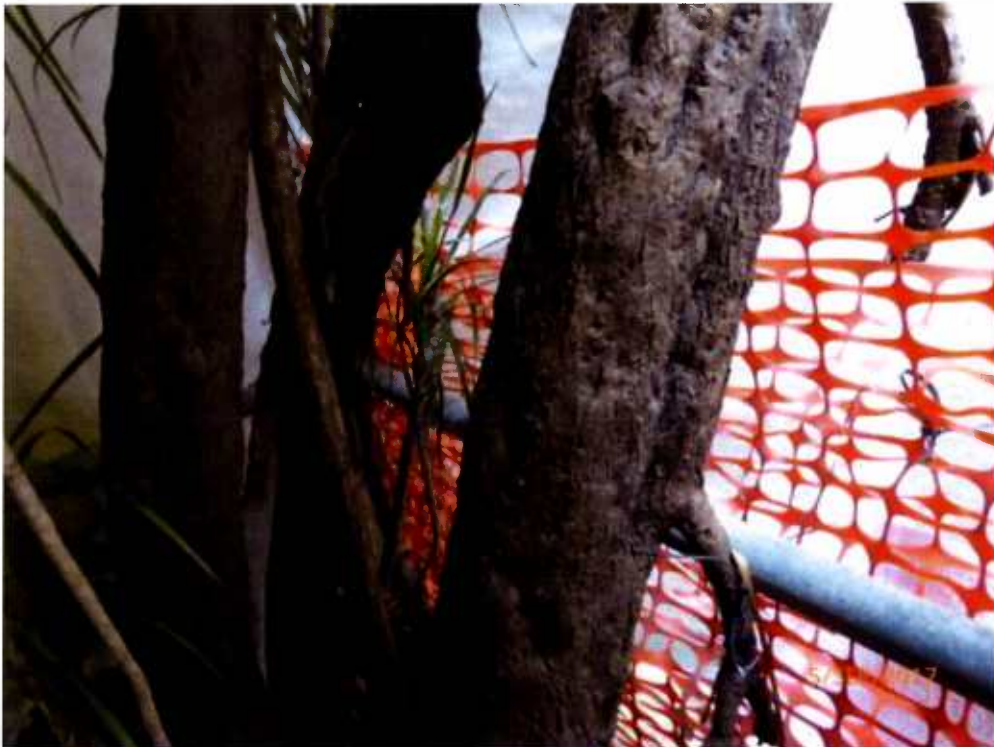
Fig. 6 Health condition of the mid trunk is fair.

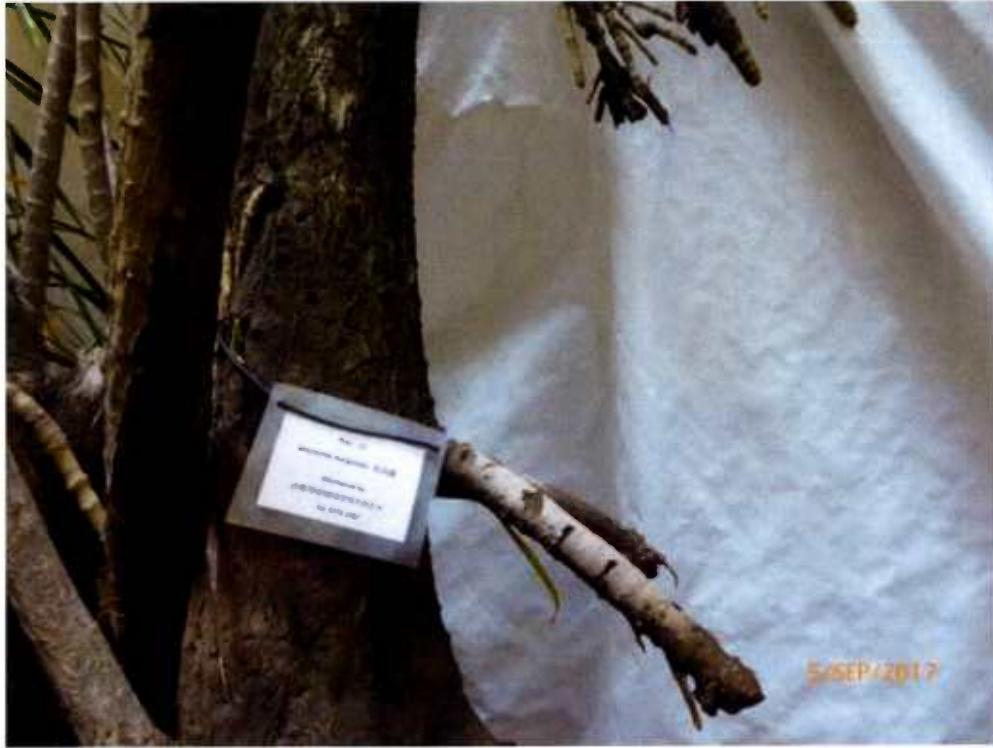
Fig. 7 Health condition of the upper trunk also is fair.

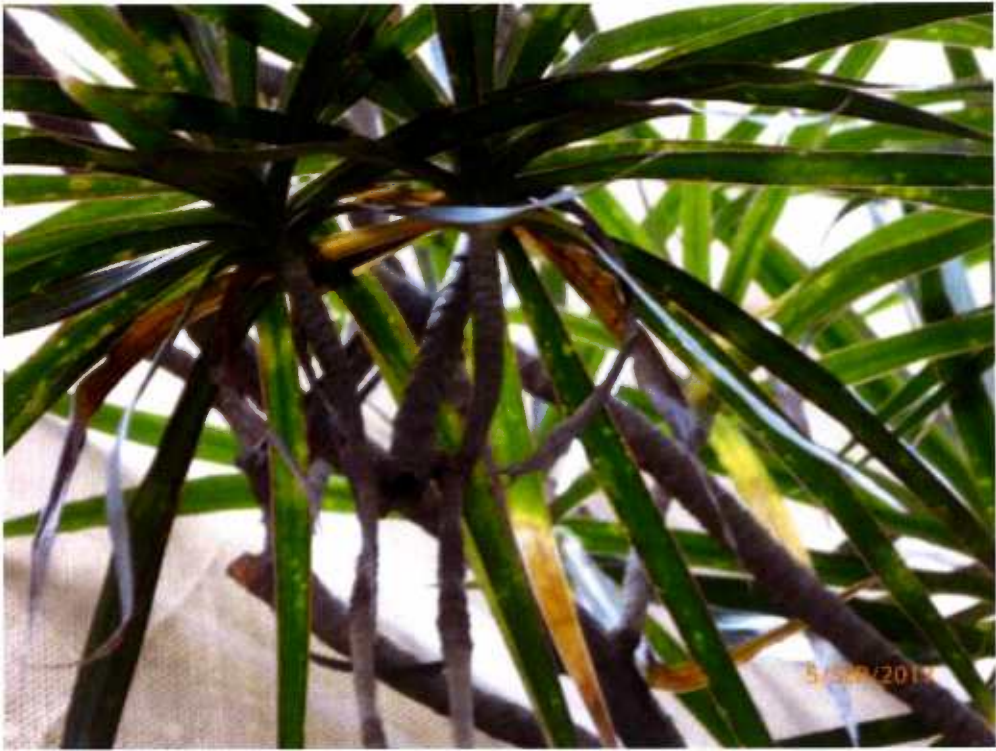
Fig. 9 A large shelter has been erected at site to protect the tree.

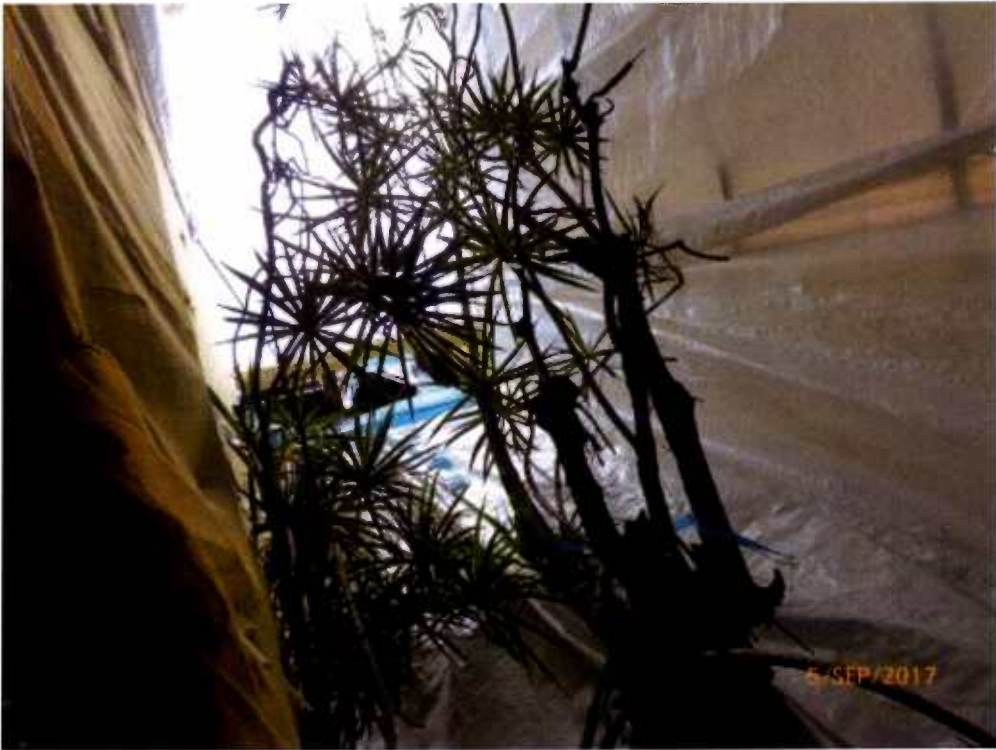
Fig. 10 A working platform is set up close to Tree-11.

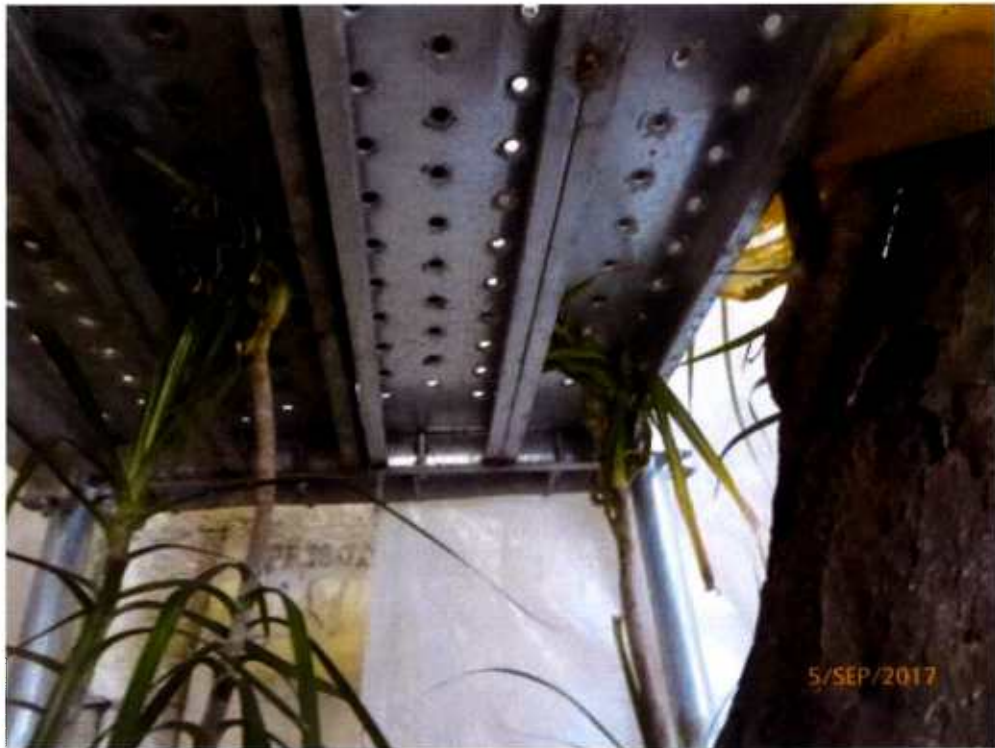
Fig. 11 Renovation works are in progress near Tree-11.

1. Keep close monitoring on the growth of Tree-11 especially during the nearby renovation works are in progress.
