Central Police Station Conservation
and Revitalisation Project:
76th Monthly EM&A Report
(1 February to 28 February 2018)

Issue Date: March 2018

Environmental Resources Management

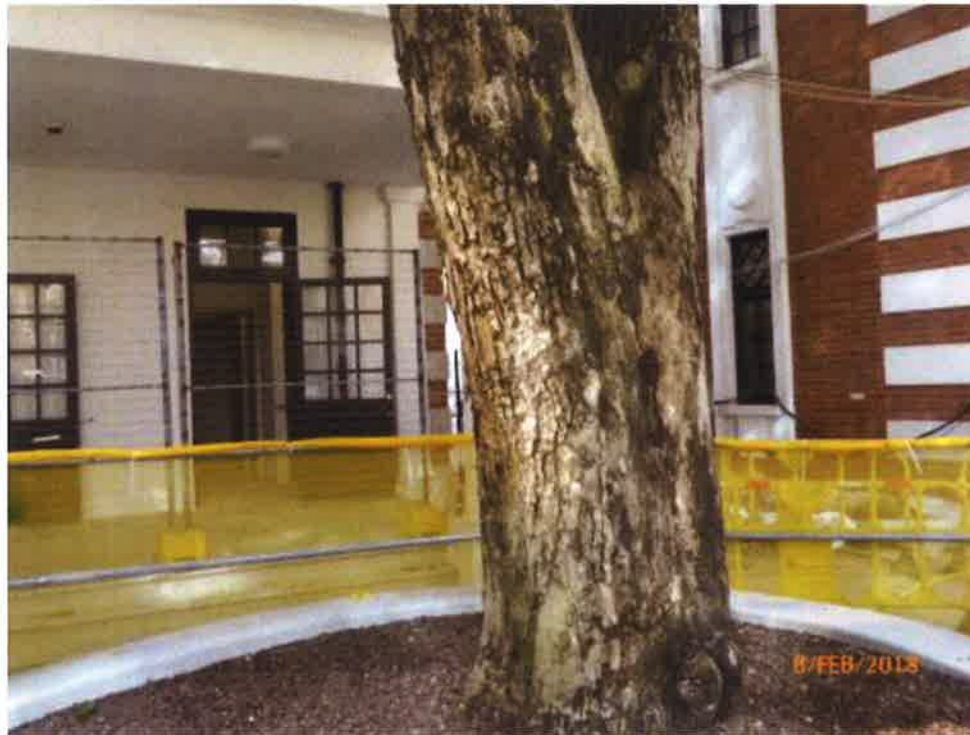
Fig. 3 Health condition of the lower trunk is fair.

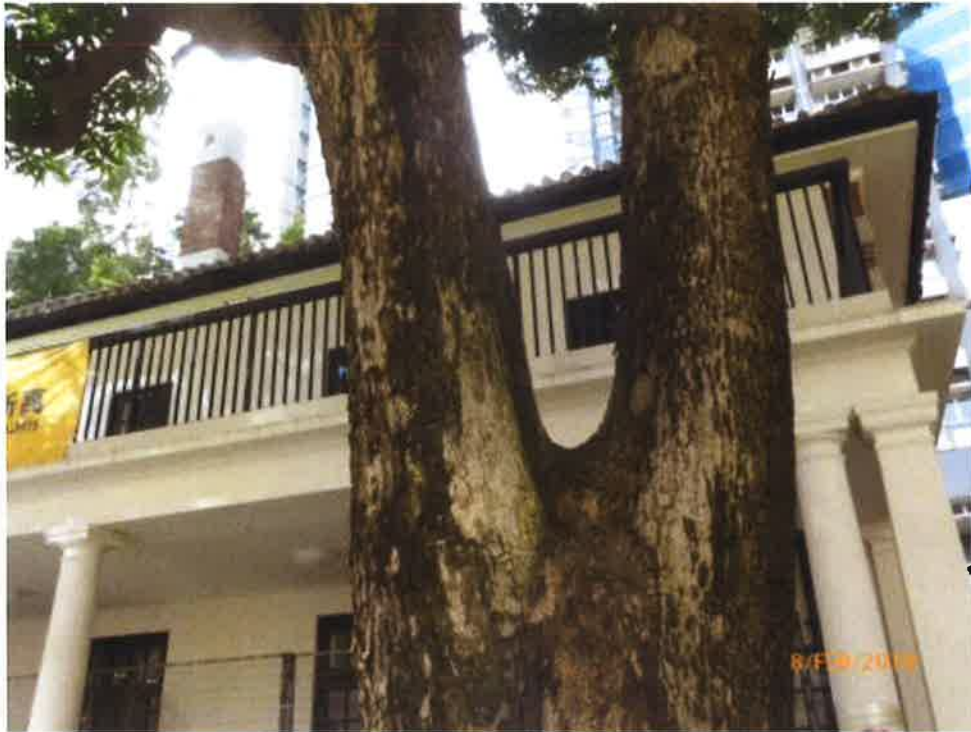
Fig. 4 Health condition of the mid trunk is fair.

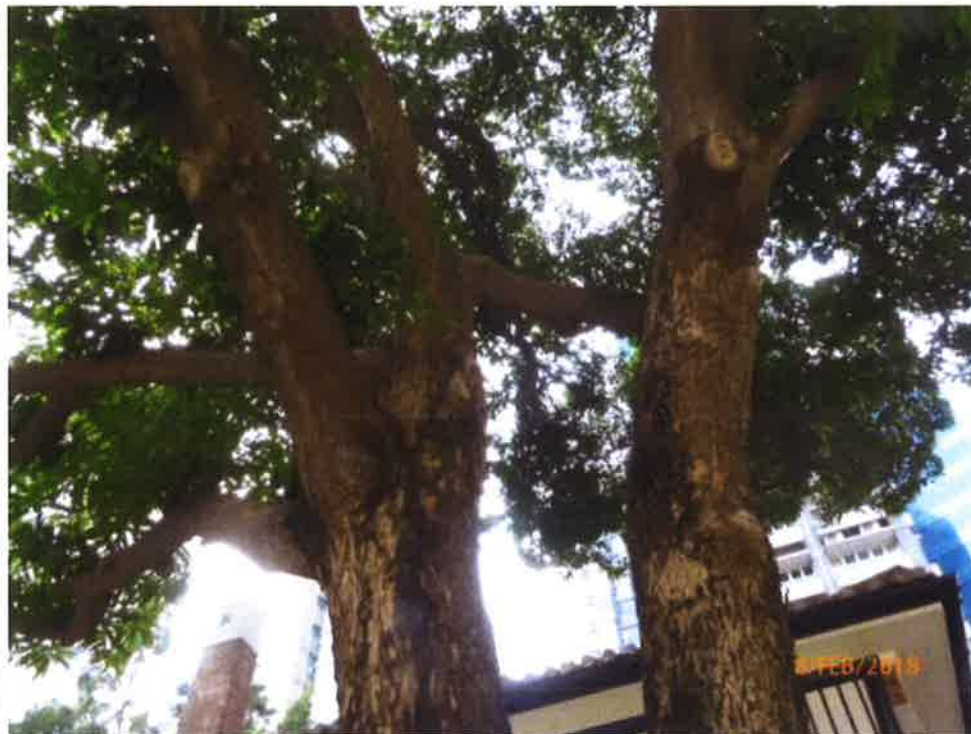
Fig. 5 Health condition of the upper trunk also is fair.

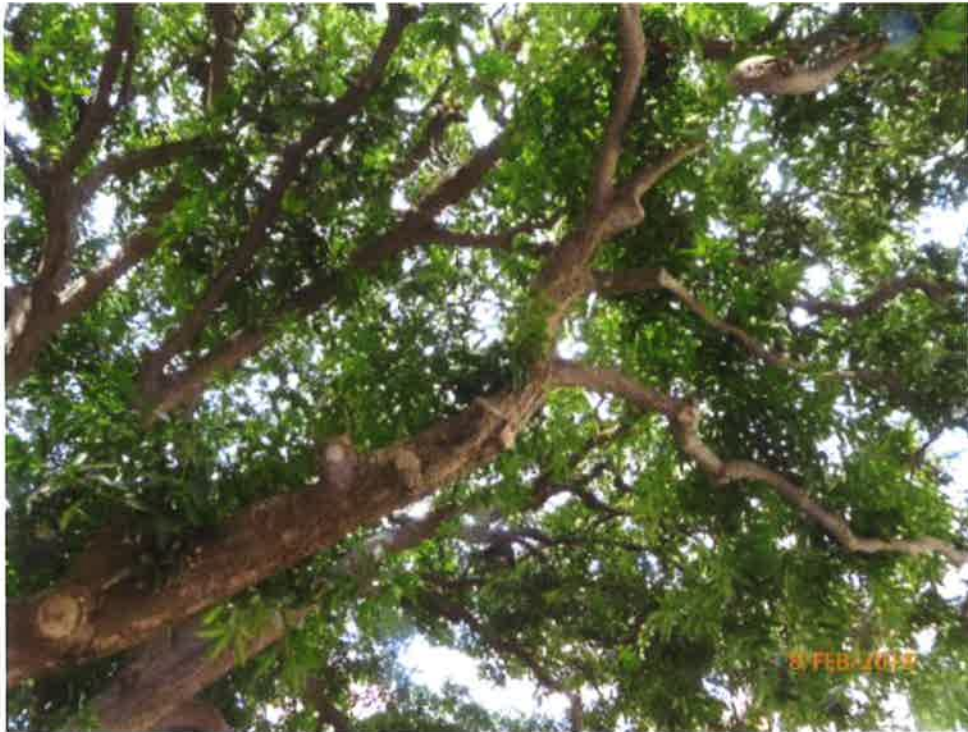
Fig. 6 The crown is full of vigorous and green leaves.

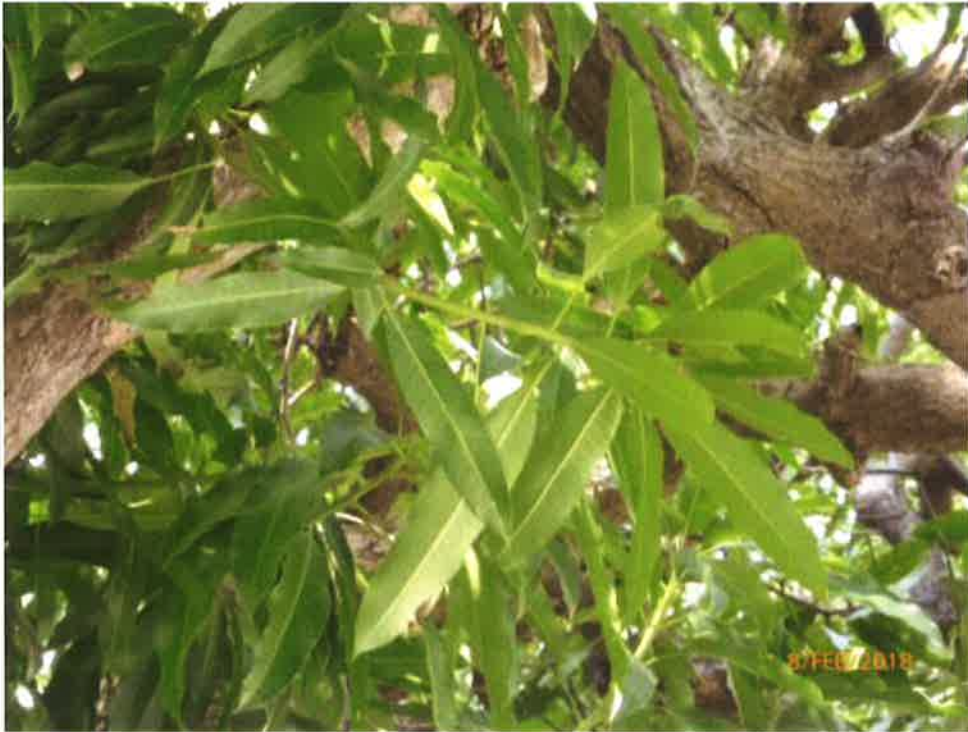
Fig. 8 Some young and green leaves appear on the tree.

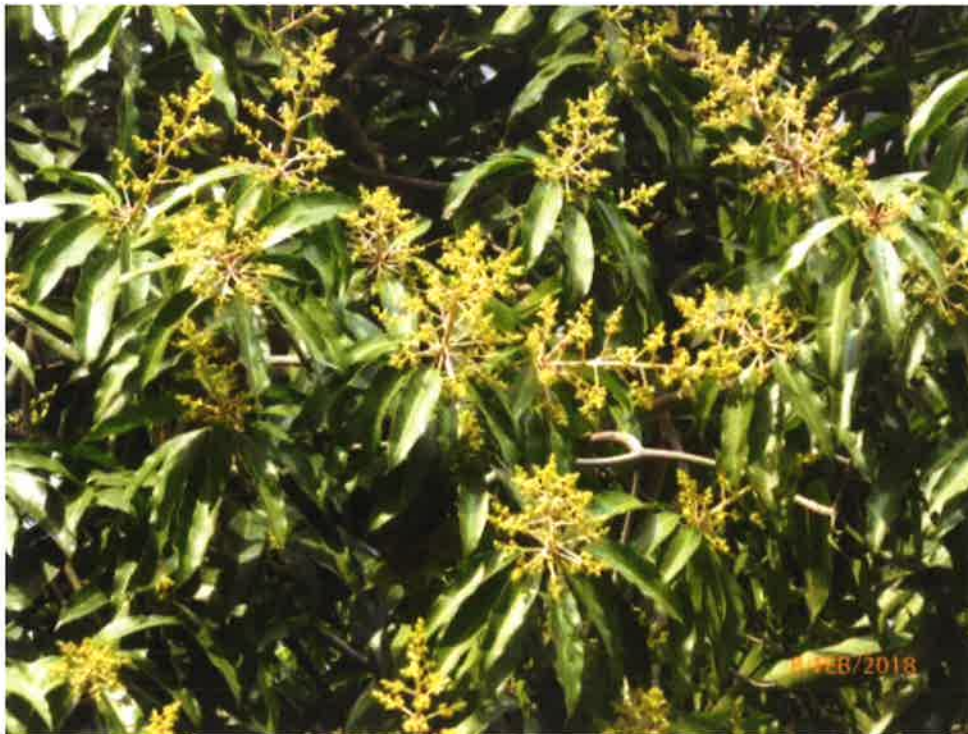
Fig. 9 Many flowers also appear on Tree-5.

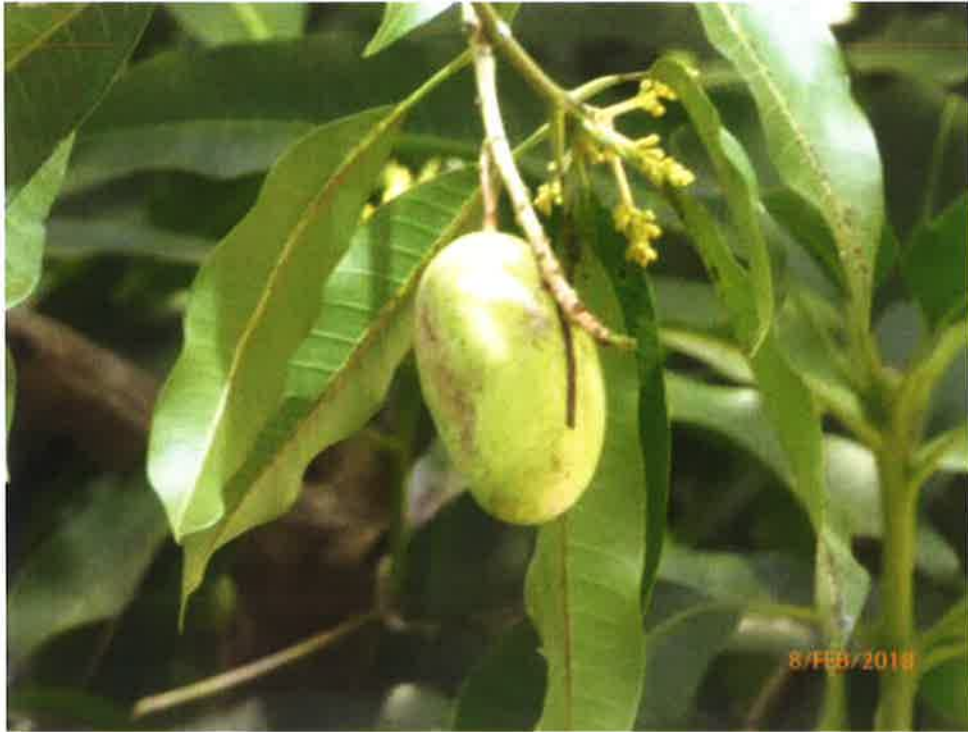
Fig. 10 A mango fruit still remains on the tree.

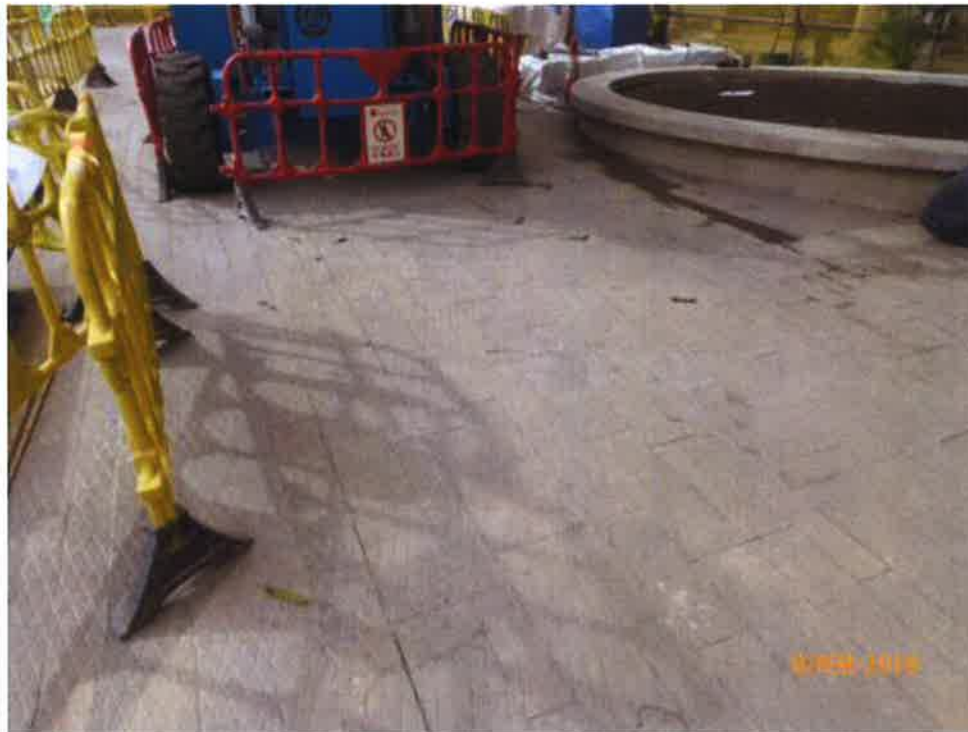
Fig. 11 The site near the planter is clean and tidy.

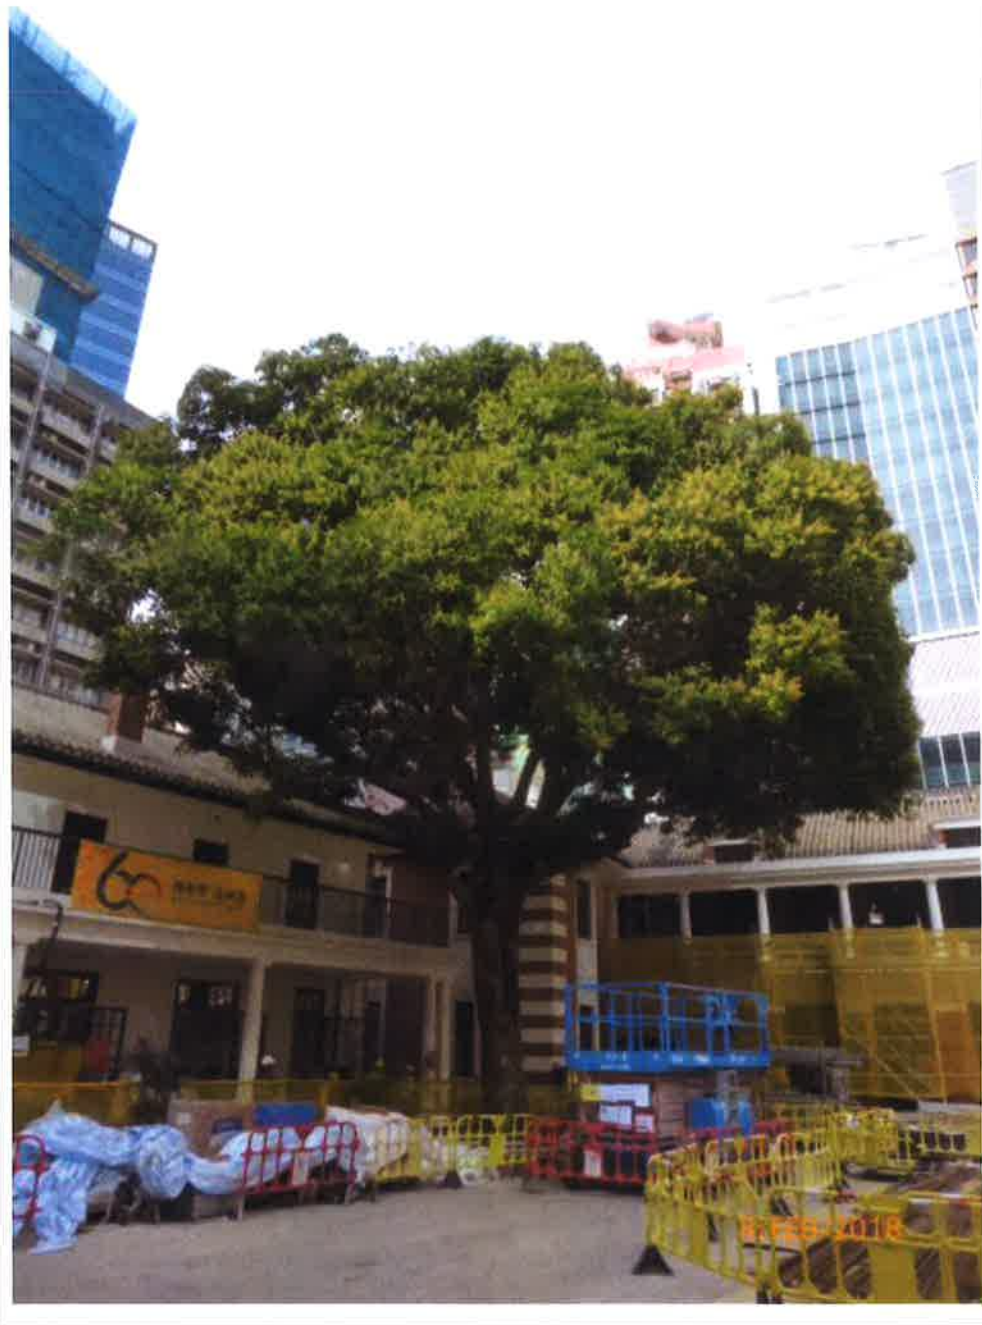
Fig. 12 Overall view of Tree-5 during inspection on 8th February 2018.

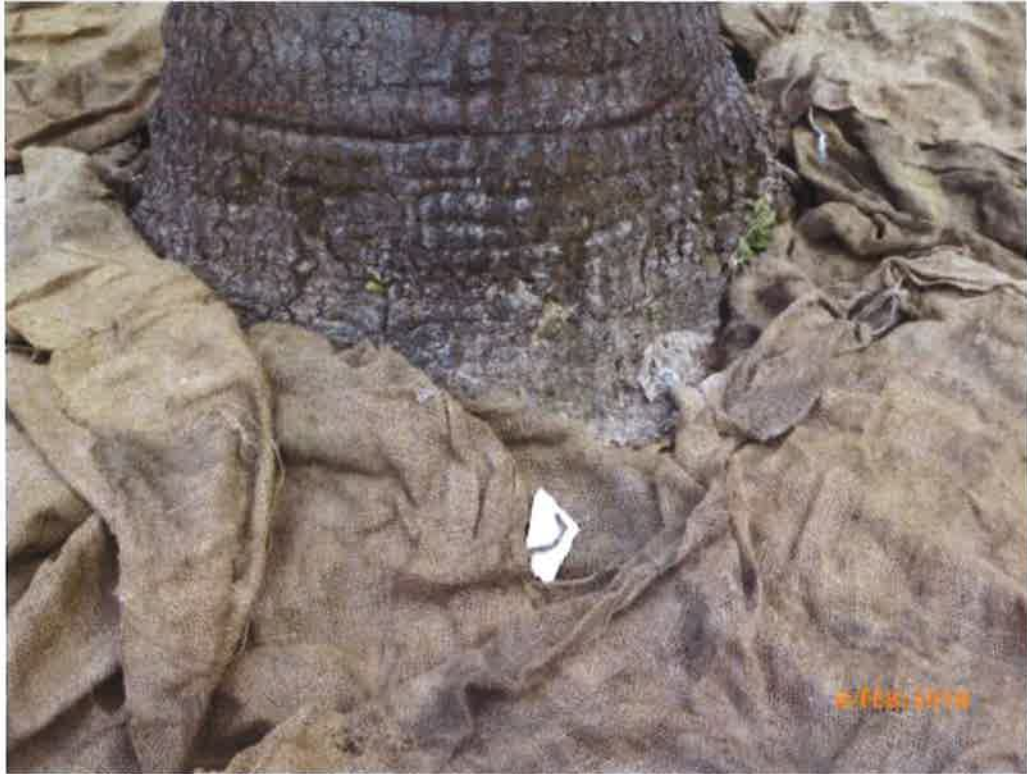
Fig 3. Health condition of the lower trunk is fair.

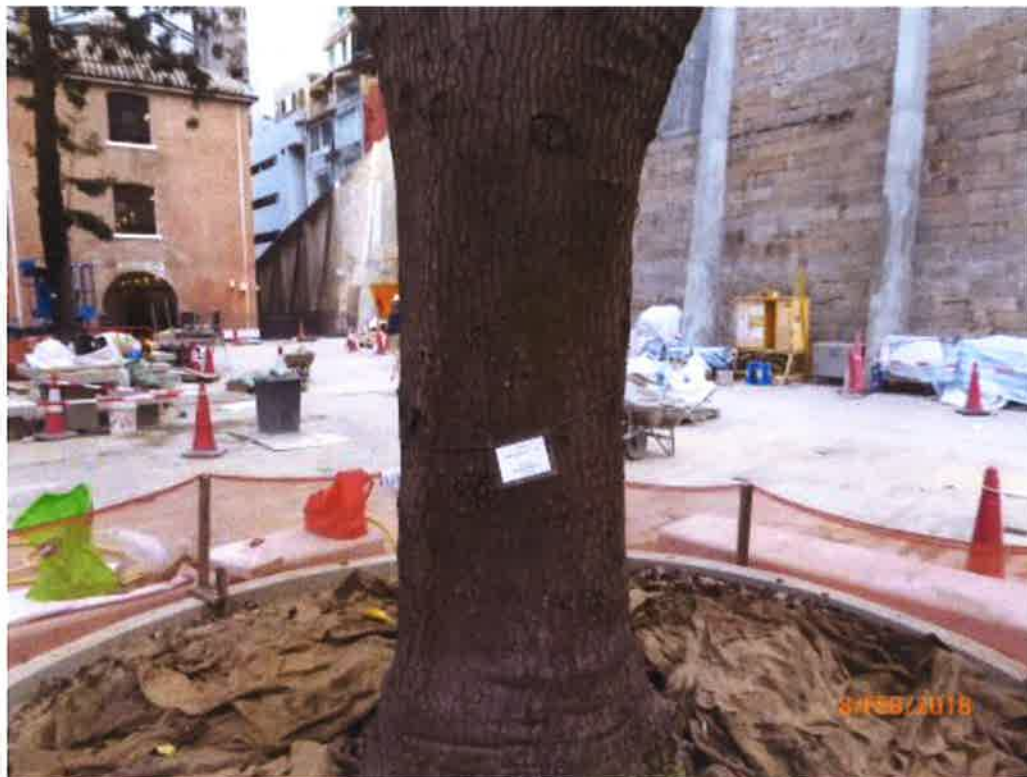
Fig. 4 Health condition of the mid trunk is fair.

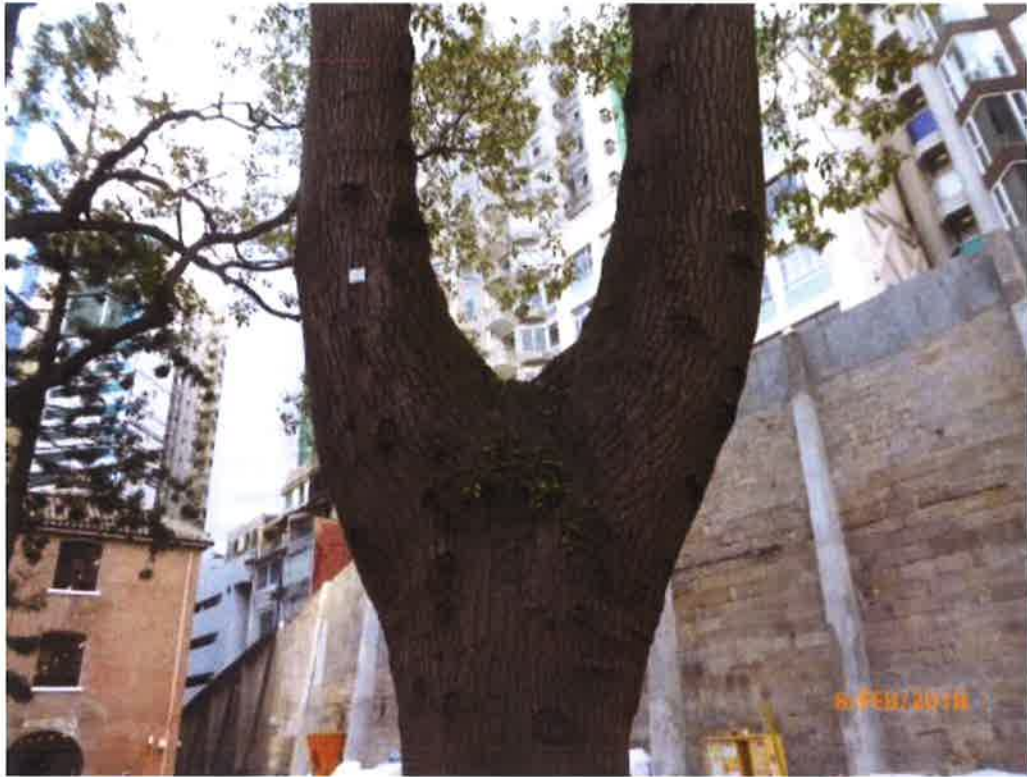
Fig. 5 Health condition of the upper trunk also is fair.

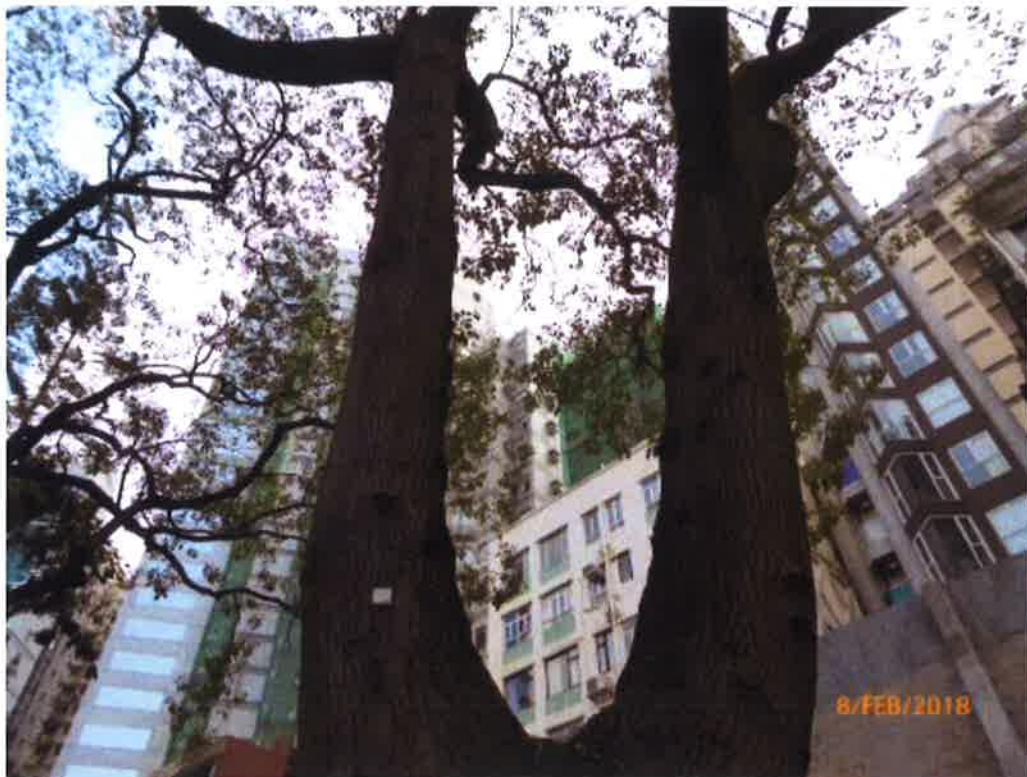
Fig. 6 Leaves on the crown are rather sparse.

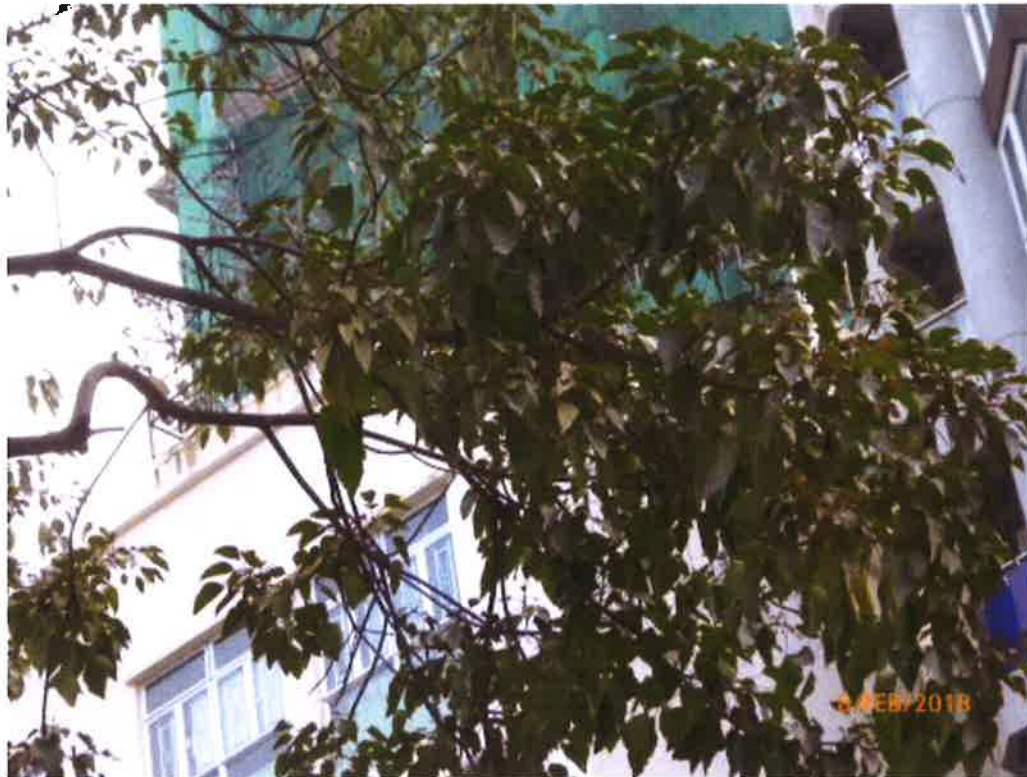
Fig. 8 Some young and green leaves appear on the tree.

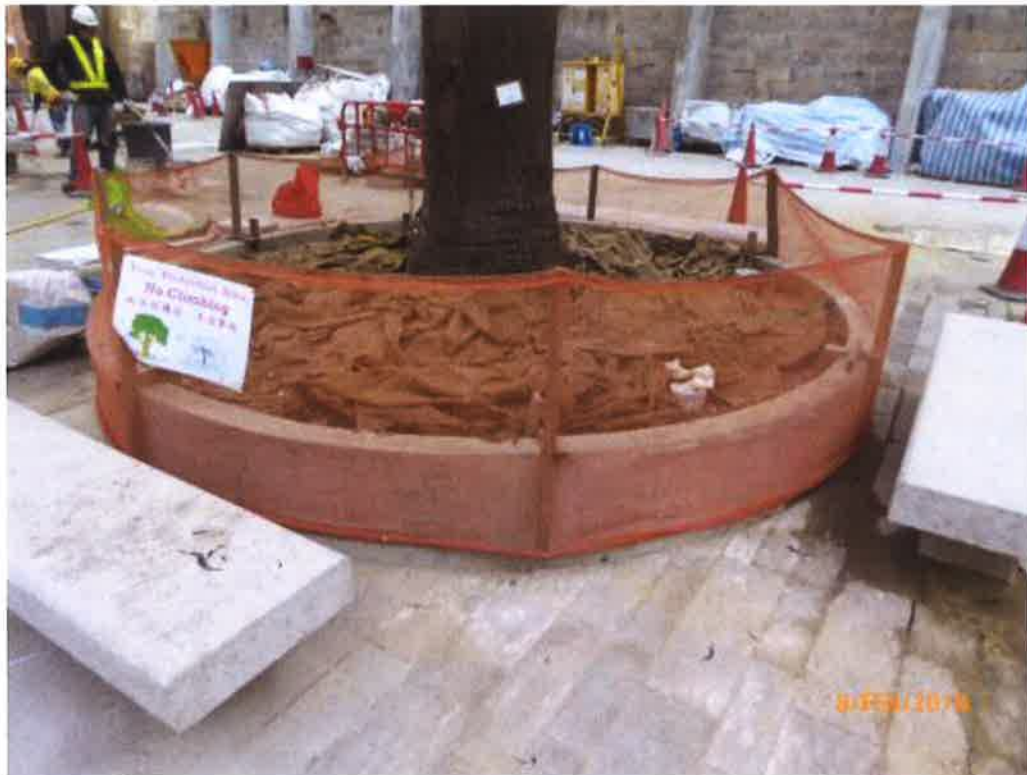
Fig. 11 Renovation works are in progress near the tree.

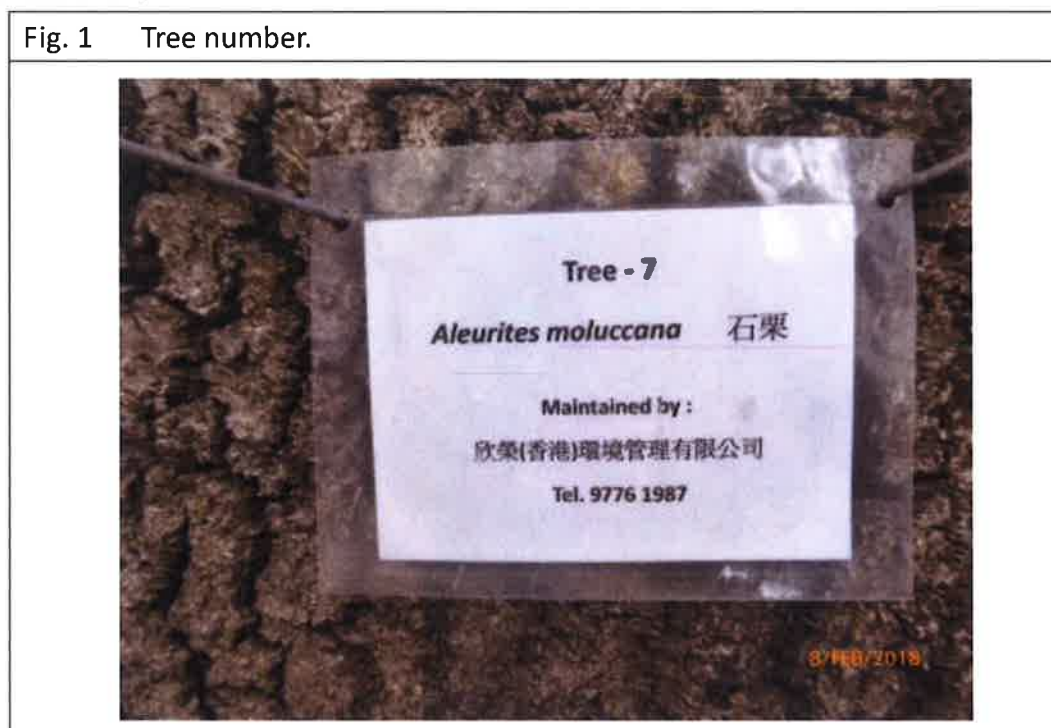
Fig. 2 Root collar is normal. The planter is covered with wet hessian clothes.

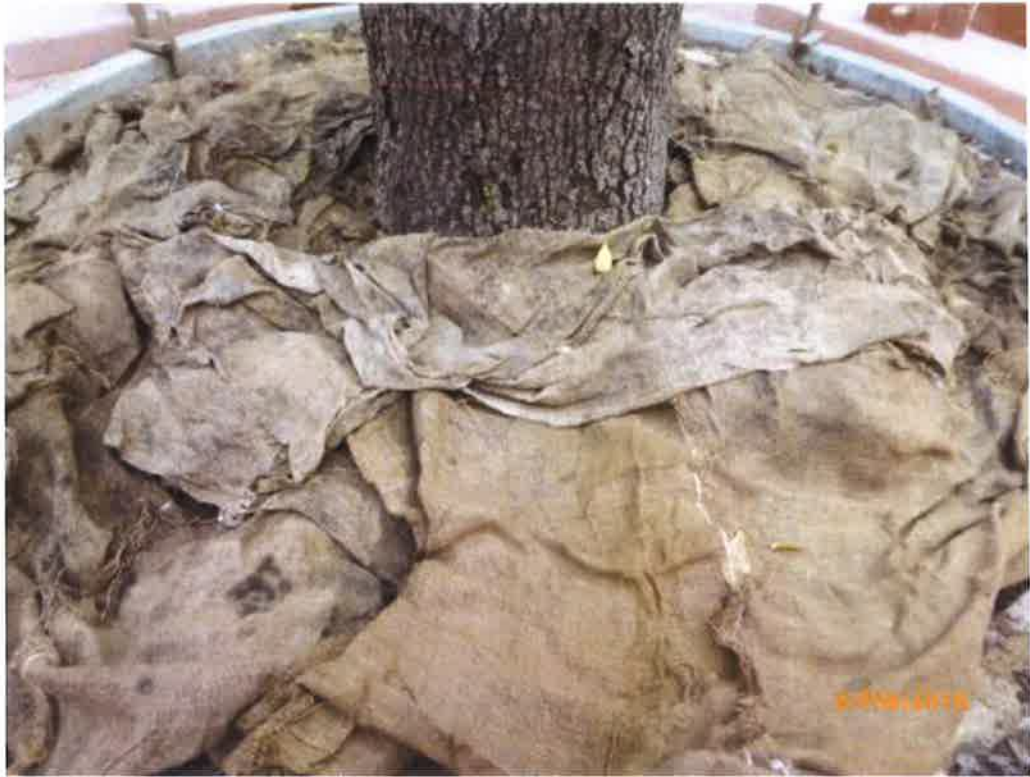
Fig 3. Health condition of the lower trunk is fair.

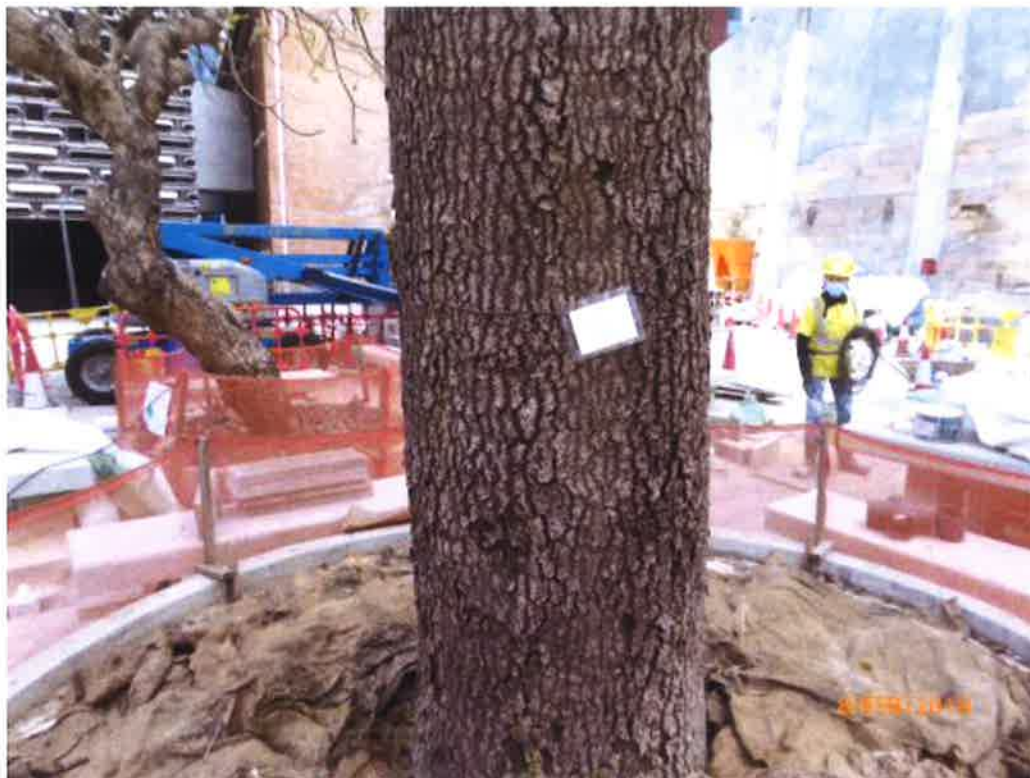
Fig. 4 Health condition of the mid trunk is fair.

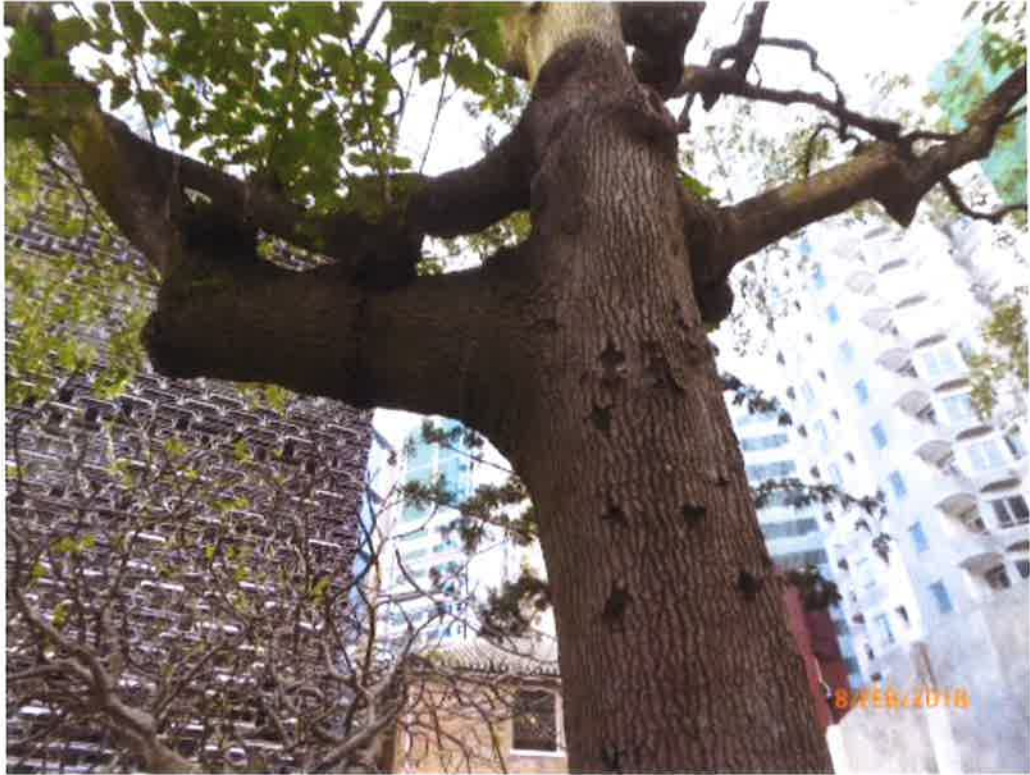
Fig. 5 Health condition of the upper trunk also is fair.

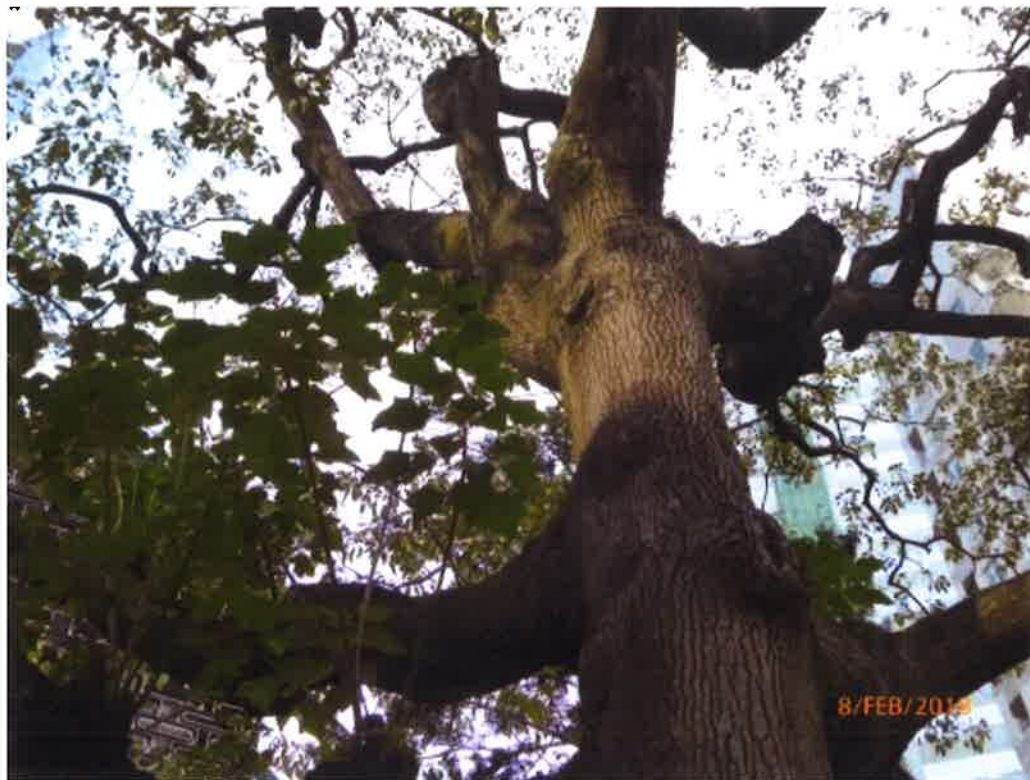
Fig. 6 Leaves on the crown are still sparse.

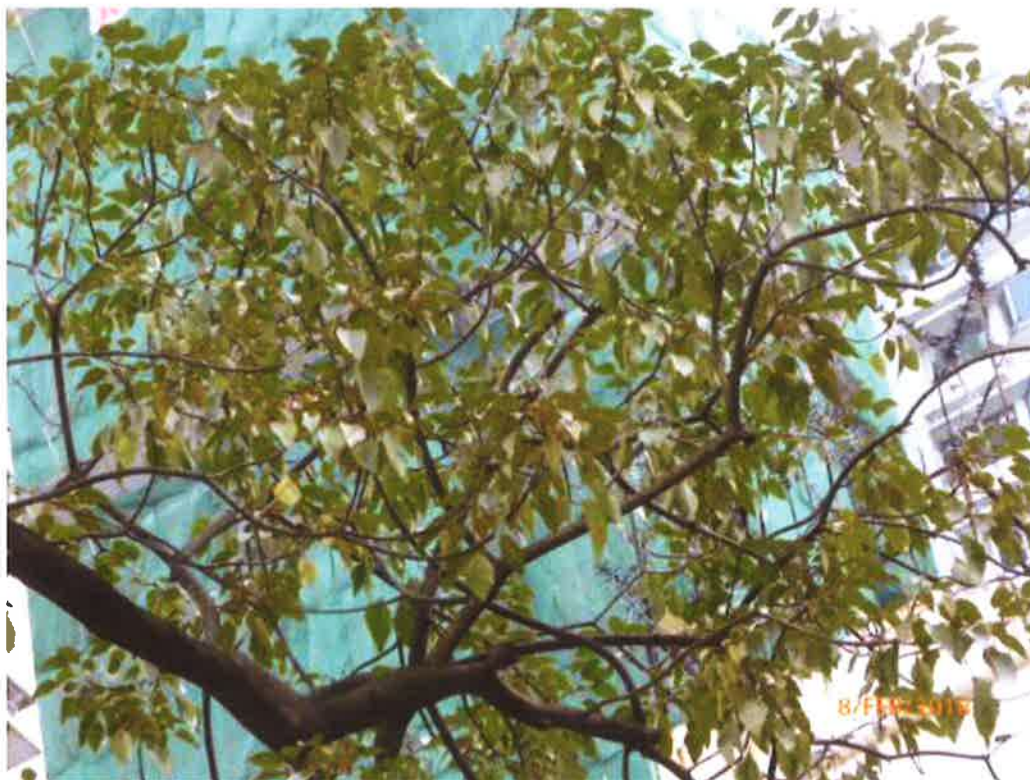
Fig. 8 Some young and green leaves appear on the tree.

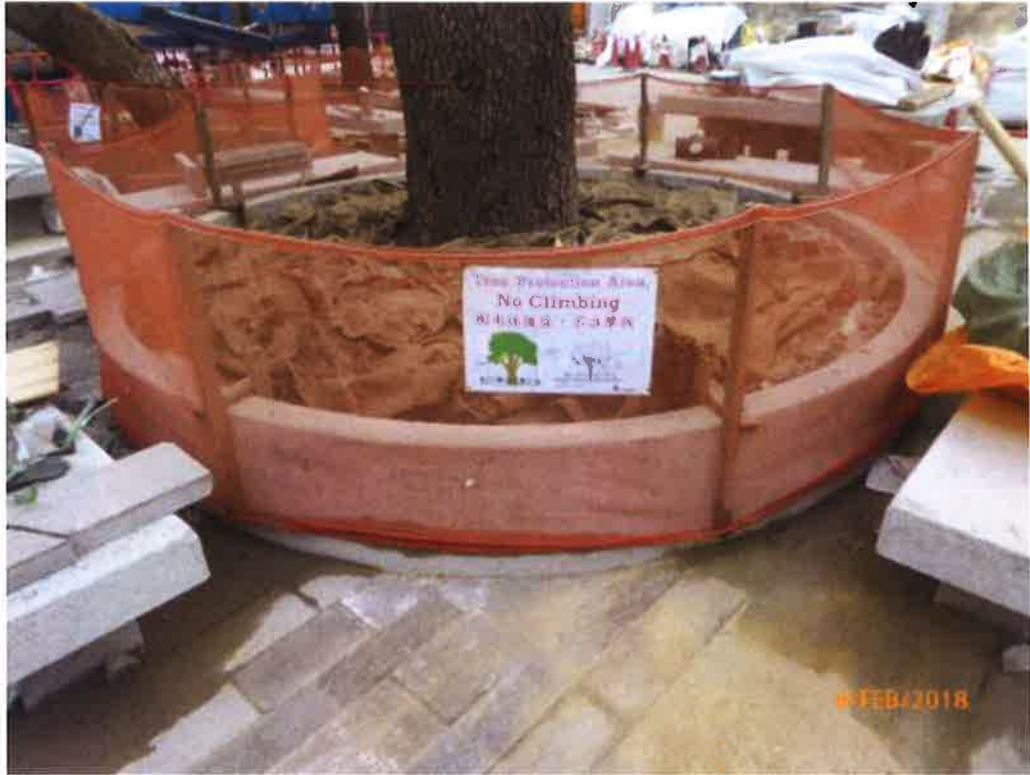
Fig. 11 Renovation works are in progress near the tree.

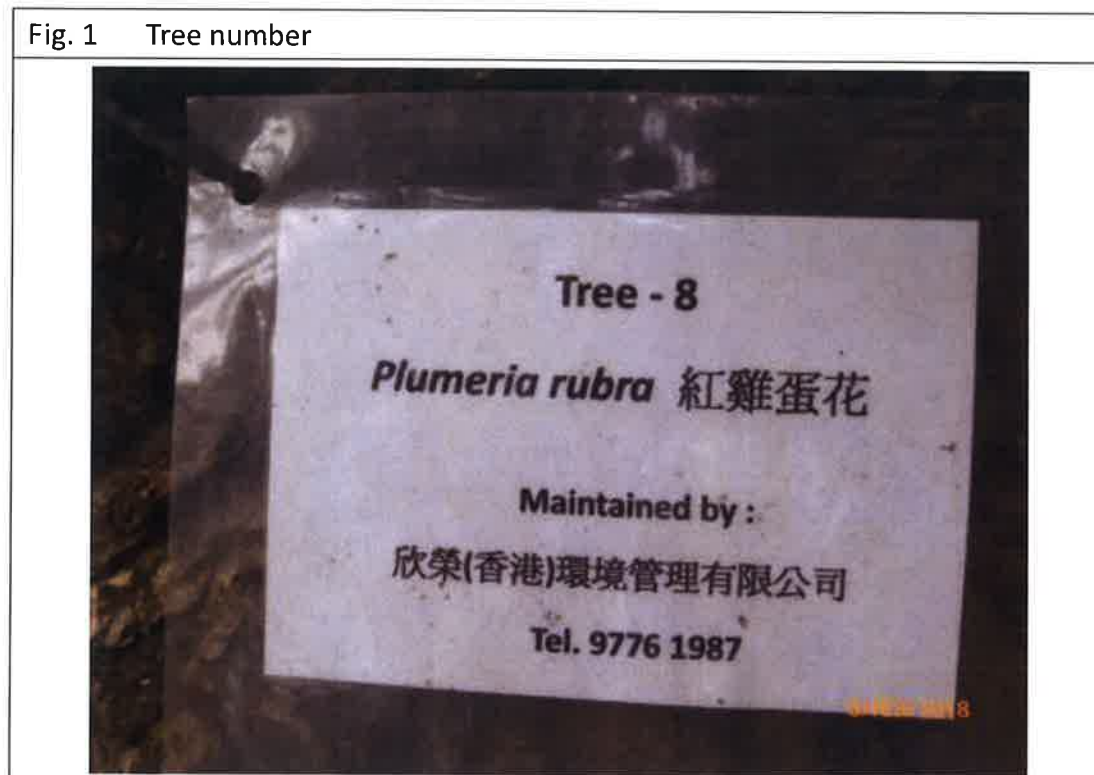
Fig. 2 Root collar is normal. The planter is covered with mulch and dry leaves.

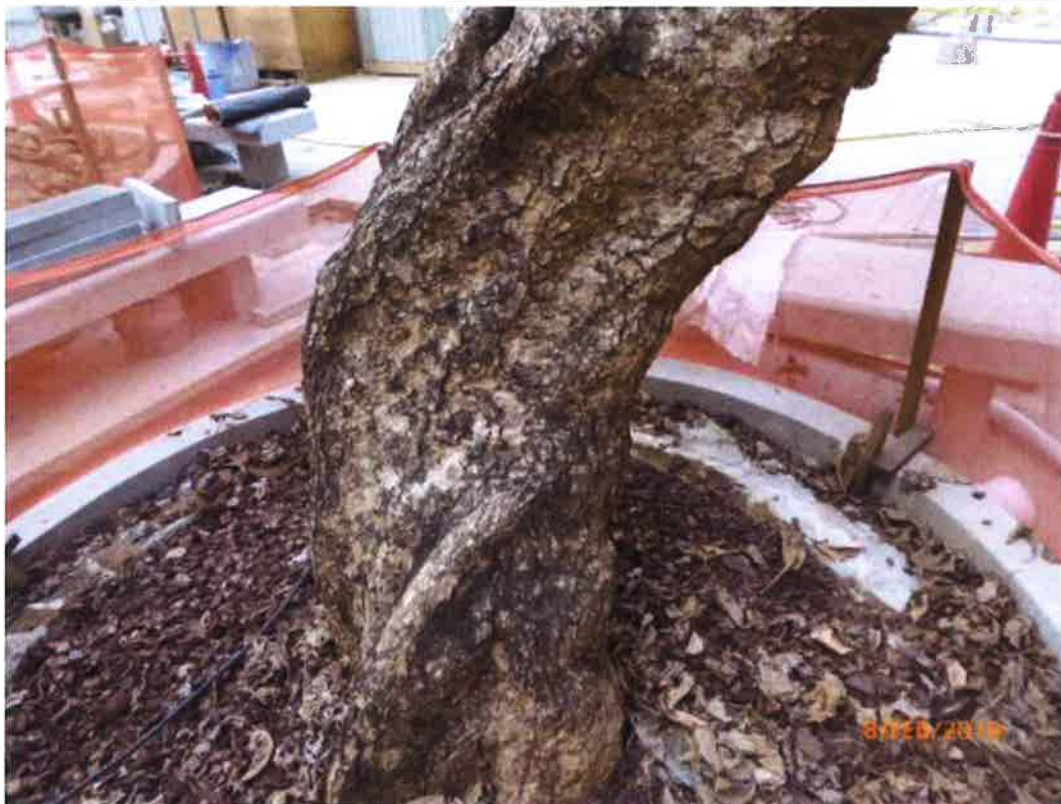
Fig. 4 Health condition of the mid trunk is fair.

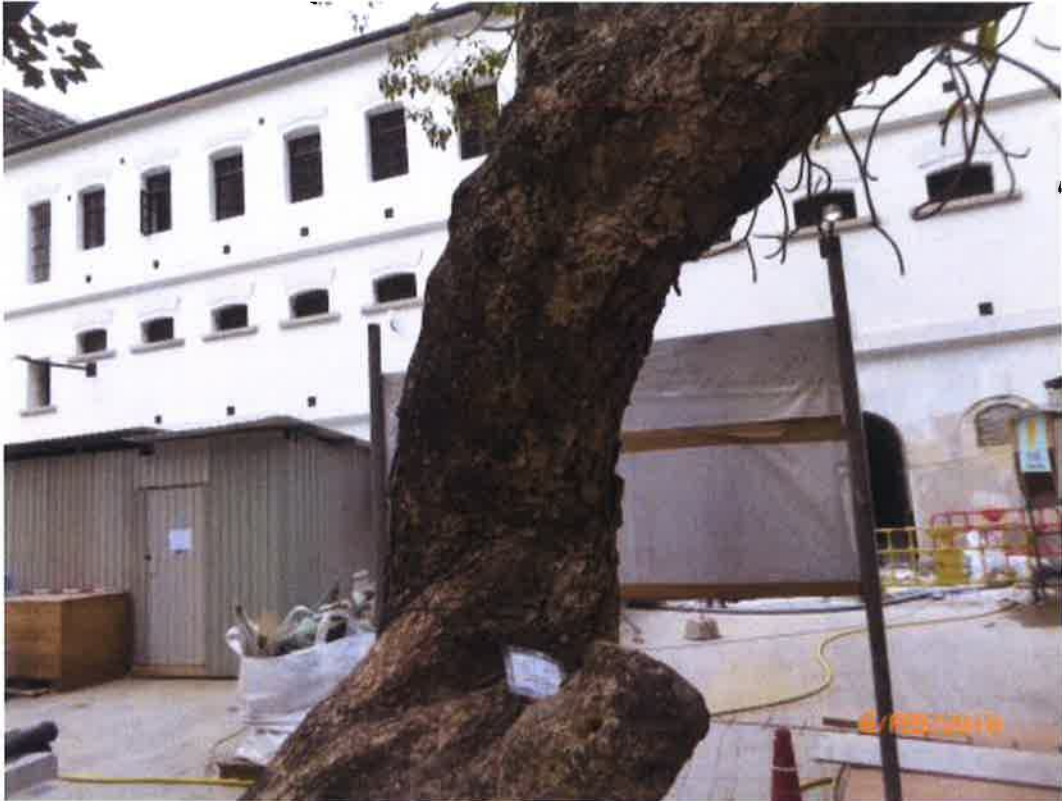
Fig. 5 Health condition of the upper trunk also is fair.

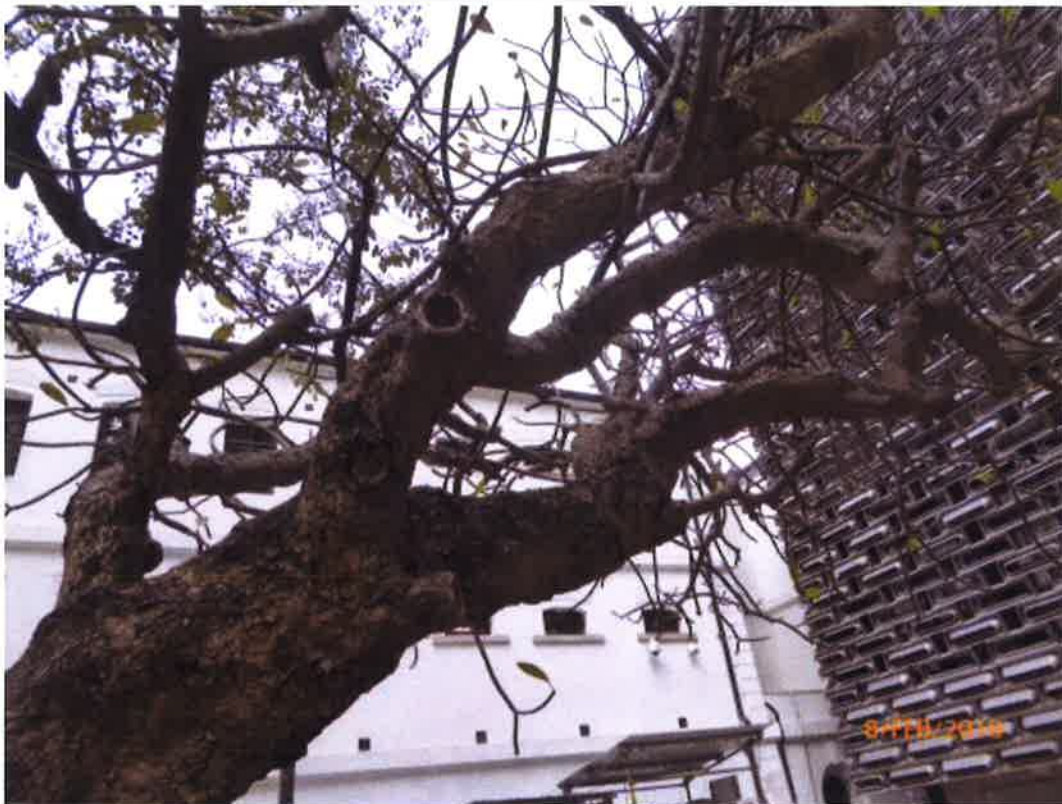
Fig. 6 As dry season has come, leaves are sparse on the tree.

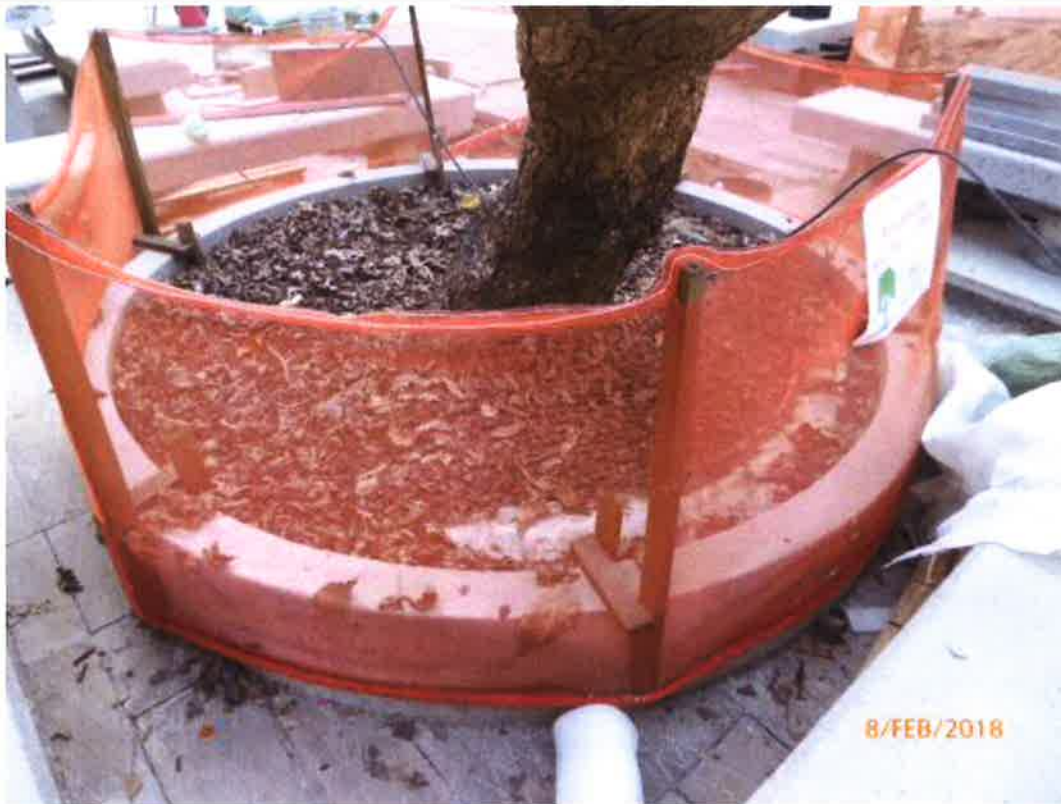
Fig. 10 Renovation works are in progress near Tree-8.

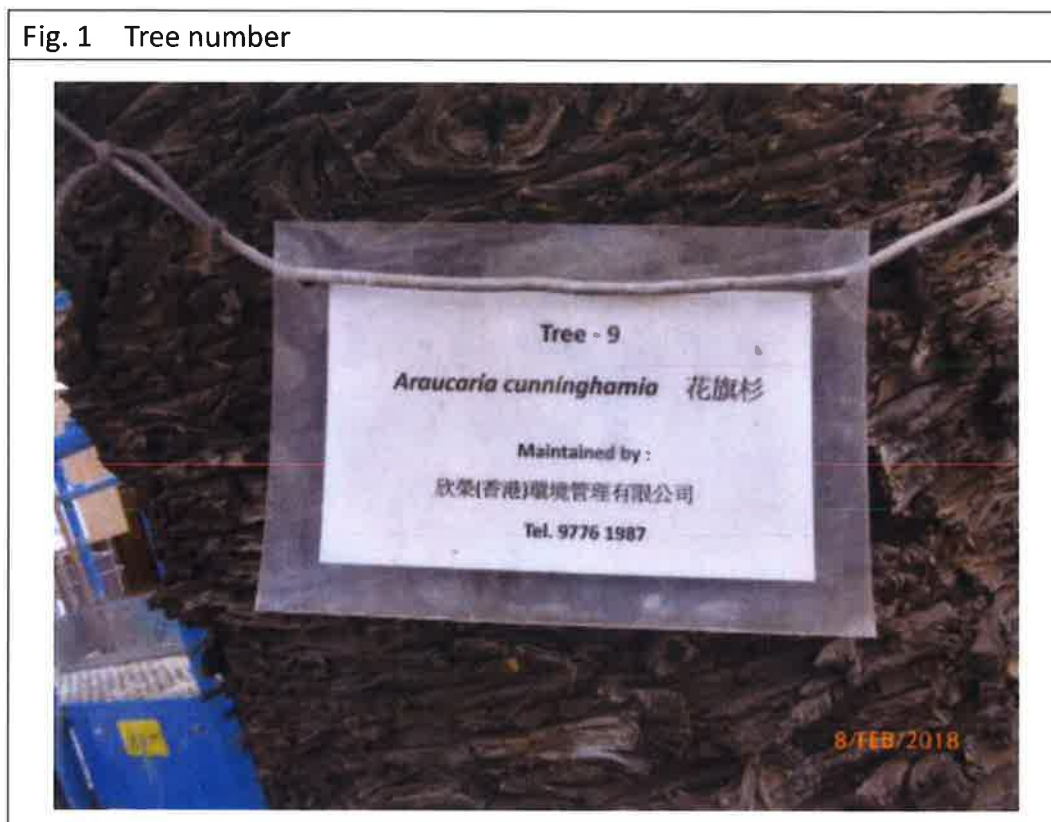
Fig. 2 Root collar is normal. The planter is covered with mulch and dry leaves.
