Central Police Station Conservation
and Revitalisation Project:
76th Monthly EM&A Report
(1 February to 28 February 2018)

Issue Date: March 2018

Environmental Resources Management

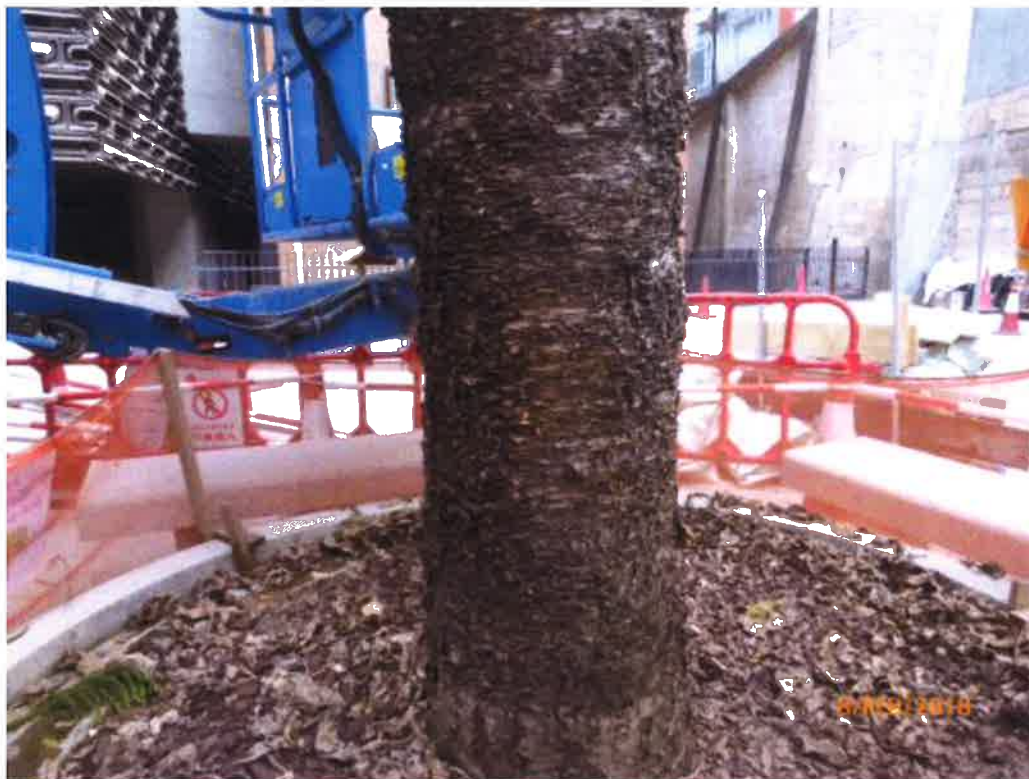
Fig. 4 Health condition of the mid trunk is fair.

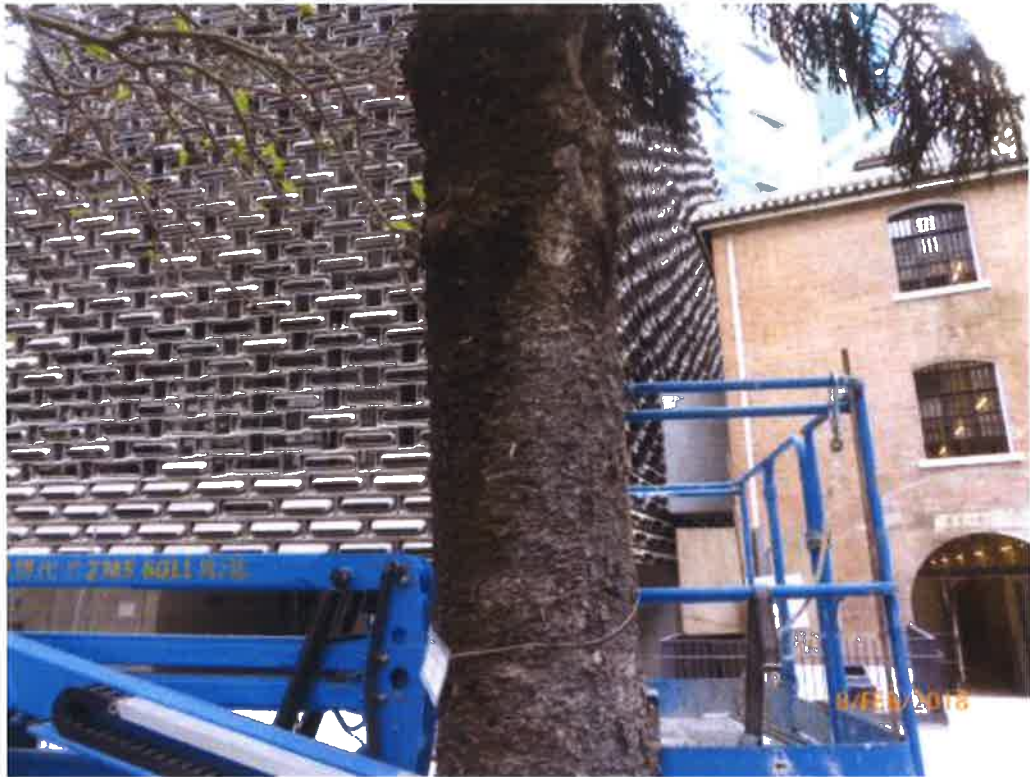
Fig. 5 Health condition of the upper trunk also is fair.

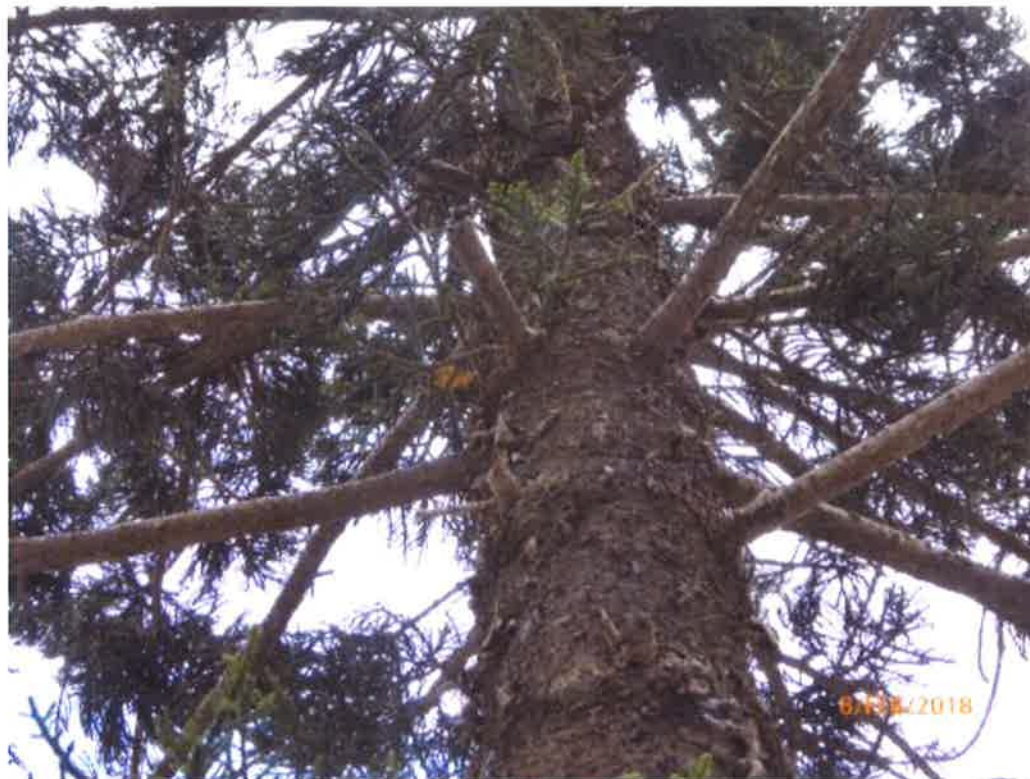
Fig. 6 The crown is full of vigorous and green leaves.

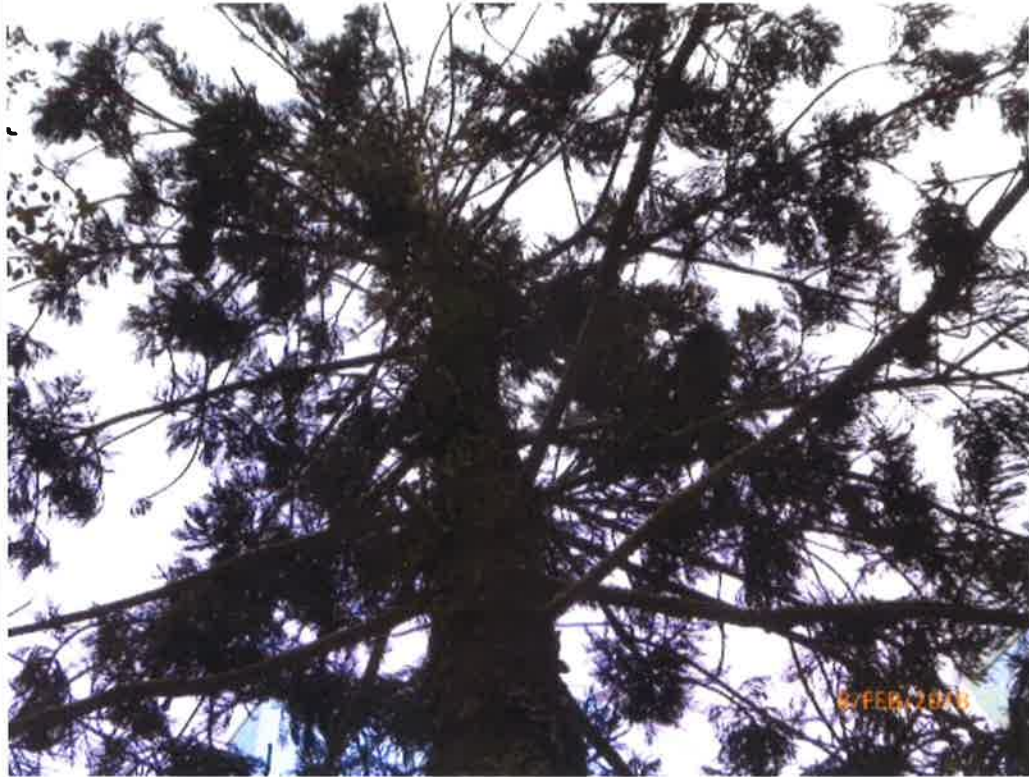
Fig. 7 Vigorous and green leaves also are growing on the lower branches.

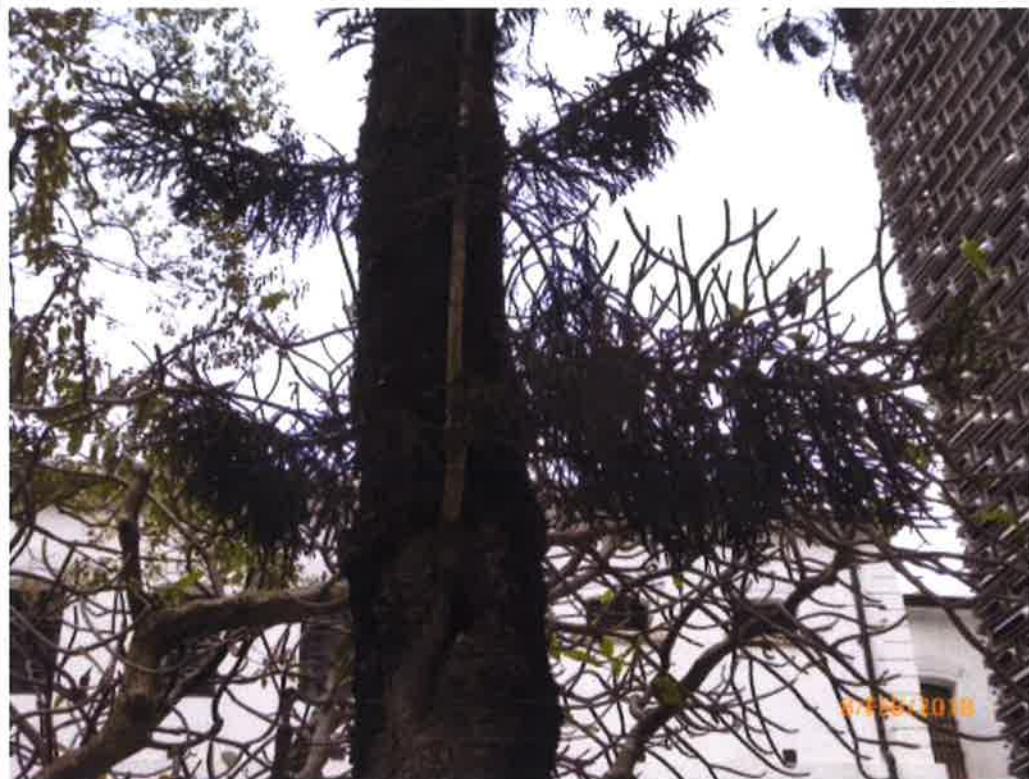
Fig. 8 Some young and green leaves appear on the mid trunk.

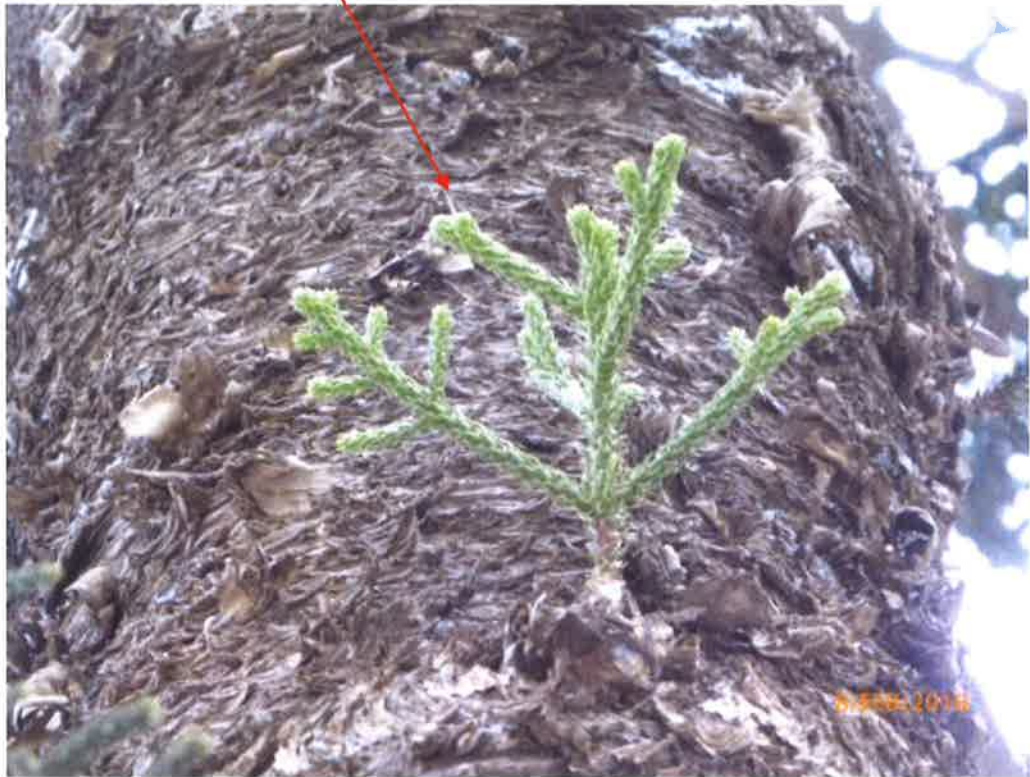
Fig. 9 Some young and green leaves also appear on the upper branches.

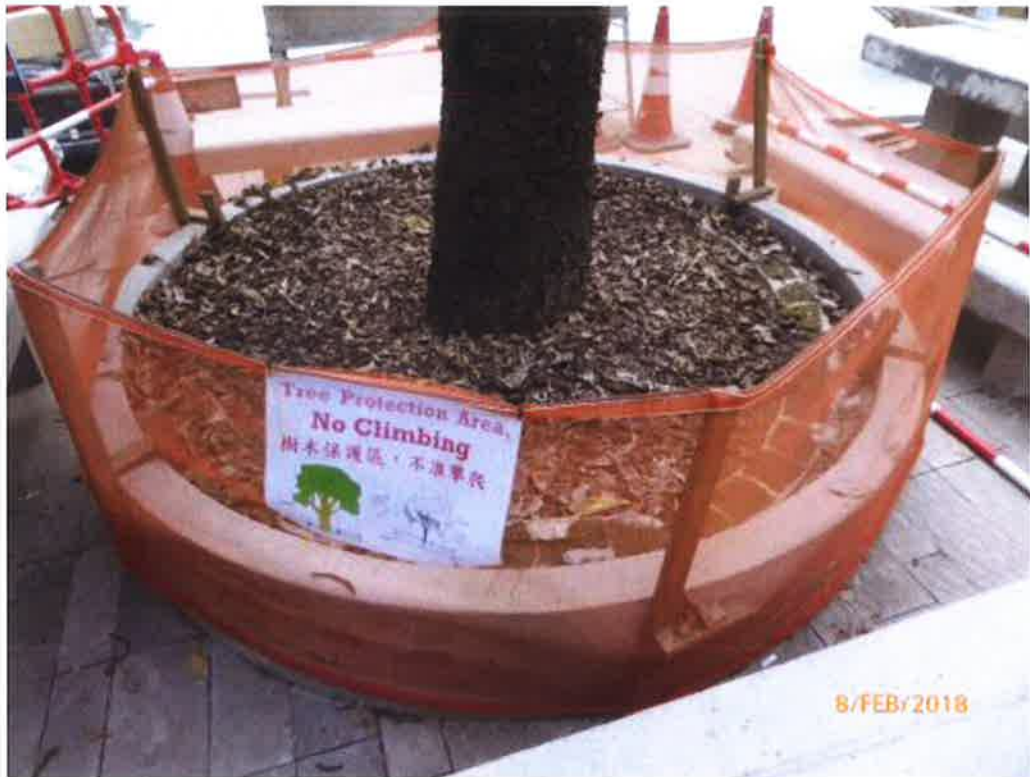
Fig. 11 The site near Tree-9 is clean and tidy.

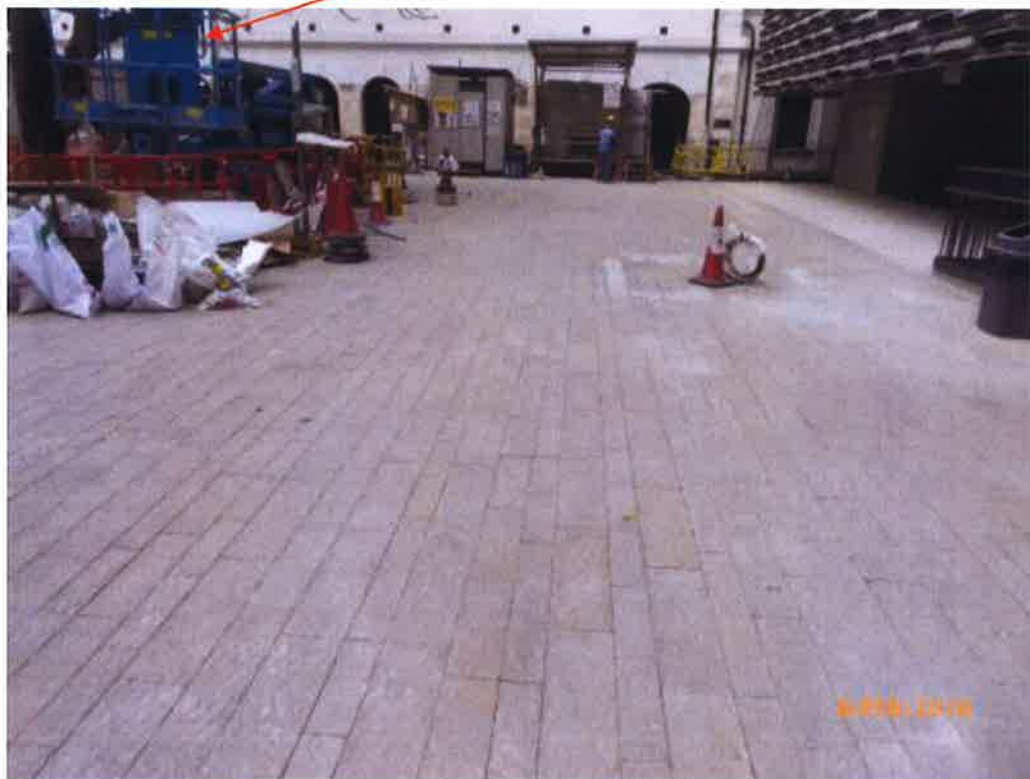
Fig. 12 Overall view of Tree-9 during inspection on 8th February 2018.

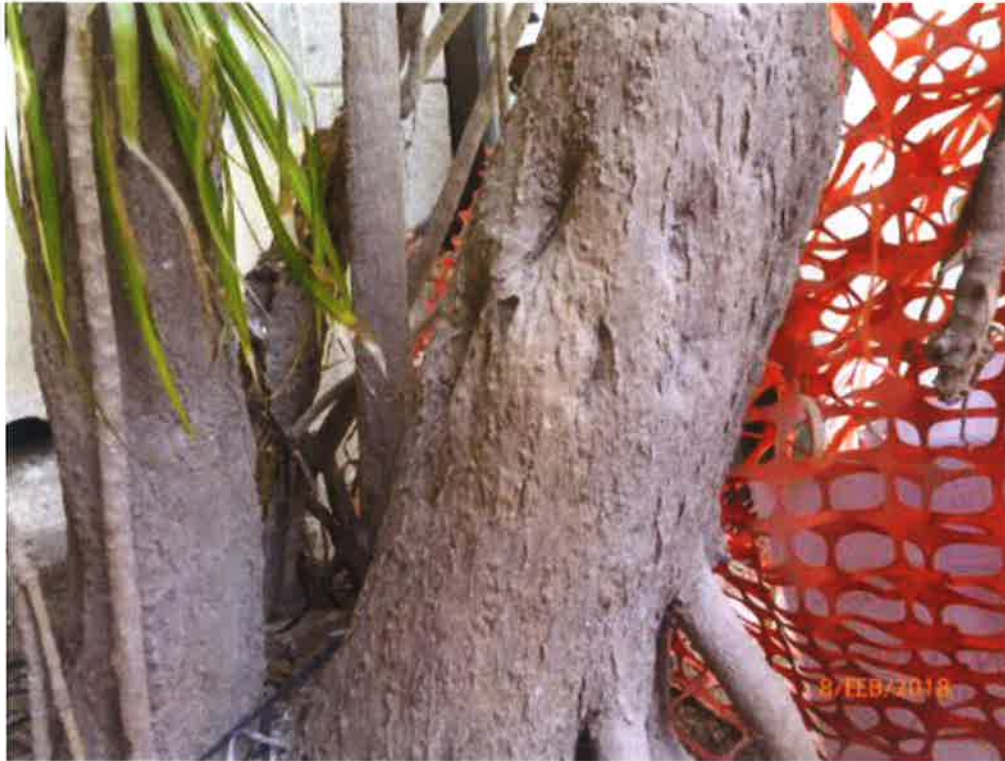
Fig. 5 Health condition of the mid trunk is fair.

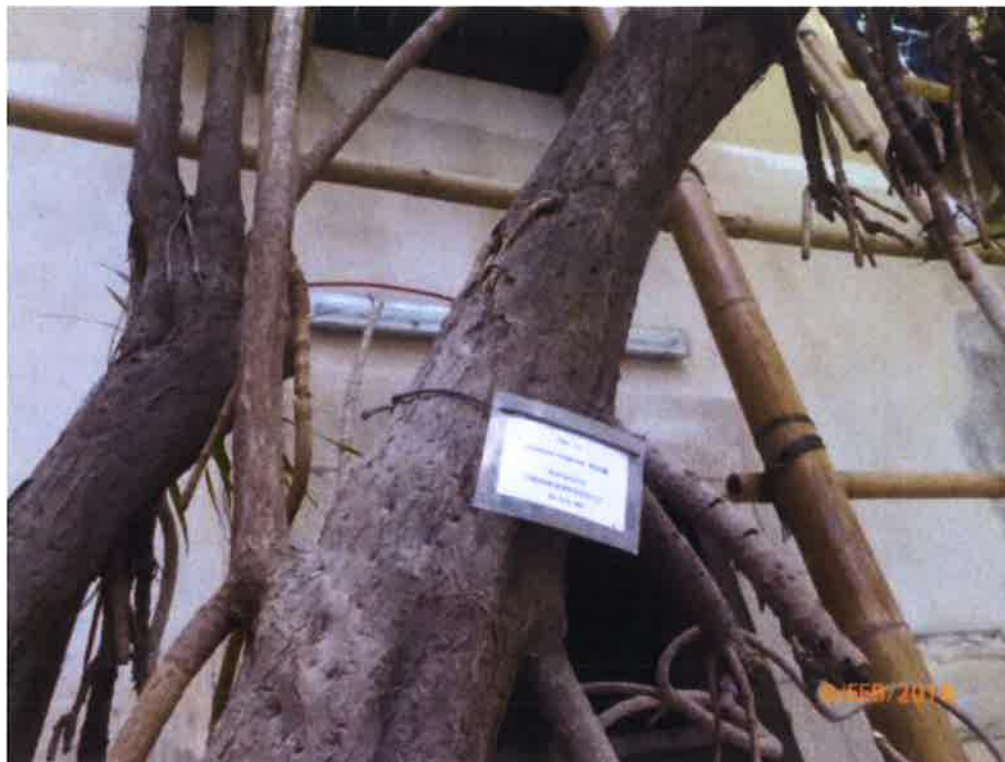
Fig. 6 Health condition of the upper trunk also is fair.

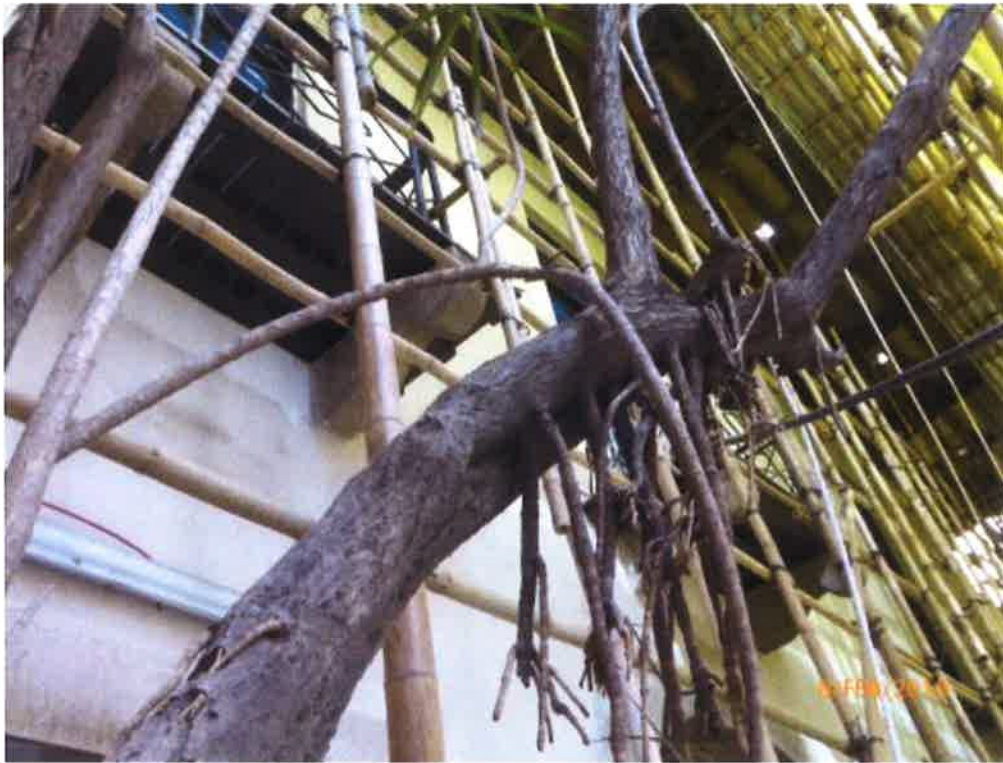
Fig. 7 Withered leaves still appear on the upper branches of Tree-11.

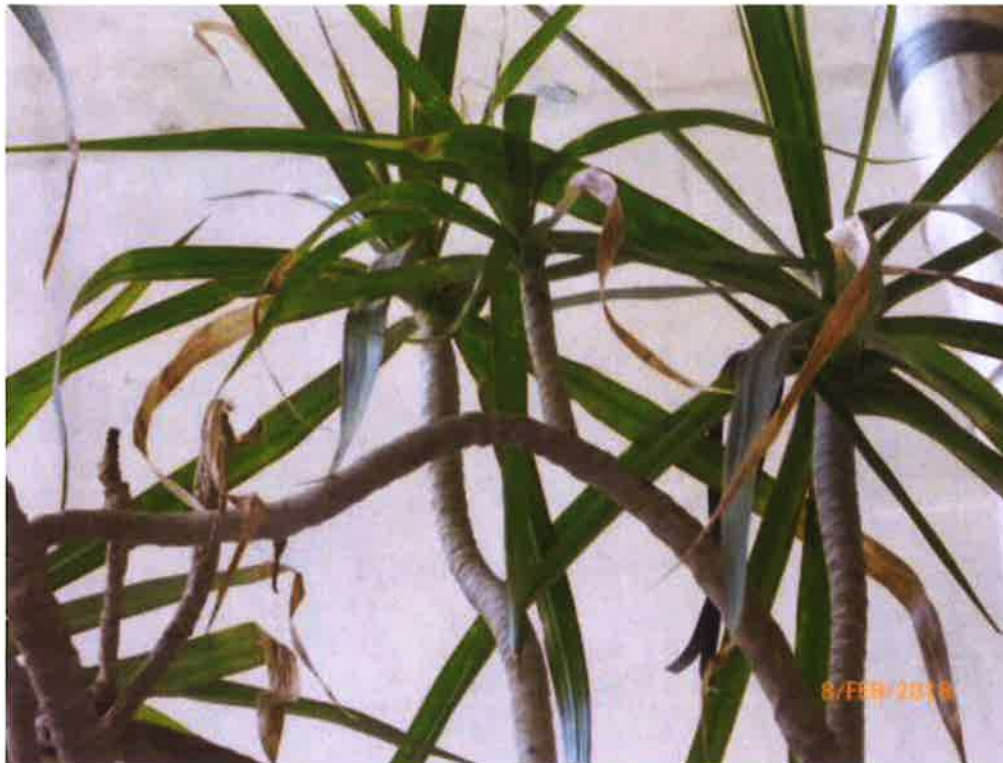
Fig. 8 Withered leaves also appear on the lower branches of Tree-11.

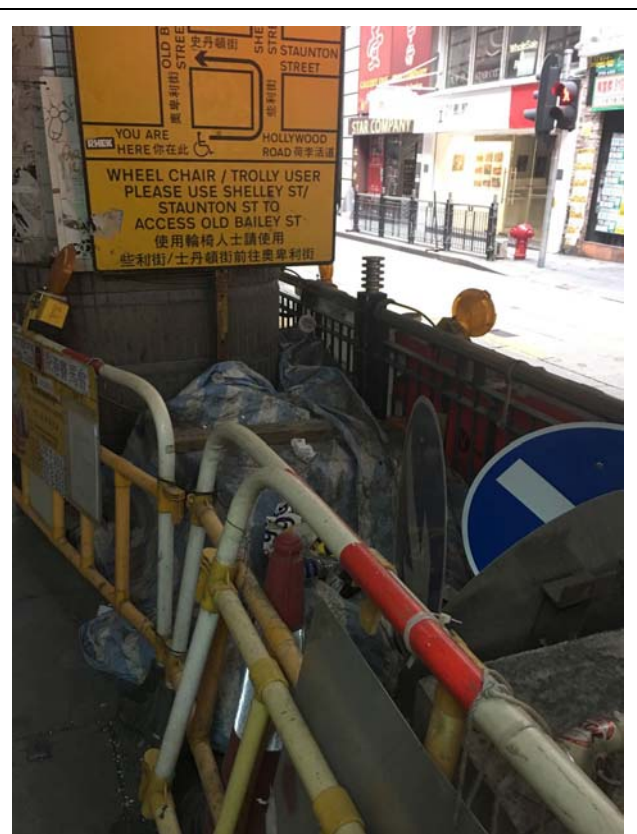
2. A small area at the junction of Old Bailey Street and Hollywood was barricaded for temporary storage of materials for the ongoing footbridge construction. A photo of the temporary storage area is shown in *Photo 2* and its location is shown in *Figure 1*. No construction waste is placed in the temporary storage area. The temporary storage area, which is included in the approved works area for the footbridge construction, only occupies part of the sidewalk of Hollywood Road and is considered not causing significant obstruction to the pedestrians. The temporary storage area would be in place until June 2018 which is the expected completion month of the footbridge construction.

Photo 2: Temporary Storage Area (CPS Site)

All construction works are carried out strictly following the necessary requirements specified in EIA, EM&A Manual, EMP, Method Statements, General and Particular Specifications of this Project. The Contractor has been reminded to maintain tidiness of the construction waste skip and its surroundings. Construction waste should only be stored inside the waste skip and should be cleared on a daily basis to prevent accumulation. With regard to the temporary storage area at the junction of Old Bailey Street and Hollywood Road, the Contractor was also reminded to keep the temporary storage area tidy and clear of litter.
