The Jockey Club CPS Limited

Central Police Station Conservation
and Revitalisation Project:
First Monthly EM&A Report
(From 24 October 2011 to 30
November 2011)

Environmental Resources Management

Reference 0095646

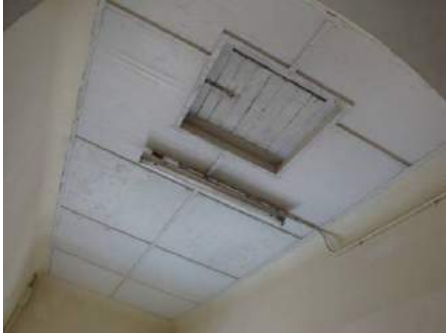
Element no.	Description	Photo ref	Significance
01.001	Flat plywood ceiling lining with plain rectangular cover battens

Adverse
01.002	Plaster coving at abutments of walls and ceilings

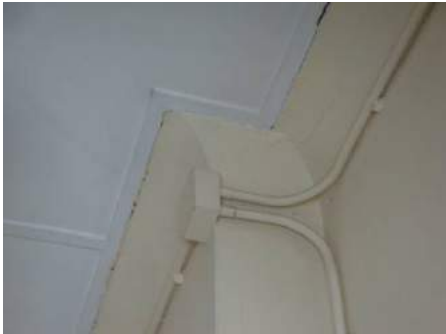
Low
01.003	Lay-in grid suspended ceiling

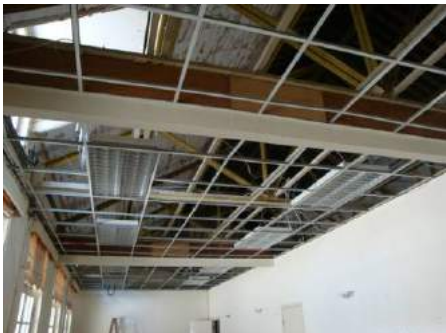
Adverse
01.004	Timber thresholds at external doors and internal doors between main corridor and individual rooms

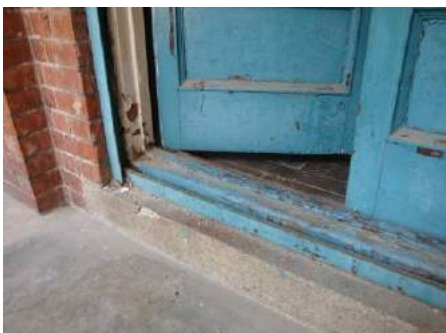
Low

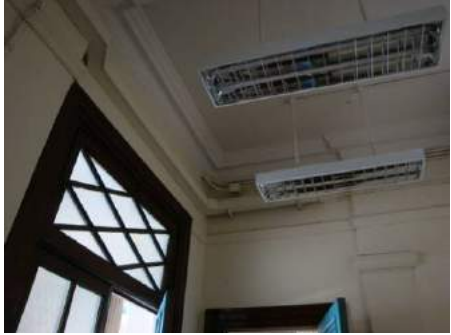
Element no.	Description	Photo ref	Significance
01.005	Plaster box cornice

Moderate
01.006	Panelled doors

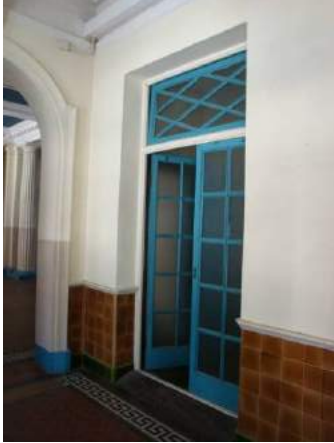
Moderate
01.007	External shutters

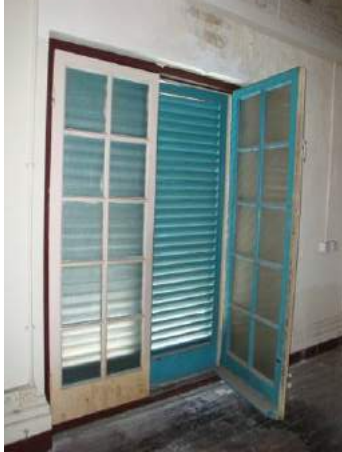
High

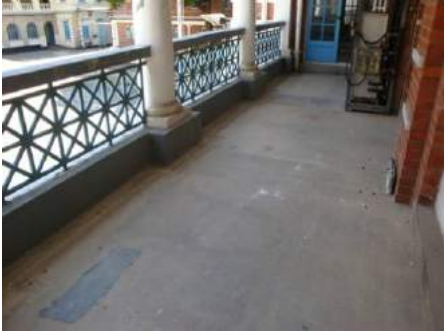
Element no.	Description	Photo ref	Significance
01.008	External terraces at 1/F

High
01.009	Plaster ceilings on GF and LG1

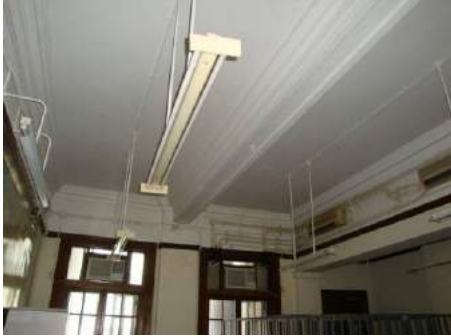
Moderate
01.010	Timber door frames and architraves

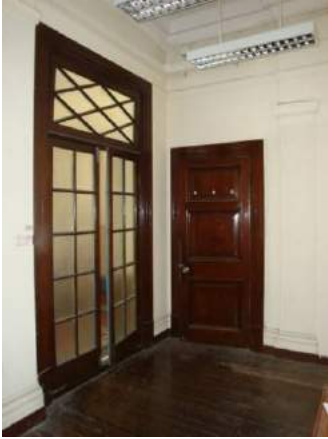
Moderate

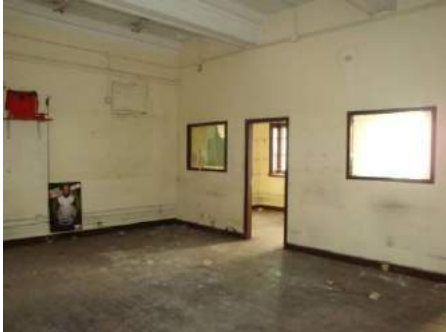
Element no.	Description	Photo ref	Significance
01.011	Concrete floor

Low
01.012	Rainwater goods	 	Adverse
01.013	Exterior decorations	 	Adverse

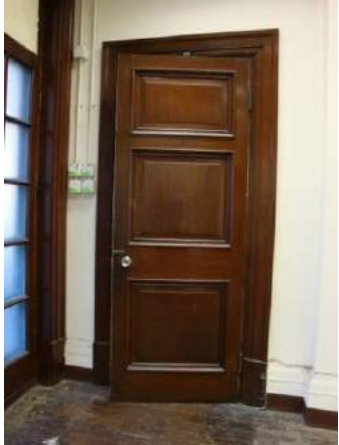
Element no.	Description	Photo ref	Significance
01.014	Existing door openings

Moderate
01.015	Existing walls

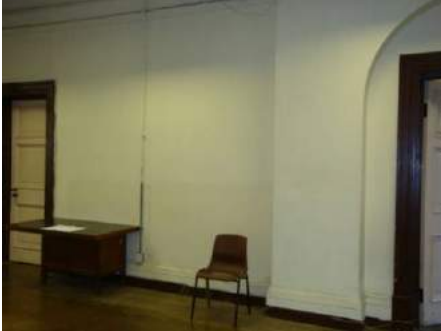
Moderate
01.016	Altered doors and windows

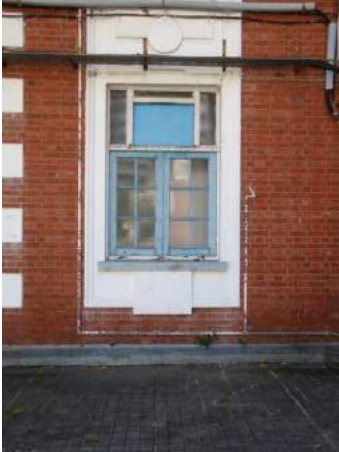
Adverse

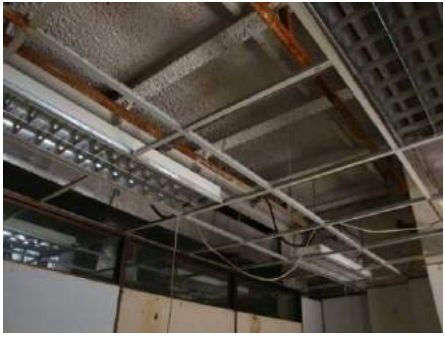
Element no.	Description	Photo ref	Significance
01.017	Mezzanine floor in room 01/LG1/13

Adverse
01.018	Cast iron grilles above Service Corridor 01/LG1/35

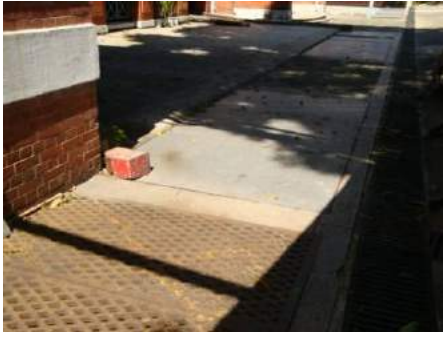
High
01.019	Perforated concrete deck above lightwell

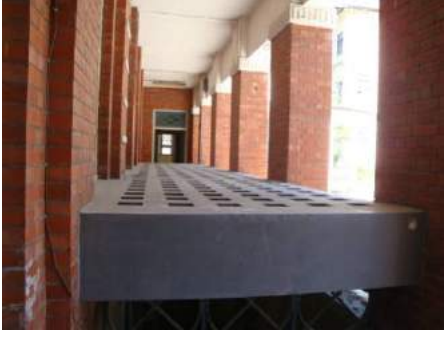
Adverse

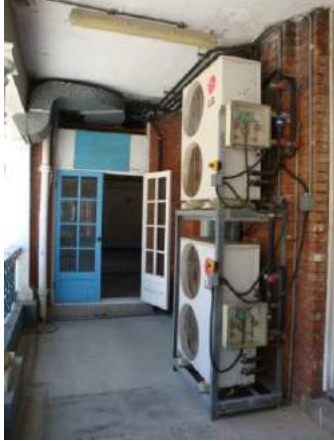
Element no.	Description	Photo ref	Significance
01.020	External airconditioning units and other external services

Adverse
01.021	Stair balustrades

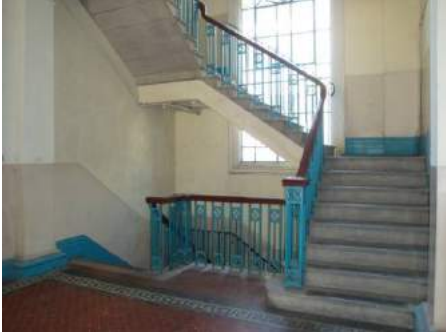
High
01.022	Main corridors

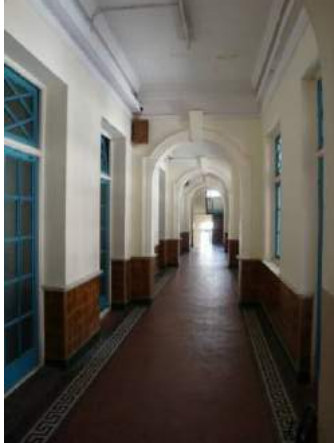
High

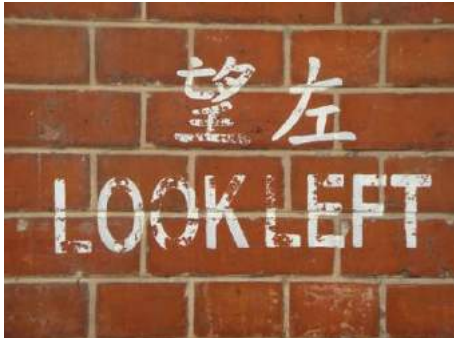
Element no.	Description	Photo ref	Significance
01.023	Painted signs

High
01.024	Fixed signs

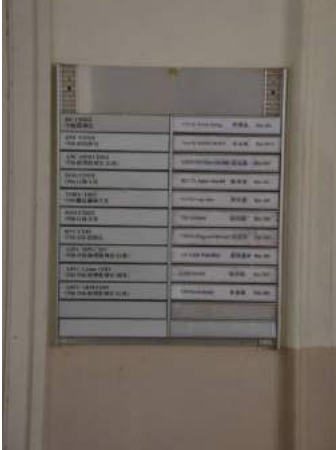
Low-High
01.025	Pitched roofs

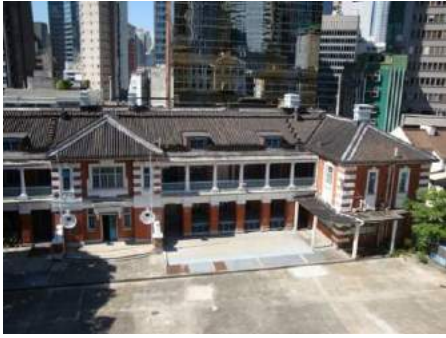
High

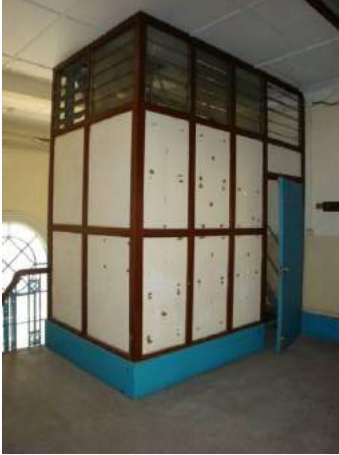
Element no.	Description	Photo ref	Significance
01.026	Enclosure at First Floor landing of main stair

Adverse
01.027	Steel railing enclosure at FF level

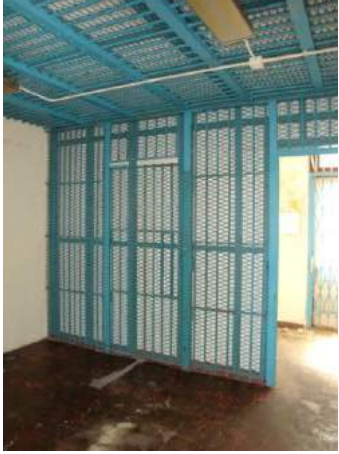
Low

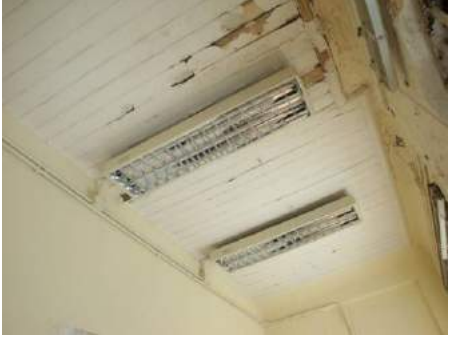
Element no.	Description	Photo ref	Significance
01.028	Tongued and grooved timber boarded ceilings in East and West wings

Moderate
01.029	Modern partitions

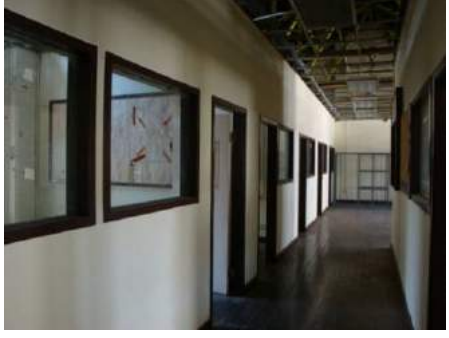
Adverse
01.030	Tiled dado

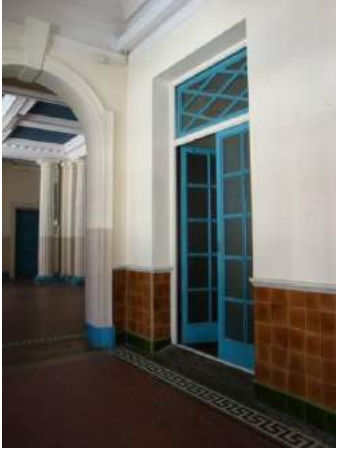
High

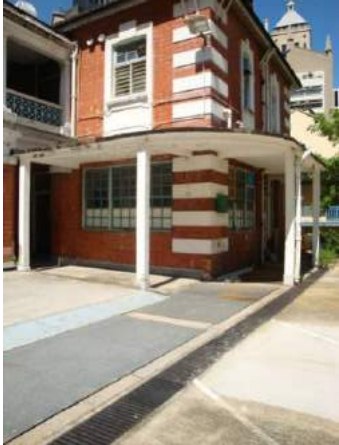
Element no.	Description	Photo ref	Significance
01.031	Reinforced concrete canopy and sash windows

Moderate

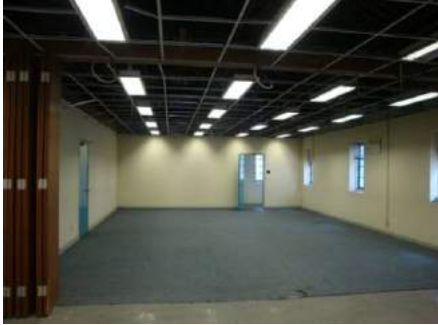
Element no.	Description	Photo ref.	Significance
02.001	Lay-in grid suspended ceiling

Adverse
02.002	Modern internal doors	 	Adverse
02.003	Modern partitions

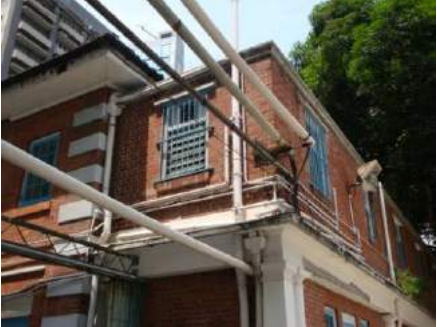
Element no.	Description	Photo ref.	Significance
02.004	External airconditioning units and other external services

Adverse
02.005	Brickwork walls enclosing rooms at GF and FF East side

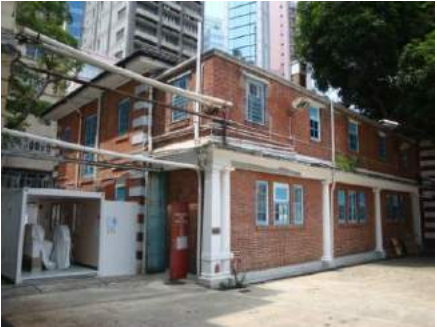
Low
02.006	Concrete floors

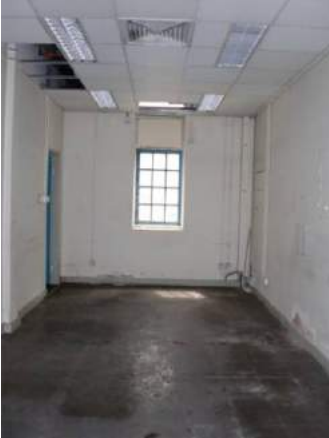
Low

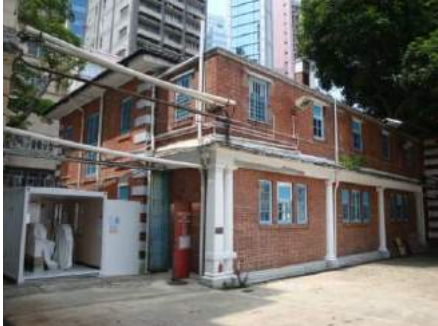
Element no.	Description	Photo ref.	Significance
02.007	Rainwater goods

A photograph showing the exterior of a brick building. Several white rainwater pipes run vertically and horizontally across the facade. A red fire hydrant is visible on the ground in front of the building. The building has multiple windows and a small entrance area.	Adverse
02.008	Altered doors and windows

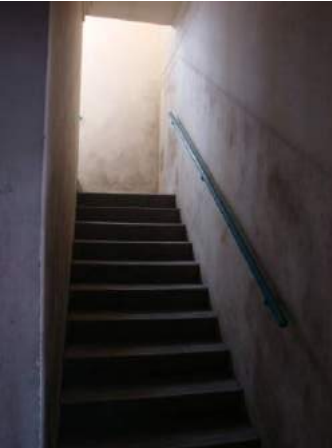
A close-up photograph of a brick wall. A window opening is visible, which has been altered with a bright blue frame. The original window structure appears to be missing or replaced. The brickwork is reddish-brown.	Adverse
02.009	Concrete stairs

A photograph of an interior concrete staircase. The stairs are made of grey concrete and lead upwards. A green handrail is mounted on the right side of the wall. The walls are also made of concrete.	Adverse

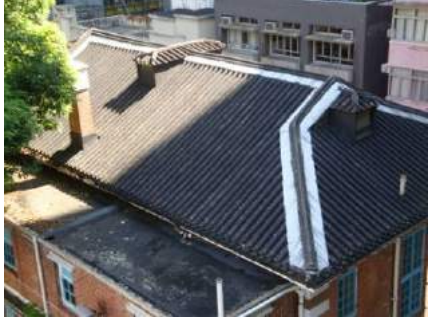
Element no.	Description	Photo ref.	Significance
02.010	Pitched roofs

High
02.011	Roof structure and tiled soffit

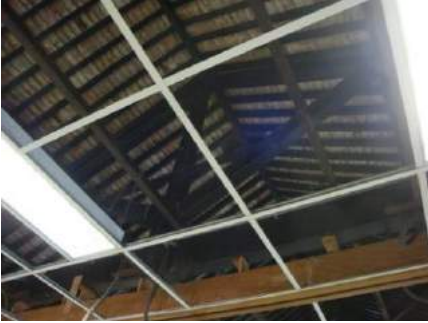
High

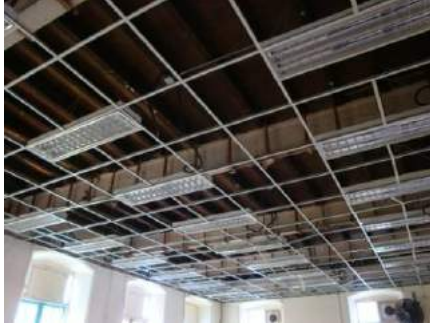
Element no.	Description	Photo ref.	Significance
03.001	Lay-in grid suspended ceiling

Adverse
3.002	Panelled doors

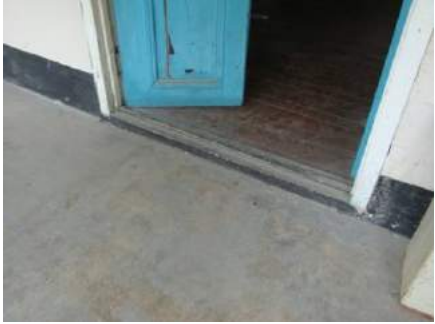
Element no.	Description	Photo ref.	Significance
03.004	Timber thresholds at external doors and internal doors between main corridor and individual rooms

Low
03.005	Timber spandrel panels below windows

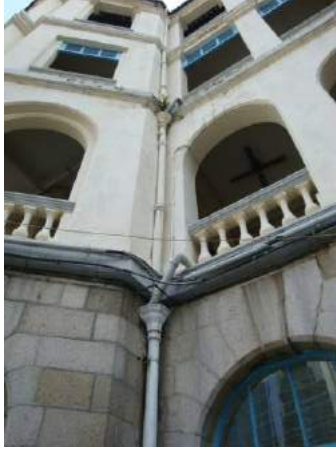
Element no.	Description	Photo ref.	Significance
03.007	Rainwater goods

Adverse
03.008	Exterior decorations

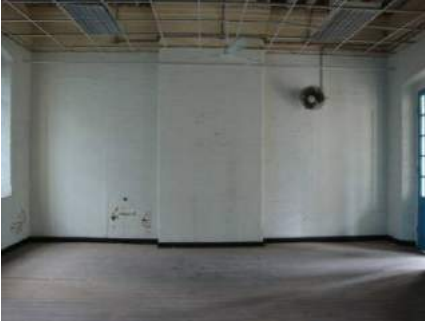
Element no.	Description	Photo ref.	Significance
03.010	Form new door openings

Low
03.011	Altered doors and windows

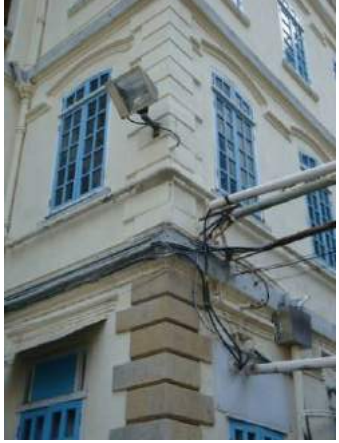
Adverse
03.012	External airconditioning units and other external services

Adverse

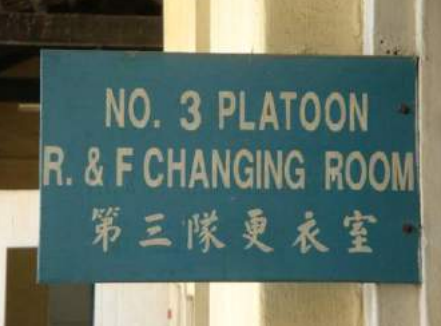
Element no.	Description	Photo ref.	Significance
03.013	Stair balustrades	 	High
03.014	Painted signs	 	High
03.015	Fixed signs

Low-High
03.016	Pitched roofs	 	High

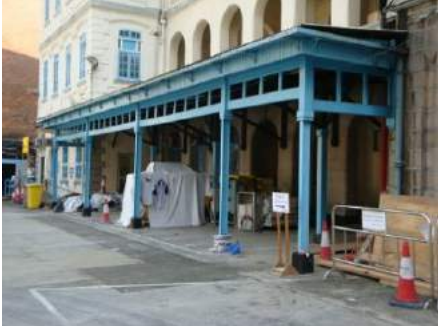
Element no.	Description	Photo ref.	Significance
03.017	Lean-to structure adjacent North wall

Moderate
03.018	Metal-frames windows at GF North elevation

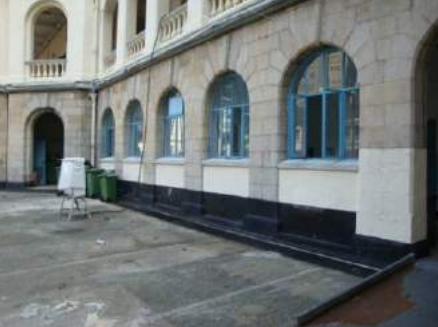
Adverse
03.019	Internal walls at Ground Floor level

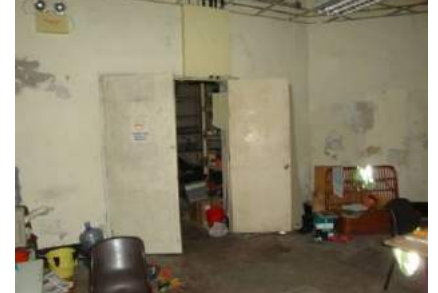
Moderate
03.020	Assembly rooms at centre of building (all floors)

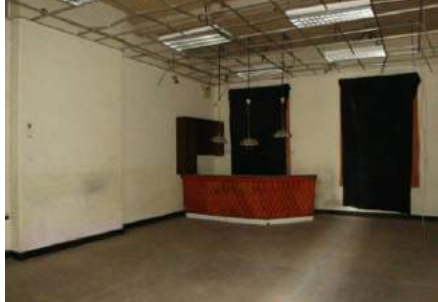
Moderate

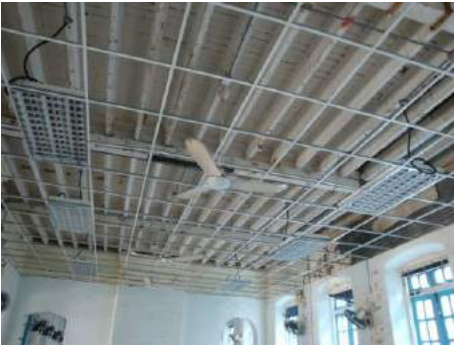
Element no.	Description	Photo ref.	Significance
03.021	Exposed soffits of timber floors

Moderate
03.022	Existing window frames/openings

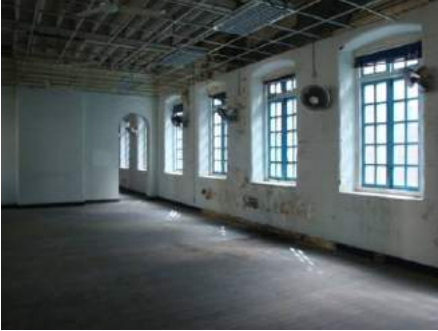
High
03.023	Single storey outbuildings on south side

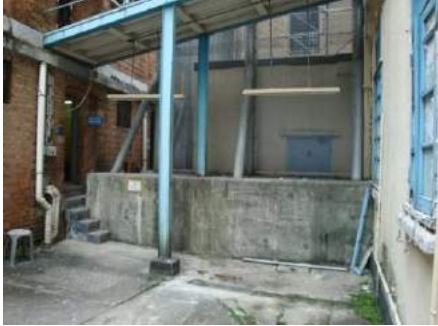
Adverse

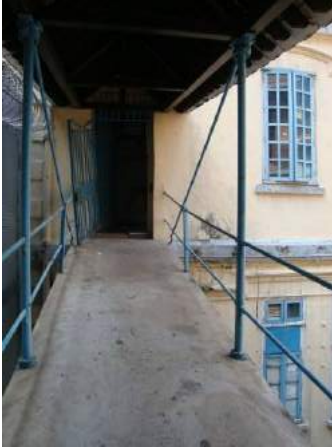
Element no.	Description	Photo ref.	Significance
03.024	Bridge at east end

Moderate
03.025	Chimneypiece on Ground Floor

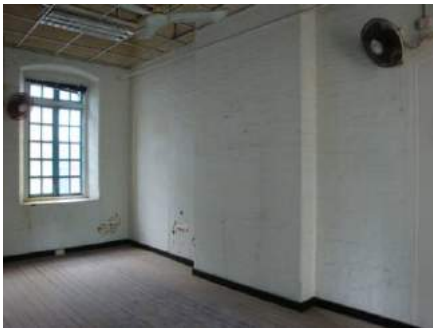
Low
03.026	Window in south wall; original dormitory space

Moderate

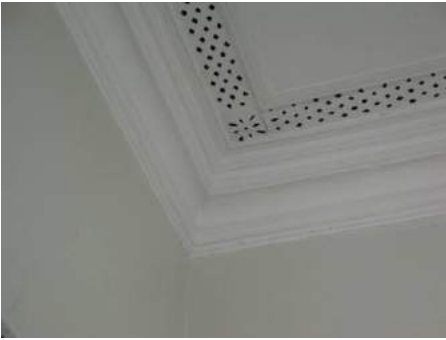
Low
04.003	Plaster box cornice

Moderate

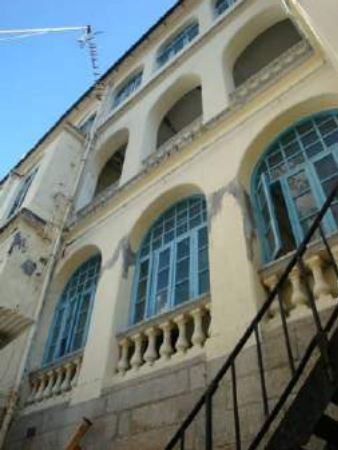
Adverse
04.009	Window frames in arcades of North and East elevations

Adverse

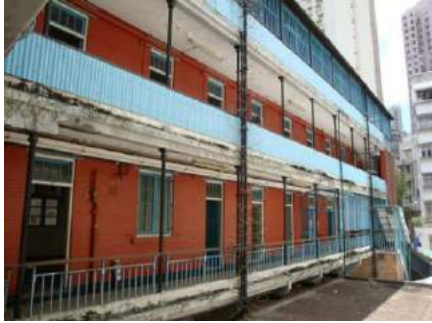
Element no.	Description	Photo ref.	Significance
08.001	Panelled doors

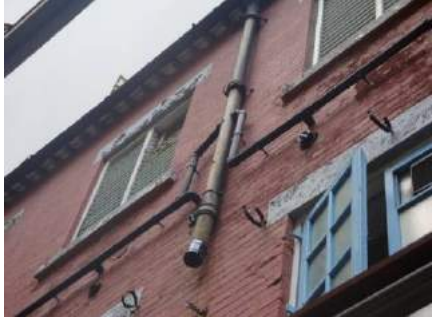
Low
08.002	Rainwater goods

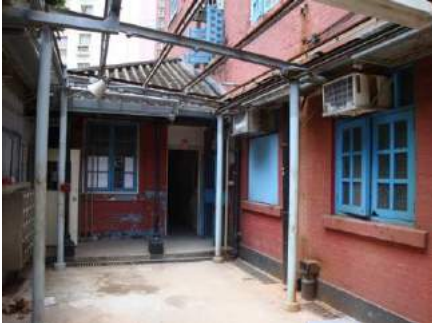
Adverse
08.003	Exterior decorations

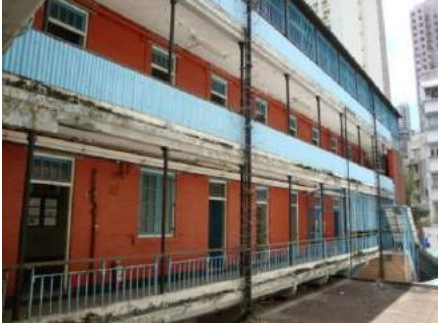
Element no.	Description	Photo ref.	Significance
08.004	Block existing door openings

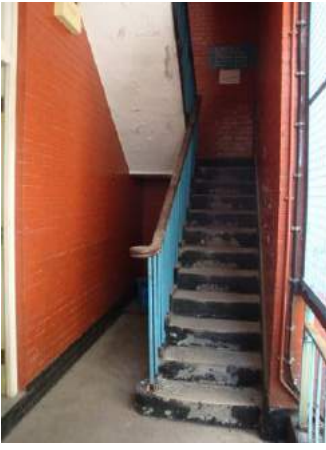
High
08.006	External stair at west end

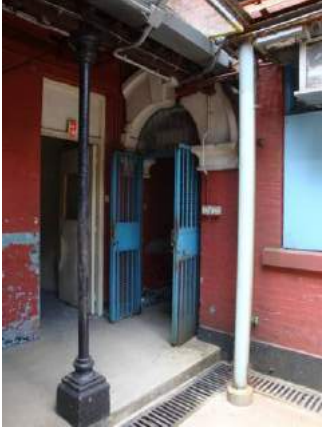
Element no.	Description	Photo ref.	Significance
08.007	External airconditioning units and other external services

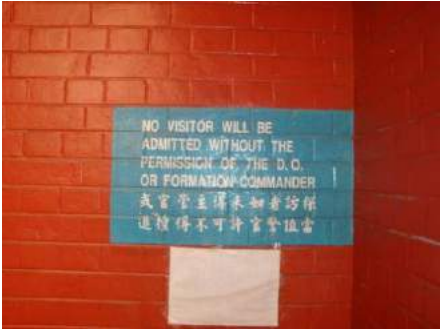
Adverse
08.008	Painted signs

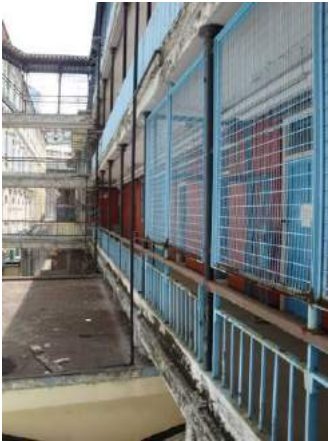
High
08.009	Wire mesh screens

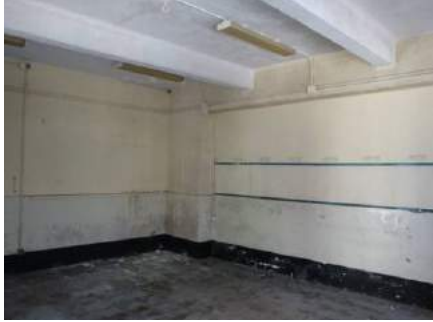
Element no.	Description	Photo ref.	Significance
08.010	Internal walls and concrete floors

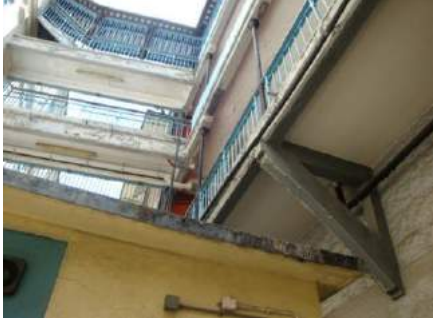
Low
08.011	Cantilever balconies on north side

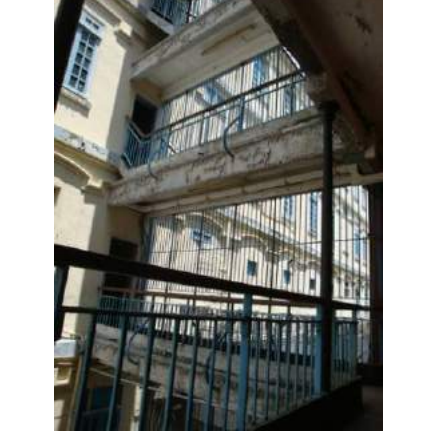
Moderate
08.012	Bridge access to Barrack Block

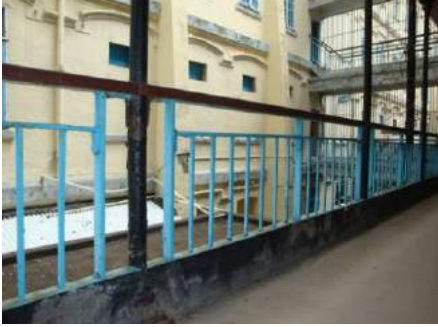
Element no.	Description	Photo ref.	Significance
08.013	Balcony balustrades

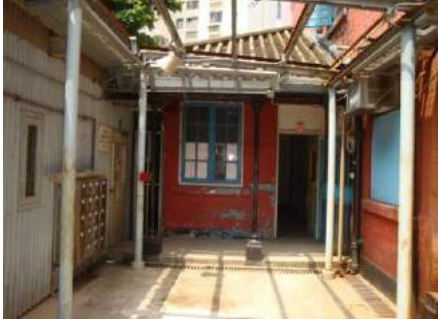
Low
08.014	Single-storey outbuilding with pitched roof over

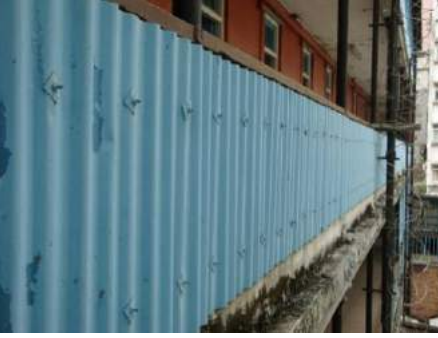
Low
08.015	Corrugated steel sheet on balcony balustrades

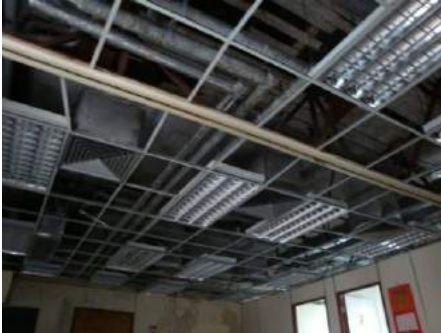
Element no.	Description	Photo ref.	Significance
09.001	Lay-in grid suspended ceiling

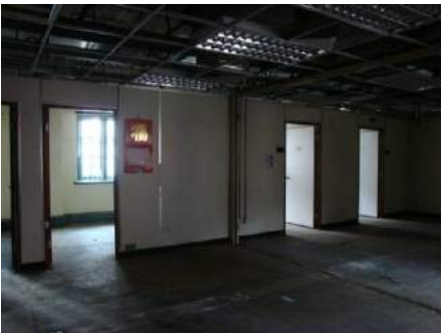
Adverse
09.002	Modern partitions

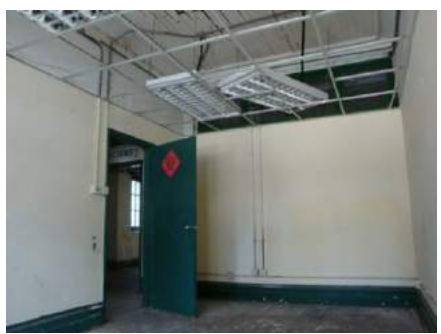
Adverse
09.003	Internal walls

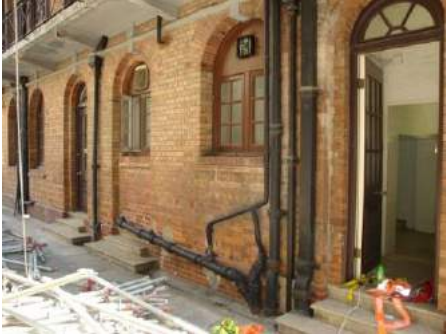
Element no.	Description	Photo ref.	Significance
09.012	Rainwater goods

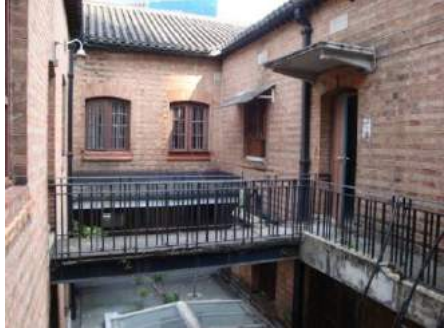
Moderate
09.013	Metal walkways across lightwell

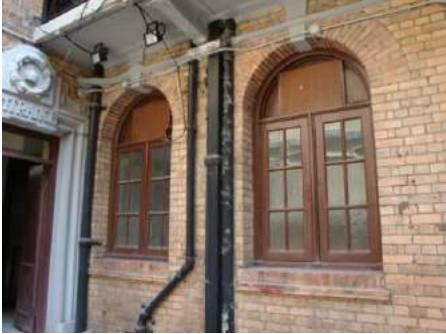
Adverse
09.014	Altered doors and windows

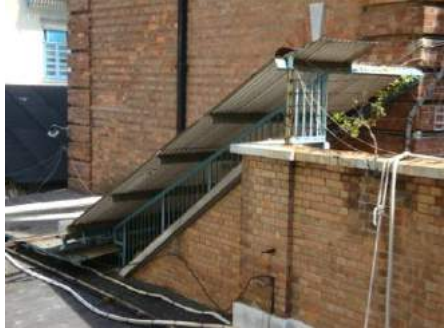
Adverse
09.015	Sloping canopy over external stair on west side

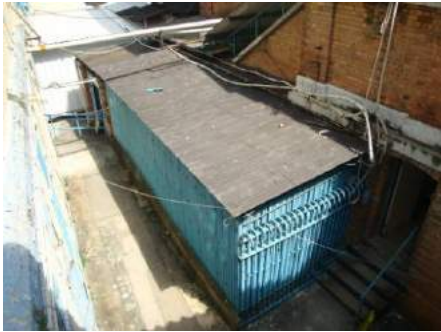
Element no.	Description	Photo ref.	Significance
09.016	Single storey secure shelter at North West corner

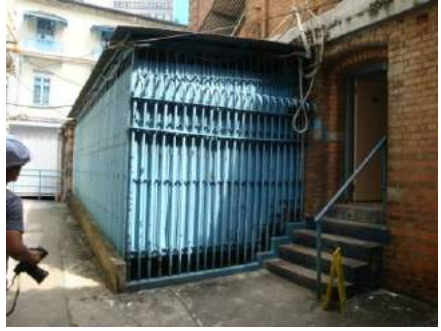
Low
09.017	Iron railing adjacent south side of item 09.016 above

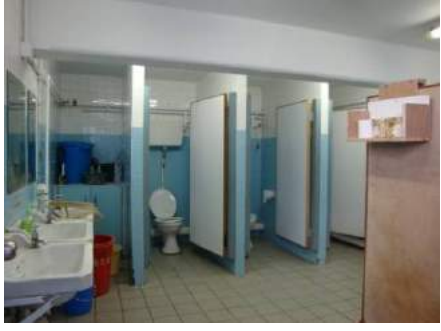
Moderate
09.018	Public toilets in 09/LG1/17, 24

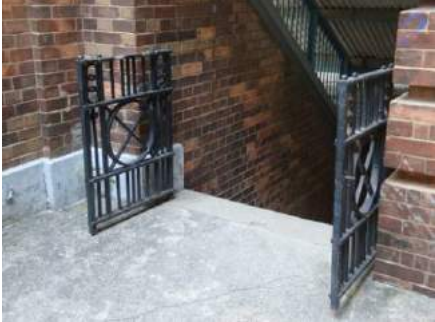
Element no.	Description	Photo ref.	Significance
09.026	Iron gates at top of external stair

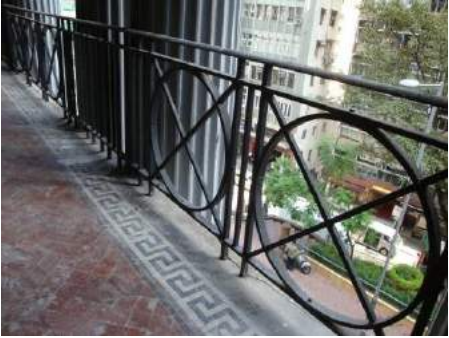
Moderate
09.027	Iron balustrade adjacent terrace at First Floor east side

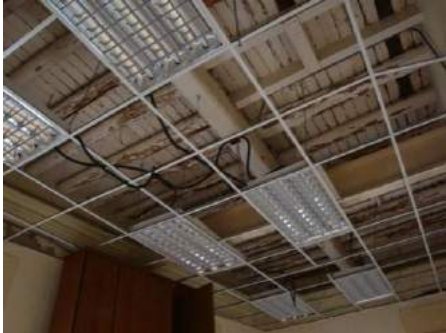
Element no.	Description	Photo ref.	Significance
10.001	Lay-in grid suspended ceiling

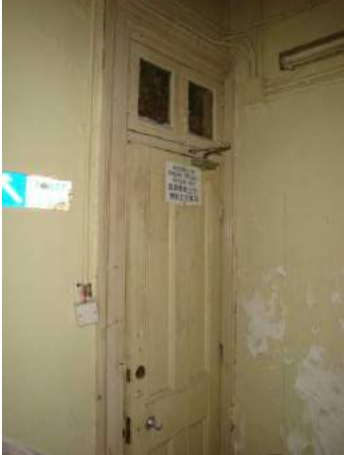
Moderate
10.003	Panelled doors and linings

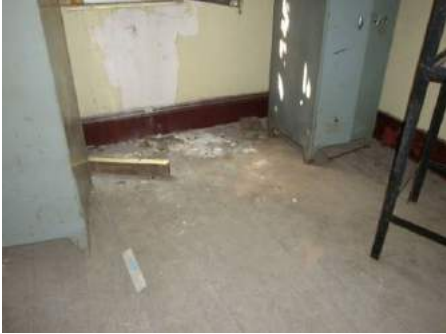
Element no.	Description	Photo ref.	Significance
10.004	Timber boarded floor with moulded skirtings

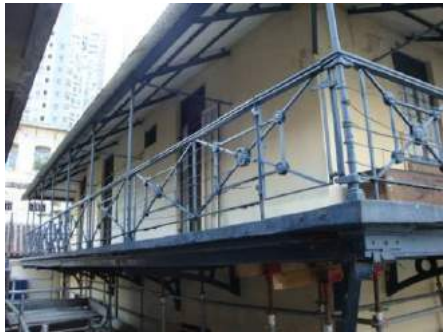
High
10.005	Exterior decorations

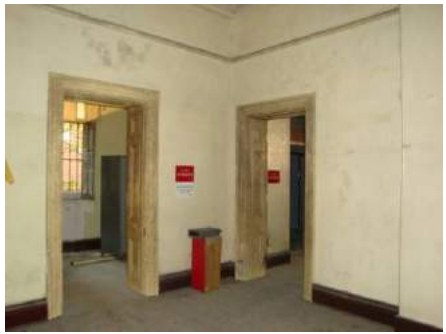
Adverse
10.006	Block existing door openings

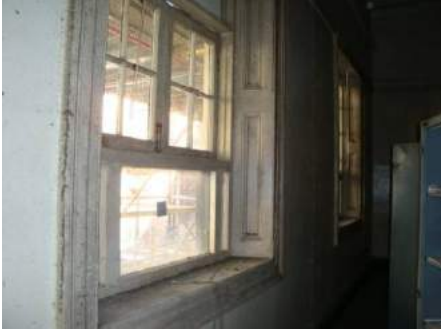
Element no.	Description	Photo ref.	Significance
10.008	Altered doors and windows

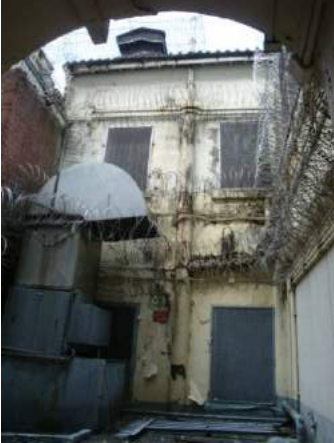
Adverse
10.009	External airconditioning units and other external services

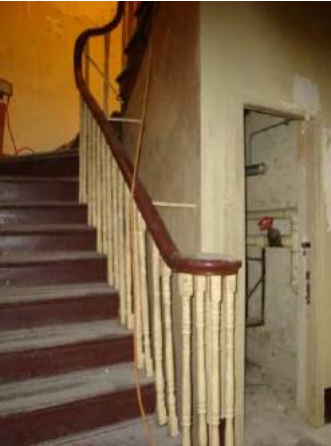
Adverse
10.010	Stair balustrades

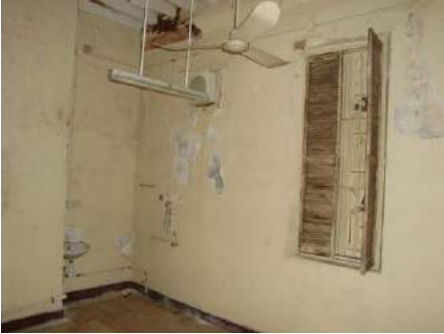
Element no.	Description	Photo ref.	Significance
10.015	Blocked windows on south elevation of south-east wing

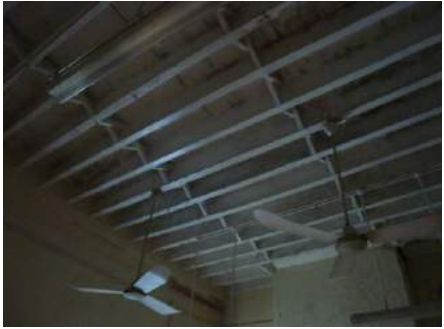
Adverse
10.016	Open-joisted ceiling on Ground Floor of south-east wing

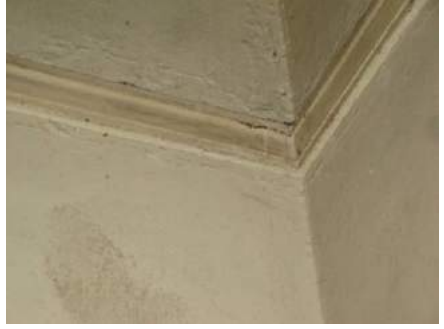
Moderate
10.017	Moulded timber picture rail

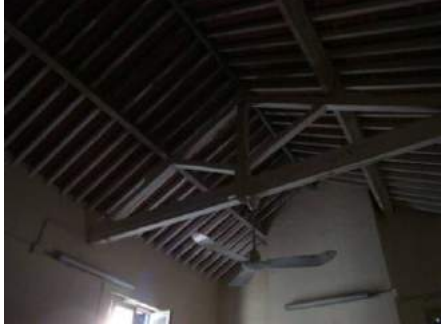
Low
10.018	Timber roof structure above south-east wing

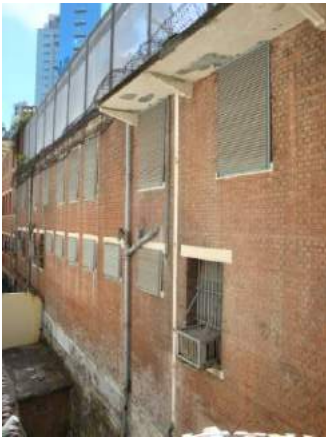
Adverse
11.009	Rainwater goods

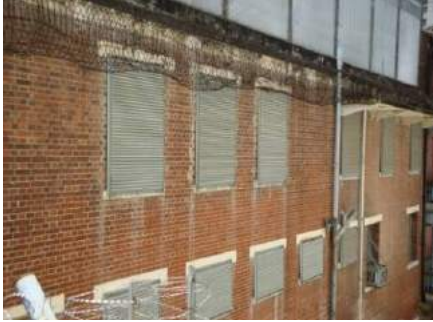
Adverse

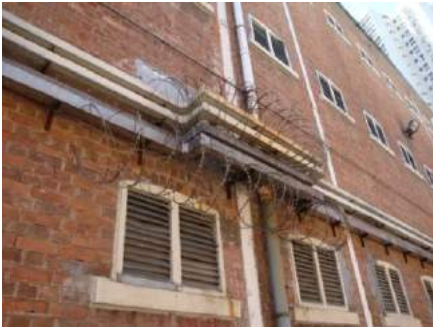
Adverse

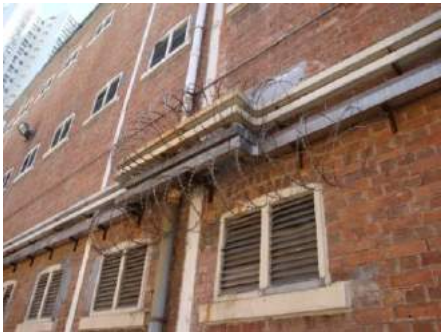
Adverse

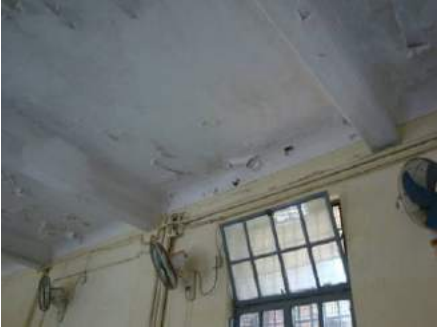
Low
13.012	Communal cells at Ground Floor

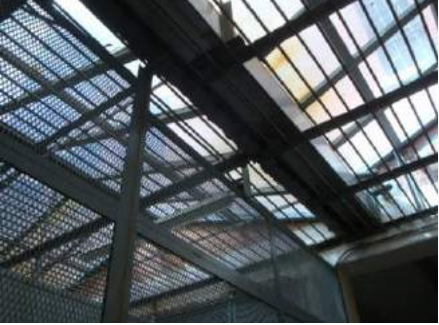
Element no.	Description	Photo ref.	Significance
13.013	Rooflight and security bars over communal cells

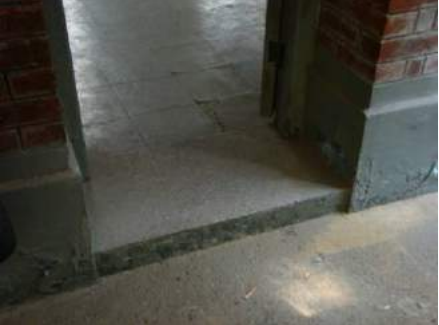
13.014	Granite threshold at external door openings

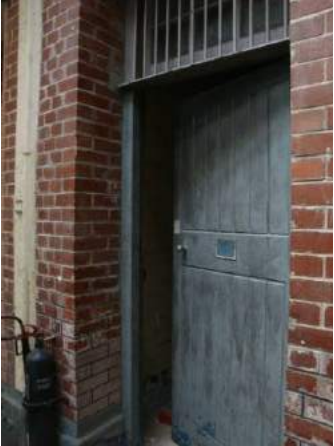
13.015	Timber boarded doors with fanlight over

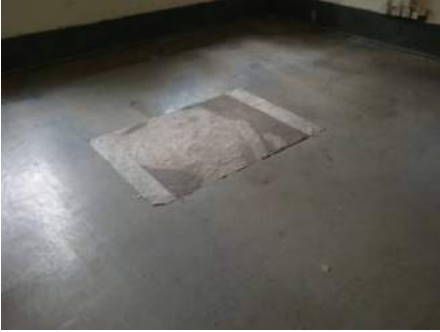
Element no.	Description	Photo ref.	Significance
13.015	Vinyl tile floor

Adverse

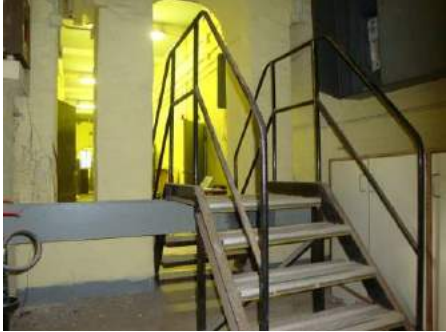
Element no.	Description	Photo ref.	Significance
14.013	Structural steelwork bracing and temporary access stair

Adverse
14.014	RC staircase at north-east corner

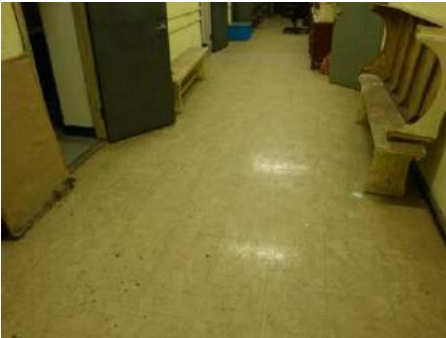
Low
14.015	Vinyl tile floor on suspended timber floor

Adverse

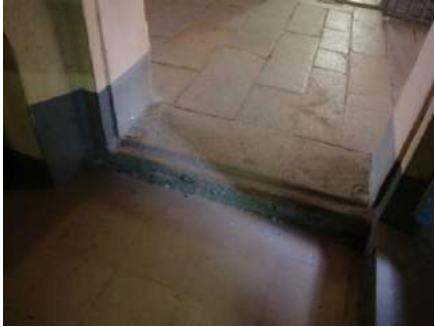
Moderate
14.040	Granite threshold at doorway between cross-passage and East Wing

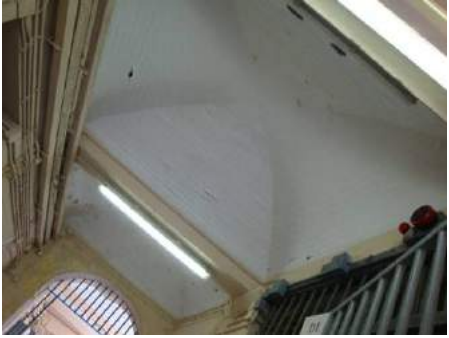
Moderate
14.041	Brick vault over cross-passage

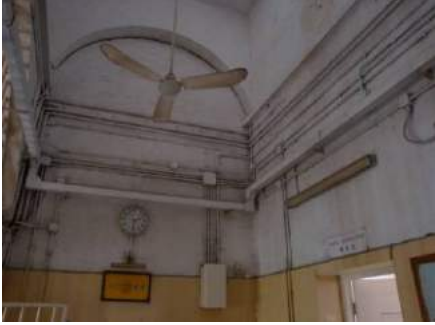
Element no.	Description	Photo ref.	Significance
14.048	Services installations

Adverse
14.049	Metalwork and structural steel framing on exterior (typical)

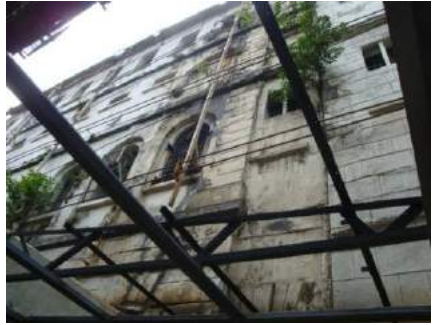
Adverse
14.050	Blind arcade, south elevation

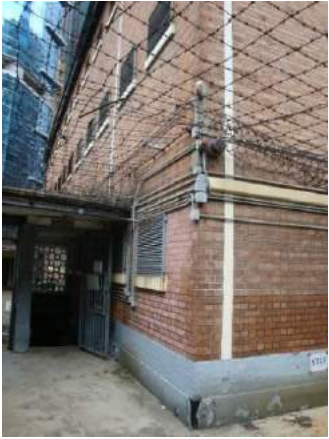
Moderate
15.004	Services installations

Adverse
15.005	Metal louvres over cell window openings

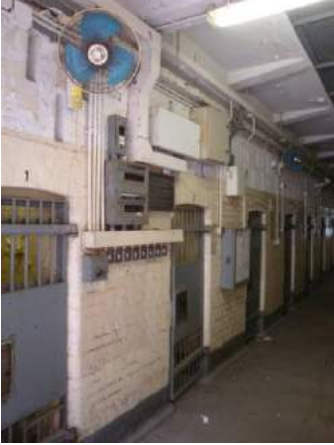
High
15.010	Services installations

Adverse
15.011	Balcony balustrades

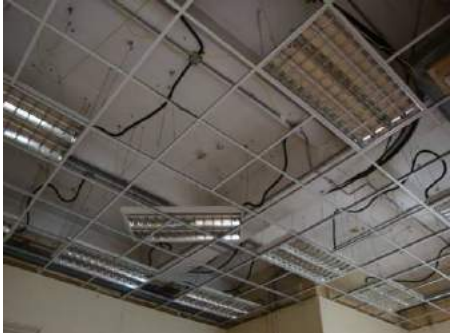
Element no.	Description	Photo ref.	Significance
17.001	Lay-in grid suspended ceiling

Adverse
17.002	Rainwater goods

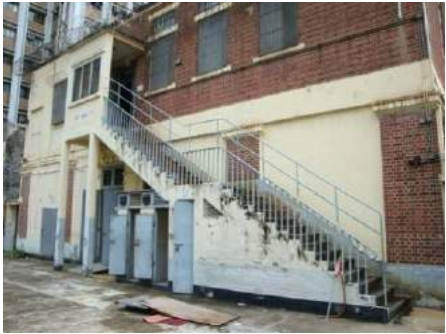
Low
17.003	Exterior decorations

Adverse

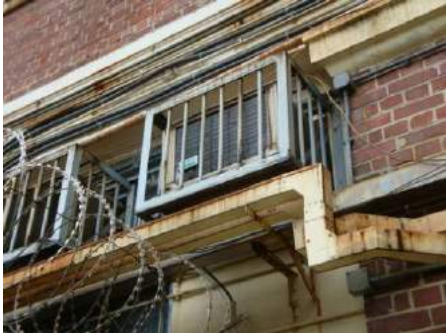
Element no.	Description	Photo ref.	Significance
17.004	External airconditioning units and other external services

Adverse
17.005	Fixed signs

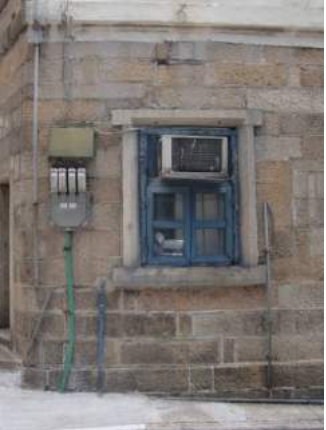
High
19.003	Rainwater goods and other external services

Adverse

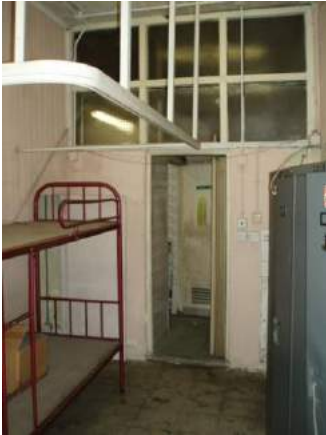
Moderate
19.008	Modern partitions

Adverse
19.009	Electrical services

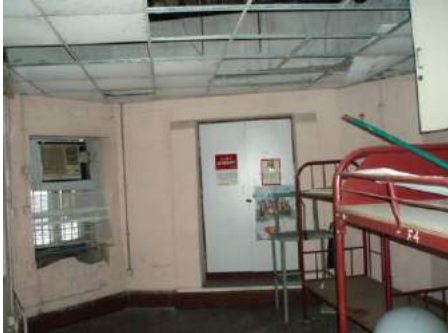
Element no.	Description	Photo ref.	Significance
19.010	Lay-in grid suspended ceiling

Adverse
19.011	Exposed timber roof structure

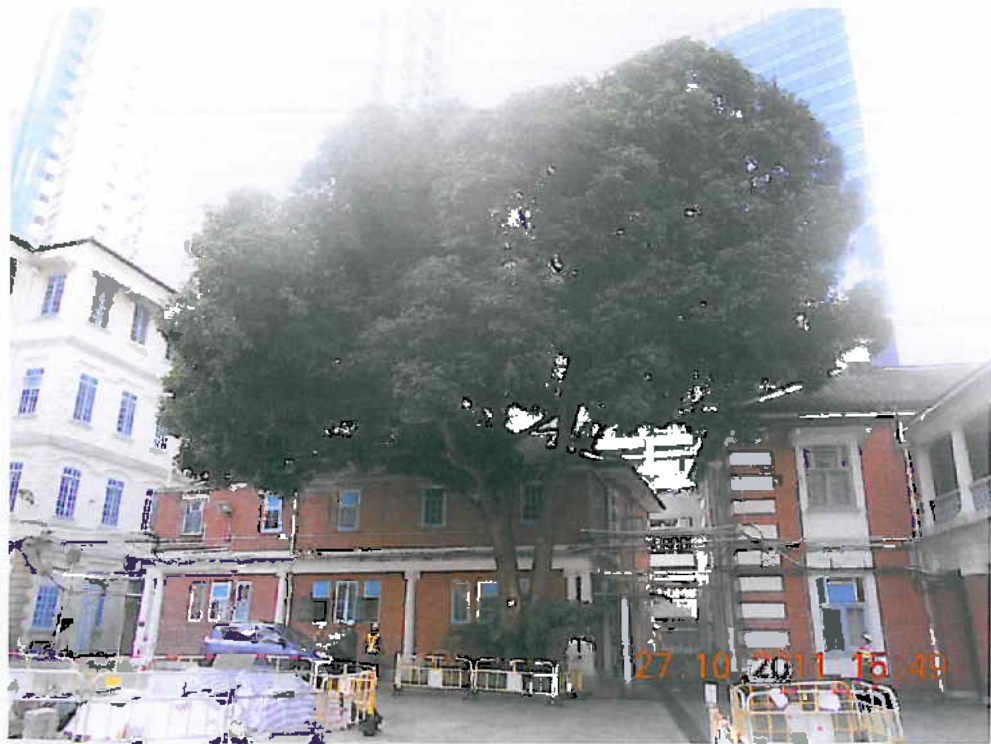
1. *Mangifera indica* is a fast growing tree normally with a large and heavy crown.
2. The tree is growing at an appropriate planter surrounded by protective fence.
3. The health condition of the tree is good at the time of inspection.

Fig 2. Overall view of the tree.

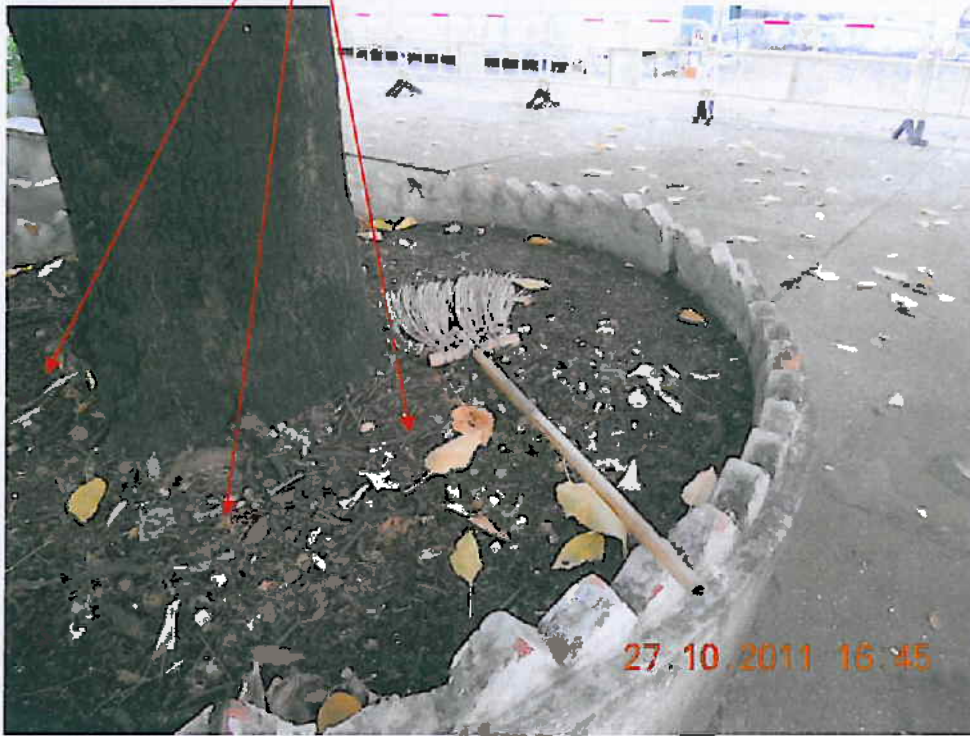
Fig. 3 Too much top soil accumulated on the root collar.

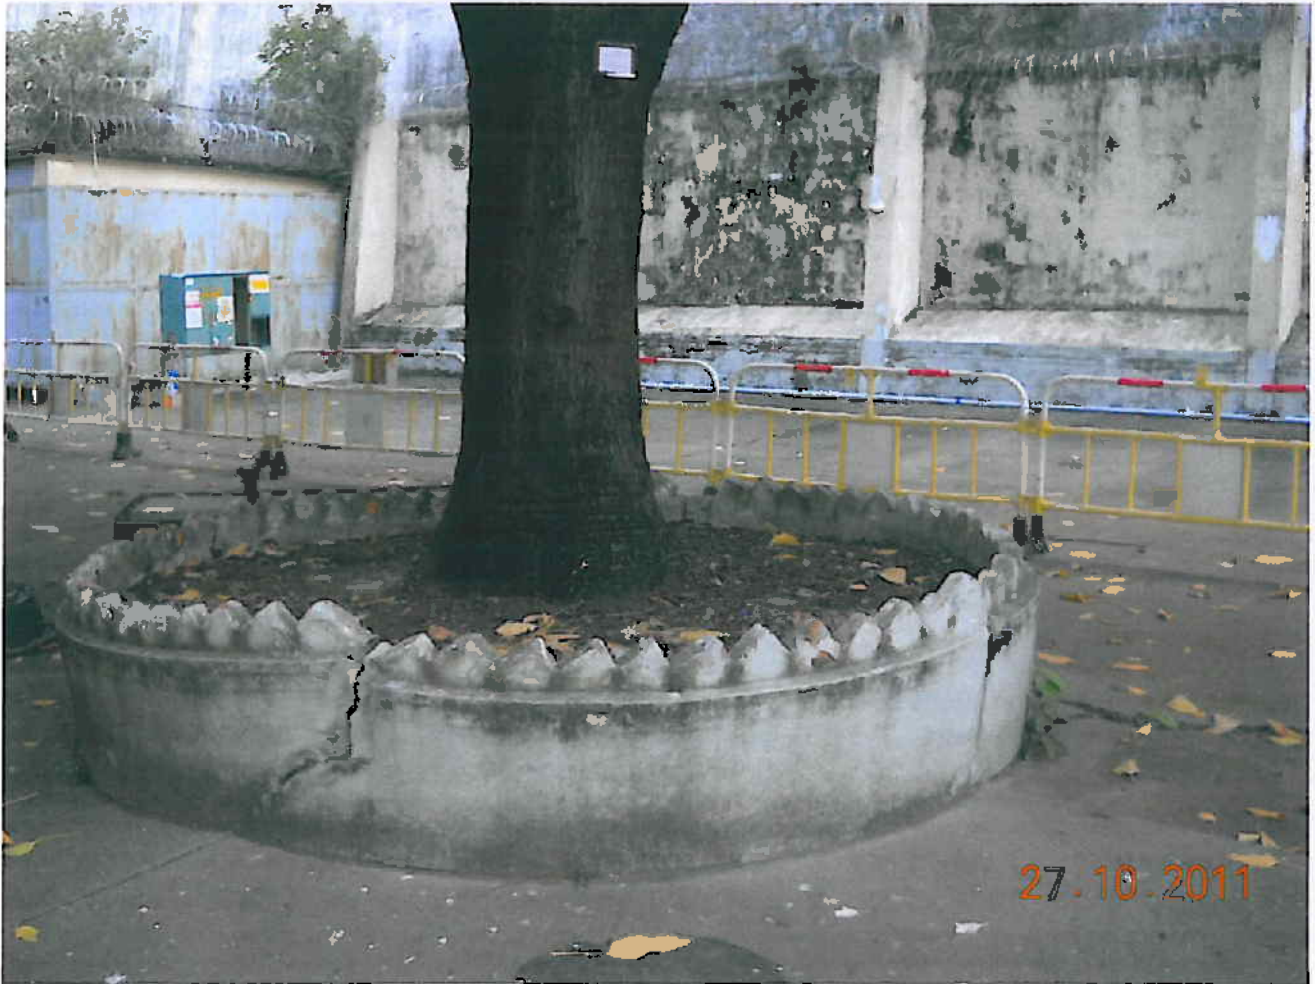
Photo 5.

Tree was surround by a raised planter, rooting area was restricted

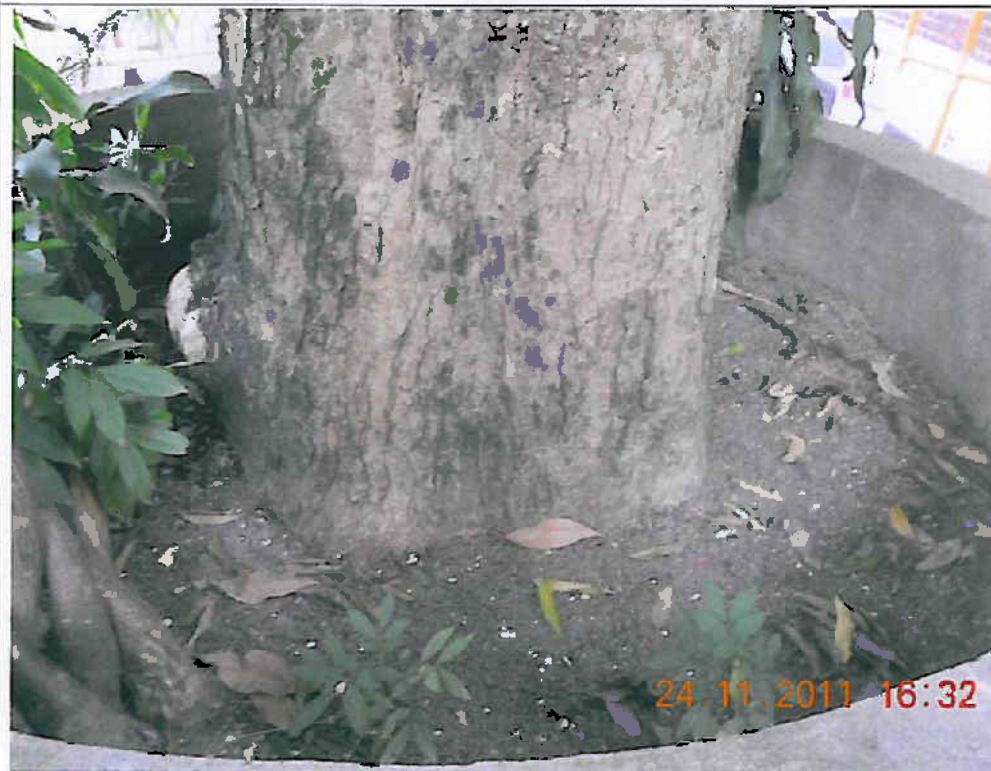
Fig. 3 Cleaning tools and rubbish have been removed prior to inspection, the planter appears clean and tidy.
