The Jockey Club CPS Limited

Central Police Station Conservation
and Revitalisation Project:
First Monthly EM&A Report
(From 24 October 2011 to 30
November 2011)

Environmental Resources Management

Reference 0095646

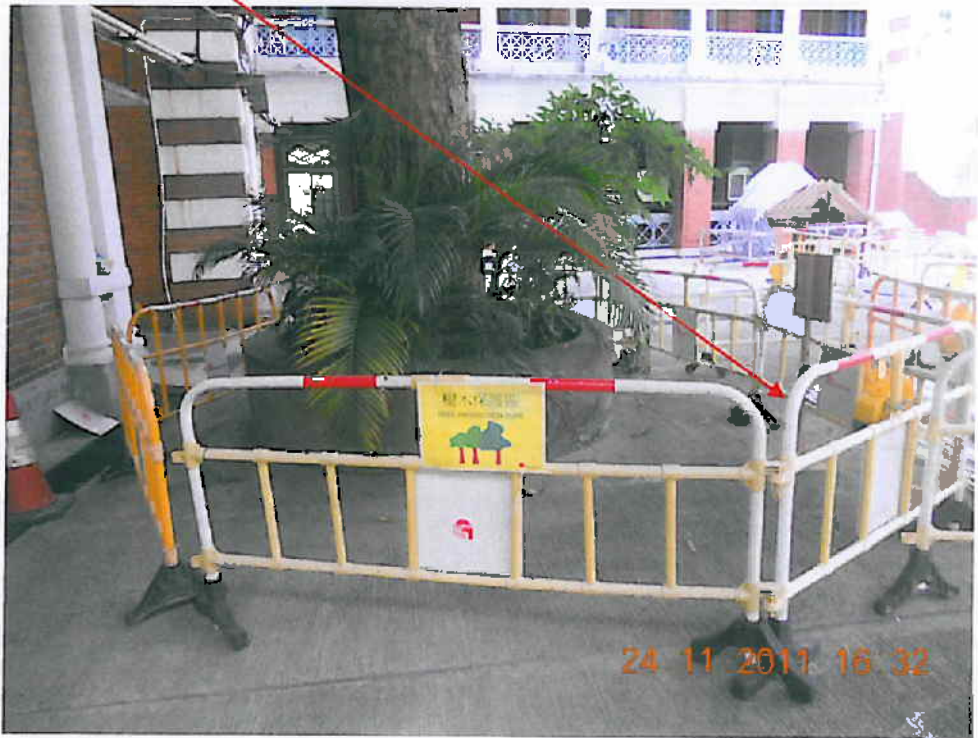
Fig. 4 The rails have been linked up as a temperate protection zone.

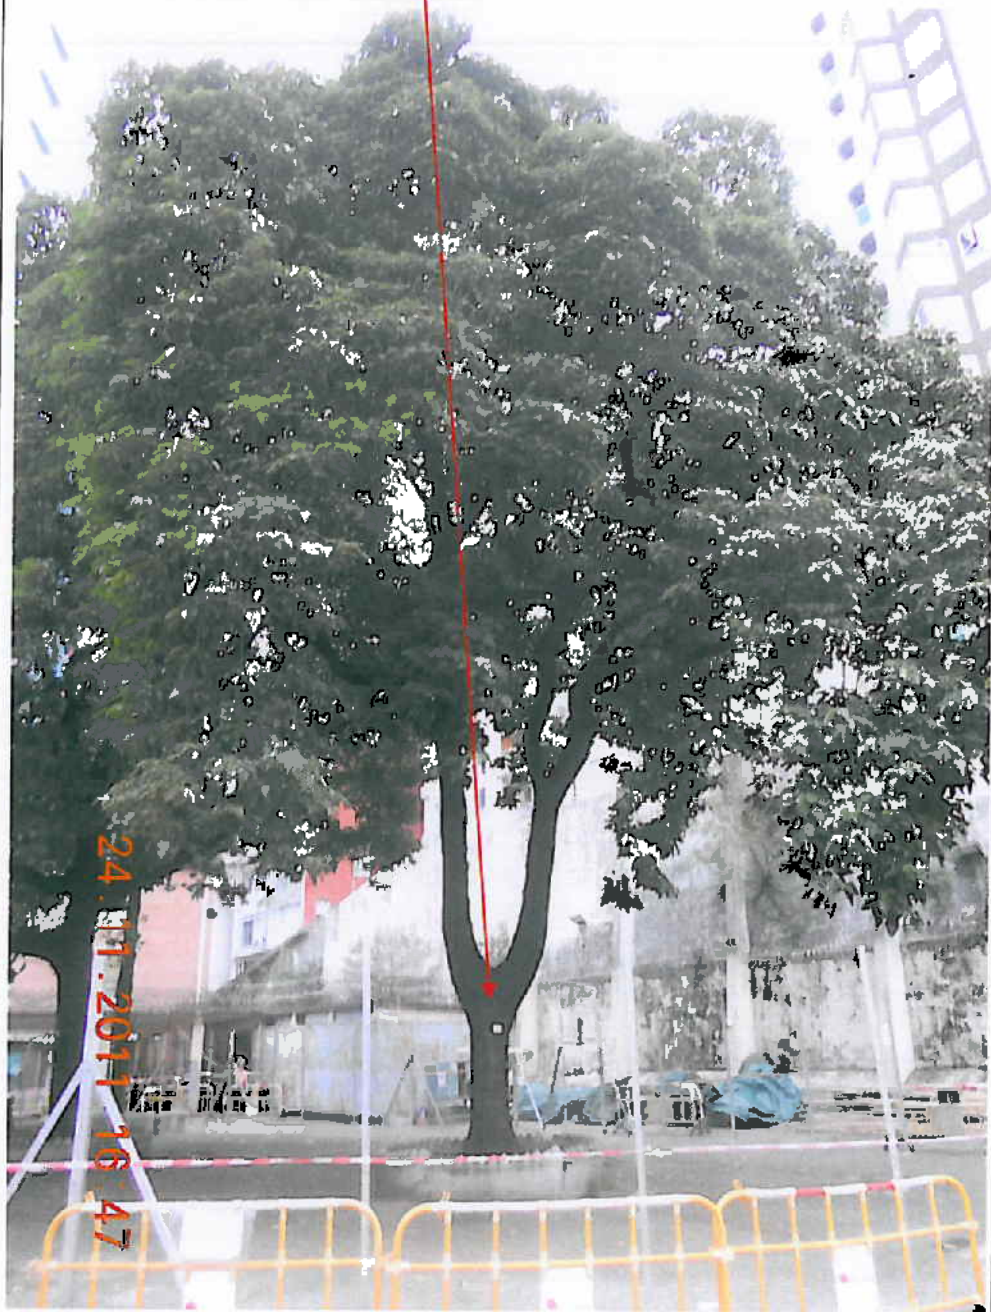
Fig 2. Overall view of the tree.

1. Overall health condition of the tree is fair.
2. Construction debris and rubbish have been removed prior to inspection.
3. The planter keeps clean and tidy at the time of inspection.

1. To erect a protective fence ^{2.5m} 2.0m high with a padlocked door beyond the crown spread or the designated protection zone of all the existing trees.

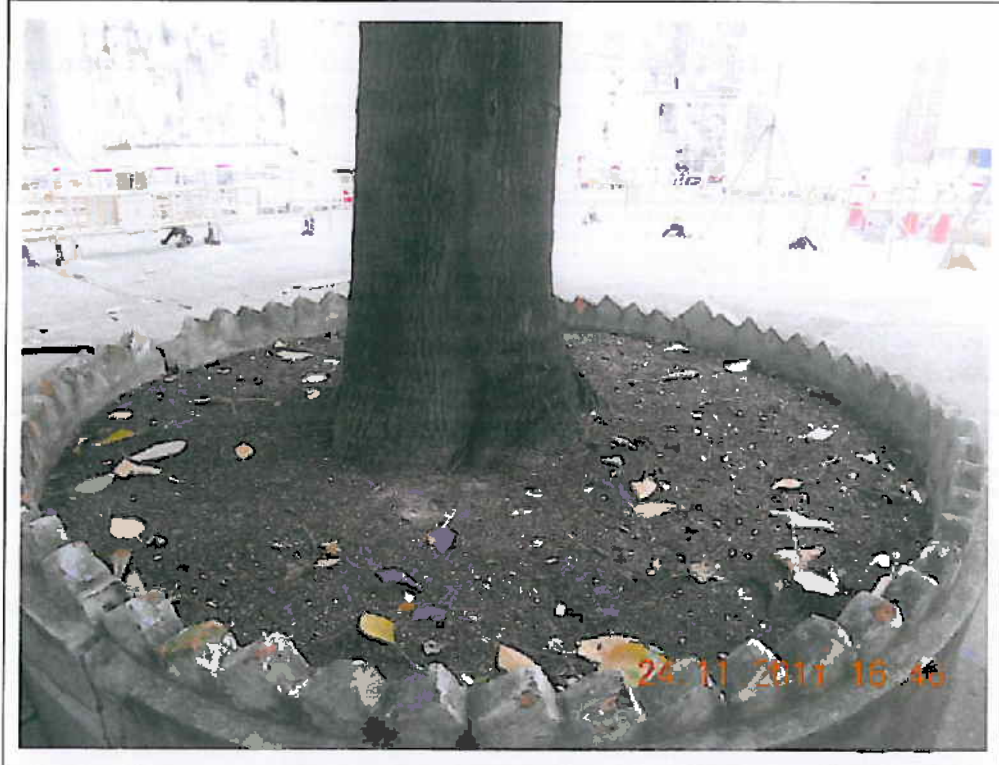
Fig. 3 The planter keeps clean and tidy at the time of inspection.

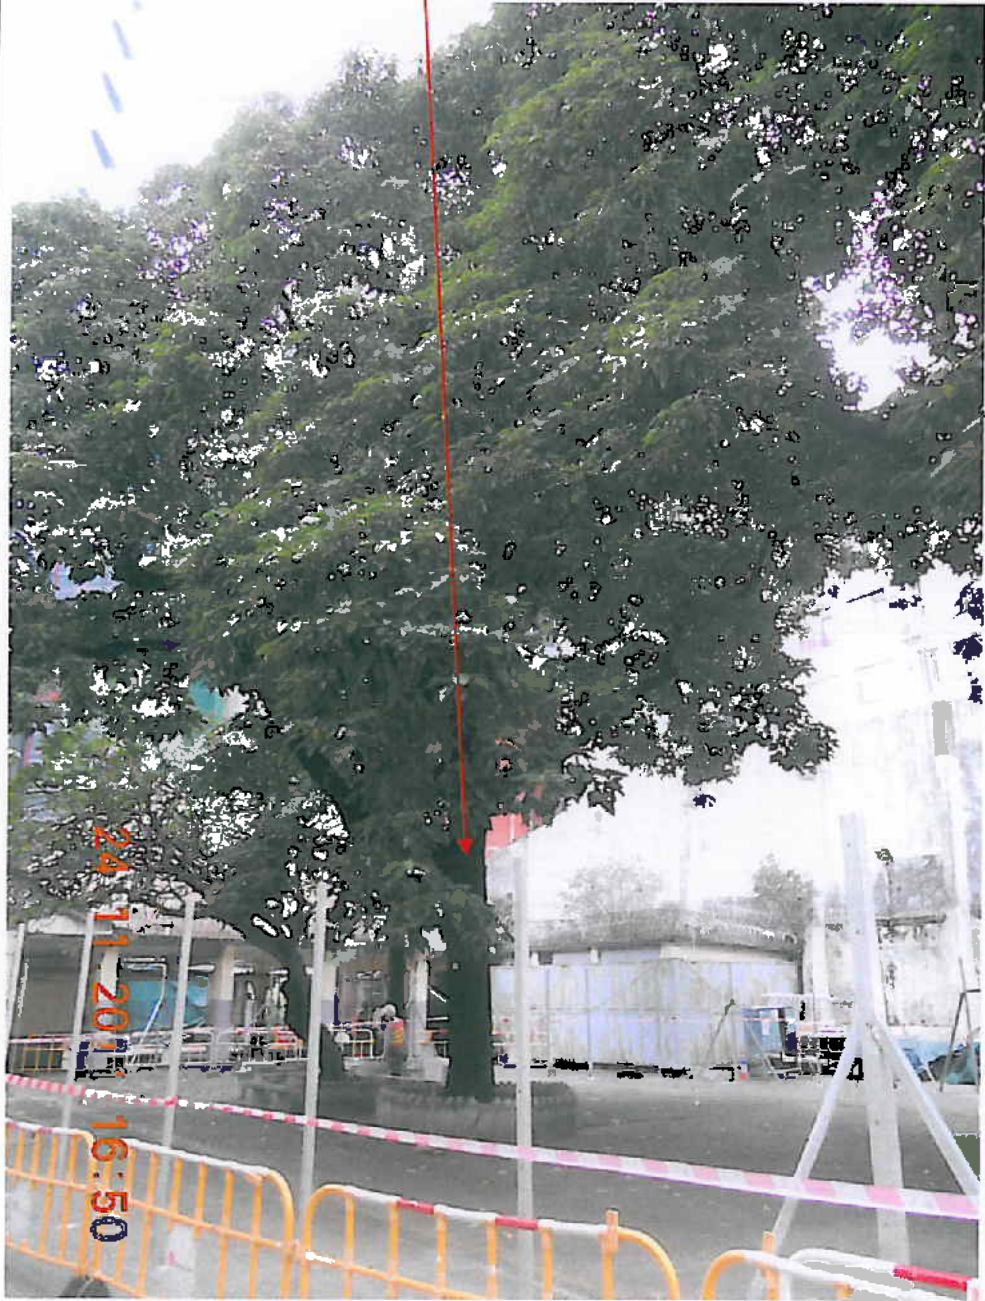
Fig 2. Overall view of the tree.

1. Overall health condition of the tree is fair.
2. The planter keeps clean and tidy at the time of inspection.

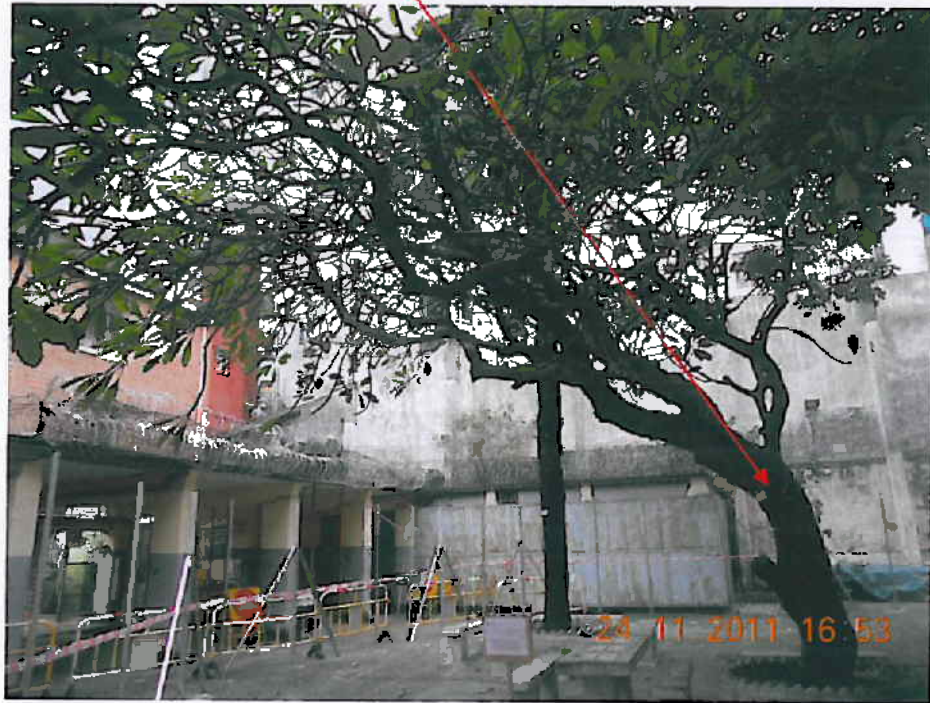
Fig 2. Overall view of the tree.

1. Overall health condition of the tree is fair.
2. The construction debris at the planter had been cleared prior to inspection.
3. The planter is clean and tidy at the time of inspection.

1. To erect a protective fence 2.0m high with a padlocked door beyond the crown spread or the designated protection zone of all the existing trees.

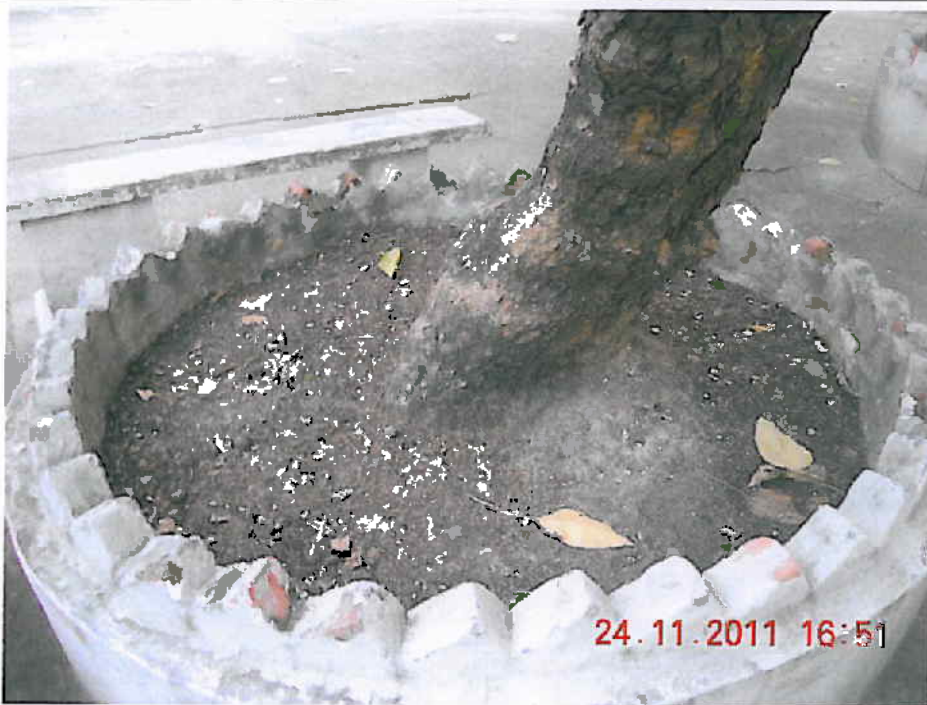
Fig. 3 The planter is clean and tidy at the time of inspection.

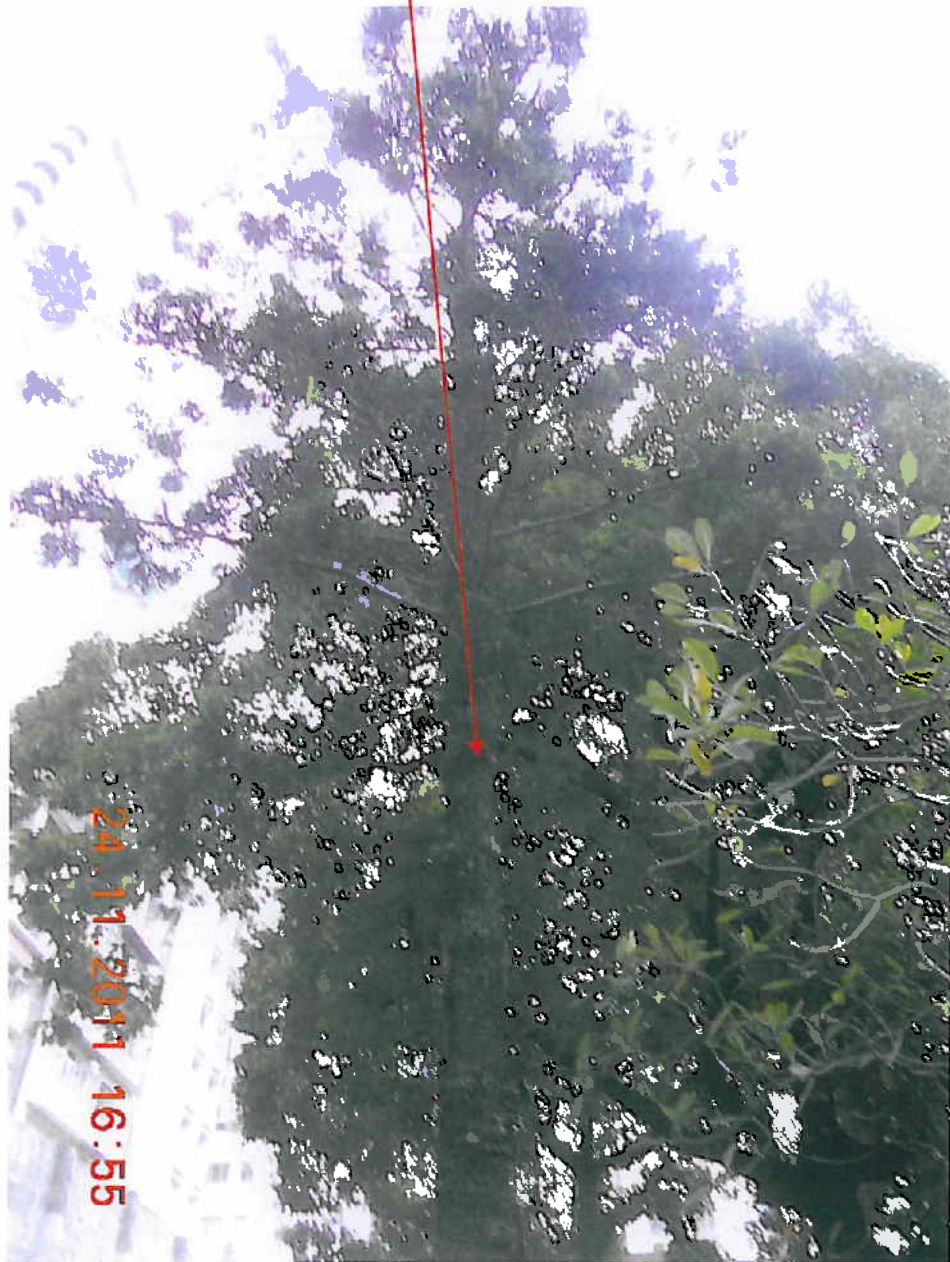
Fig 2. Overall view of the tree.

1. Overall health condition of the tree is fair.
2. Under-growth and rubbish had been cleared prior to inspection.
3. The planter is clean and tidy at the time of inspection.

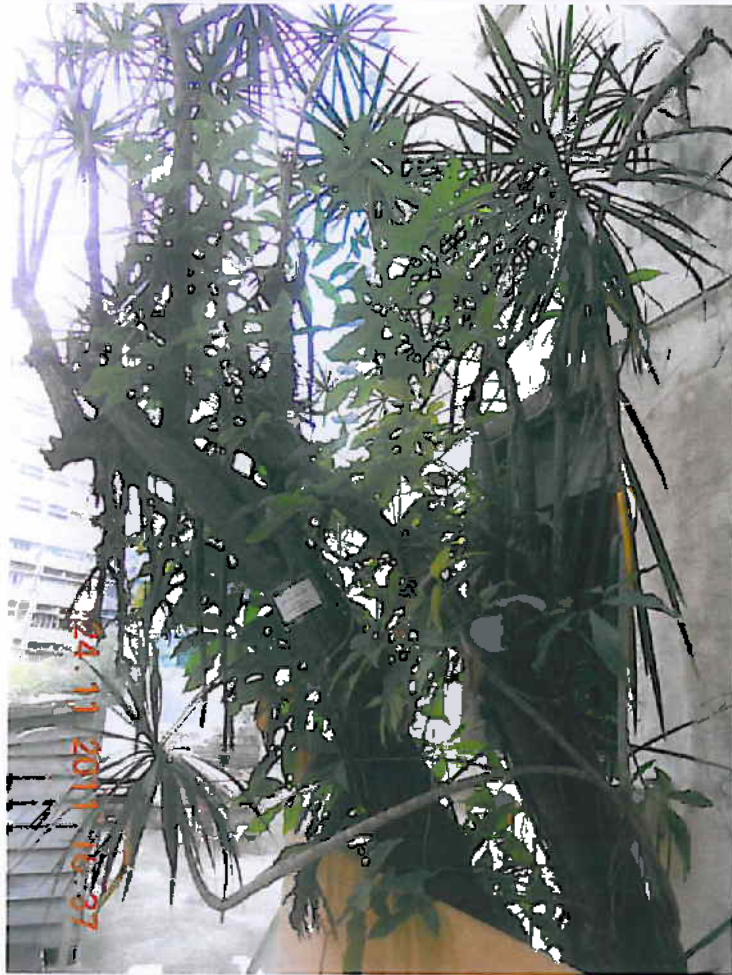
Fig 2. Overall view of the tree.

1. Overall health condition of the tree is fair.
2. Temperate fence has been erected at the planter.
3. Under-growth and rubbish have been cleared prior to inspection.
4. The planter is clean and tidy at the time of inspection.

1. To erect a protective fence 2.0m high with a padlocked door beyond the crown spread or the designated protection zone of the existing tree.

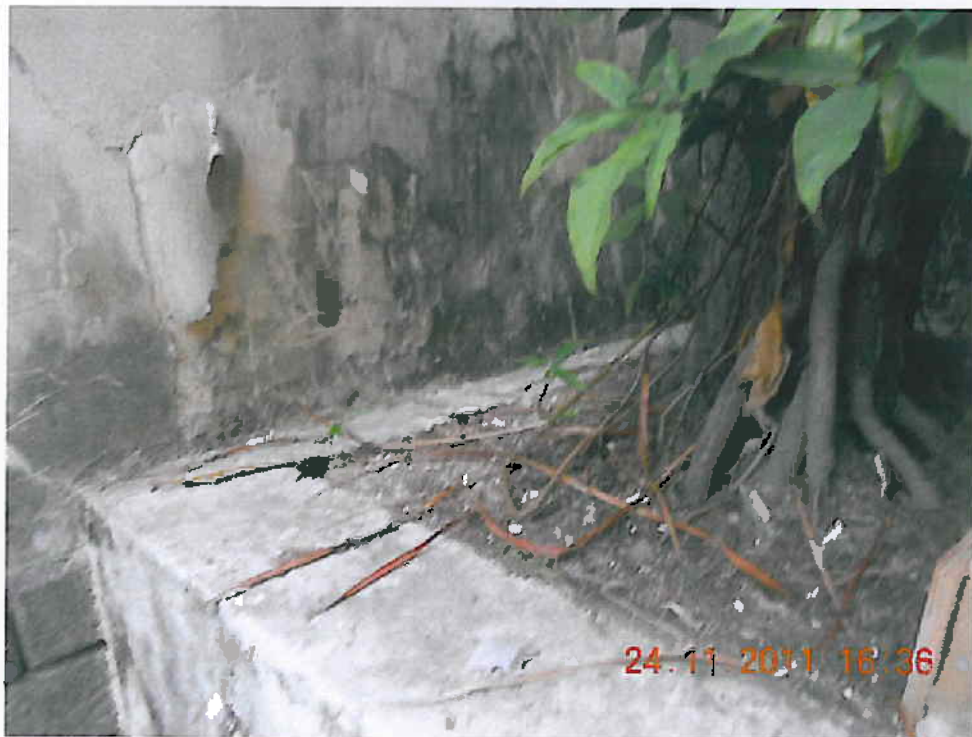
Fig 3 The planter is clean and tidy at the time of inspection.

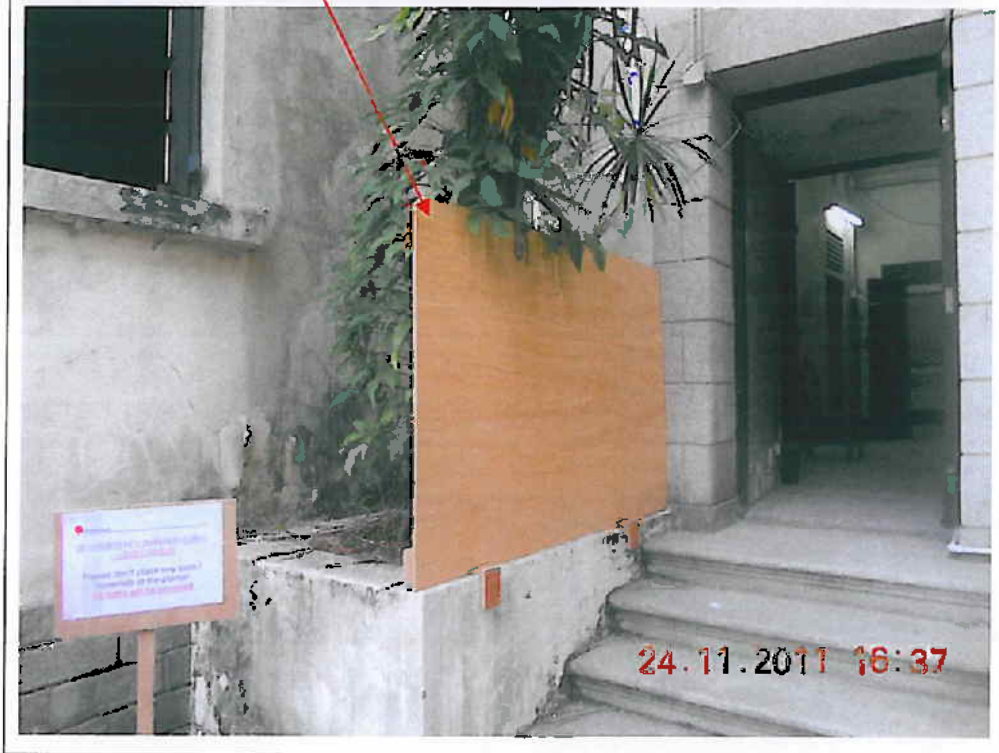
Fig. 4 Temperate fence has been erected at the planter.
