Central Police Station Conservation
and Revitalisation Project:
65th Monthly EM&A Report
(1 March to 31 March 2017)

Issue Date: April 2017

Environmental Resources Management

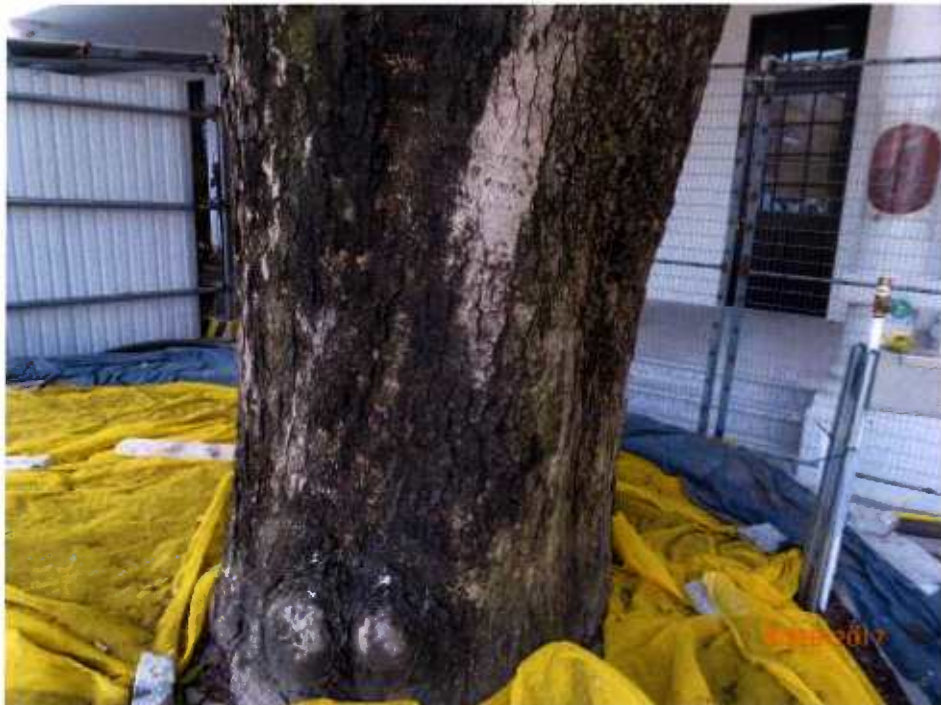
Fig. 3 Health condition of the lower trunk is fair.

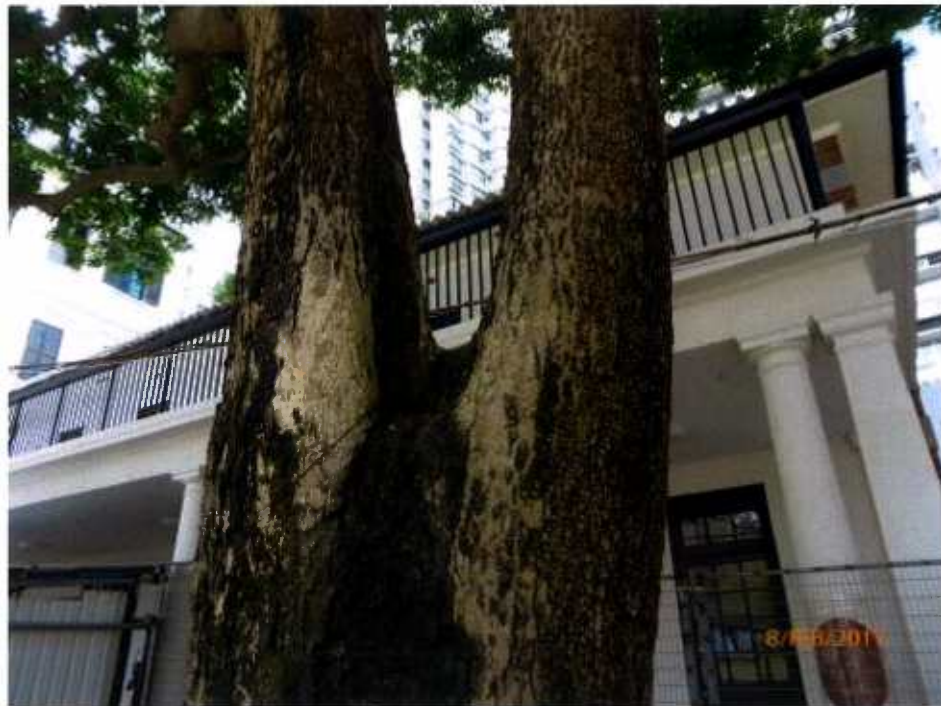
Fig. 4 Health condition of the mid trunk is fair.

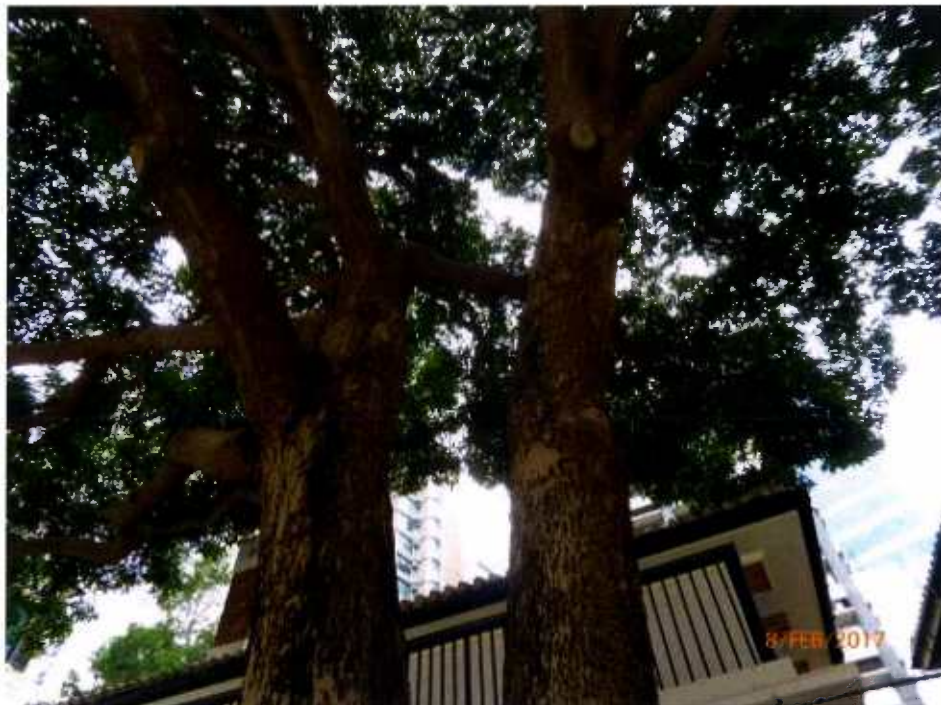
Fig. 5 Health condition of the upper trunk also is fair.

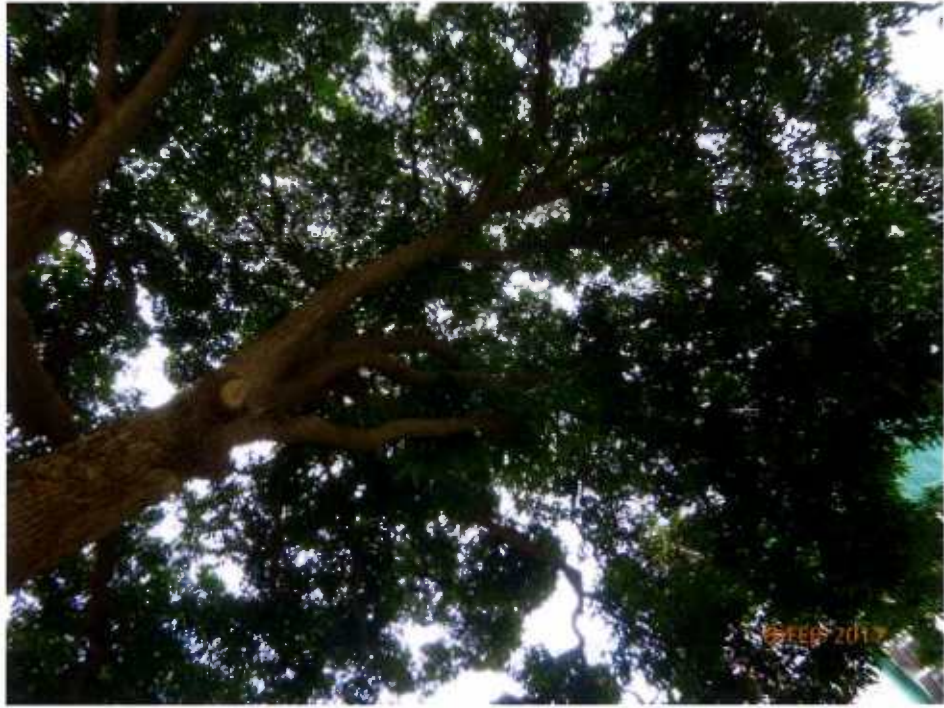
Fig. 6 The crown is full of vigorous and green leaves.

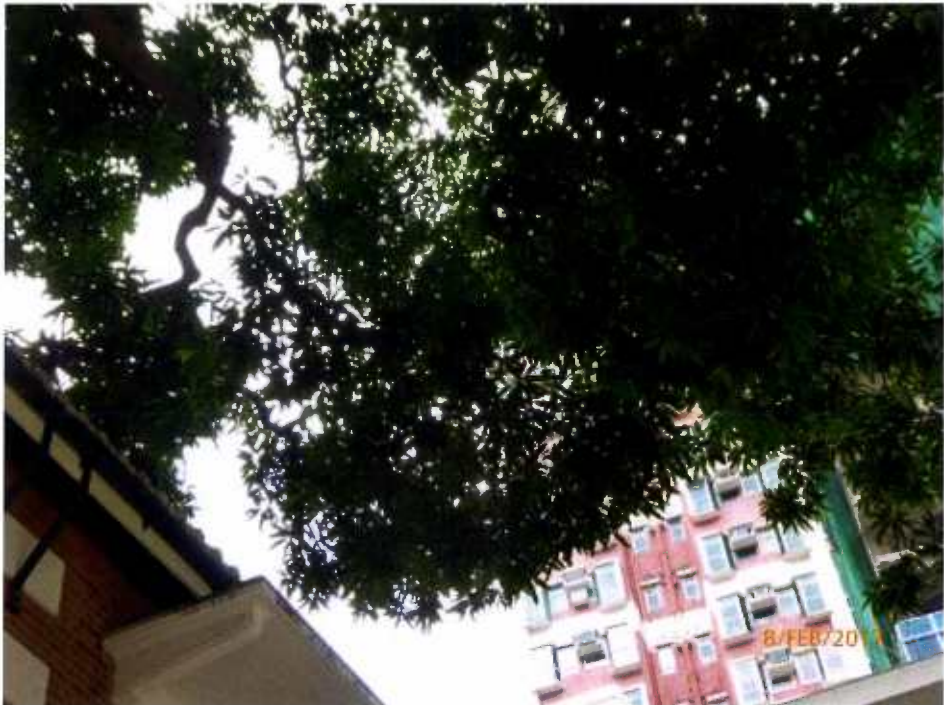
Fig. 7 Vigorous and green leaves also appear on the lower branches.

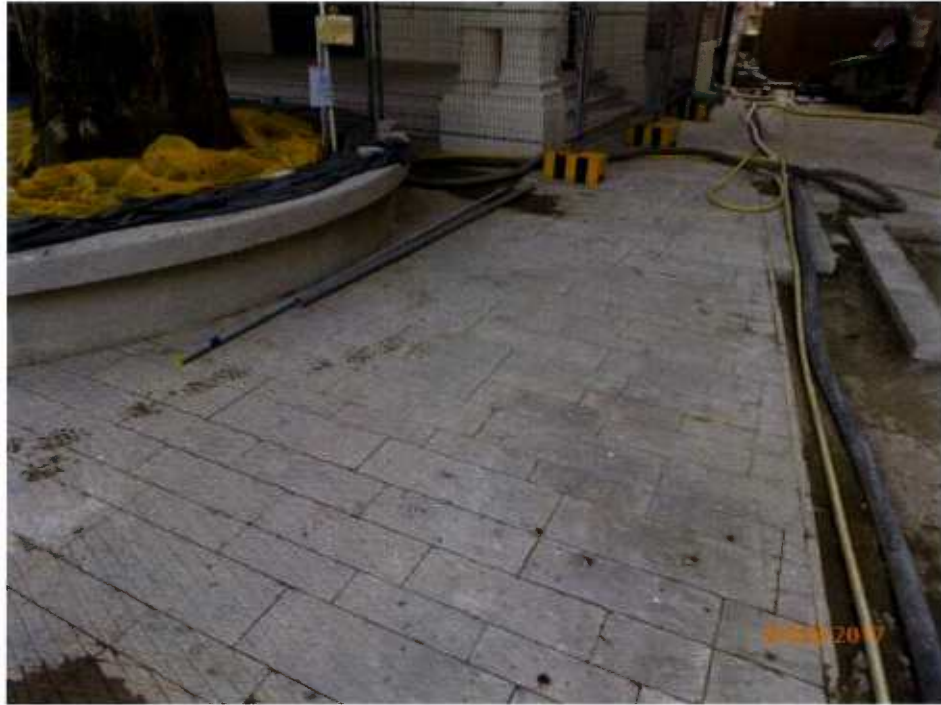
Fig. 10 The site near Tree-5 is clean and tidy.

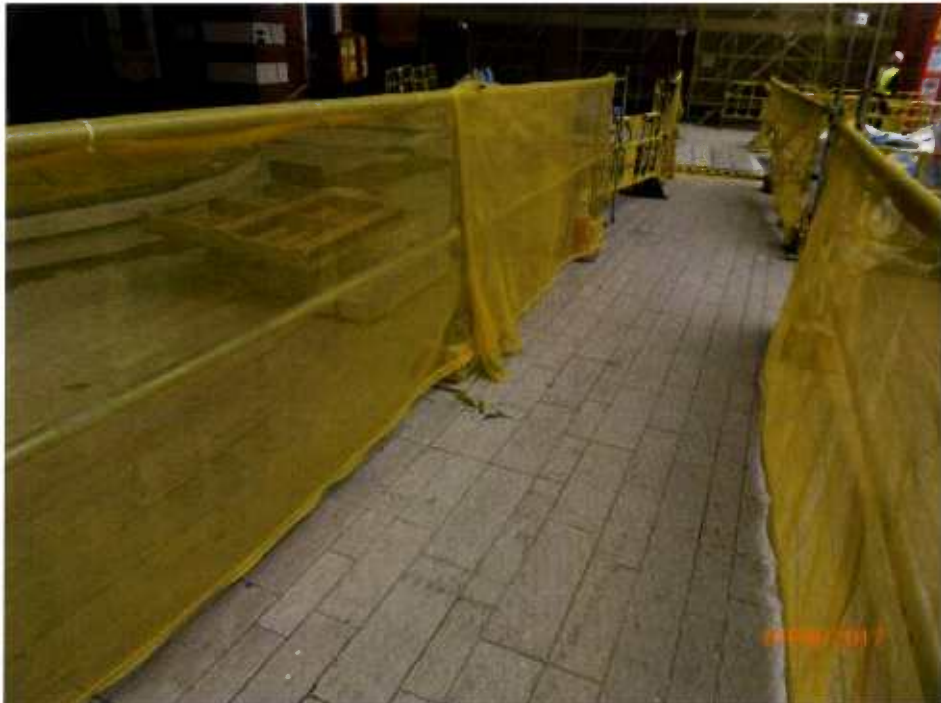
Fig. 11 The access near Tree-5 also appears clean and tidy.

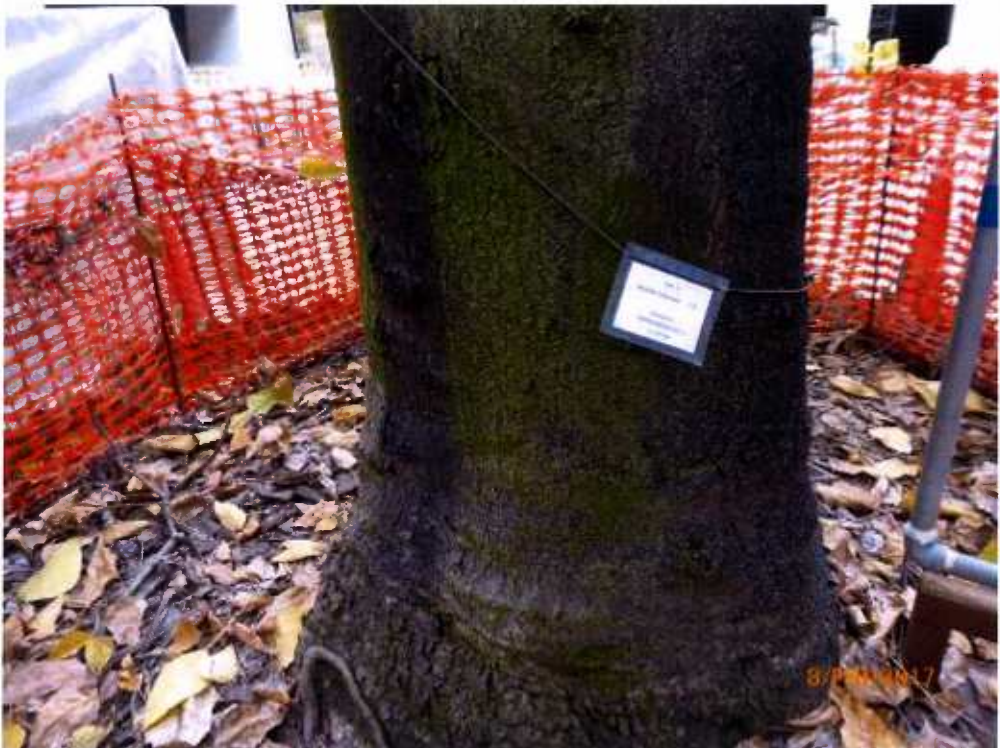
Fig 3. Health condition of the lower trunk is fair.

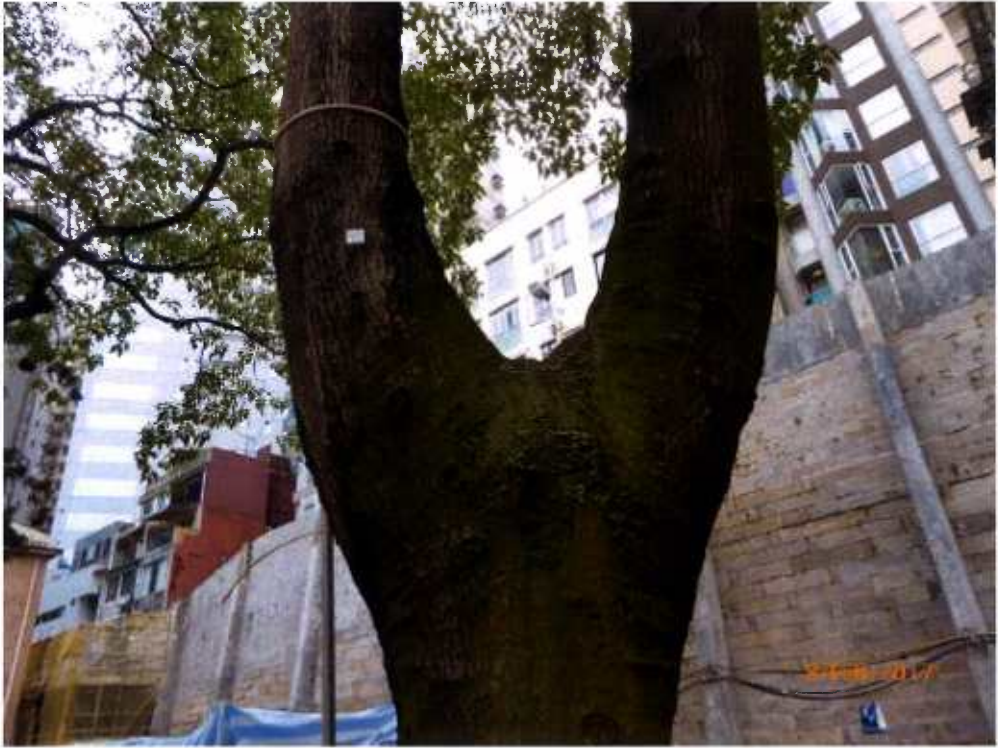
Fig. 4 Health condition of the mid trunk is fair.

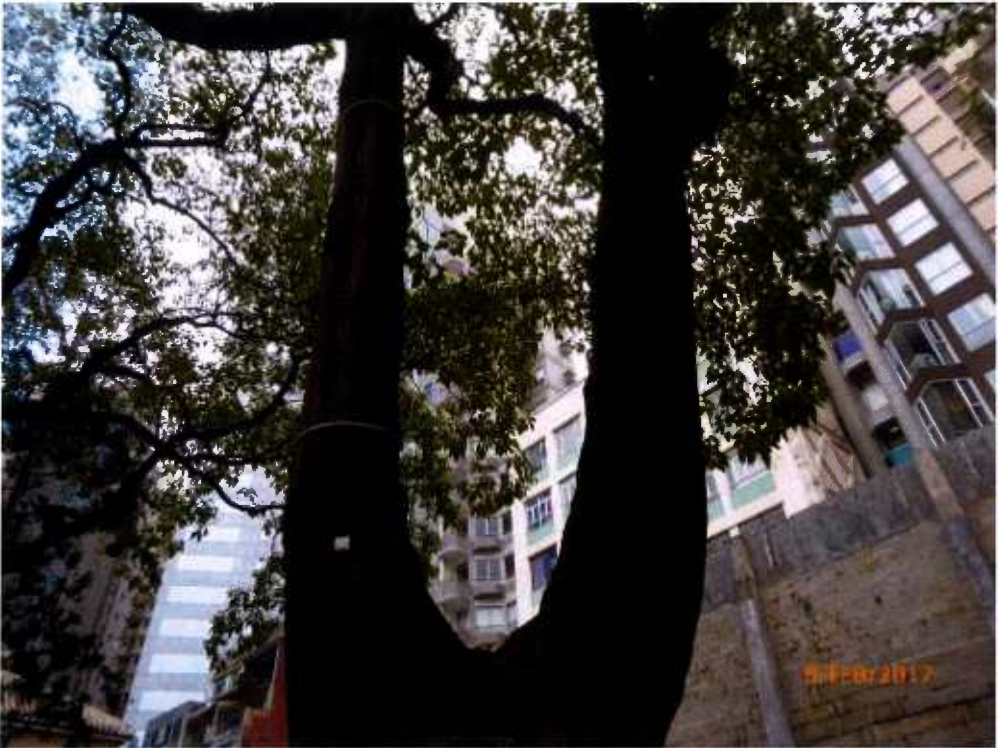
Fig. 5 Health condition of the upper trunk also is fair.

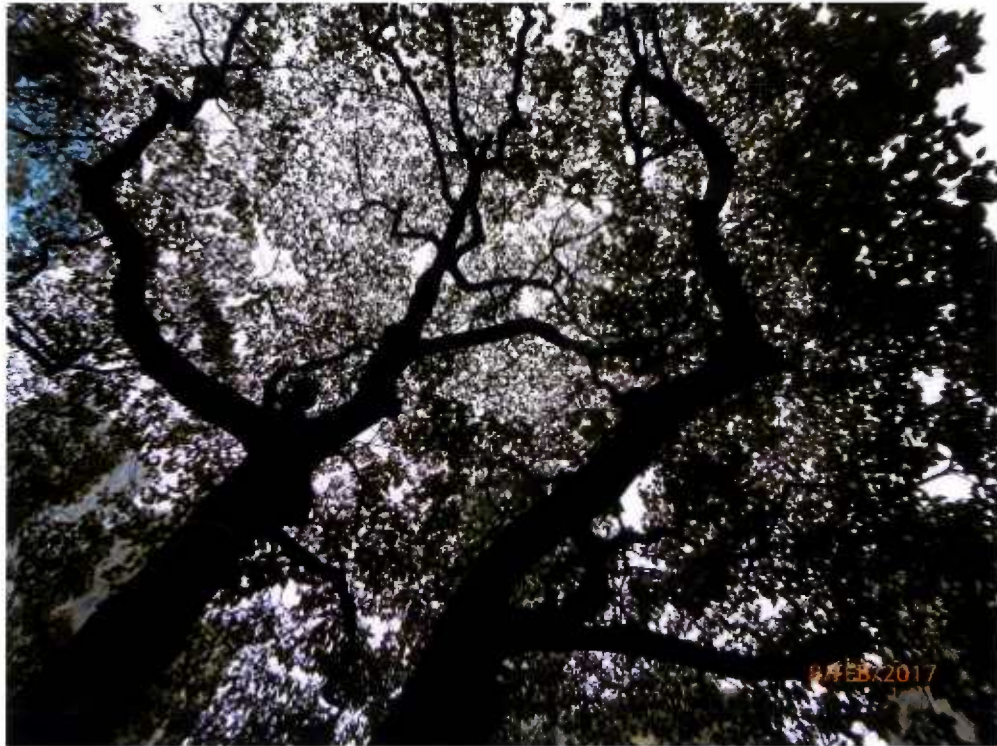
Fig. 6 The crown is full of vigorous and green leaves.

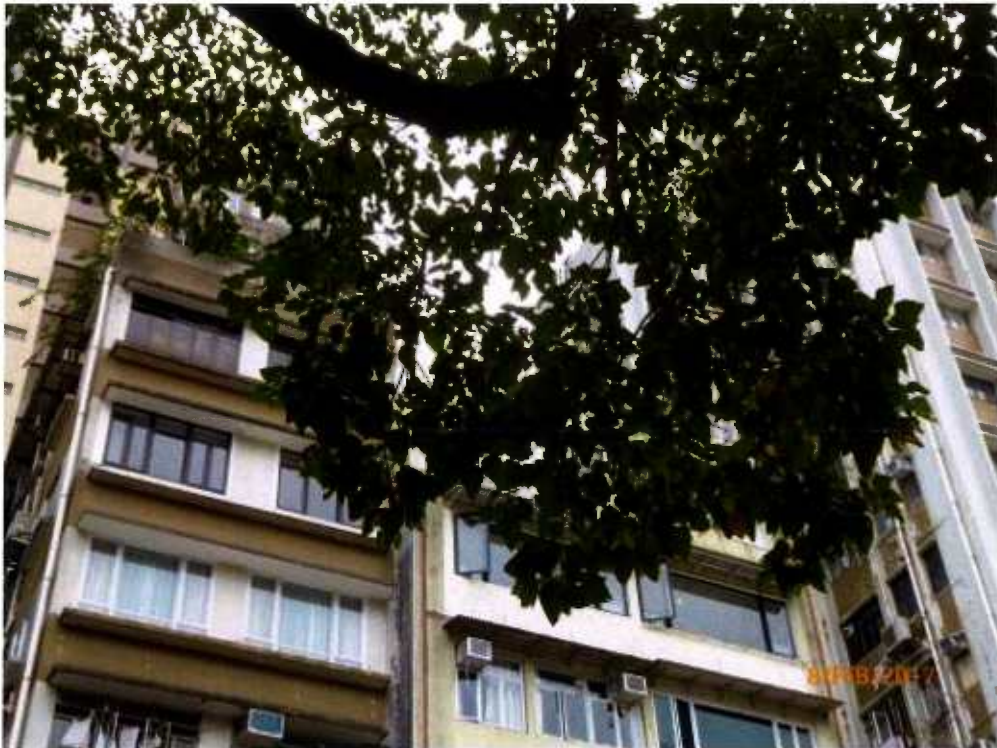
Fig. 7 Vigorous and green leaves also are growing on the lower branches.

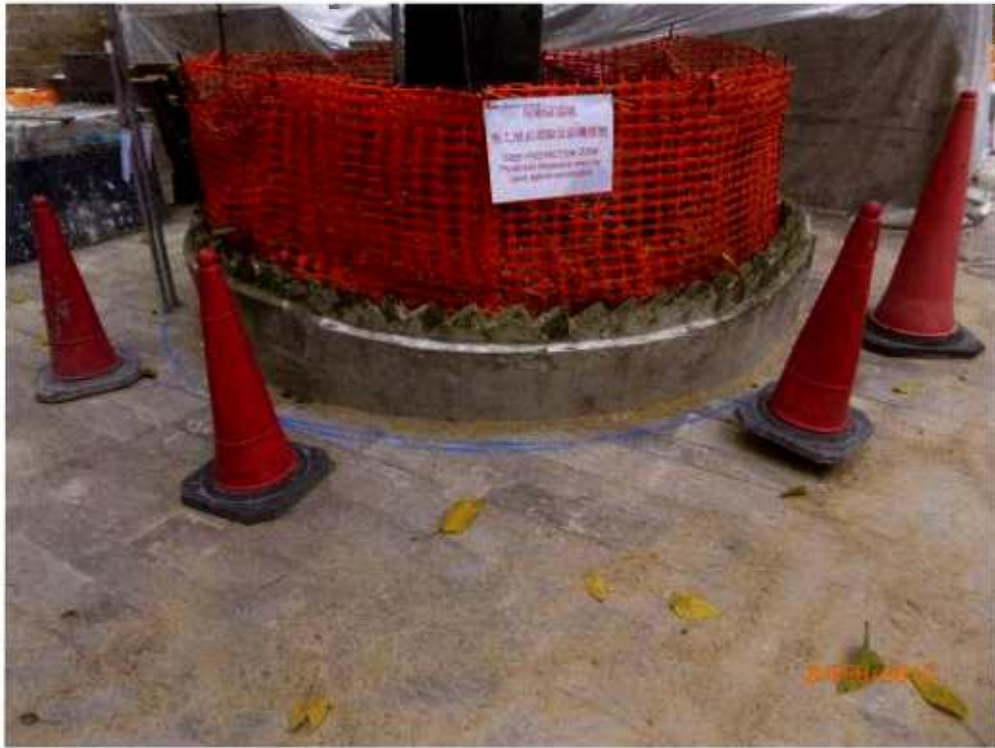
Fig. 10 The tree protection zone is in good order.

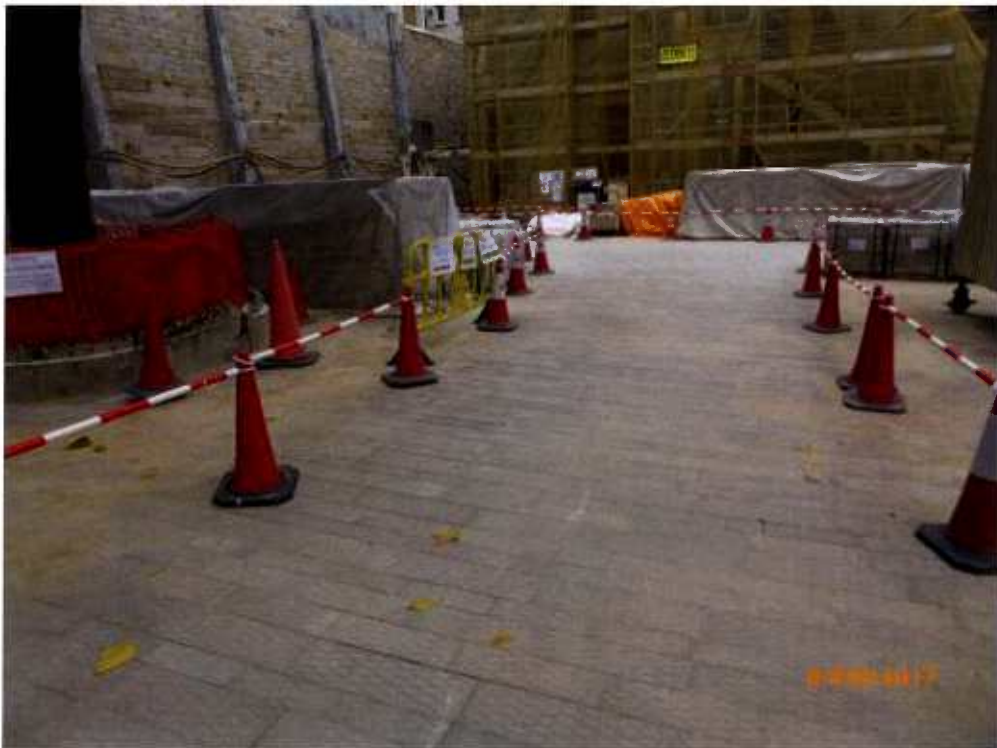
Fig. 11 The site near the planter is clean and tidy.

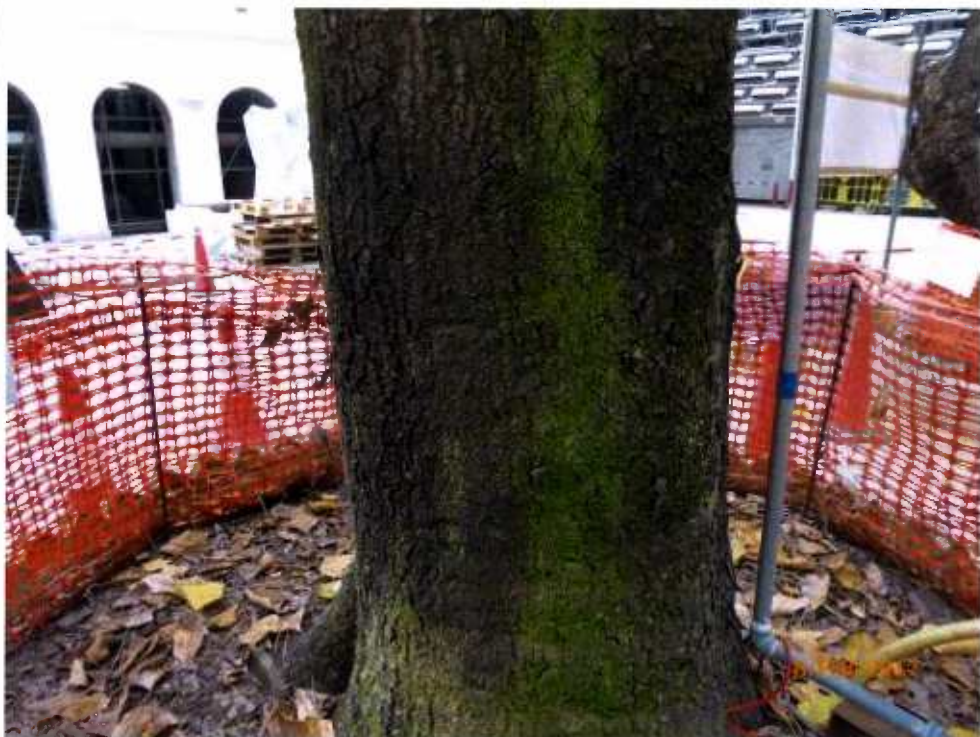
Fig 3. Health condition of the lower trunk is fair.

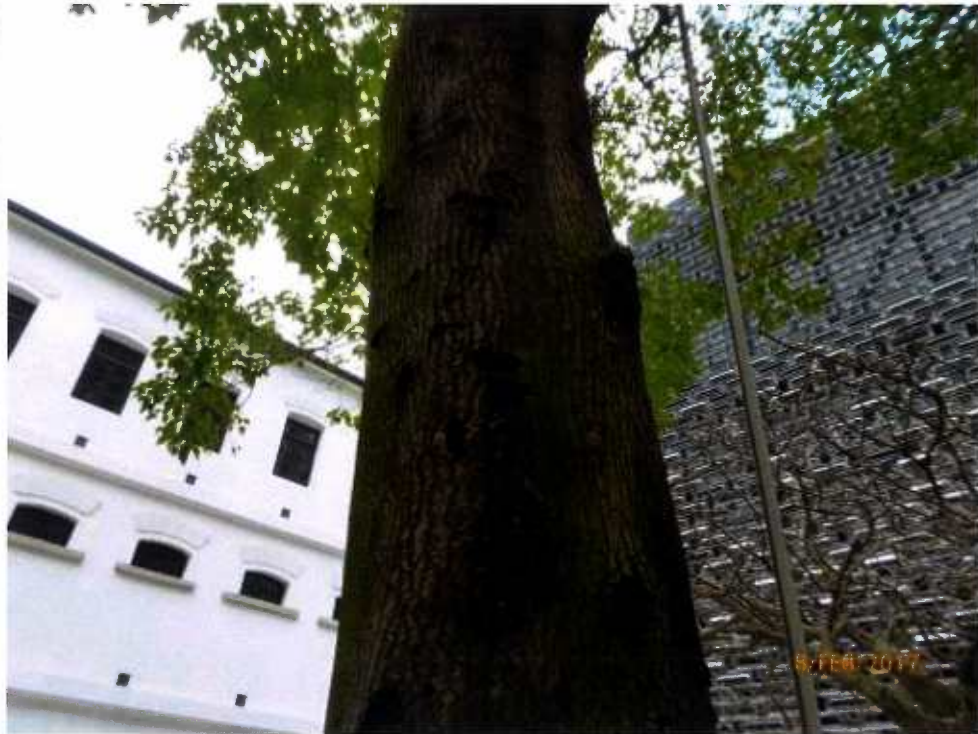
Fig. 4 Health condition of the mid trunk is fair.

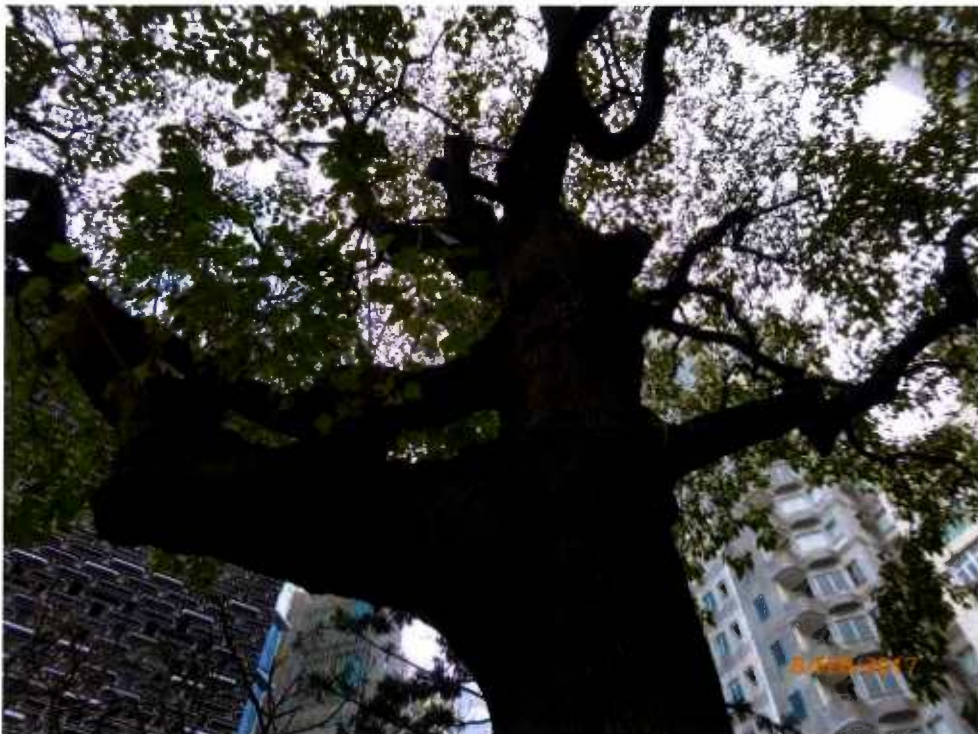
Fig. 5 Health condition of the upper trunk also is fair.

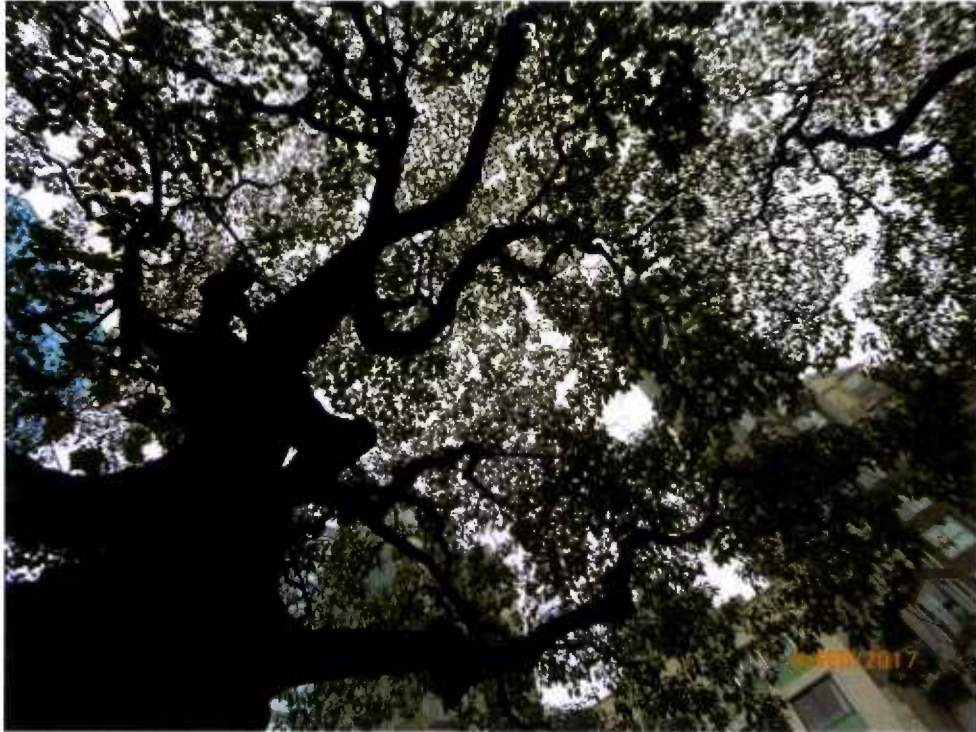
Fig. 6 The crown is full of vigorous and green leaves.

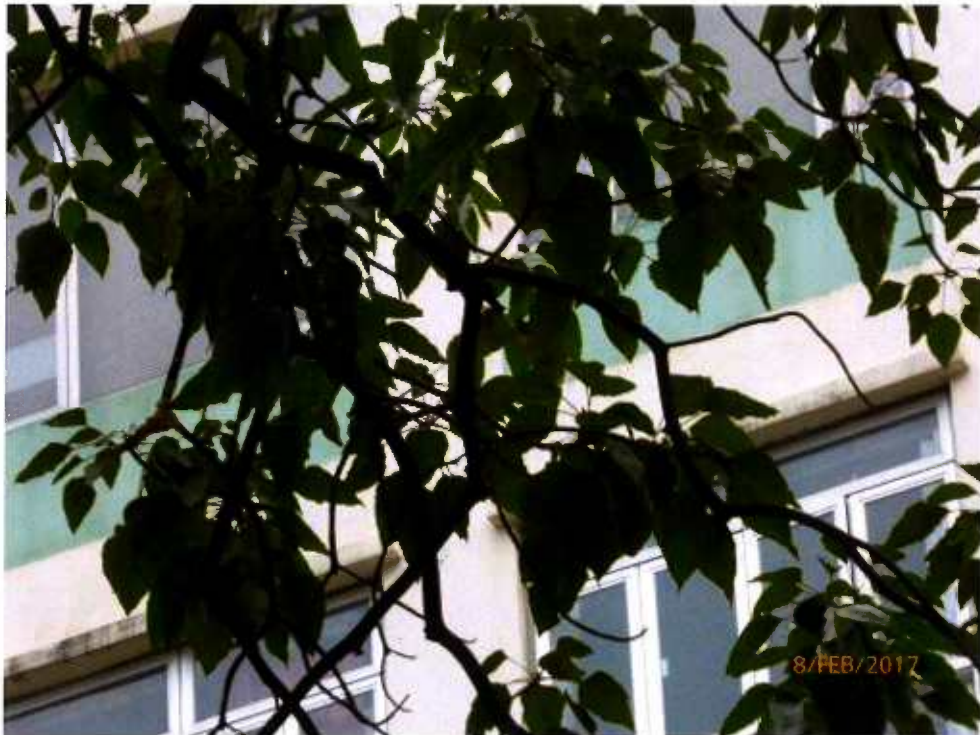
Fig. 7 Vigorous and green leaves also appear on the lower branches.

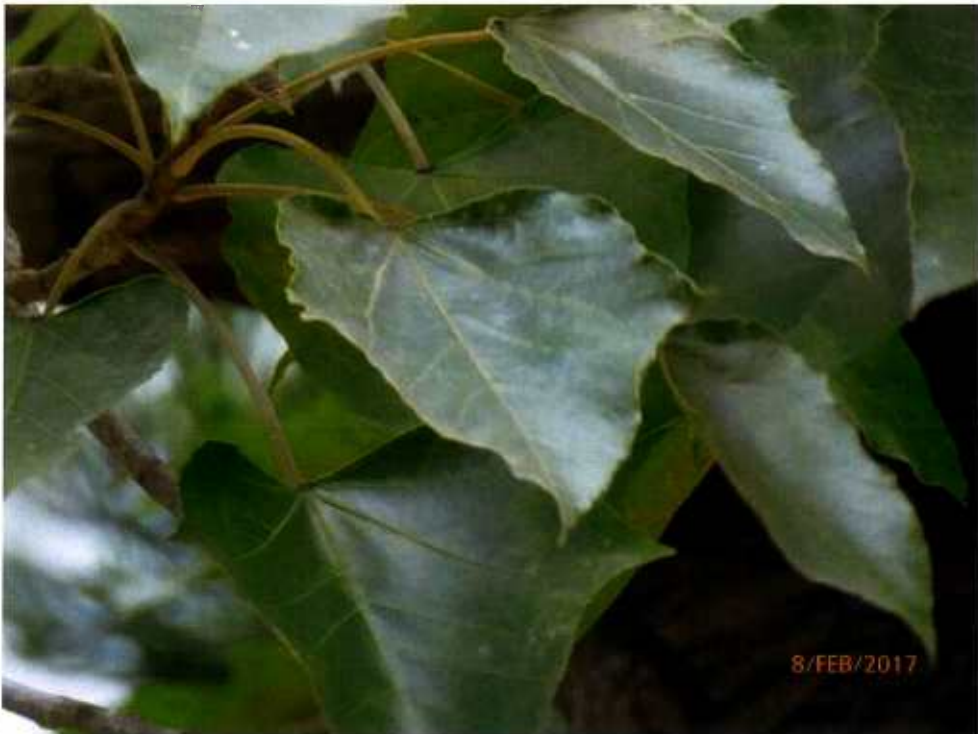
Fig. 9 Signs of Pest (Mealy Bugs 粉狀介殼蟲) are rarely found on Tree-7 due to Pest Control Operation on 25th April 2016.

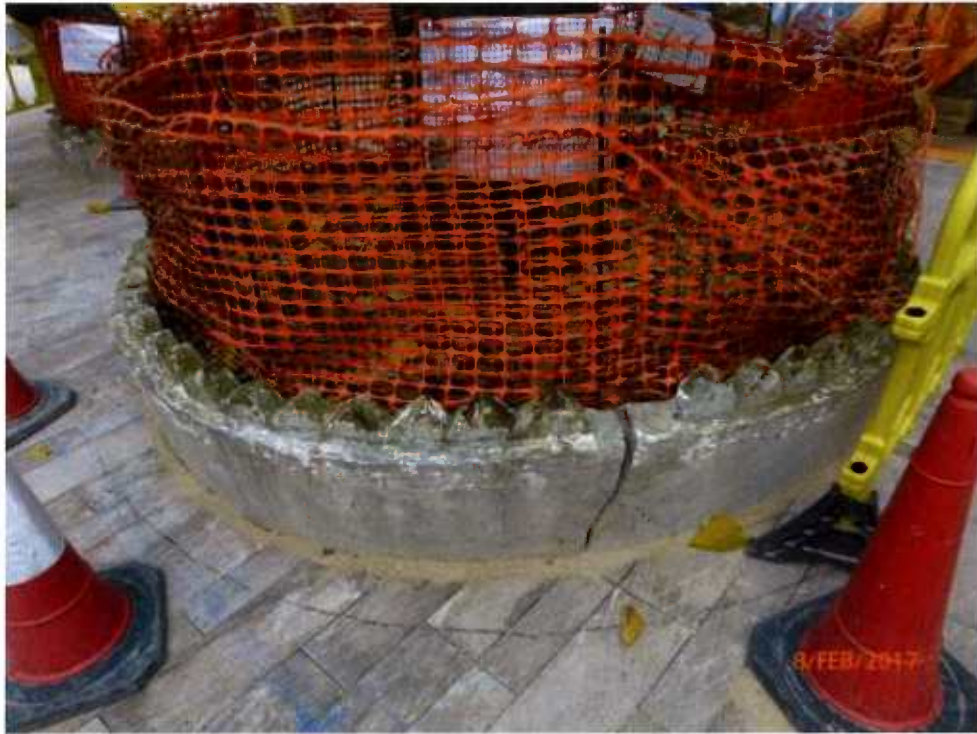
Fig. 10 The tree protection zone is in good order.

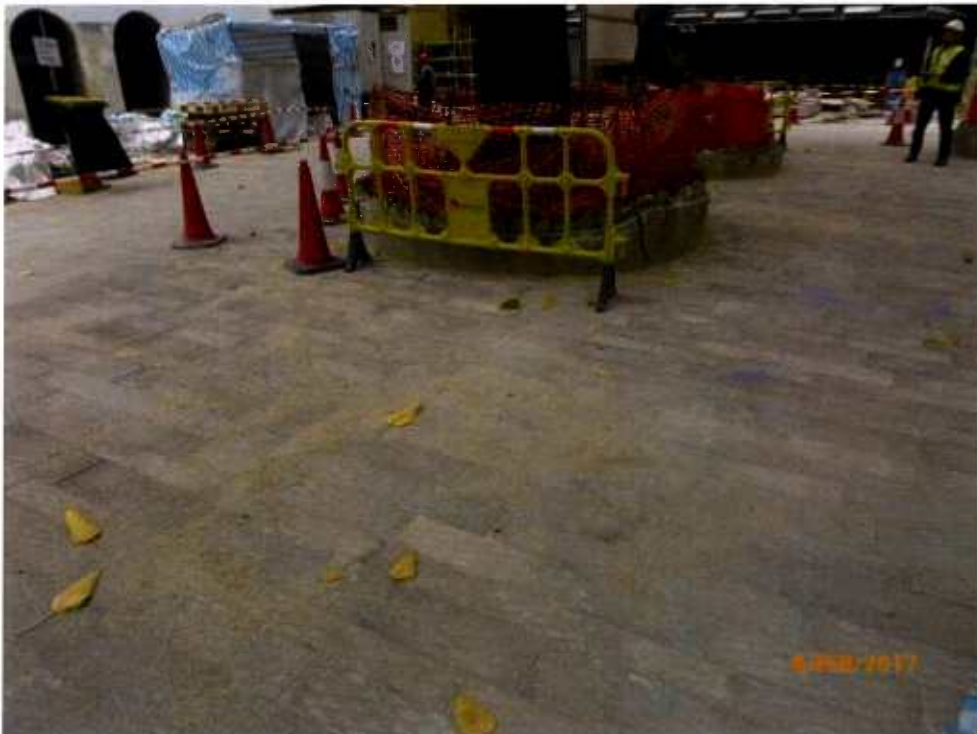
Fig. 11 The site near the tree appears clean and tidy.

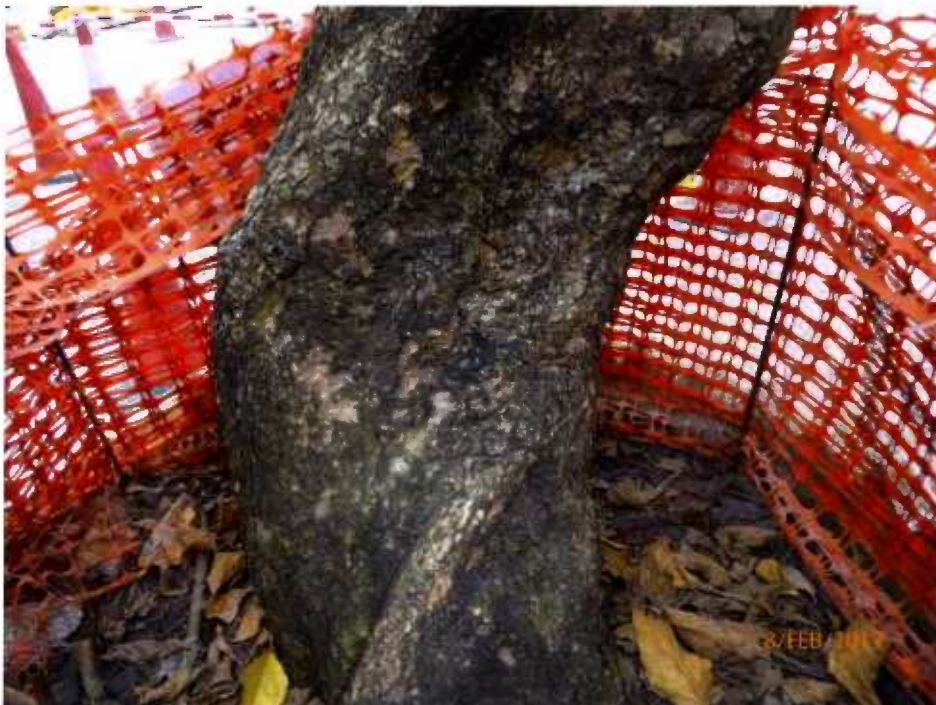
Fig. 4 Health condition of the mid trunk is fair.

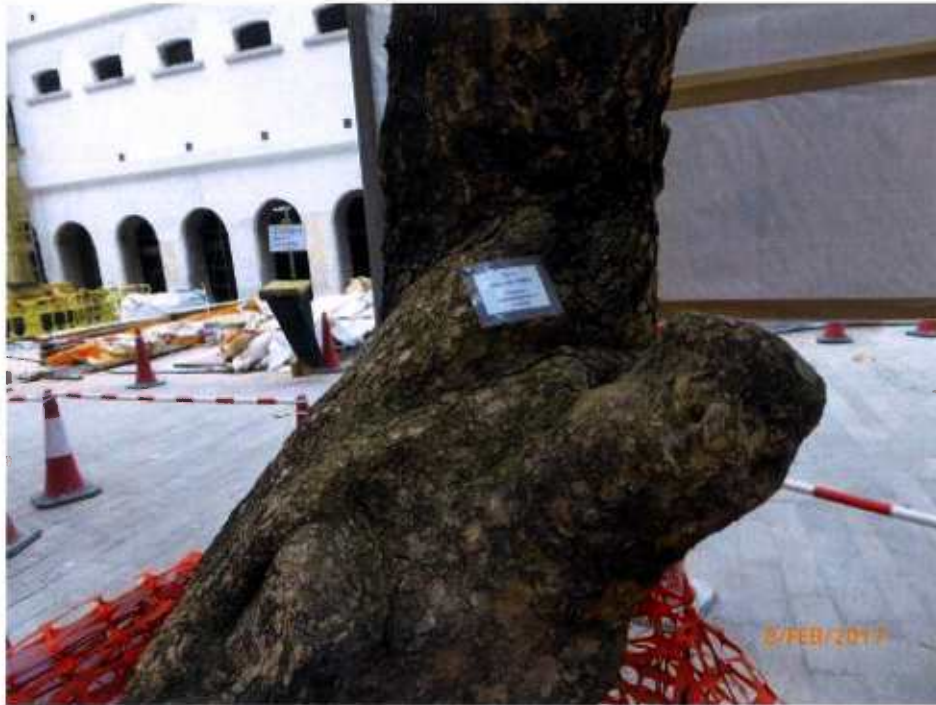
Fig. 5 Health condition of the upper trunk is fair..

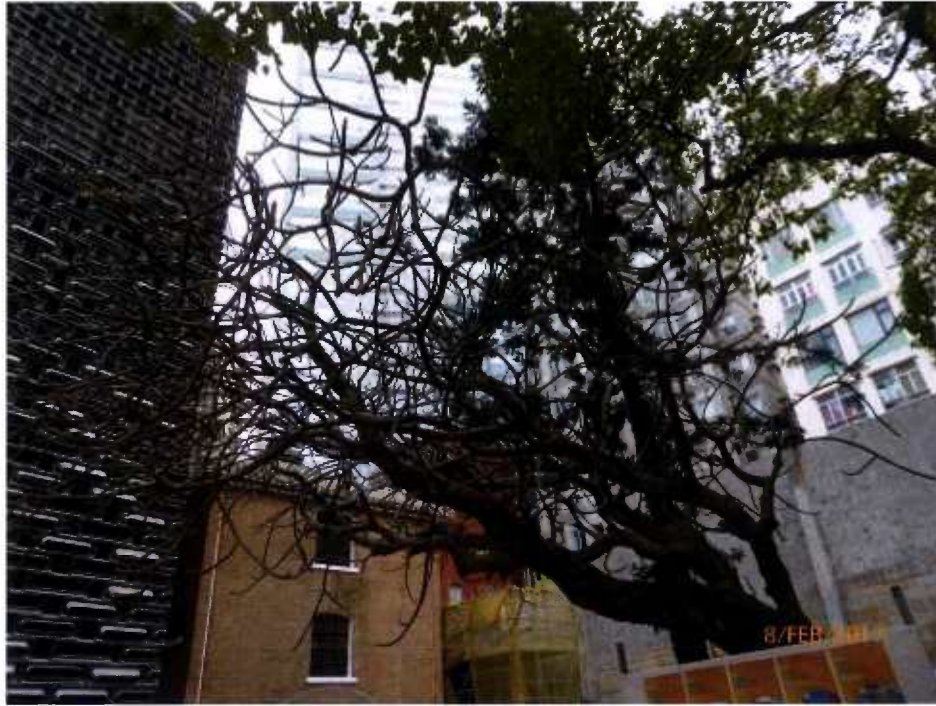
Fig. 7 Only a few leaves still remain on the tree.

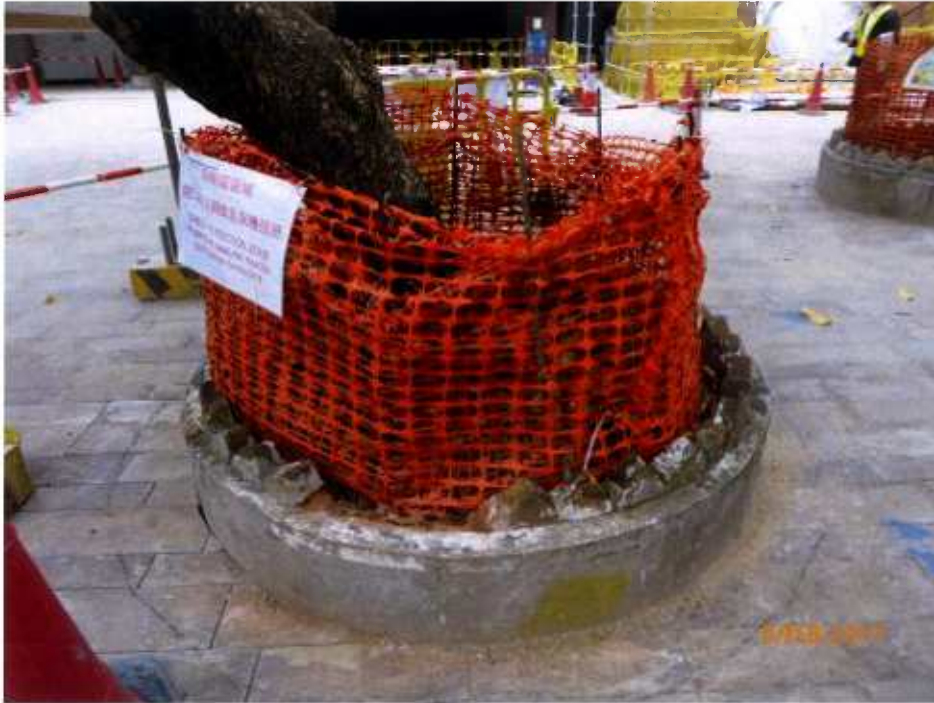
Fig. 9 The site near the tree is clean and tidy.

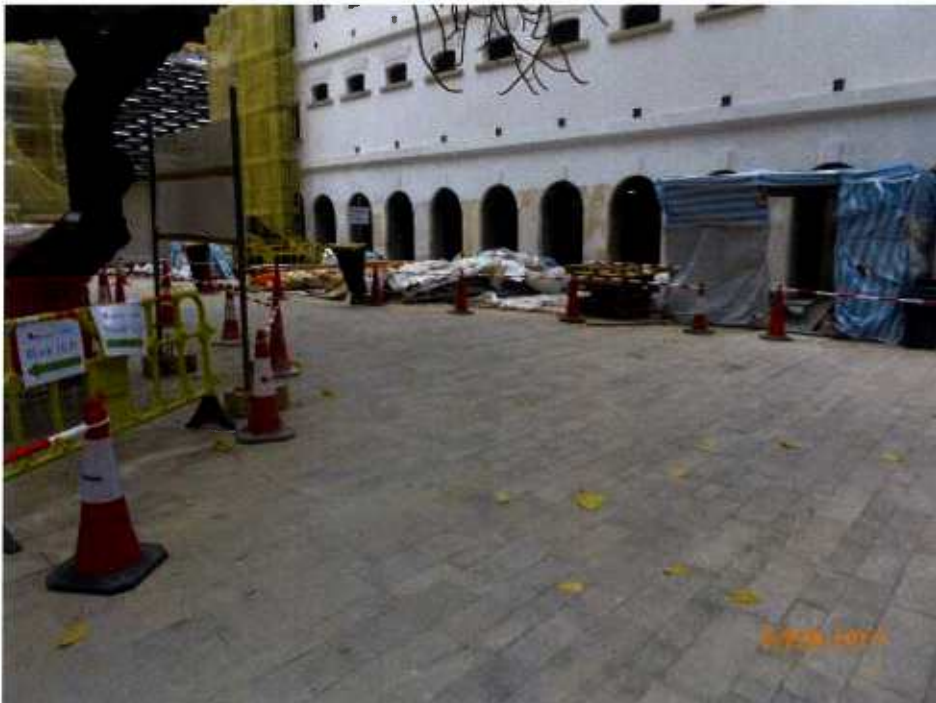
Fig. 10 Overall view of Tree-8 during inspection on 8th February 2017.

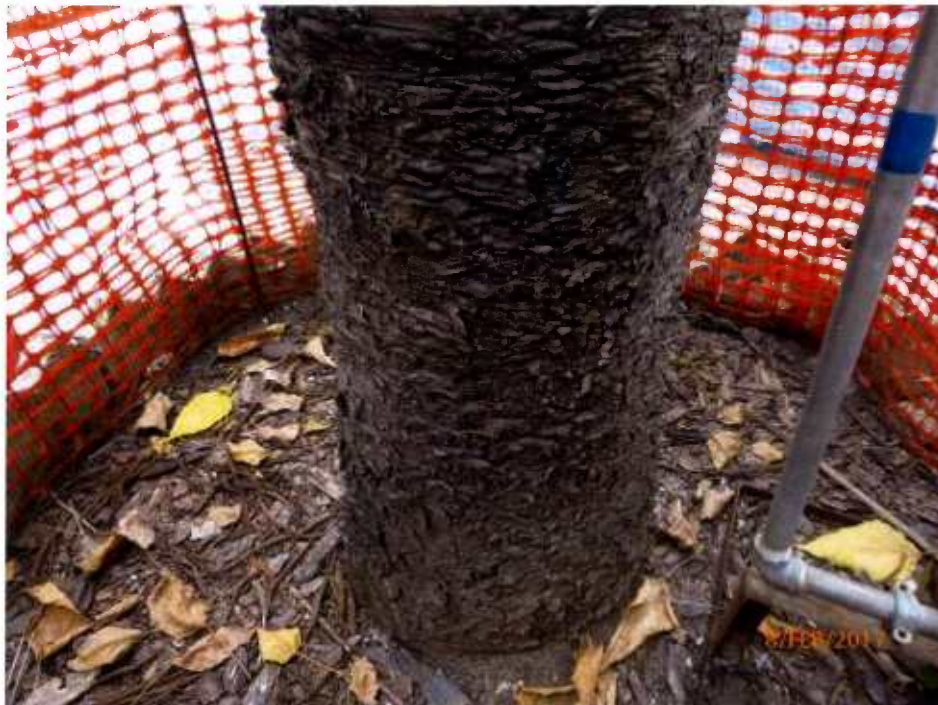
Fig. 4 Health condition of the mid trunk is fair.

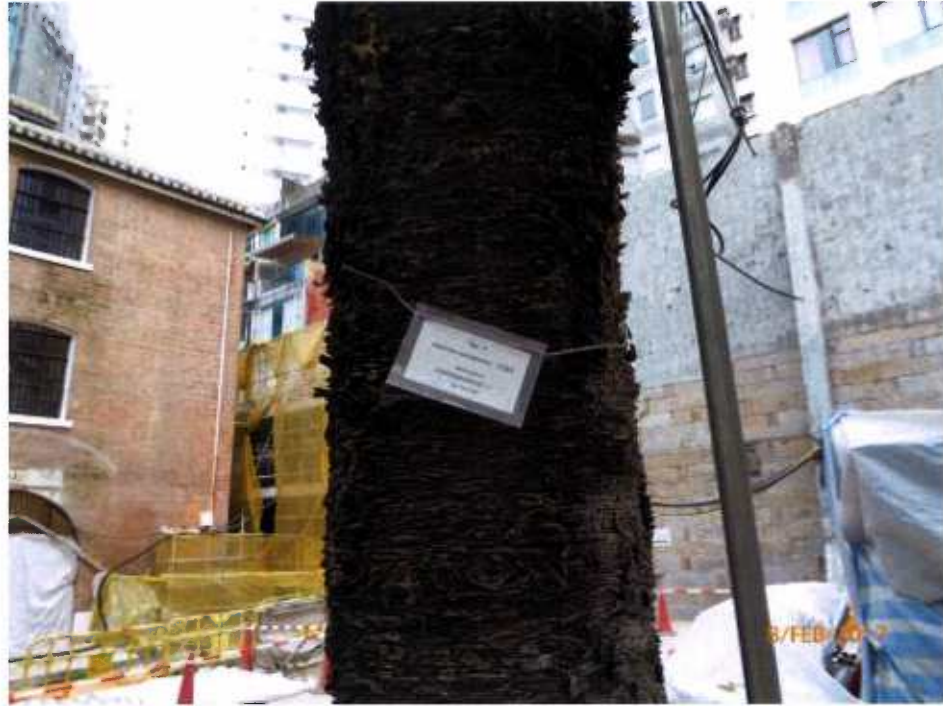
Fig. 5 Health condition of the upper trunk also is fair.

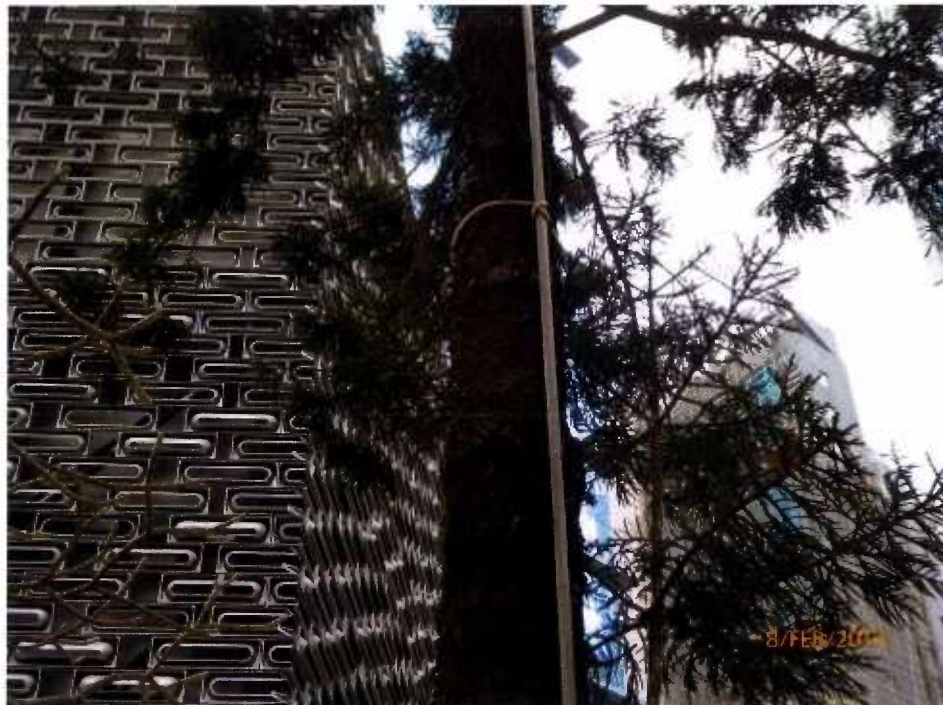
Fig. 6 The crown is full of vigorous and green leaves.

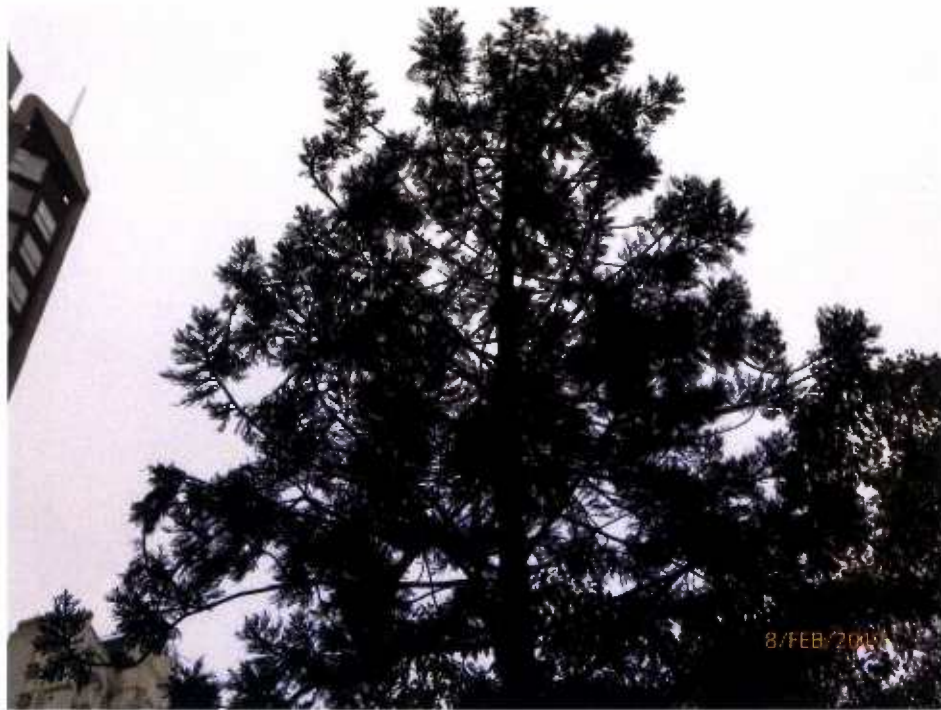
Fig. 7 Vigorous and green leaves also are growing on the lower branches.

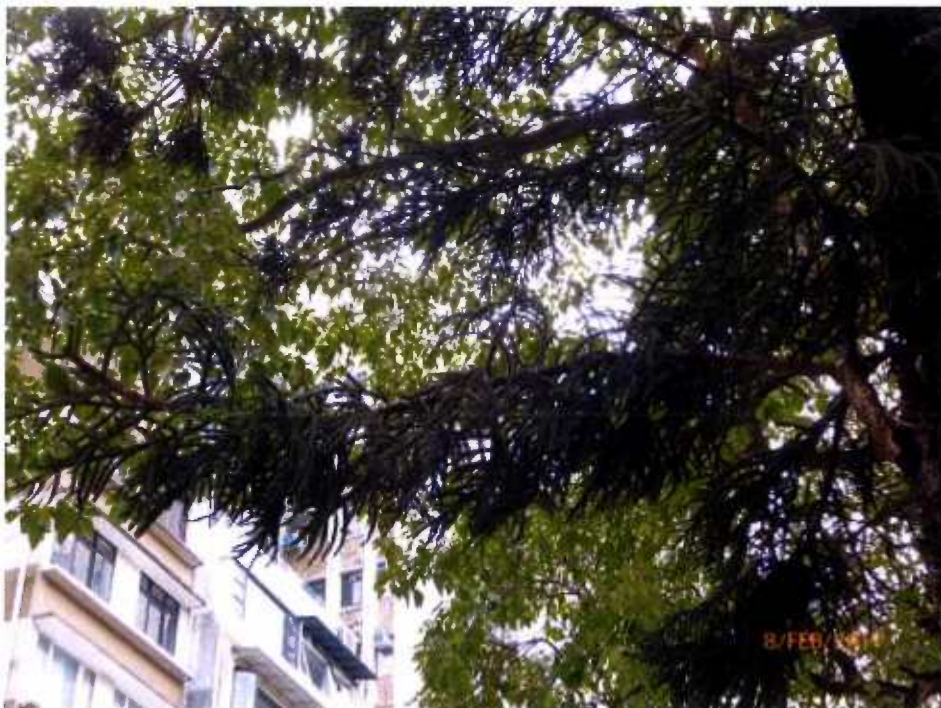
Fig. 8 The fresh fruit still appears on the tree.
