Central Police Station Conservation
and Revitalisation Project:
65th Monthly EM&A Report
(1 March to 31 March 2017)

Issue Date: April 2017

Environmental Resources Management

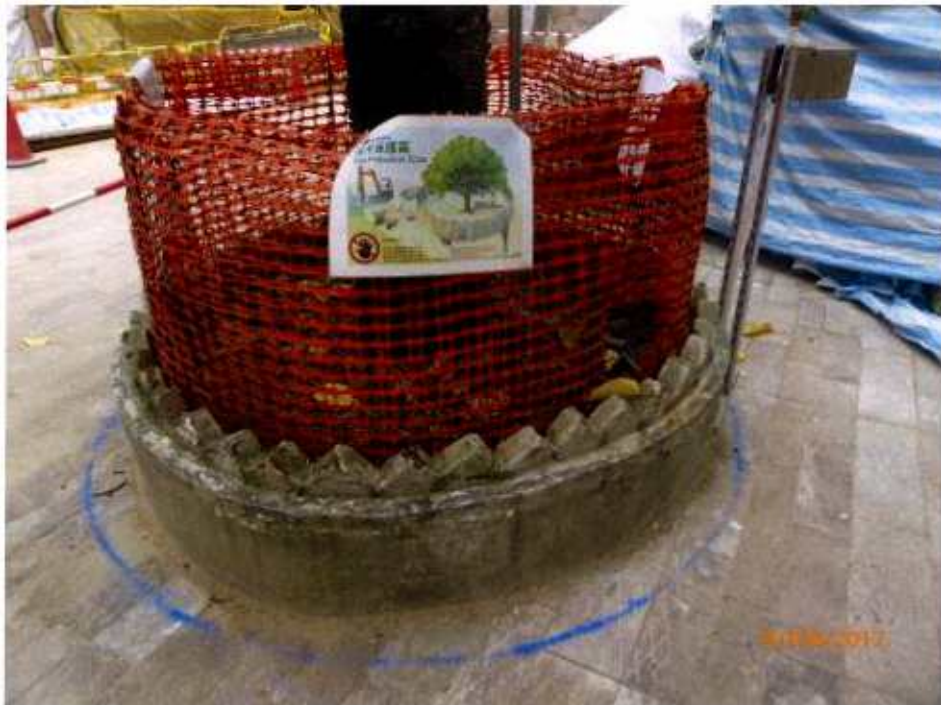
Fig. 10 The site near the planter is clean and tidy.

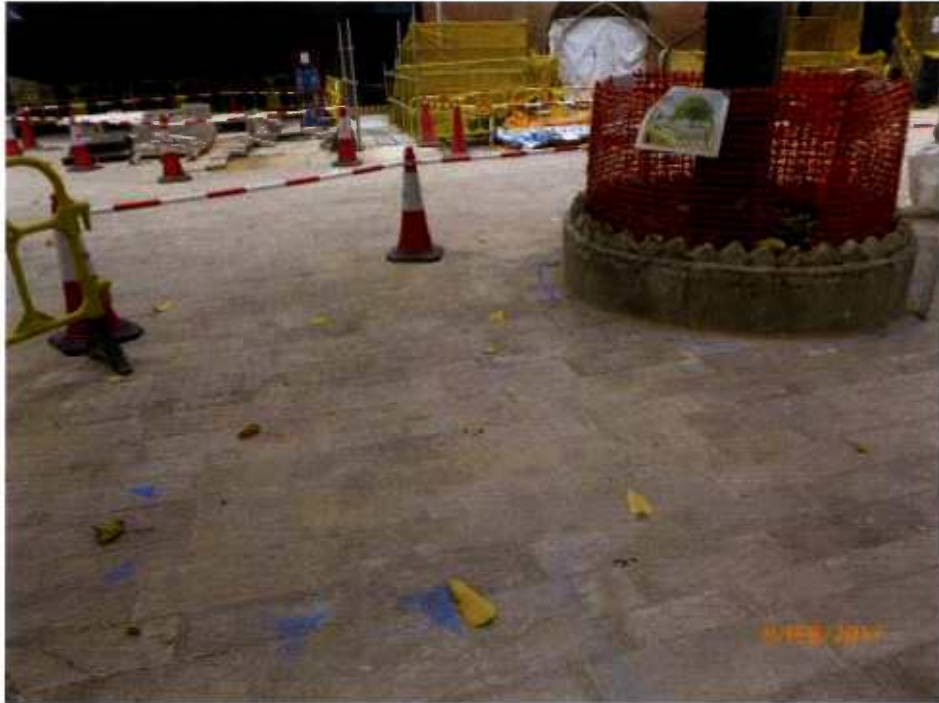
Fig. 11 The access near the tree also appears clean and tidy.

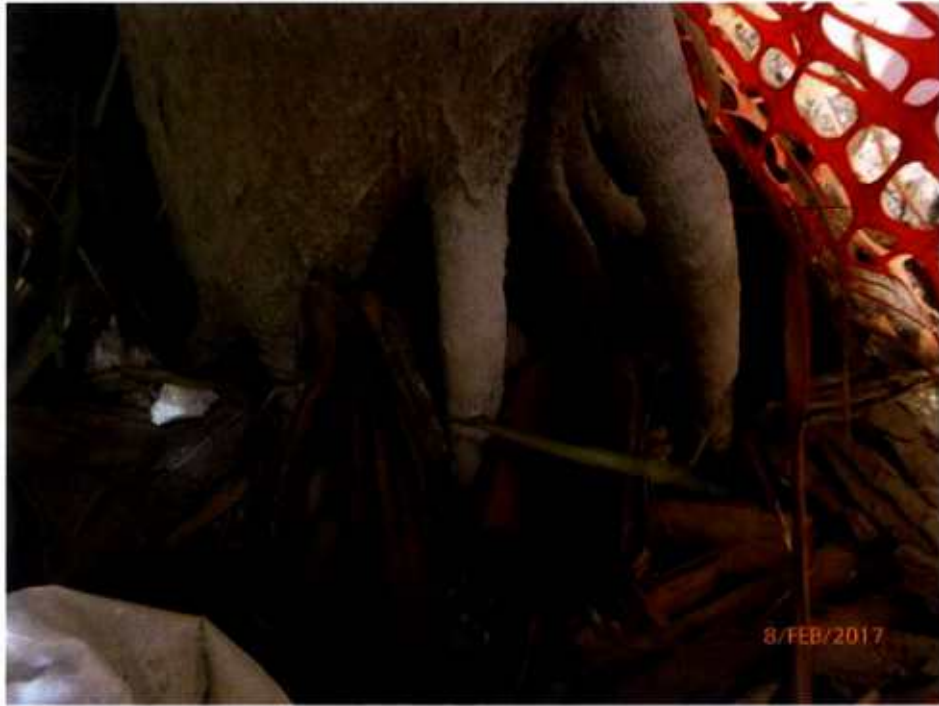
Fig. 3 A few construction debris remain at the planter.

1. To remove the construction debris away from the planter.
2. To keep close monitoring on the growth of the tree.

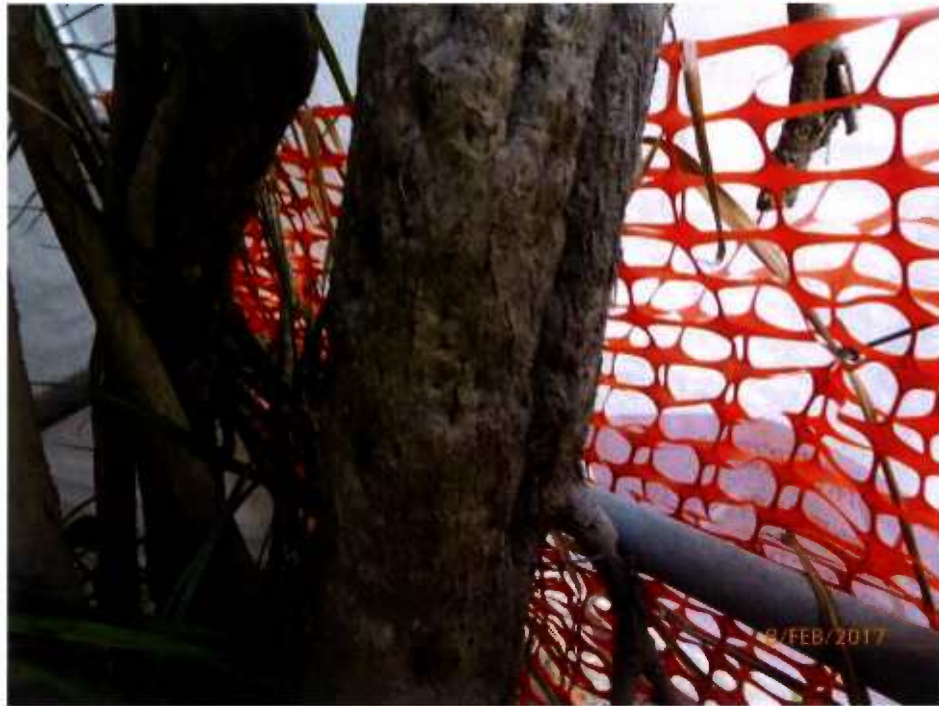
Fig. 5 Health condition of the mid trunk is fair.

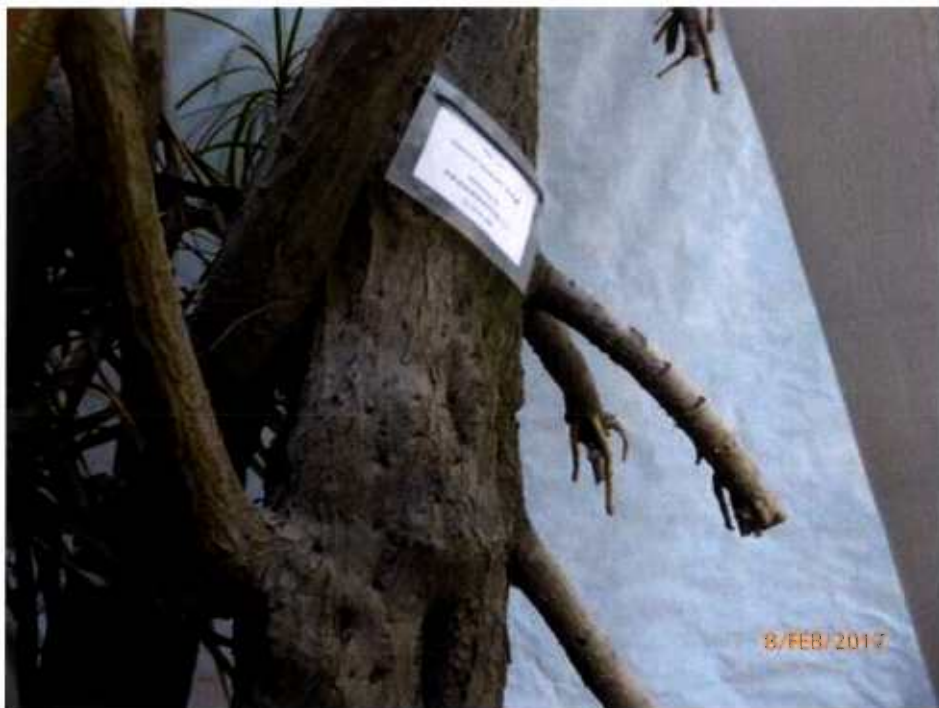
Fig. 6 Health condition of the upper trunk also is fair..

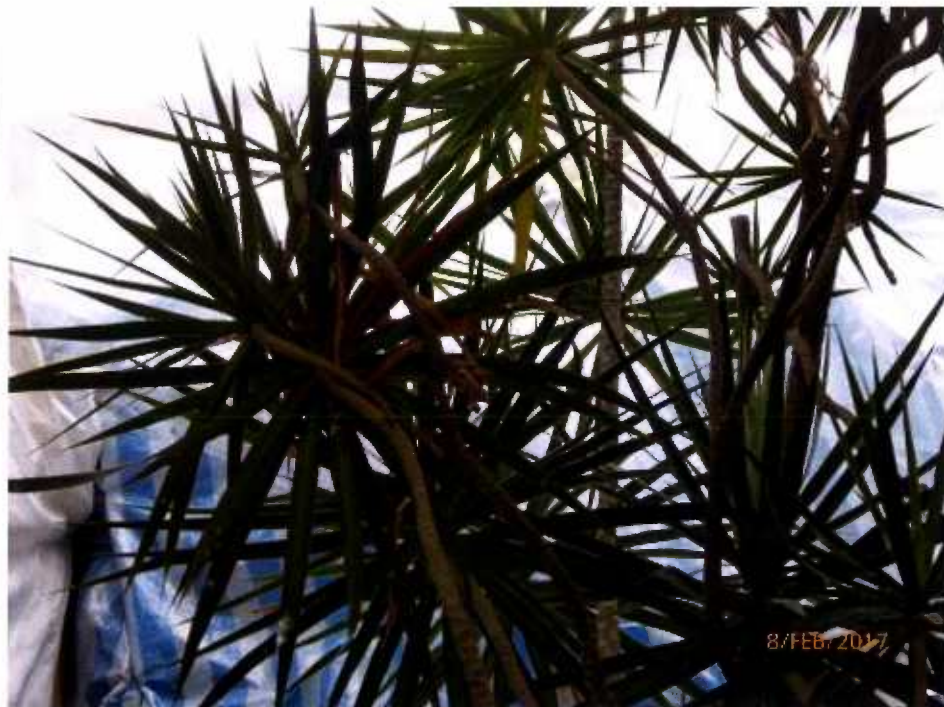
Fig. 8 Some withered leaves also appear on the lower branches.

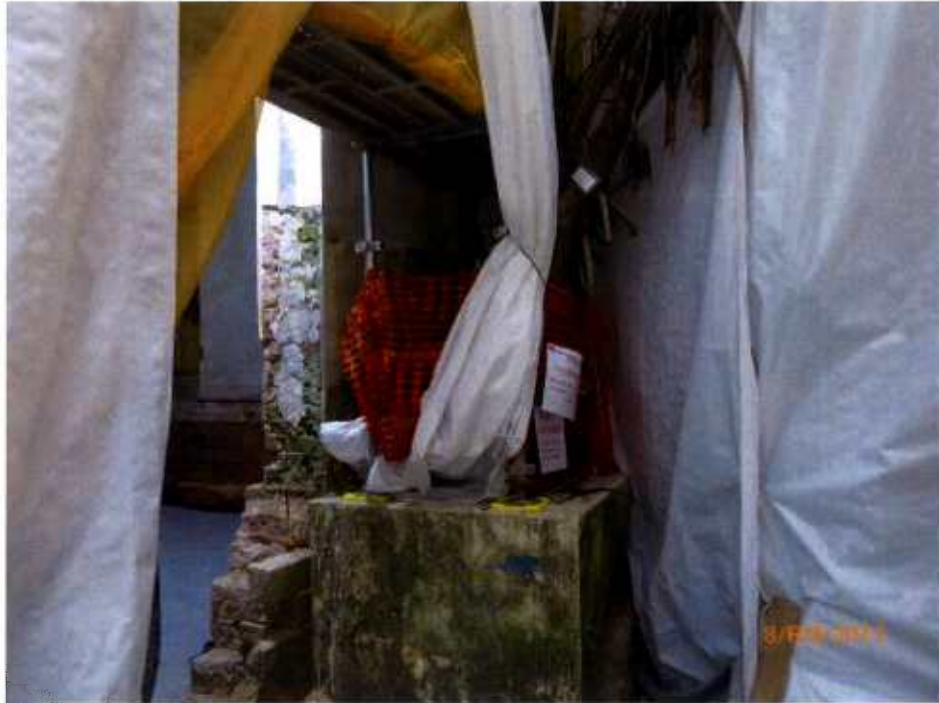
Fig. 11 Renovation works are in progress near Tree-11.

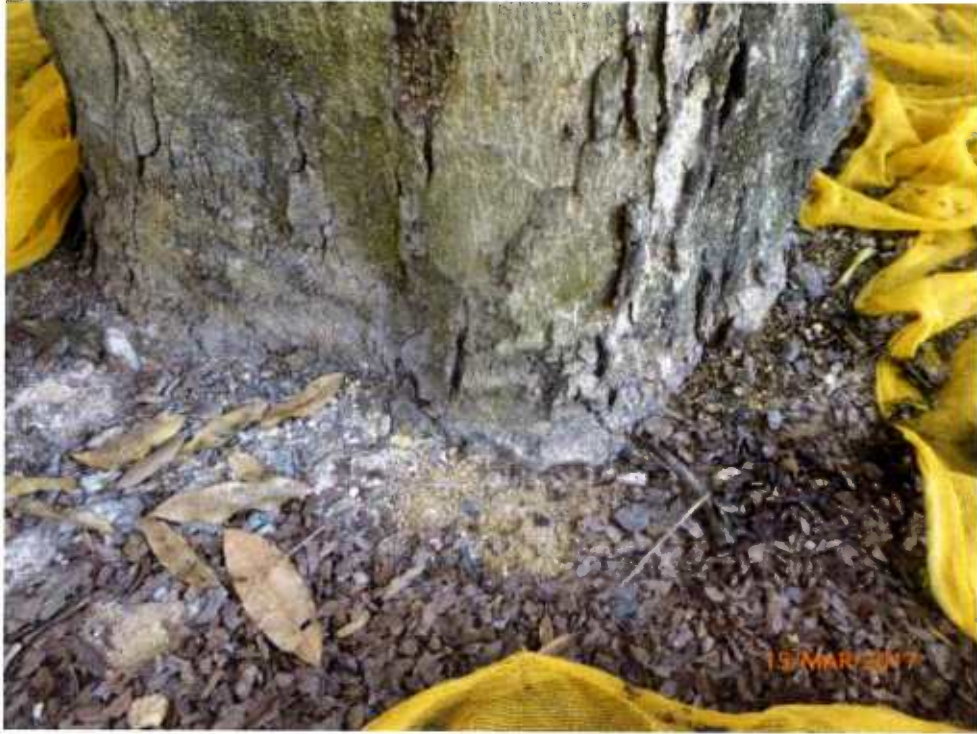
Fig. 3 Health condition of the lower trunk is fair.

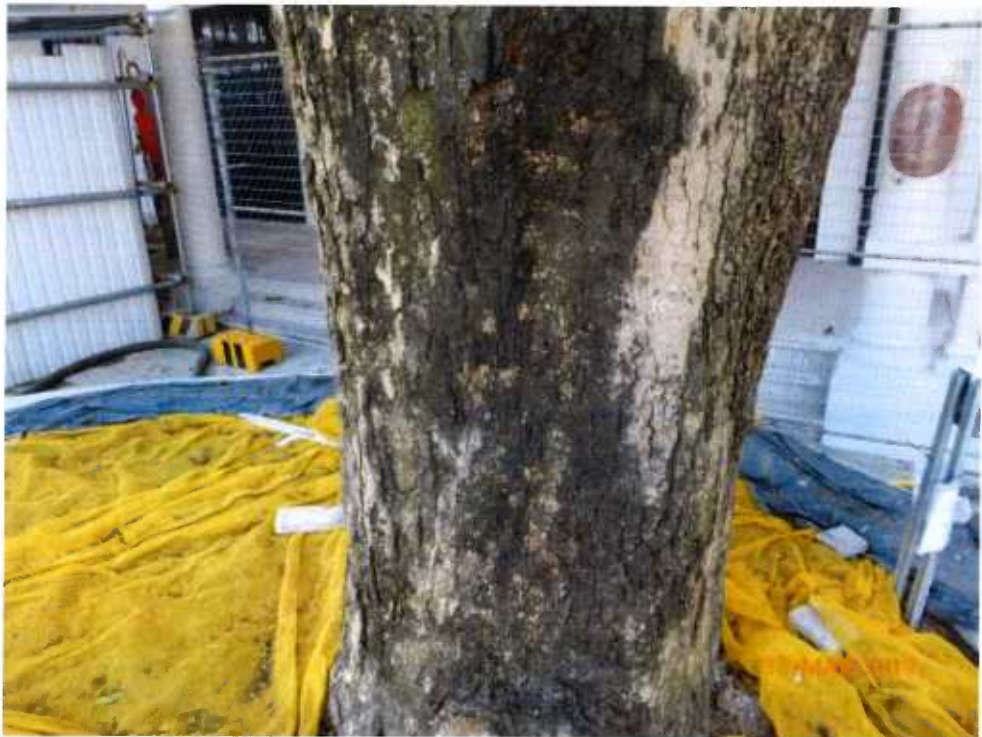
Fig. 4 Health condition of the mid trunk is fair.

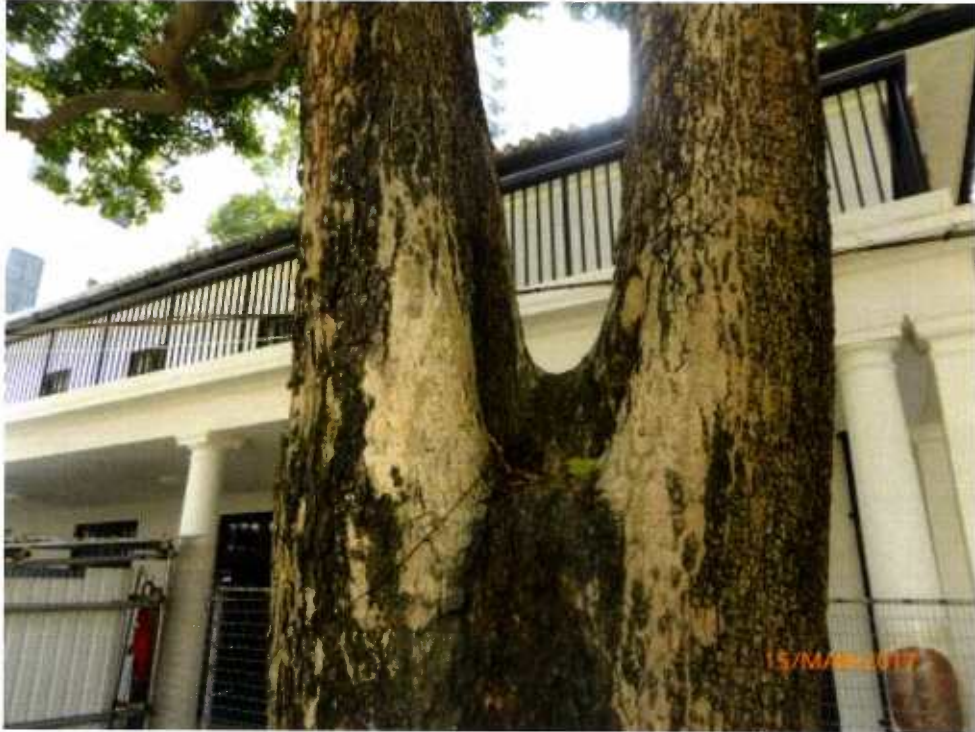
Fig. 5 Health condition of the upper trunk also is fair.

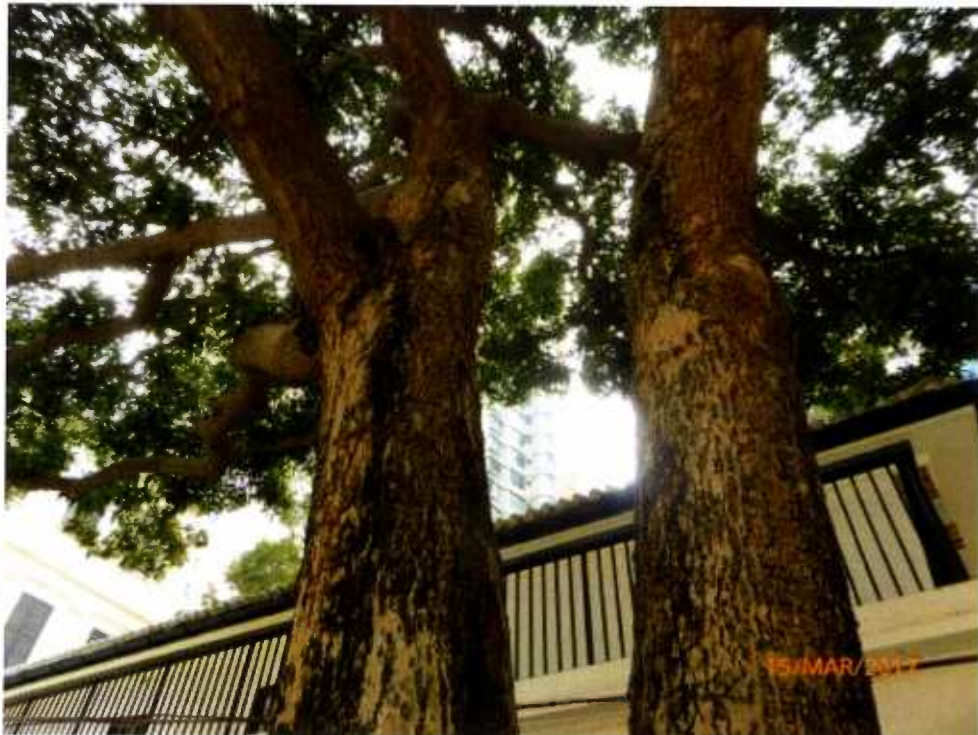
Fig. 6 The crown is full of vigorous and green leaves.

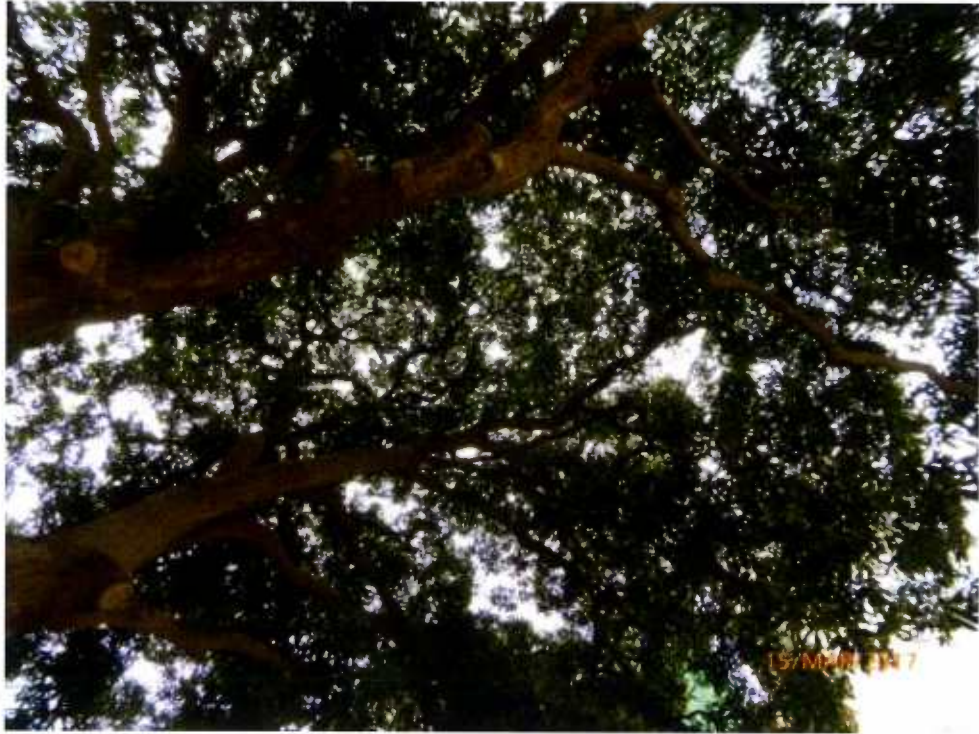
Fig. 7 Vigorous and green leaves also appear on the lower branches.

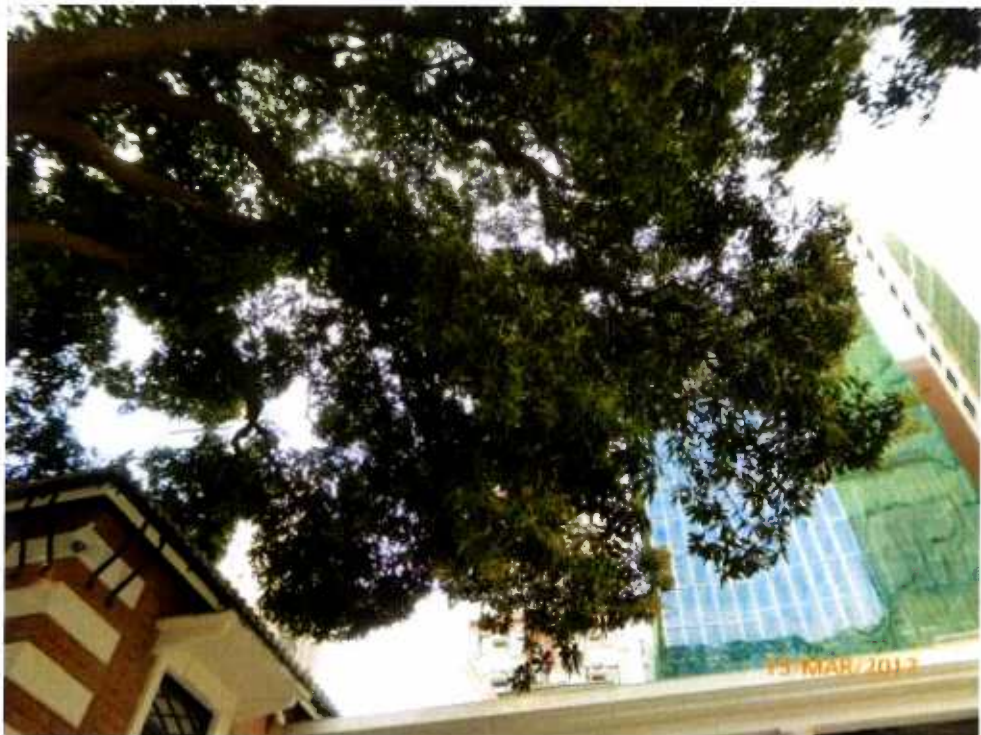
Fig. 8 Lots of flower appear on the tree.

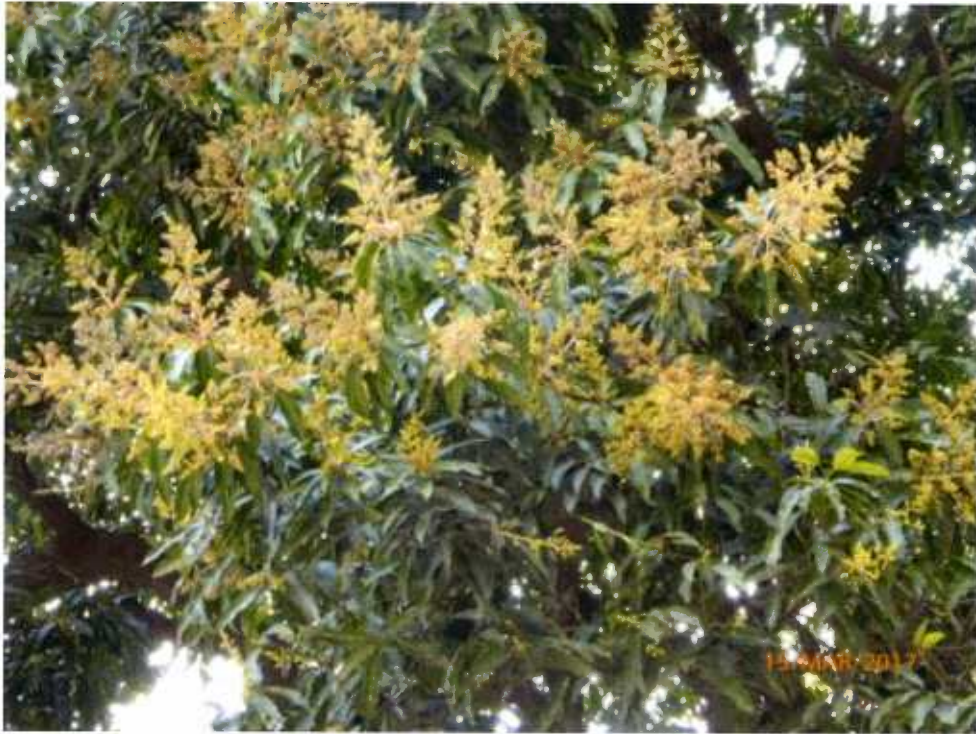
Fig. 9 Topsoil has been backfilled at the planter by December 2016.

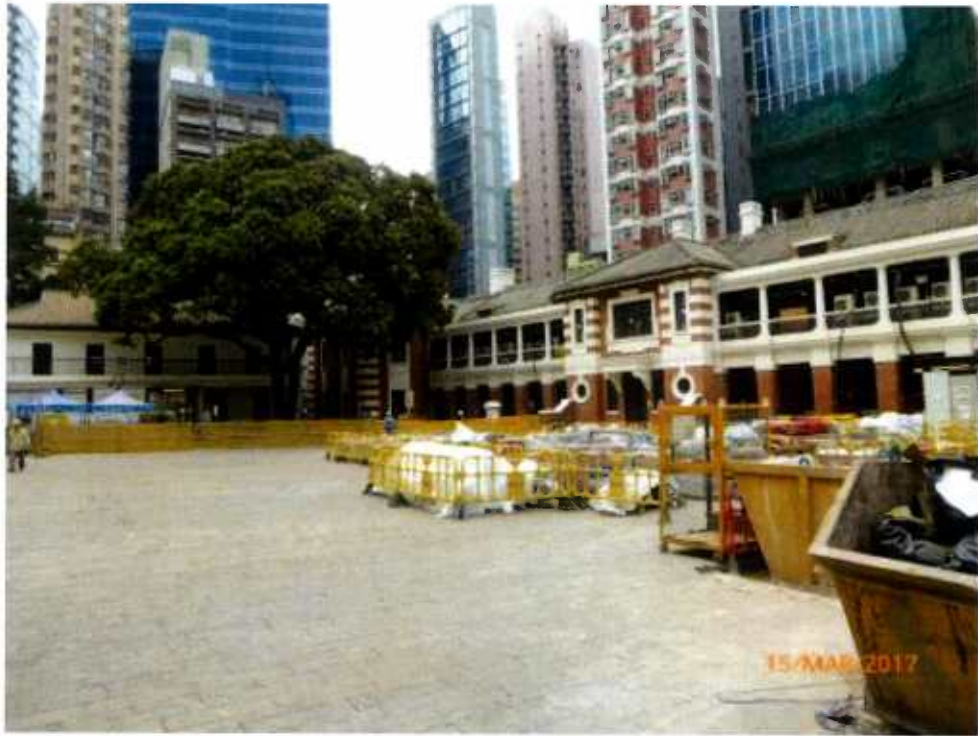
Fig. 11 The access near Tree-5 also is clean and tidy.

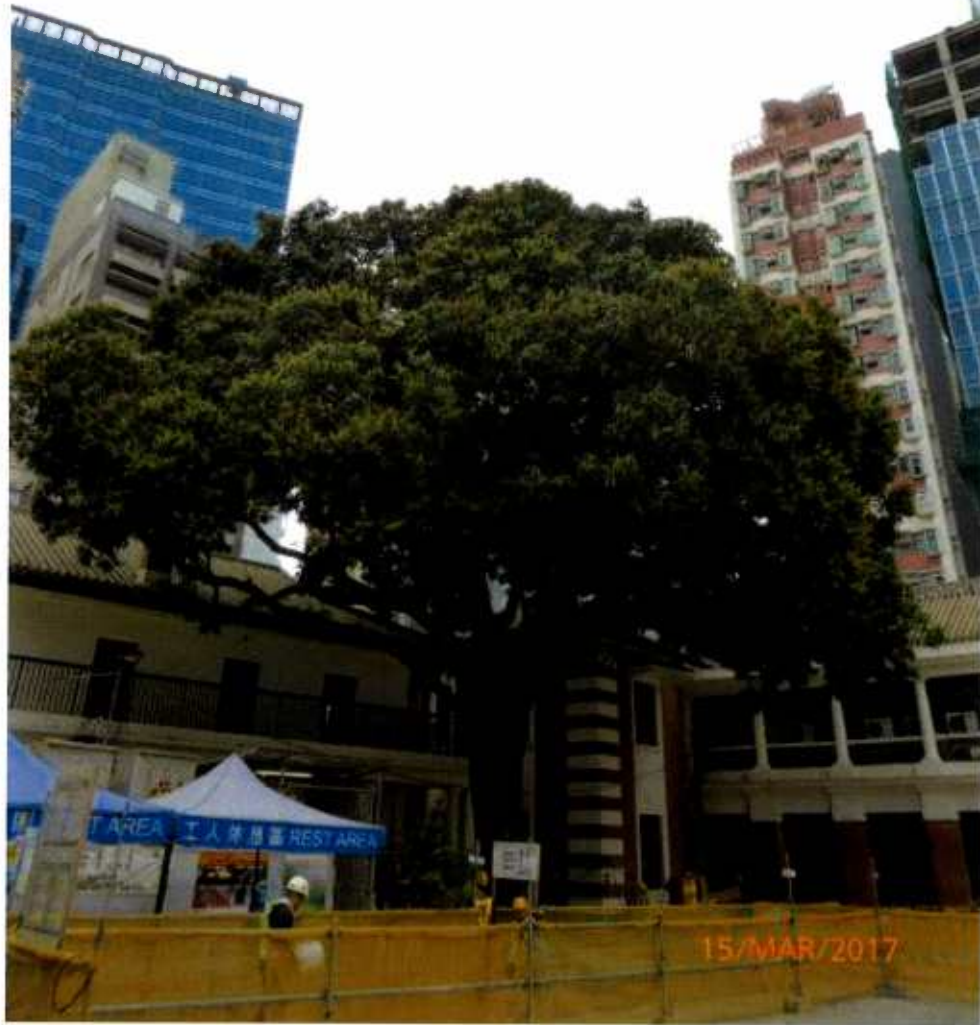
Fig. 12 Overall view of Tree-5 during inspection on 15th March 2017.

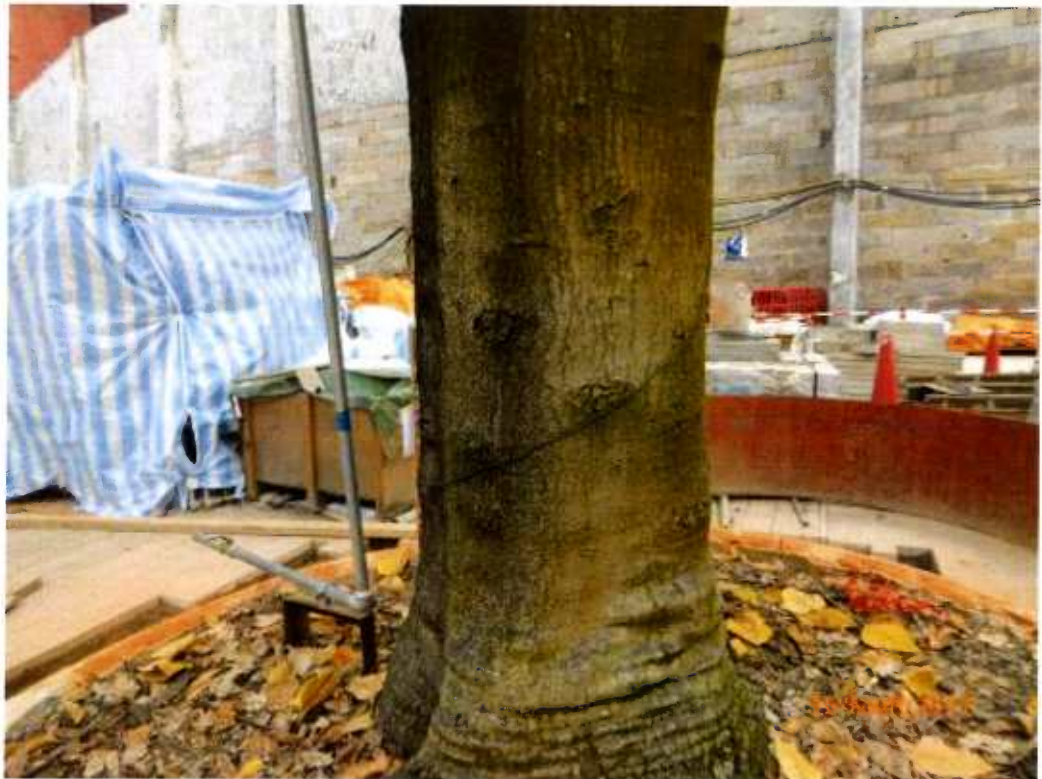
Fig. 4 Health condition of the mid trunk is fair.

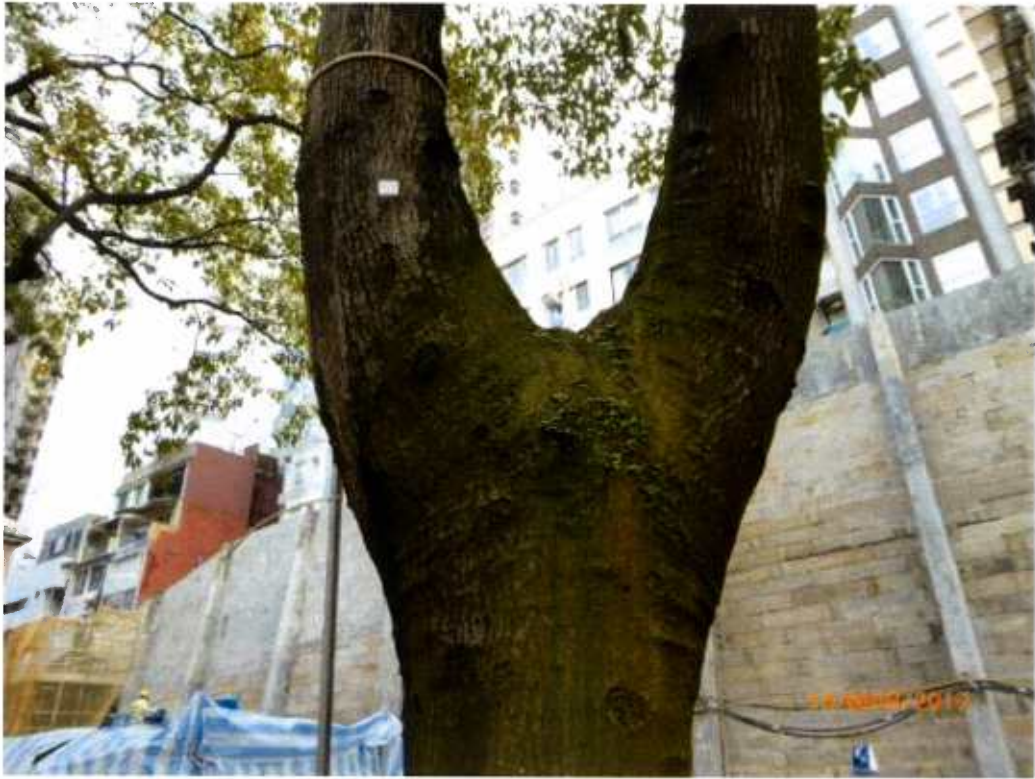
Fig. 5 Health condition of the upper trunk also is fair.

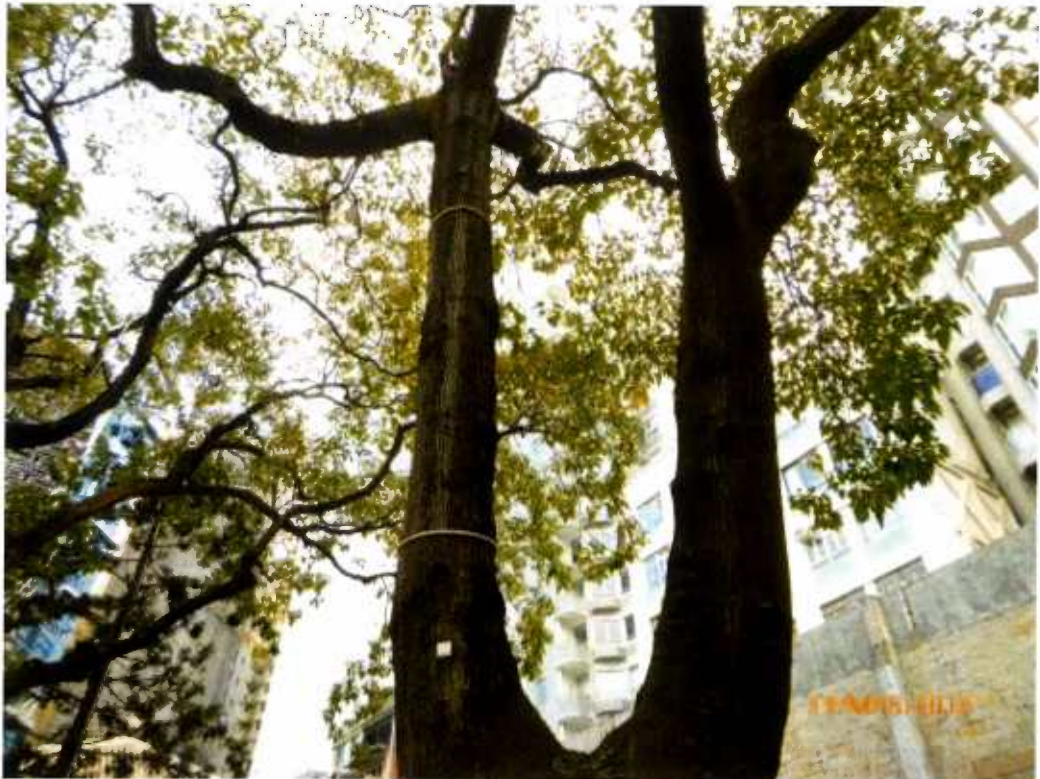
Fig. 6 The crown is full of vigorous and green leaves.

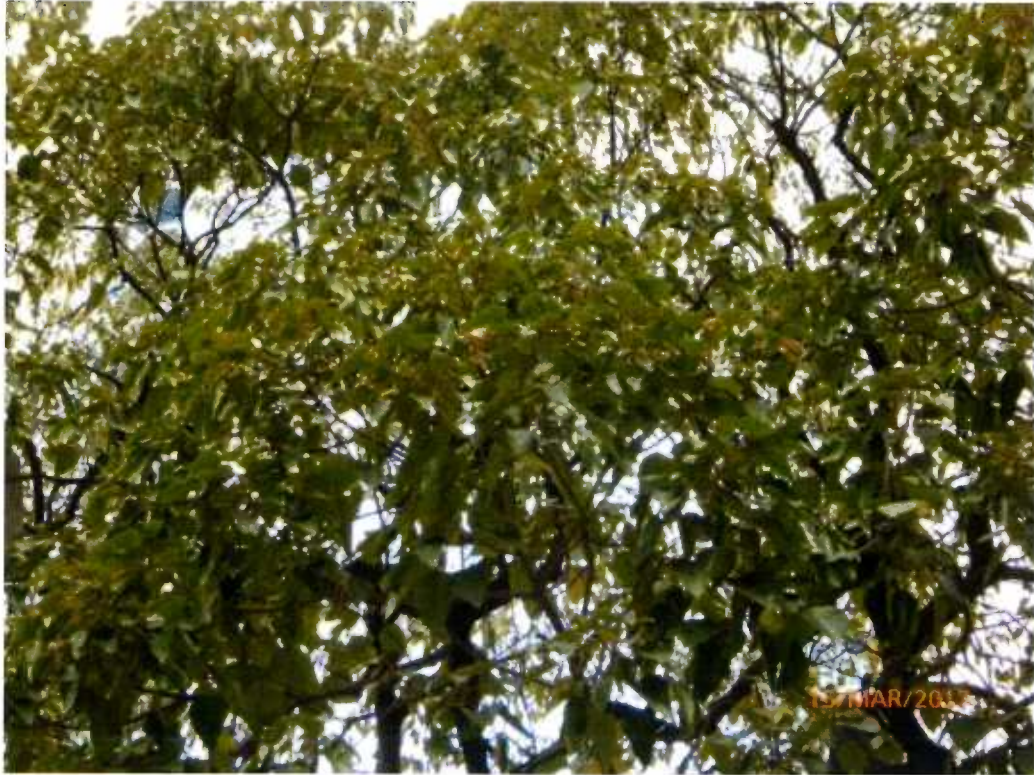
Fig. 7 Vigorous and green leaves also are growing on the lower branches.

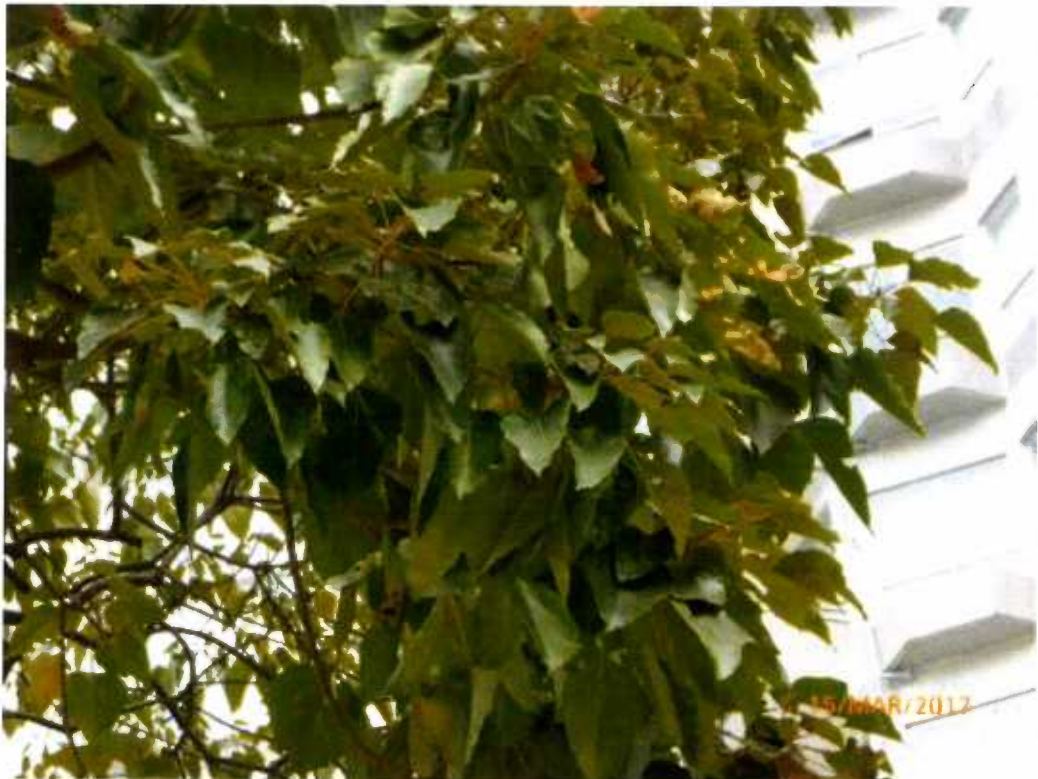
Fig. 8 Faded leaves still appear on the tree due to dry seasons.

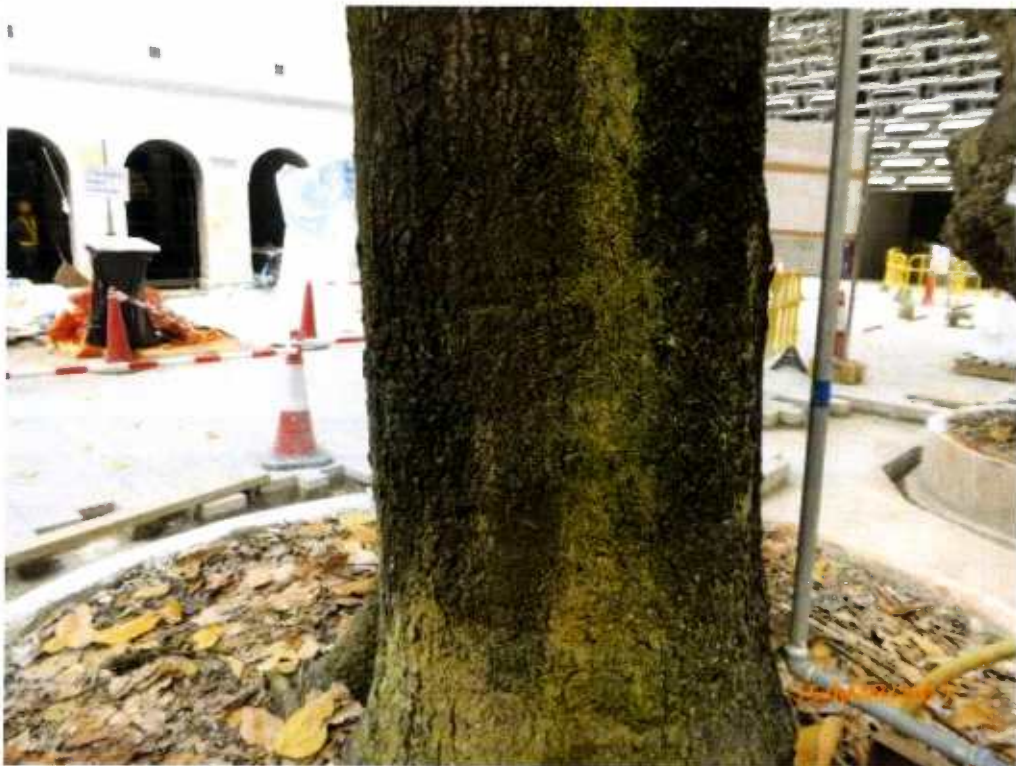
Fig. 4 Health condition of the mid trunk is fair.

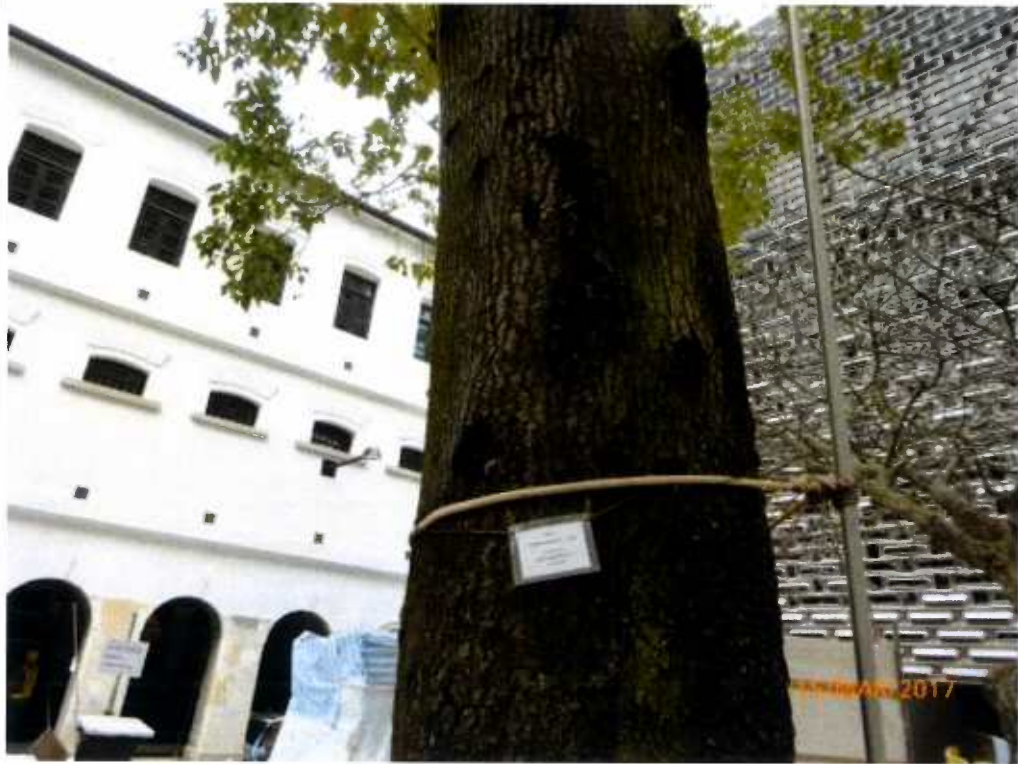
Fig. 5 Health condition of the upper trunk also is fair.

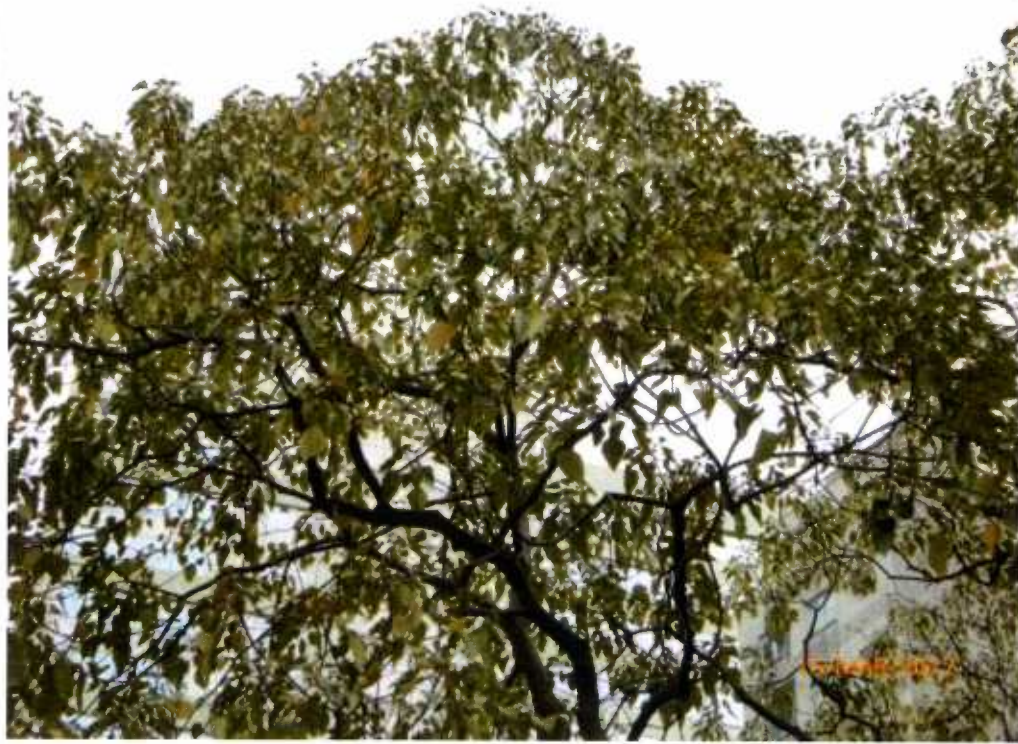
Fig. 7 Vigorous and green leaves also appear on the lower branches.

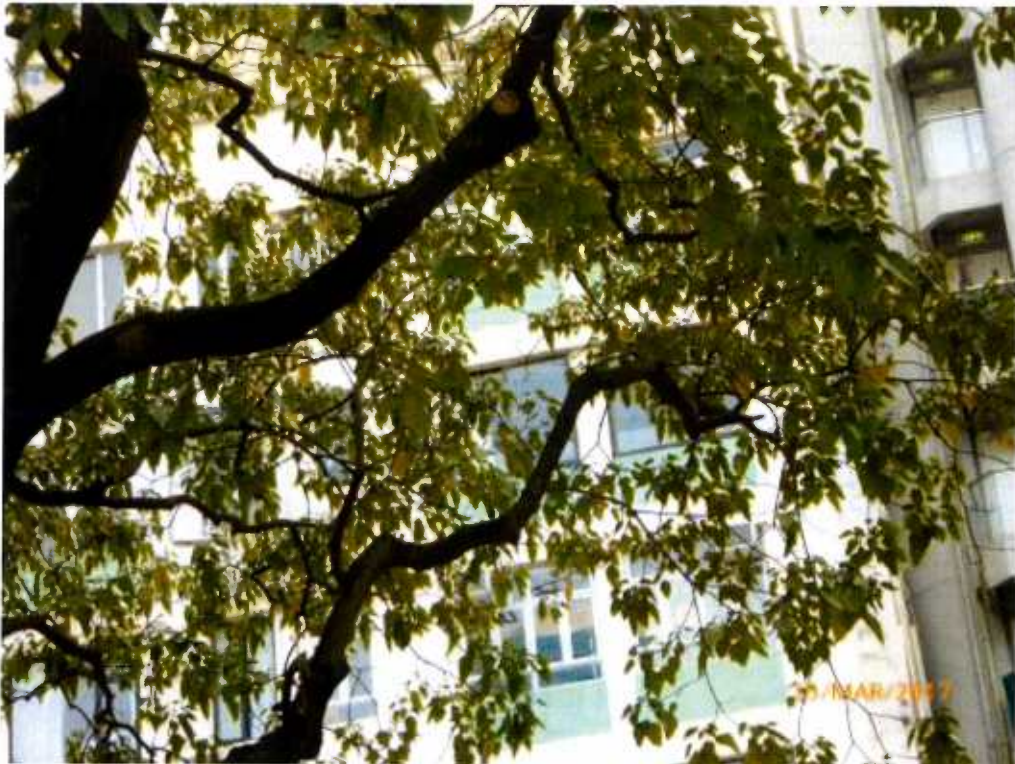
Fig. 8 Faded leaves still appear on the tree due to dry seasons.

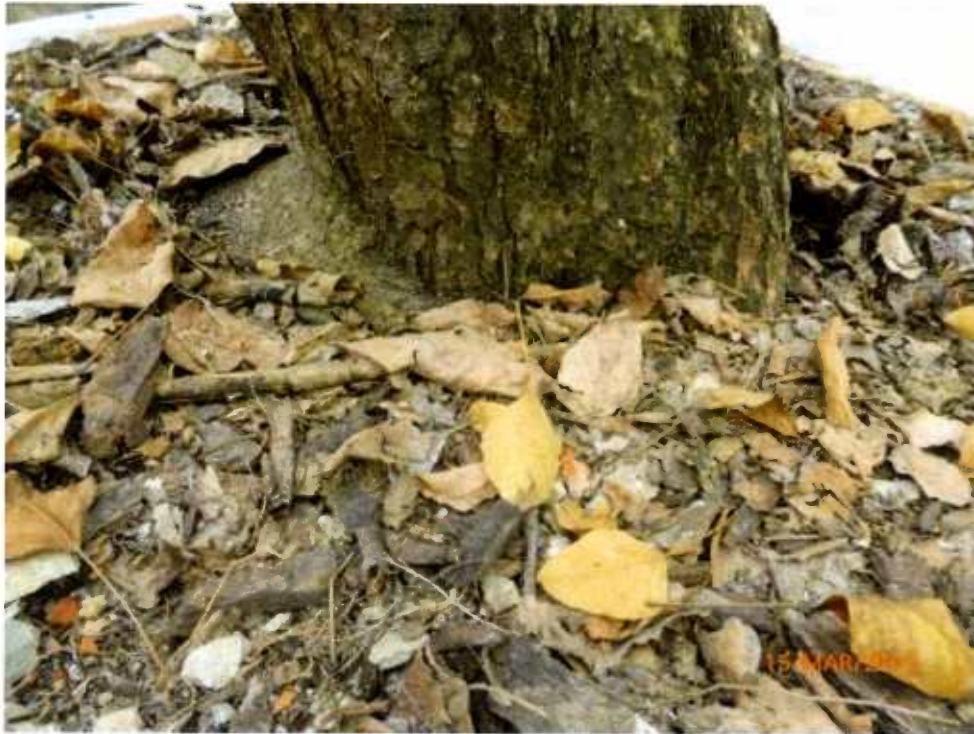
Fig. 3 Health condition of the lower trunk is fair.

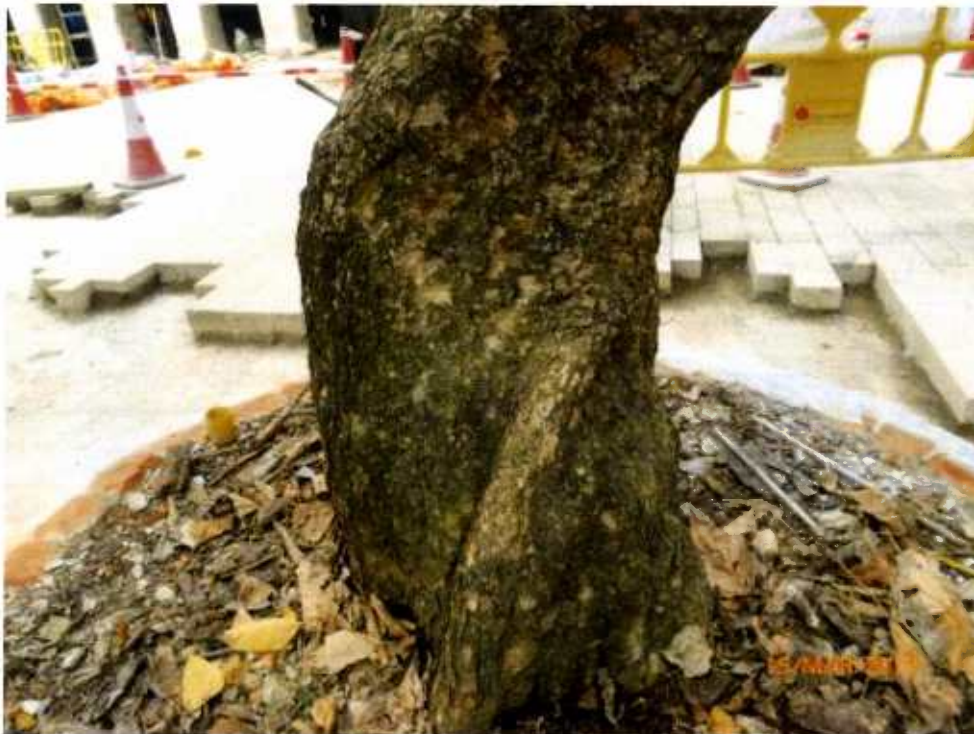
Fig. 4 Health condition of the mid trunk is fair.

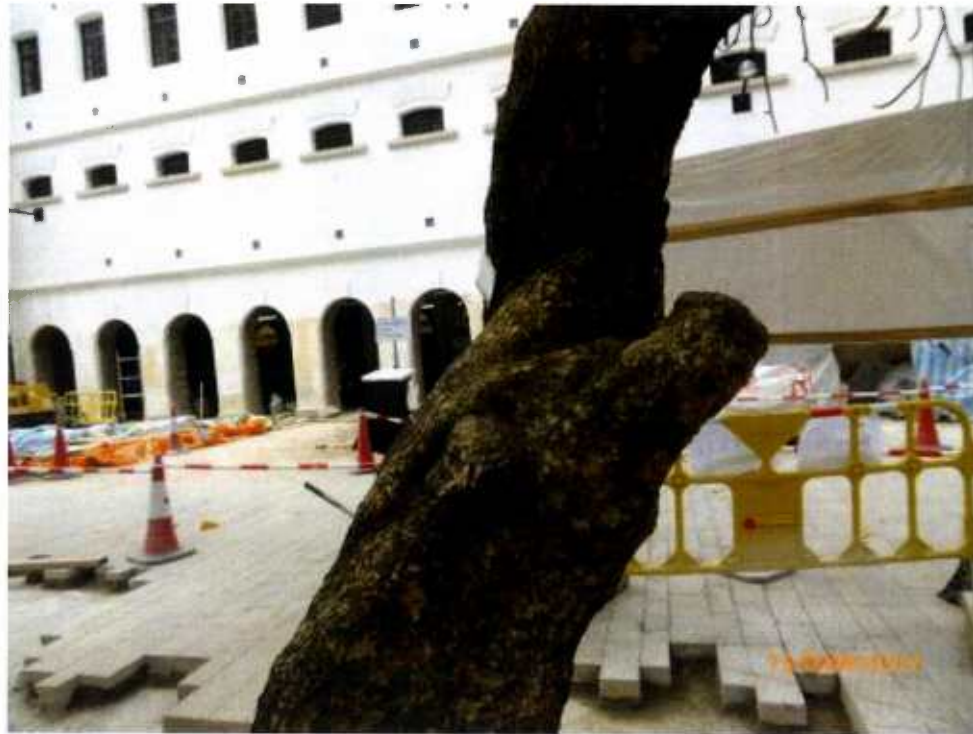
Fig. 5 Health condition of the upper trunk is fair..

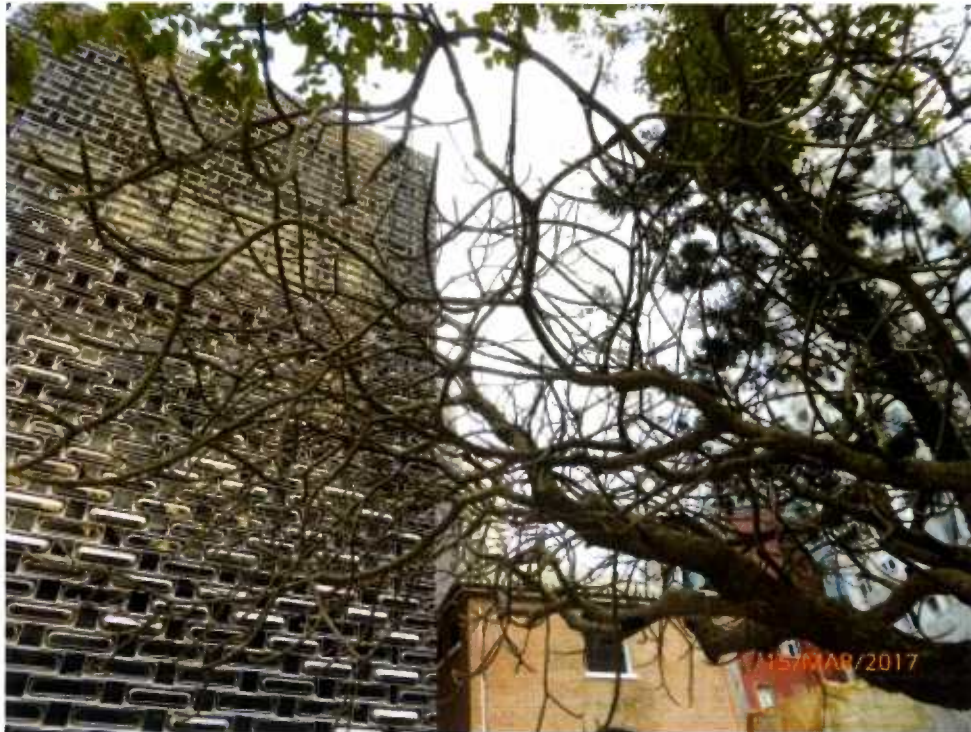
Fig. 7 Fresh buds appear on the tree.

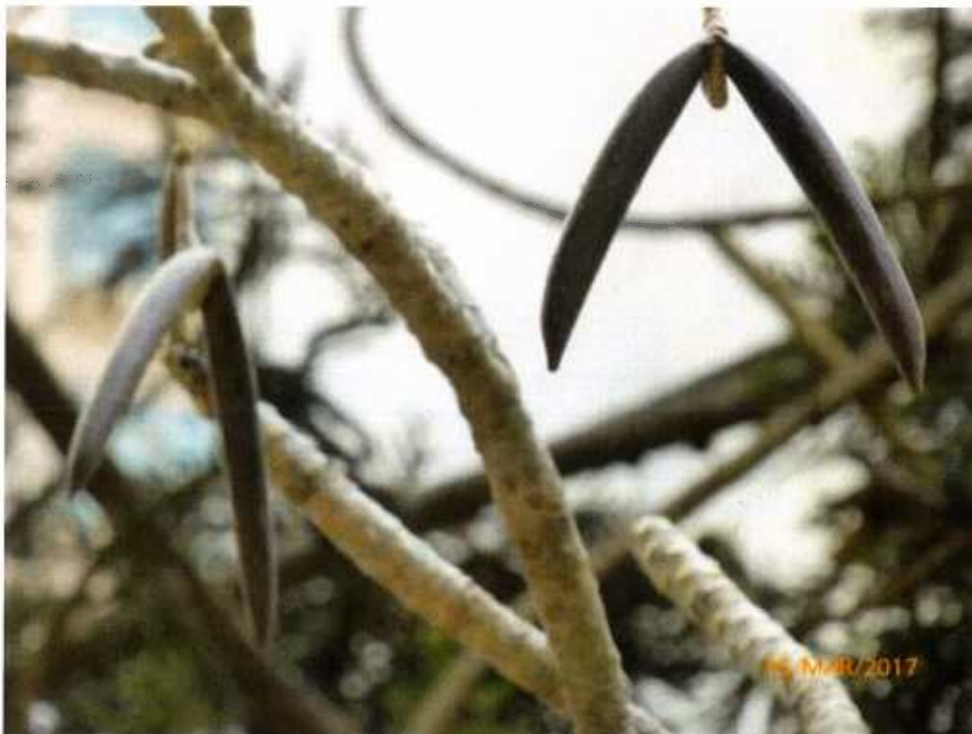
Fig. 8 The planter is being re-built.
