Central Police Station Conservation
and Revitalisation Project:
65th Monthly EM&A Report
(1 March to 31 March 2017)

Issue Date: April 2017

Environmental Resources Management

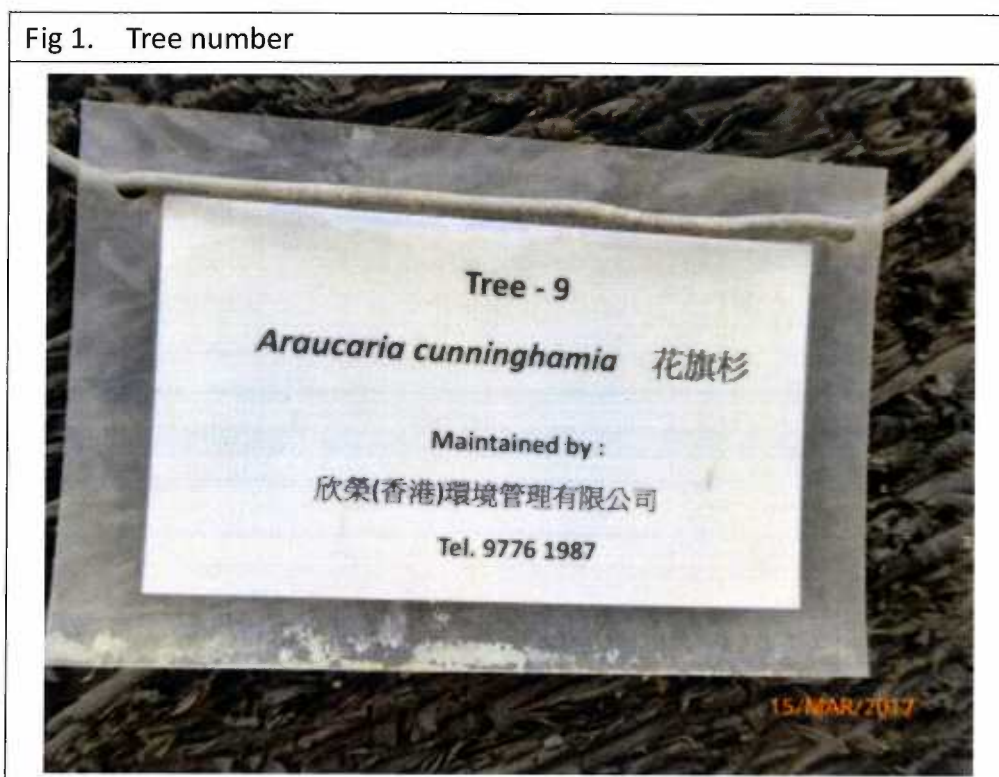
Fig 2. Root collar is normal. The planter is covered with mulch and leaves.

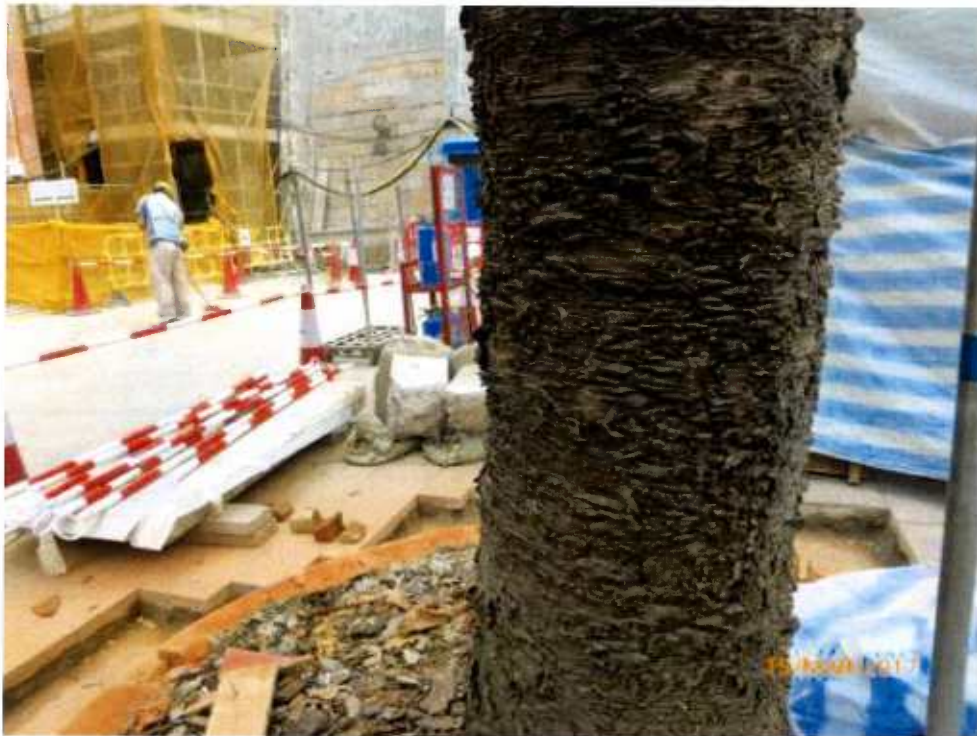
Fig. 4 Health condition of the mid trunk is fair.

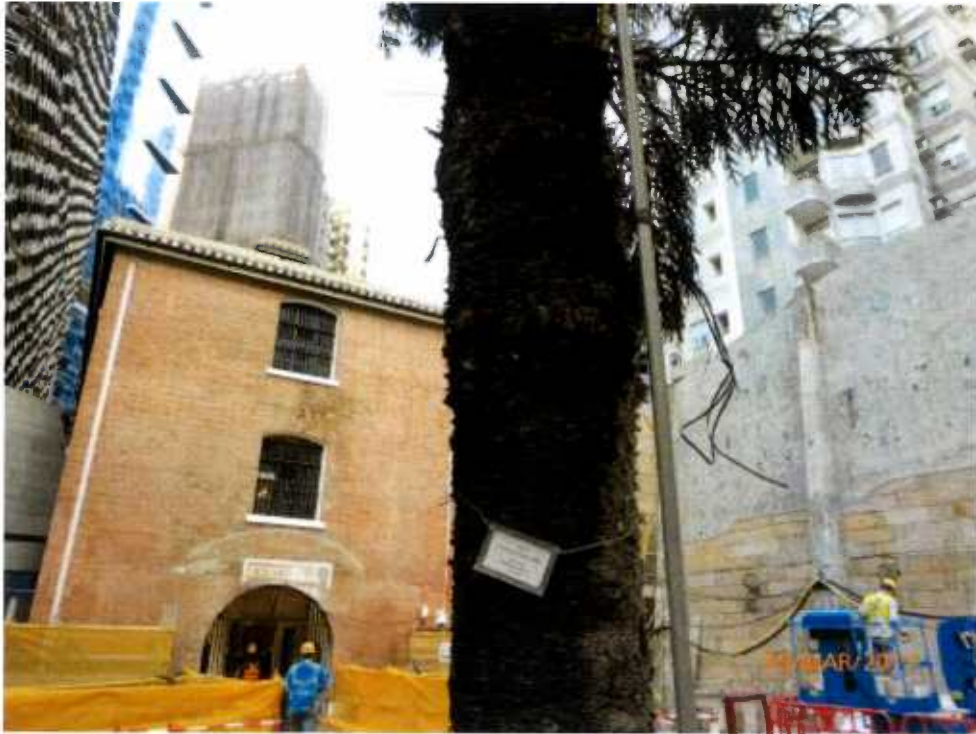
Fig. 5 Health condition of the upper trunk also is fair.

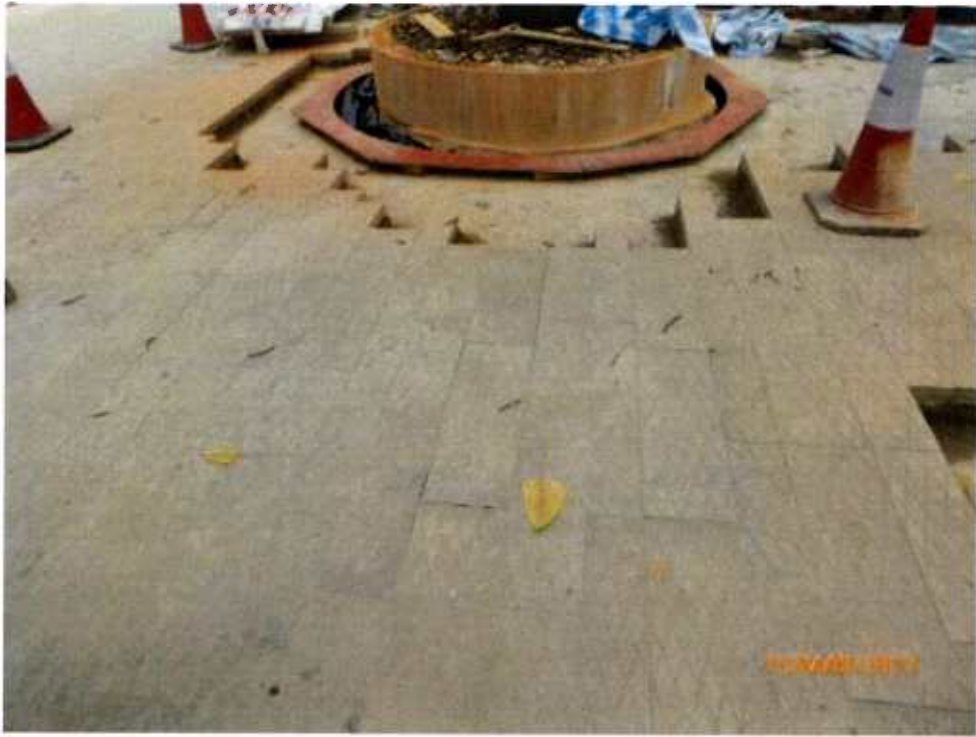
Fig. 11 The access near the tree also appears clean and tidy.

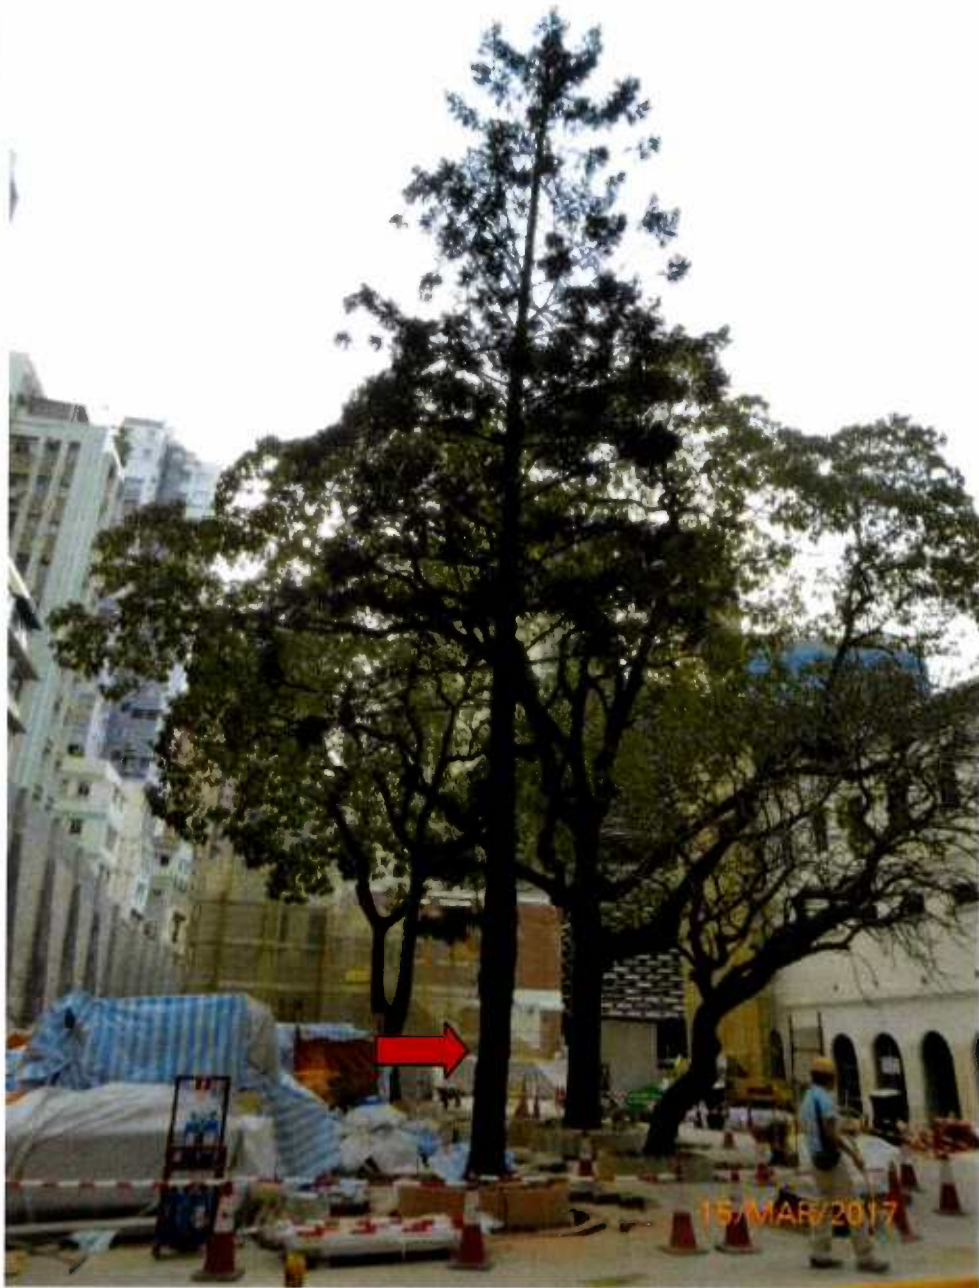
Fig. 12 Overall view of Tree-9 during inspection on 15th March 2017.

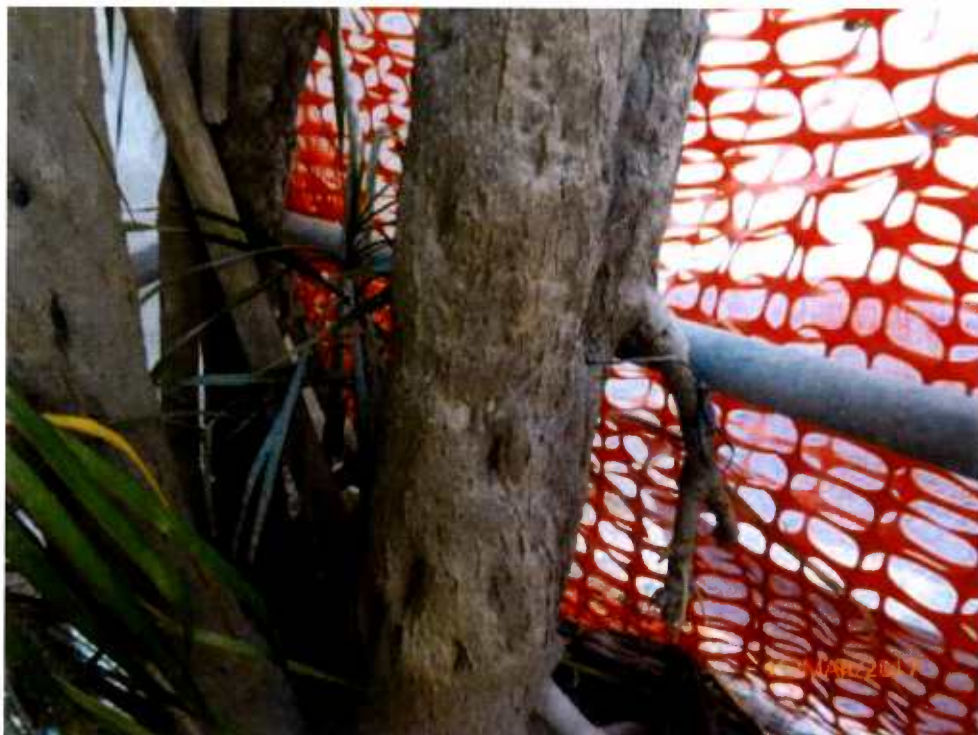
Fig. 5 Health condition of the lower trunk is fair.

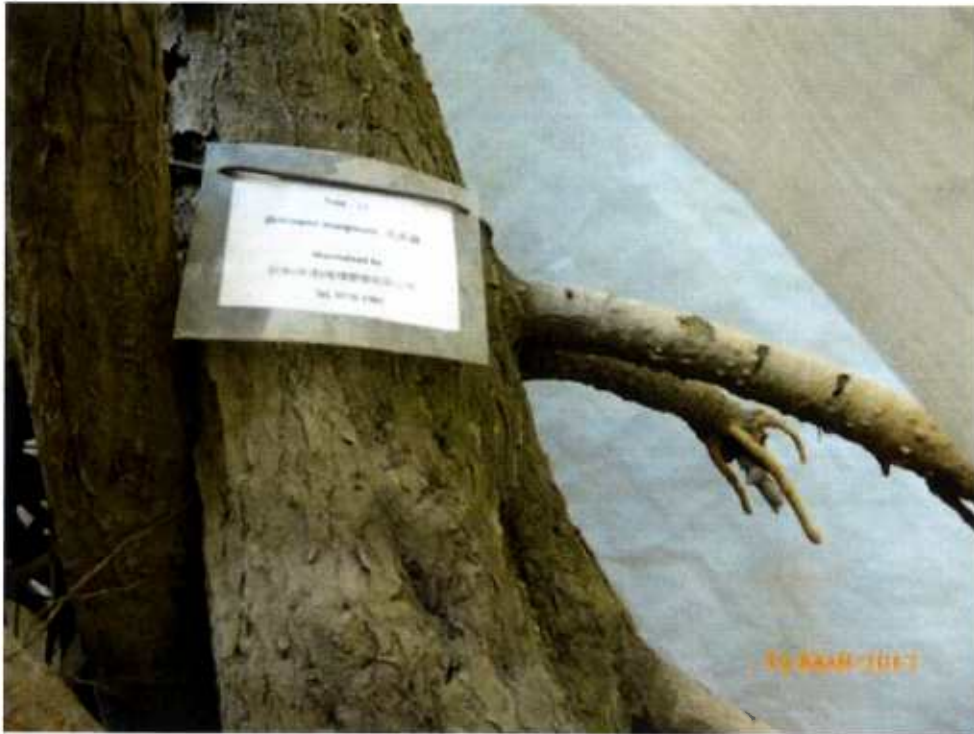
Fig. 6 Health condition of the mid trunk is fair..

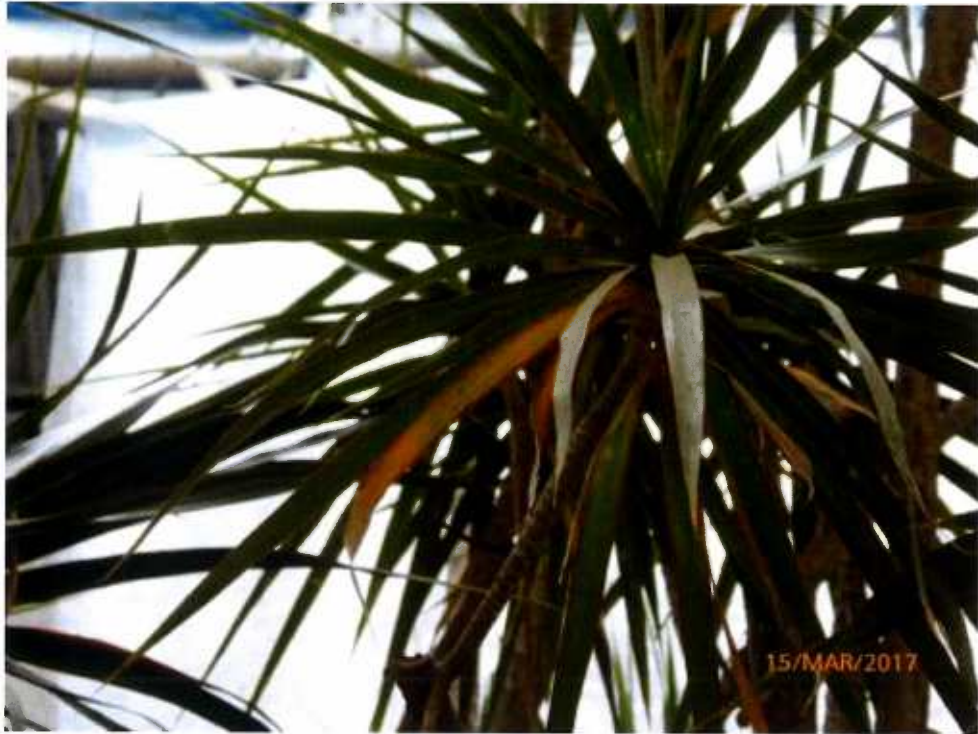
Fig. 8 Some withered leaves still appear on the upper branches.

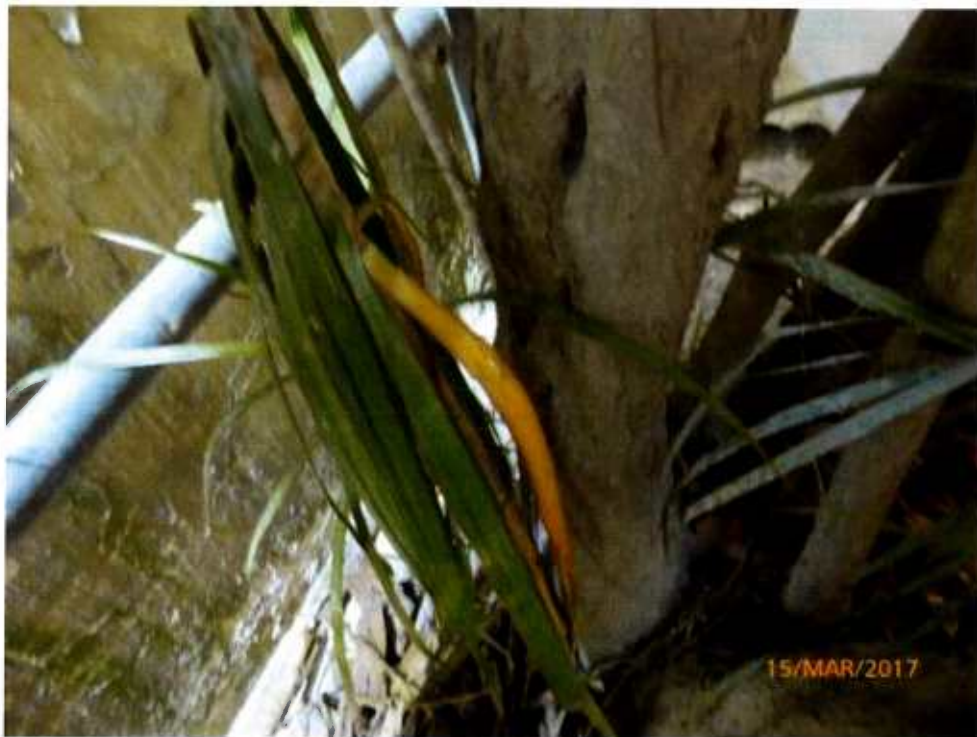
Fig. 9 Withered leaves also appear on the bottom part of Tree-11.

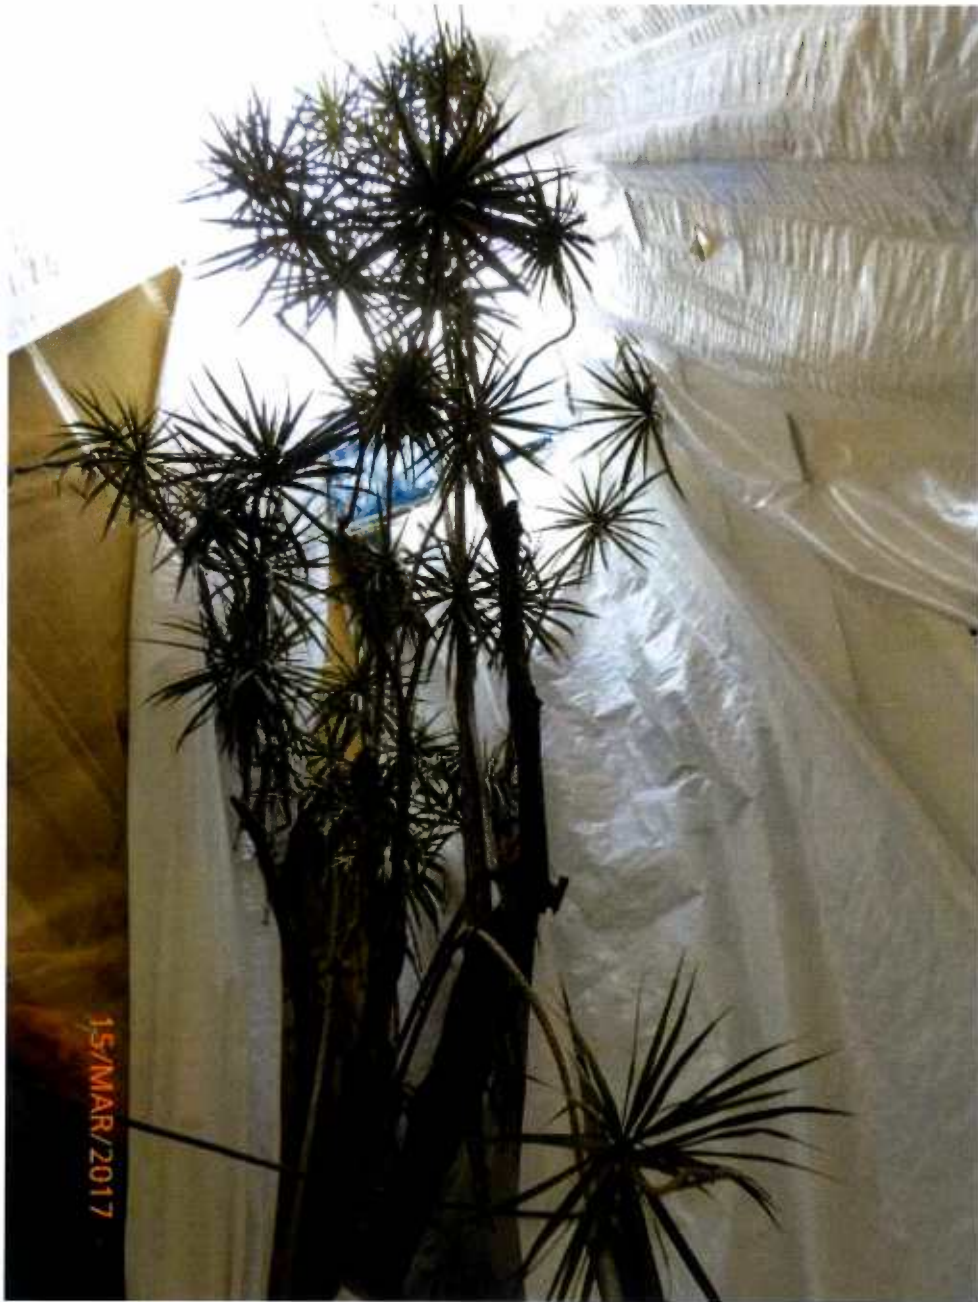
Fig. 12 Overall view of Tree-11 during inspection on 15th March 2017.
